Report on the Restoration of the East Gate,

Ta Nei Temple, Angkor, Cambodia

2019 - 2022

Tokyo National Research Institute for Cultural Properties (TOBUNKEN)

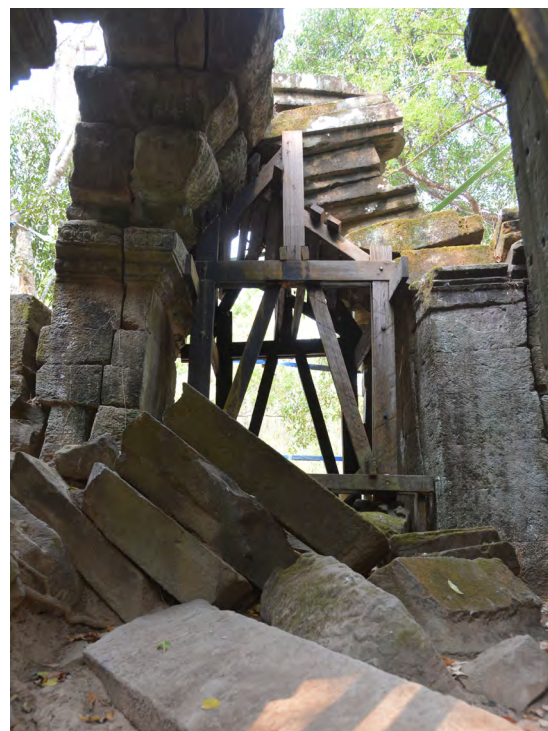
Figure 2.1.4 Inside the East Gate before restoration

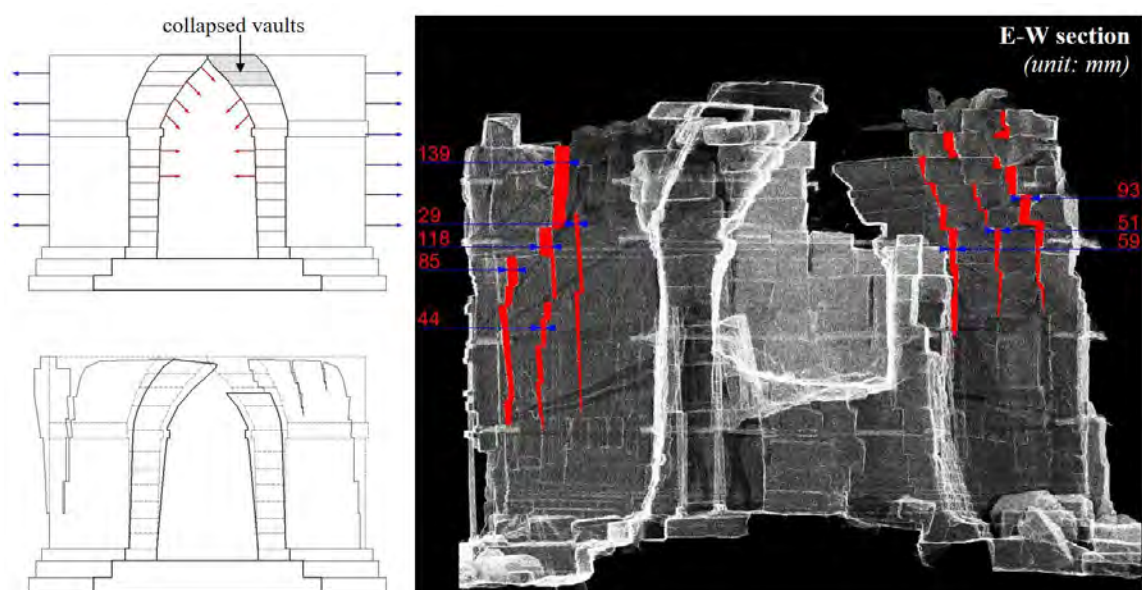
Figure 4.1.9 Example of risk and damage assessment with 3D laser scanning

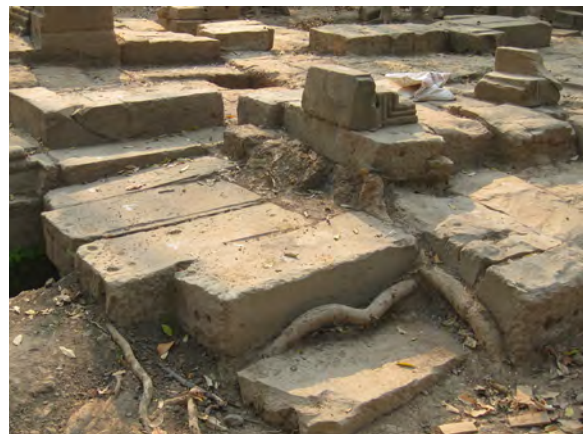
Due to partial subsidence in the dismantled base structure area, adjustments were made during reassembly. Adjusting the northern half of the western wing, done from the bottom of the base structure, posed challenges but was eventually completed within the determined scope. When adjusting the level of the sandstone in the layer corresponding to the floor, efforts were made to

Figure 8.3.1 Conditions inside the base structure during the dismantlement

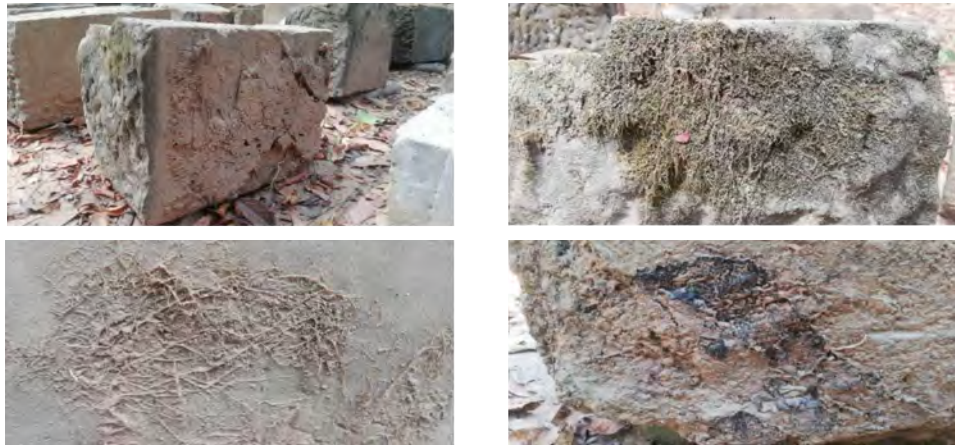
Figure 9.1.1 Examples of stone damage

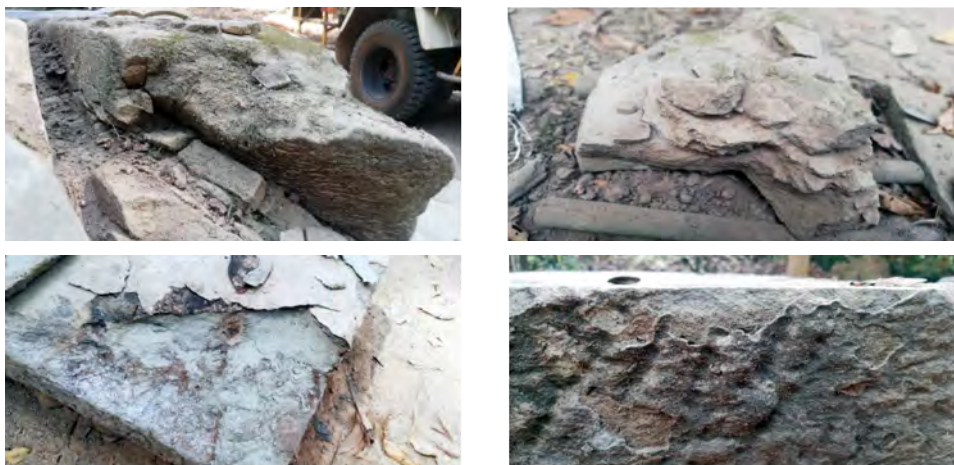
Figure 9.1.2 Examples of stone decays

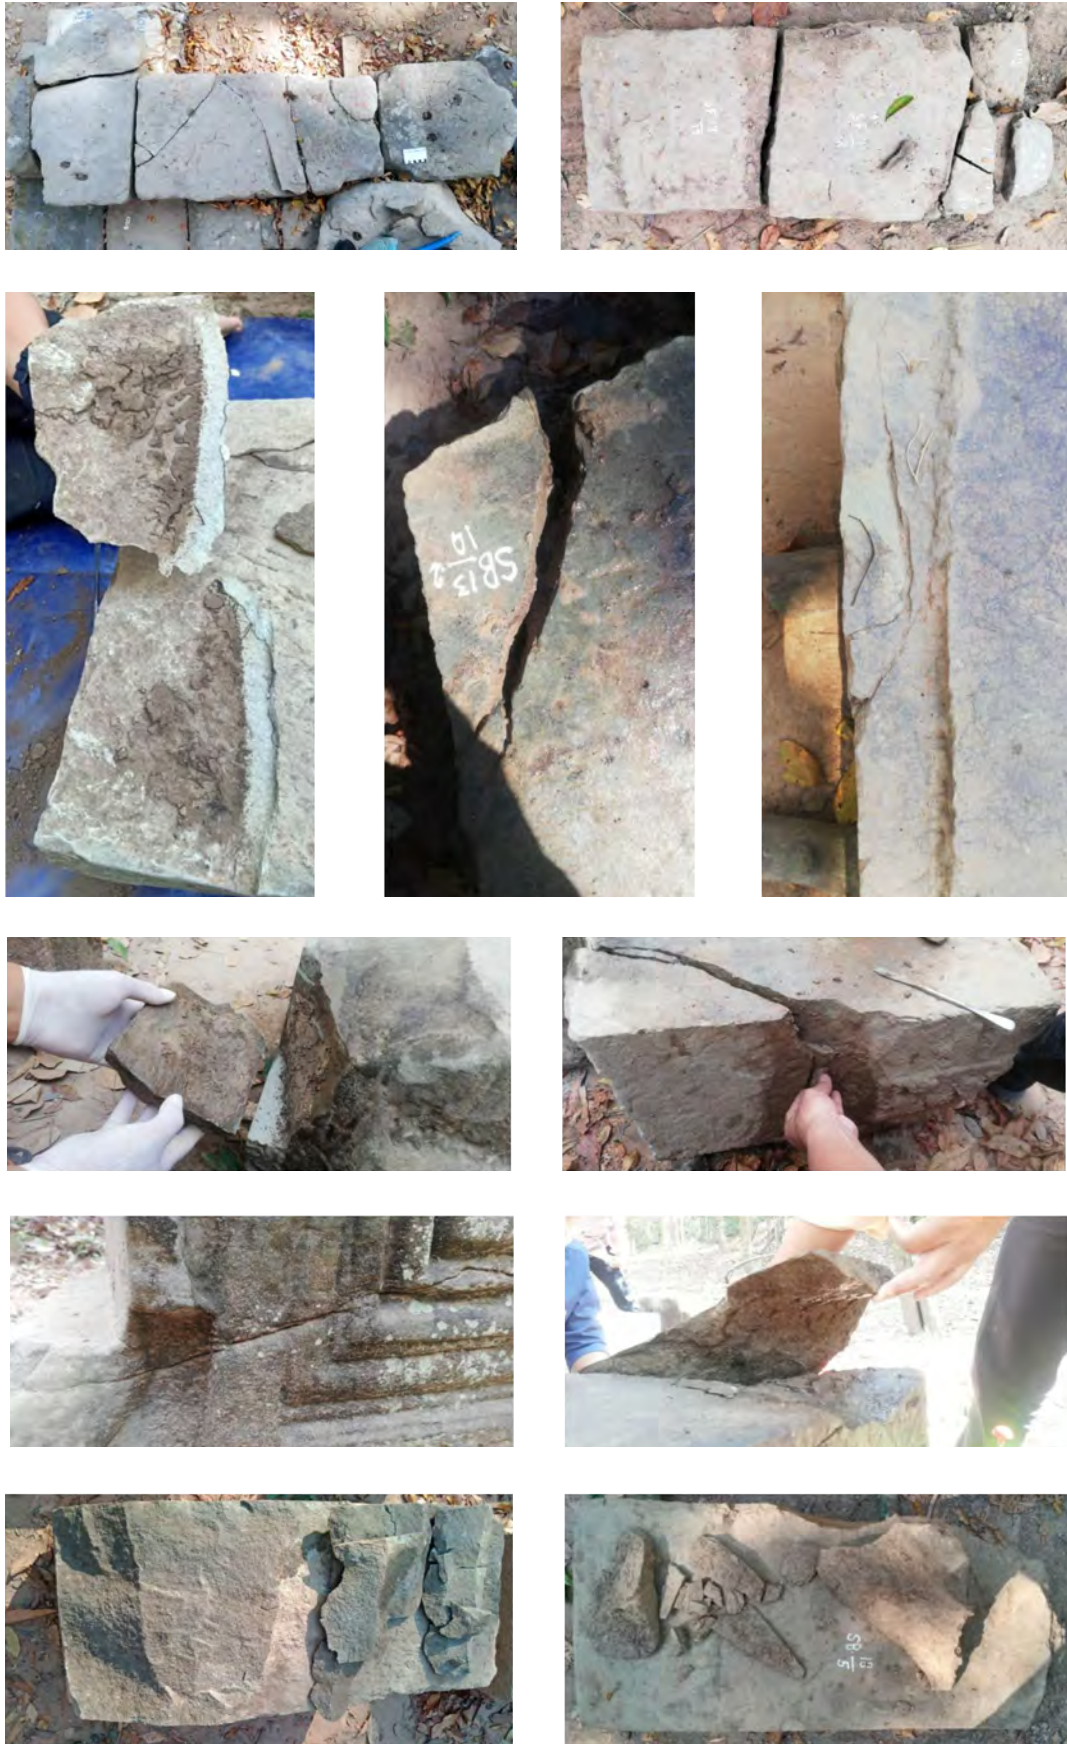
Figure 9.1.3 Examples of stone cracks

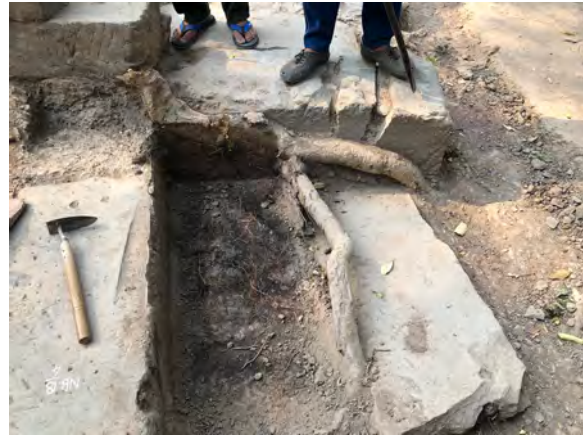
Figure 9.2.27 Tree root's penetration of the base structure

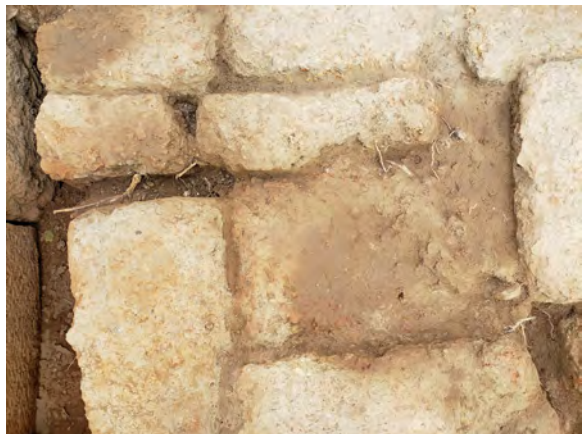
Figure 9.2.29 Situation of the penetration of tree roots

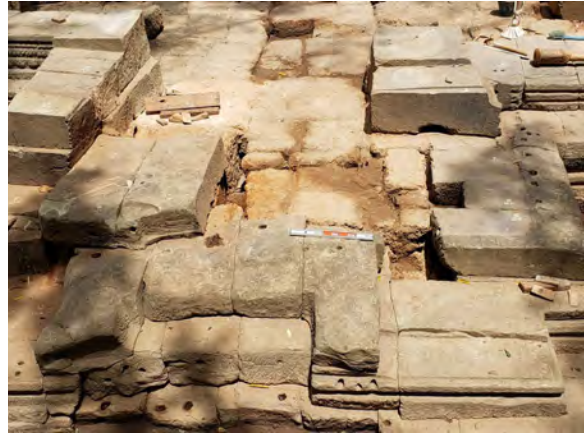
Figure 9.2.33 Deteriorated substrate laterite in the east wing

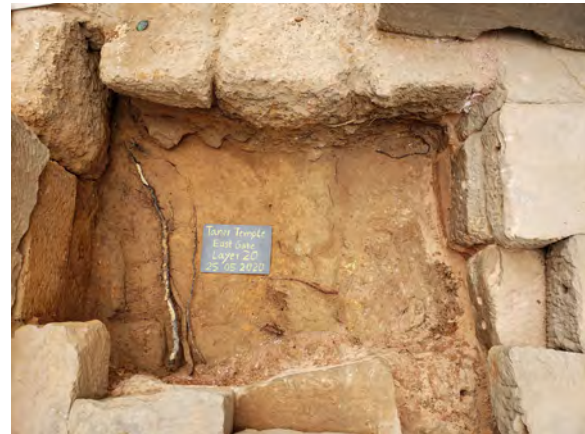
Figure 9.2.35 Condition of the compacted soil below the deteriorated substrate laterite in the east wing

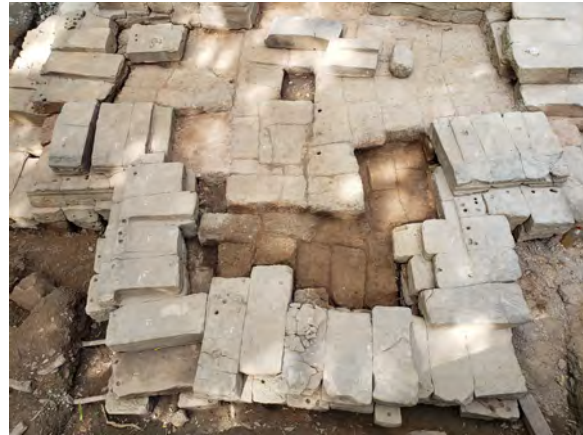
Figure 9.2.39 Condition of the substrate laterite in the west wing (Layer 19)

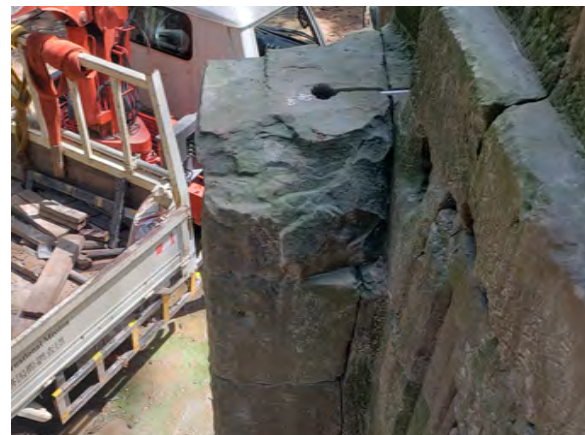
Figure 9.2.71 Deteriorated top surface of the pillaster at the southwest corner
