大般若経厨子

平成11年度修復事業

品名：大般若経厨子

所蔵：クリーブランド美術館 アメリカ合衆国

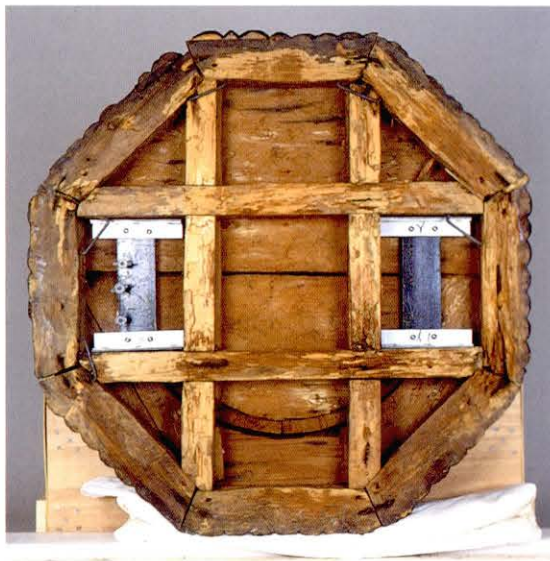
7 底部 (修復前)
Underside of the shrine (before restoration)

10. Condition of the underside of the base after removal of the plywood board covering it (Fig. 7)
11. Relationship between the body and the base (Fig. 58)

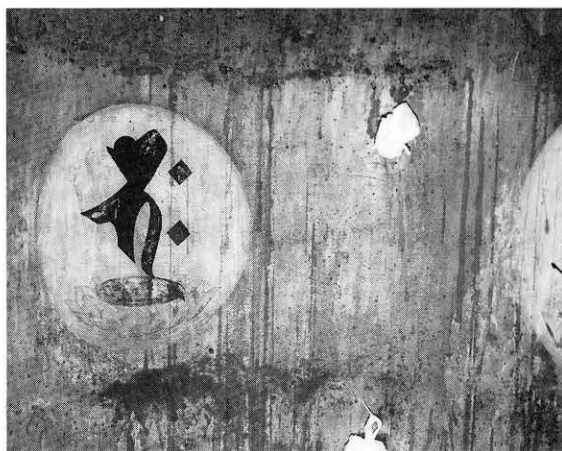
図37 種字
Sanskrit letter

4. Condition of the colored parts on the inside surface of the body—stains on the color of the Sanskrit letters probably due to rainwater from above (Fig. 37)

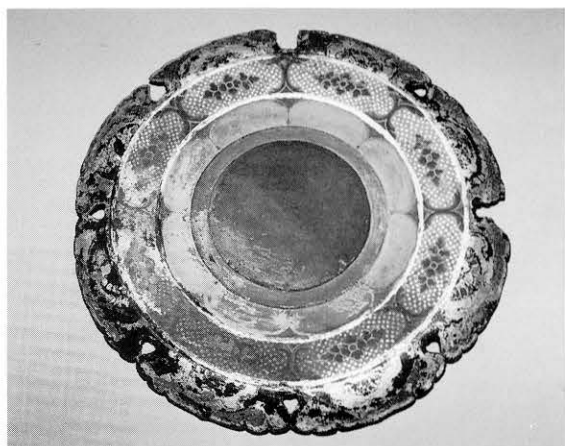
図41 天蓋
Ornamental canopy

5. Damage to the colored portion and metal fittings of the doors (Fig. 55.1)
6. Stains and changes in the color of the ornamental canopy and damage to its substrate (Fig. 41)

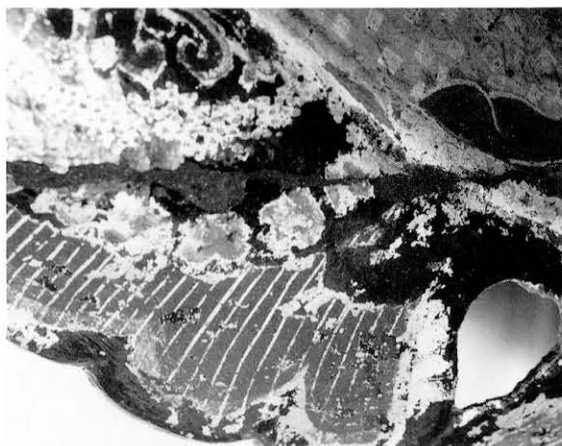
天蓋 素地の矧目に沿って布着せして補強してあった所が割れ、花形の一部分が欠失している。当初は花卉数ヶ所に鉄釘を打ち、それに紐を結び、屋蓋内側から釣り下げていたと思われる、錆びた鉄釘が残っている（図45）また裏面に天蓋を屋蓋に取り付けるために後補鉄製のボルトが取り付けられている（図44）。

図44 天蓋の亀裂
Cracks on the ornamental canopy

Ornamental canopy: There were cracks along the joints of the substrate (Fig. 44), and parts of the floral pattern were damaged and lost. Since there are some rusted nails on the roof (Fig. 45), it is believed that originally iron clamps had been nailed into several places and that strings were attached to these clamps to suspend the canopy from the roof. Now there is a metal bolt on the rear side of the ornamental canopy (Fig. 44).

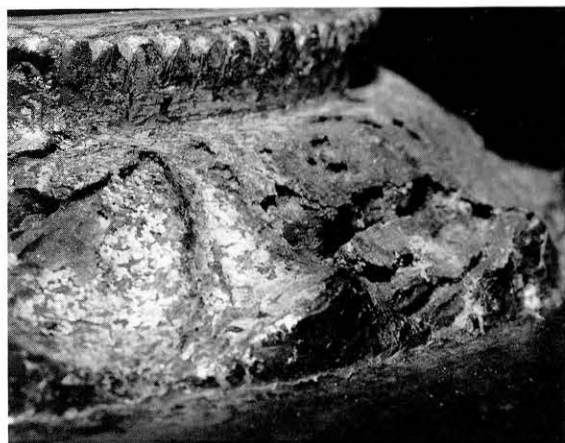
宝珠 蓮華座に虫蝕が全面に見られ（図42）木目に沿っての割れ、欠損、素地の空洞化のため、塗膜の欠損も各所にある。

図42 虫損のある宝珠蓮華座
Lotus pedestal with holes made by insects

Holy jewel: Holes made by insects were found all over the surface of the lotus pedestal (Fig. 42). The urushi coating was damaged and lost at several places by cracks along the grain, breakage, or hollows in the substrate.

2. Condition of damage by insects on the lotus pedestal below the holy jewel (Fig. 42)
3. Damage to the substrate and urushi coating of the roof (Fig. 54)

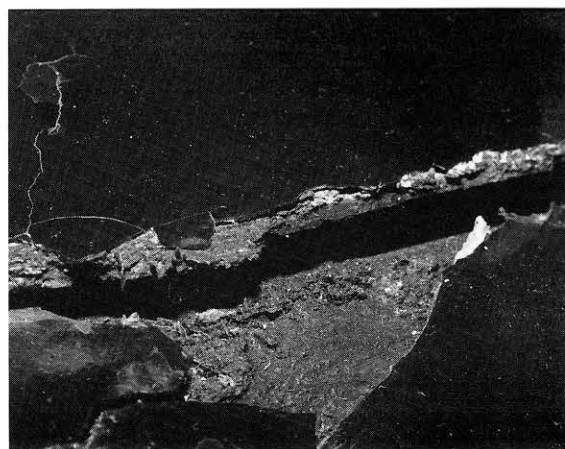
屋蓋 素地の矧目の割れのため、塗膜の剥落と共に素地の矧目に大きな隙間が生じている。又、矧目を接合するために埋め込んだ柄が2ヶ所あるが、実際にはつなぎの役割を果たしていない（図43）。

図43 屋蓋の割れ
Cracks on the roof

Roof: The urushi coating had come off due to cracks along the joints of the boards, which in turn had caused considerable openings between the boards (Fig. 43). In addition, two of the pegs that had been used to join the boards did not actually serve their function.

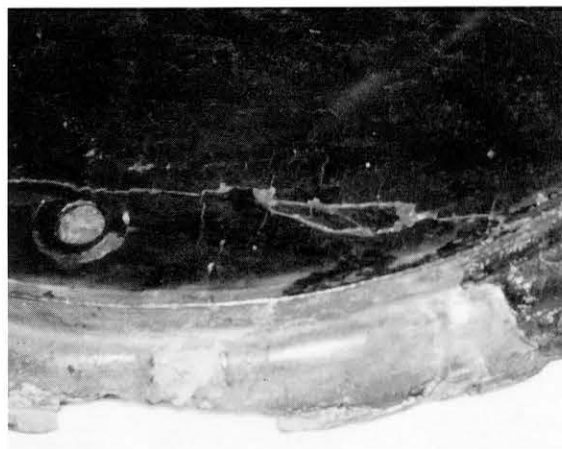
左側金具の鑲が欠失している。軸部内に据えられた十六葉蓮華座円盤の一部が塗り直され、銀化している。また、各所に虫蝕いによる欠損がある（図46）。

図46 虫損部分
Front of the top board of the base damaged by insects

lost places that had been later simply patched with no coating applied. The colored surface inside had remained in a stable condition on the whole, but there were some places where cracks in the urushi coating underneath had extended into the colored surfaces. The ring of the left metal fitting had been lost. A part of the disk of the 16-petal lotus pedestal inside the body had been retouched and its color had changed. There were also several places that had been damaged by insects (Fig. 46).

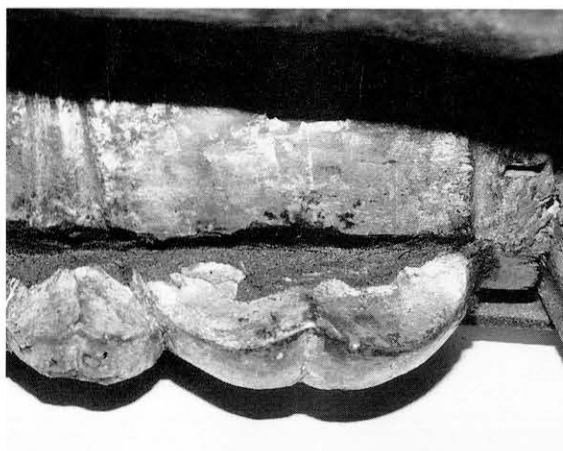
基部 天板の矧目と八材を寄せた蓮華座の接合部が素地から割れ、塗膜が大きく剥落している。また各所に虫蝕により欠失した所もあり、蓮弁の欠失箇所の後補の蓮弁が接合されている。蓮華座の水平位置がずれている所もあり、平成9年4月に催された「奈良国立博物館名宝 一世紀の軌跡」への出品に際し、分離していた蓮弁先の一部を応急的に麦漆で接着し、隙間に木屎漆を充填した（図47）。

図47 木屑を充填
Filling kokuso

Base: There were cracks in the substrate along the joints of the floor and also along the joints of the 8 boards of each of the lower 2 lotus pedestals. As a result, the urushi coating had fallen greatly at those places. In addition, there were several places that had been lost due to damage by insects and had been later restored with replacement lotus petals. Parts of the lotus pedestals were not in horizontal alignment, and when the object was displayed in the "Masterpieces from the Collection of the Nara National Museum" exhibition in April 1997, the tips of some of their petals that had been split were bonded with *mugi urushi* as an emergency measure and their openings were filled with *kokuso* (Fig. 47).

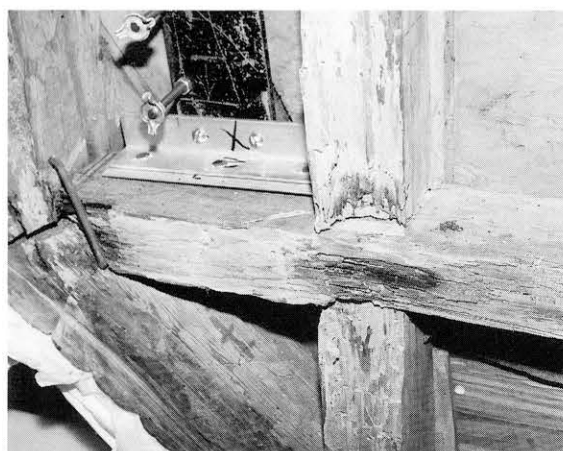
底面に後補の薄手の合板が木ネジによって張り付けられているが、これを外した所、井桁に組まれた各材及び周縁の蓮華座の八材が虫蝕により空洞状になっていて、厨子全体の重量を支える役割を果たしていない。これを支持するために応急的に鉄製のアングル（図48）が組み込まれ、数本の洋鉄釘が打たれている。又、虫蝕部分の所々に修理のために黒色の樹脂を浸透させたと思われる箇所がある。この樹脂修理についての記録はクリーブランドには残されていない。

図48 鉄製のアングル
Iron angle bar

A thin plywood board had been attached to the bottom and fixed with wooden screws. When this board was removed, it was found that all of the *igeta* wood members and the 8 boards of the peripheral lotus pedestals had been damaged by insects to such an extent that they were almost hollowed out and consequently could not support the entire weight of the object. For this reason, they were reinforced with iron angle bars (Fig. 48) and several iron nails as an emergency measure. In addition, there were some insect-damaged places where black resin seemed to have been impregnated for repair. But The Cleveland Museum does not have any record of such repairs.

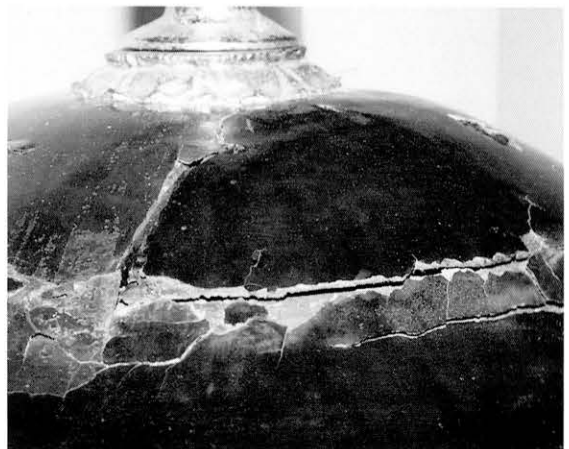
図54 屋蓋の素地と塗膜の破損状態
Damage to the substrate and urushi coating of the roof

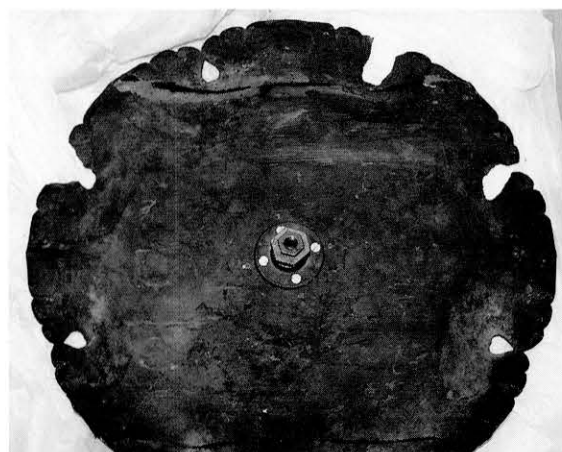
図60 天蓋の状態
Condition of the ornamental canopy

12. 16-petal lotus pedestal disk in the body and its condition (Fig. 59-1)
13. Ornamental canopy and its condition—both outside and inside (Fig. 60)
14. Structure of the roof and its condition (Figs. 67, 93 & 111)

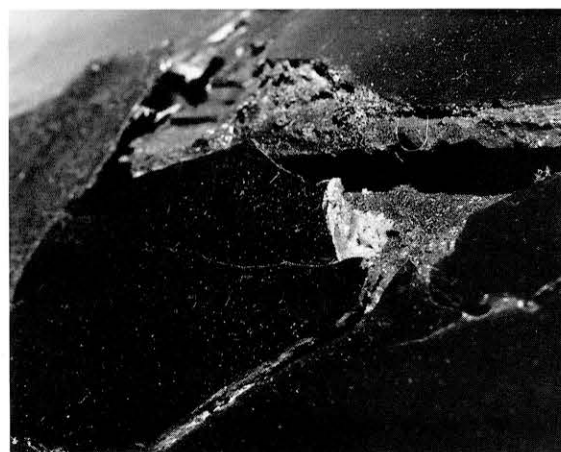
図61 屋蓋の破損状況
Damage to the roof

(15) 屋蓋の破損状態。(図61)

15. Condition of damage to the roof (Fig. 61)
16. Condition of the holy jewel (Fig. 62)

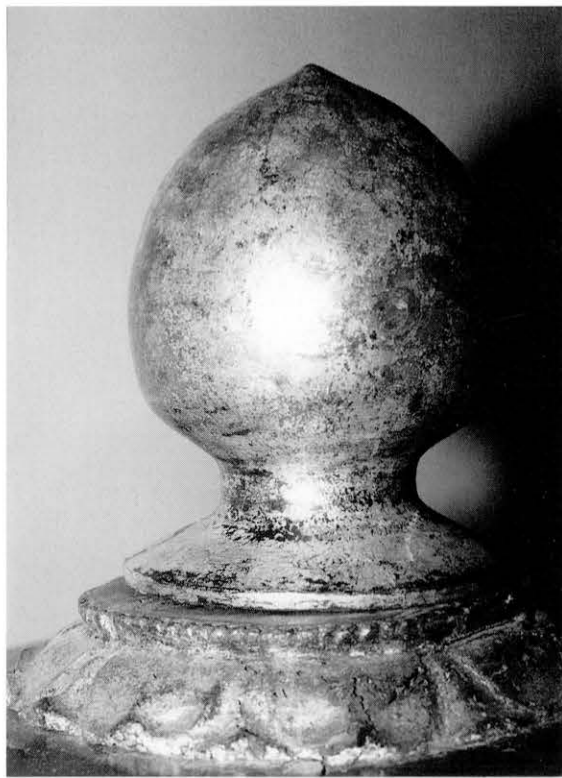
図62 宝珠の状態
Condition of the holy jewel

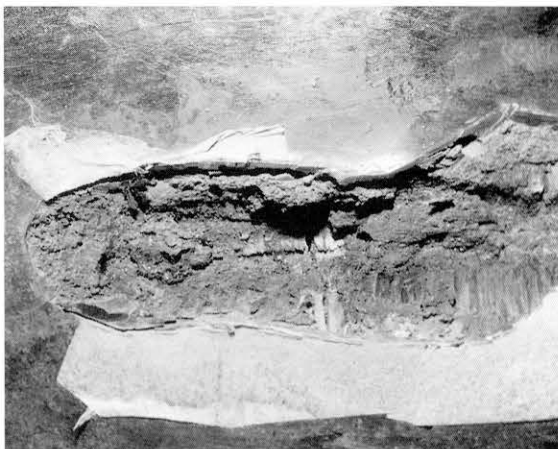
図70 屋蓋の素地割目に打たれていた鉋は錆びて劣化している
Iron clamp on the joints of the roof

(9) 錆びて劣化した鉄釘と鋸。(図70)

9. Deteriorated iron nails and clamps (Fig. 70)
10. Roof frame showing chisel marks and 6 pieces of wooden joint boards (Figs. 71)

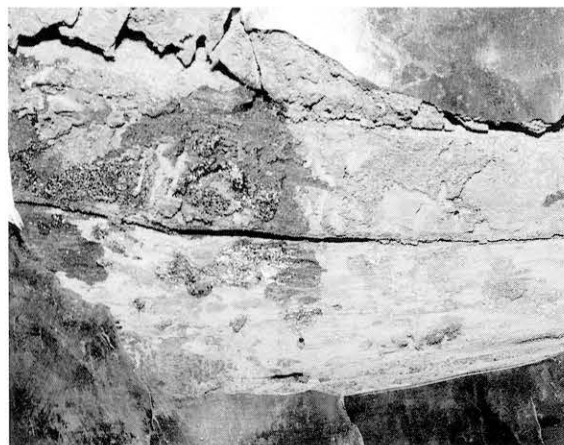
図68 塗膜を剥がした後の屋蓋の素地の状態
Condition of the substrate of the roof after the
urushi coating was removed

(6) 塗膜を剥がした後の素地の状態。(図68)

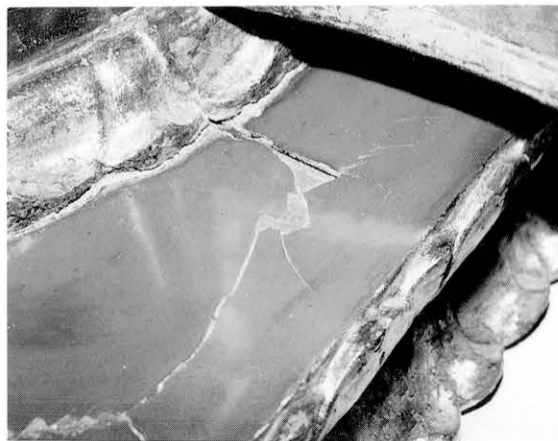
図72 基部の破損状態
Damage to the base

1. Urushi coating of the base before disassembly (Fig. 72)
2. Framework of the disassembled lotus pedestal (Fig. 73)
3. Framework of the lotus pedestal damaged by insects (Fig. 74)
4. Disassembled framework of the lotus pedestal and floor of the base; structural drawing of the *igeta* and framework (Figs. 75-1 & 76-1)

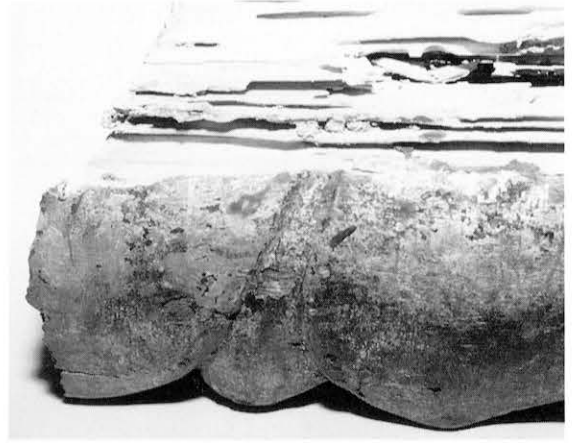
図74 虫蝕によって素地部が欠損した蓮華座
Substrate of the lotus pedestal damaged by insects

(3) 虫蝕によって欠損した蓮華座框。(図74)

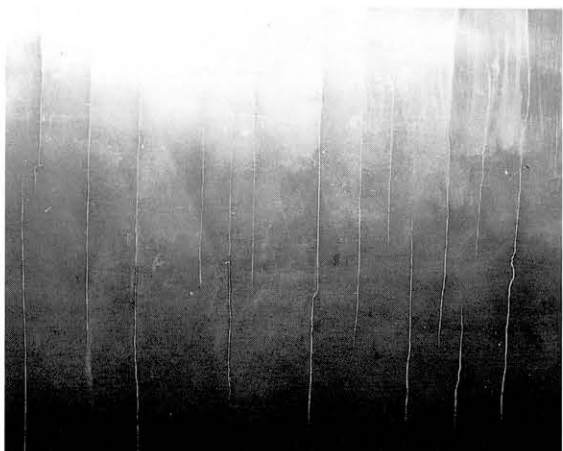
図100 扉の塗膜の亀裂
Cracks on the door

8. Cracks on the urushi coating of the doors (Fig. 100)
9. Large cracks were filled with *kokuso*, and then after urushi foundation was applied, those places were coated with urushi. Raw urushi was impregnated into the small cracks for reinforcement (Fig. 101).
