黒漆兜(雑賀鉢)

平成10・11年度
在外日本古美術保存修復協力事業

品名：黒漆兜(雑賀鉢) (江戸時代16～17c)
所蔵：メトロポリタン美術館 アメリカ合衆国
品質構造：鉄、漆塗
所蔵番号：28.60.3

請負者	田口 善明
修理担当者	田口 善明
原稿執筆	田口 善明

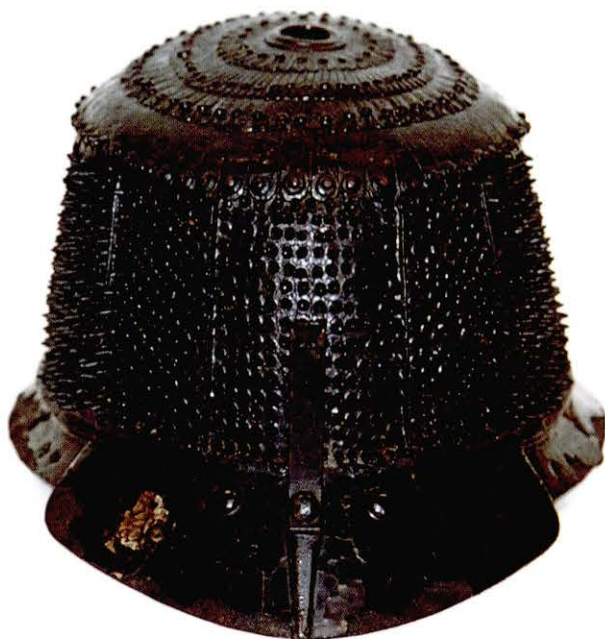
16 黒漆兜正面（修復前）
"Kuro-urushi Helmet" (front, before restoration)

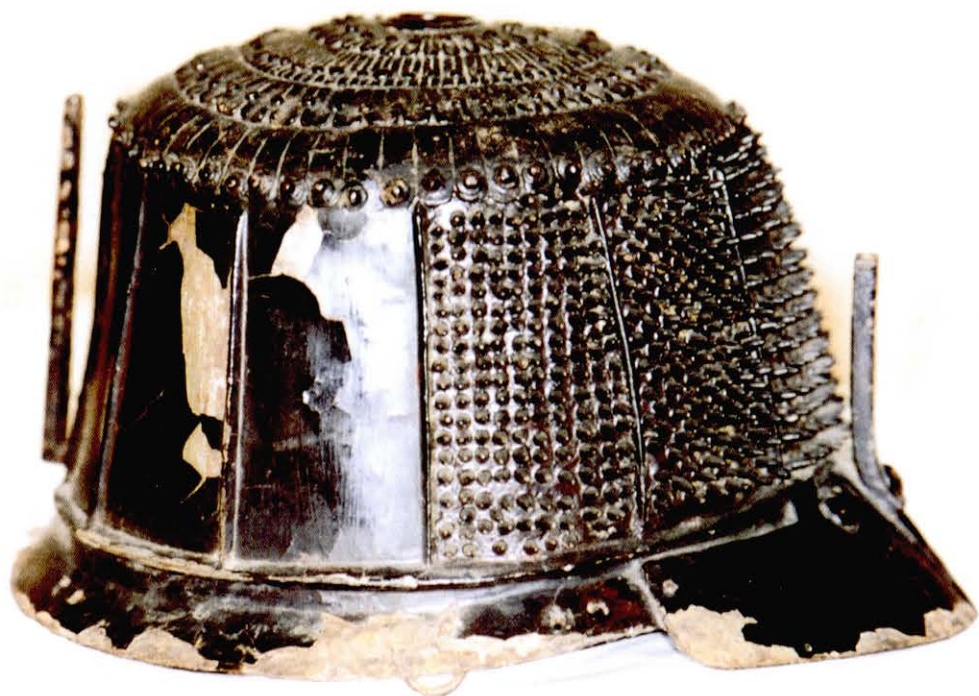
17 黒漆兜側面（修復前）
"Kuro-urushi Helmet" (side, before restoration)

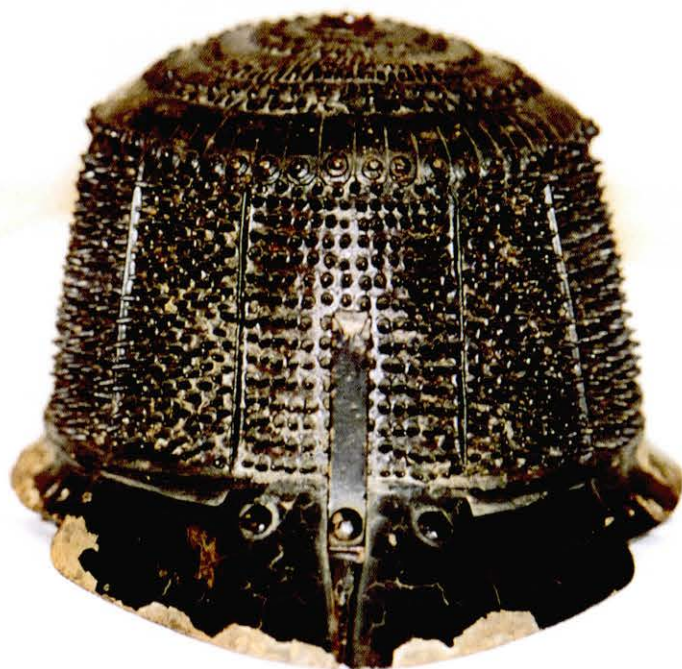
18 黒漆兜正面（修復前）
"Kuro-urushi Helmet" (front, before restoration)

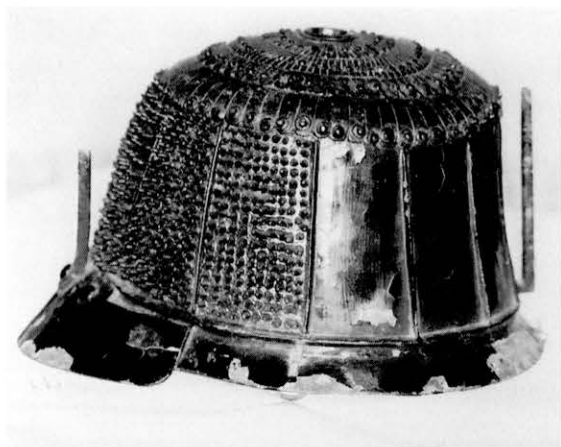
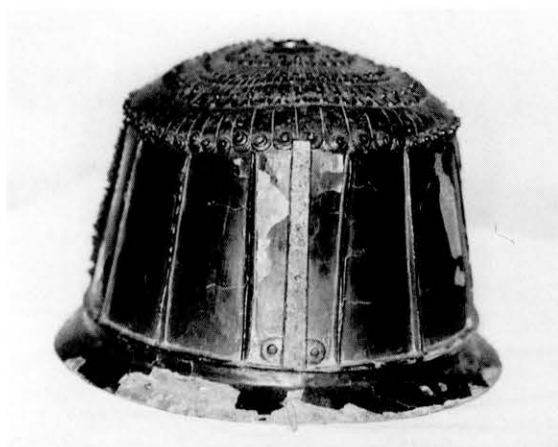
図187 修理前の兜（側面、後面）
Side view of the helmet before restoration

現在、兜の鉄製の鉢のみが残り、鍔や吹返しなどの部分を欠失し、鉢の表面全体に古色を付けている。後方部分の7間からなる筋はとくに損傷が著しく、筋を境に鉄錆が広がり、塗膜が錆によって押し上げられ、浮き上がりによって所々に罅が生じ、数箇所に塗膜の欠失を見る。また、この部分に後補の修理がなされた形跡を確認した。

眉庇、腰巻部分は内側と外側、共に漆塗膜に罅が生じ、それによる漆塗膜の剝離、欠失が見られ、欠失した漆塗膜の下から布が露出している。

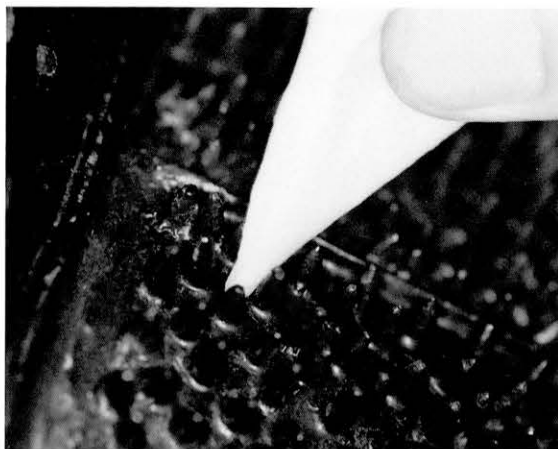
図190 小星部分のクリーニング
Cleaning the tack heads

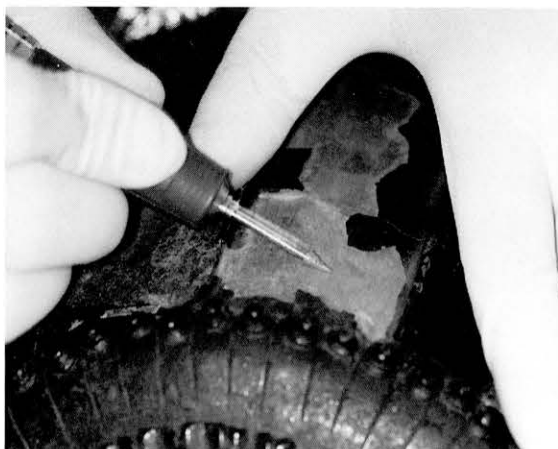
図193 地金と塗膜裏の錆除去
Removing rust on the underside of a removed urushi coating film

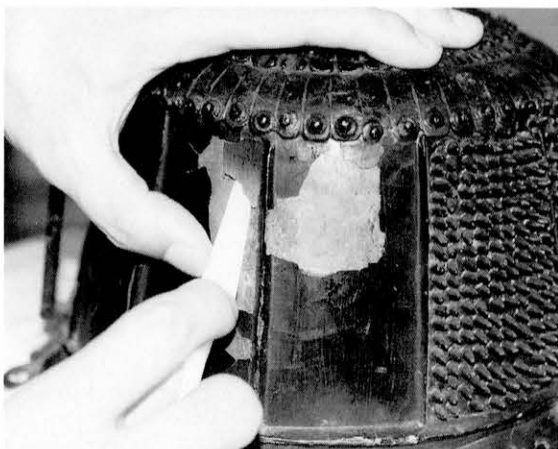
図191 浮き上がった塗膜の一時避難
Temporary removal of a lifted portion of the urushi coating film

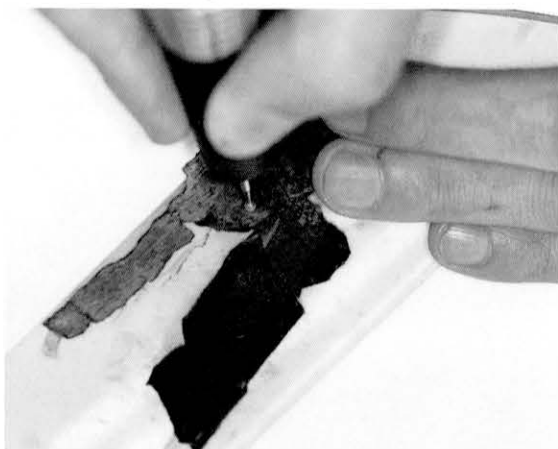
図194 リューターによる塗膜裏の錆除法
Removing rust with an air turbine

厚みのある塗膜は、リユーターの先端にダイヤモンド粉末を付着した刃を装着して、錆の除去を行った。

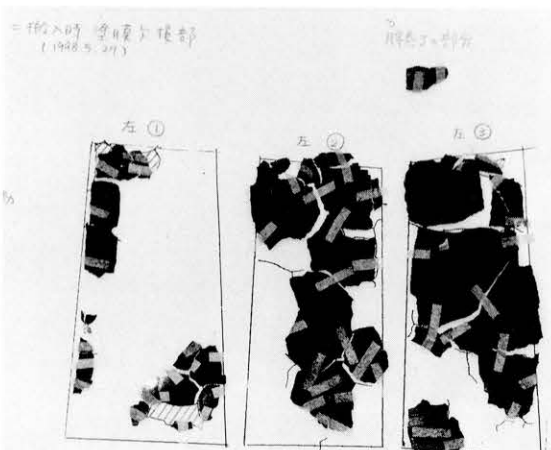
図192 塗膜の一時保管
Temporary storing of the removed urushi coating film

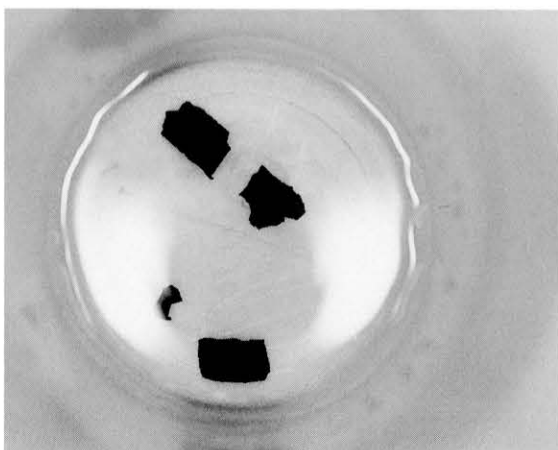
図195 酸による塗膜裏の錆の除去
Removing rust with acid

極めて薄い塗膜裏面の錆は、10%の塩酸水溶液に浸け、30分おきに引き上げ、刷毛で裏面の錆を少しずつ洗い流してゆき、90分後、完全に錆を洗い落とした。その後、5%の重曹水溶液に浸け（一瞬泡立ち、気泡が出なくなれば中和されたことになる）気泡が出なくなるのを確認し、水洗いした後、リトマス紙でPHを測り、最終的に中和を確認した。

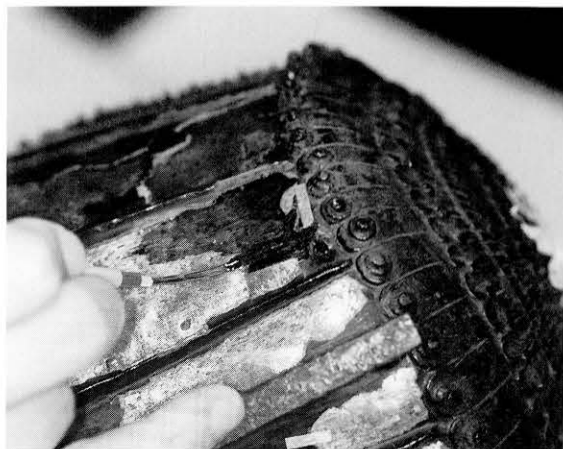
図196 劣化塗膜補強と防錆処理
Anti-corrosive treatment

- ・兜表面の劣化塗膜に対して、生正味漆にリグロイン溶剤を加えて希釈した漆を含浸させ、表面に僅かに残留した漆を拭き上げて自然乾燥を行った。場所によっては、これを数度繰り返し、劣化した塗膜を補強した。
- ・別置した後方7間の塗膜の防錆処理の方法として、露出した鉄地表面に素黒目漆を薄く2度塗り込み、密閉性をよくした後、保管していた塗膜の貼り戻しの際に、密着性をよくするために蒔地を行った。

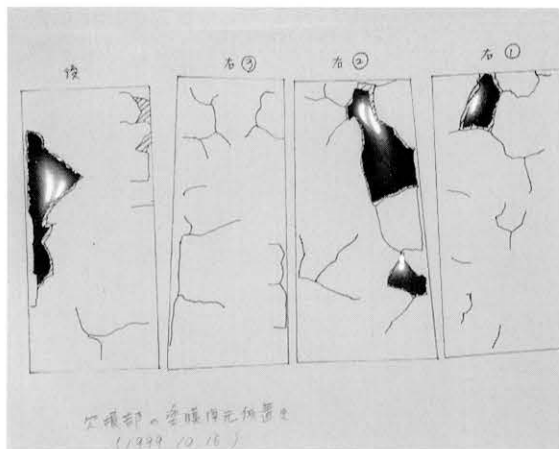
図198 塗膜欠損部分の復元
Reproducing the missing coating film

- ・周囲の漆塗膜との調和を図るため、同じ方法で漆塗膜を製作し、欠損部分に象眼して接着治具で押えた。

横10cm、縦15cm、厚1.5cmの石膏版に離型剤として、水で希釈した米糊を数度含浸させ、乾燥後、地漆を薄く付けて素黒目漆を3度塗り重ねる。その後、裏の石膏面から水を浸透させ、離型剤の糊を溶かして漆塗膜を剥離して、欠損部分の形に切り取り、象眼を行った。

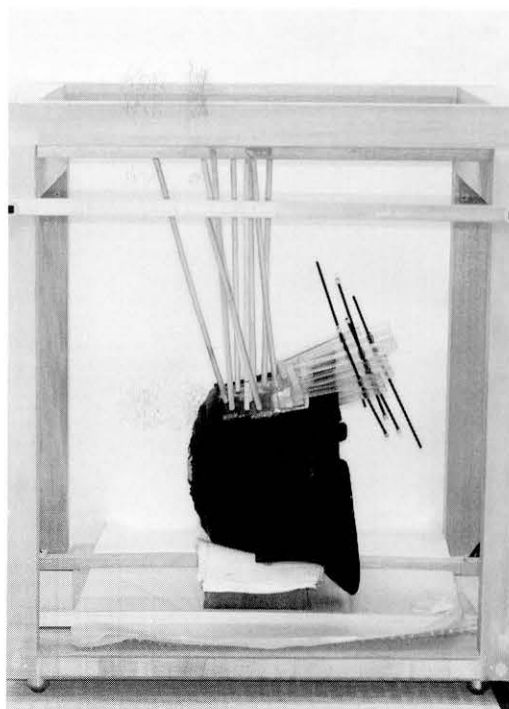
図197 浮き塗膜及び保管塗膜の貼り戻し
Re-fixing the urushi coating film

- ・塗膜を接着する際に、麦漆を用いた。麦漆は糊漆よりも接着力があり、膠漆よりも扱いやすく、溶剤で希釈したときの浸透性もよい。
- ・接着の際に使用した接着治具は、方形の丈夫な桝縁の間に棧を差し込み、桝の中に修理作品をいれ、圧着を必要とする部分に細くしなりのある竹の棒を当て、桝縁の棧に引掛け竹の張りを利用し、浮き上がった塗膜を4～5日間押えて漆の乾燥を待つしんばり方法と、接着治具を必要としない部分にはプラスチック製の軽いクランプで押えて圧着を行った。塗膜の圧着には、漆の乾燥に適した夏期に集中させ、1回の塗膜接着に要した乾燥の日数は4～5日であった。

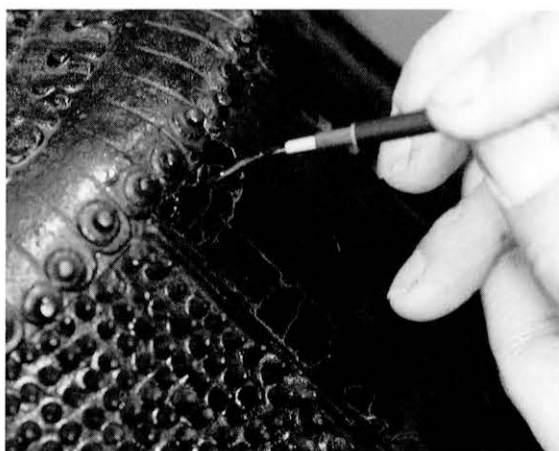
図199 色合わせ
Matching colors

- ・オリジナル塗膜と貼り戻した漆塗膜の境目に麦漆を充填し、埋められた罅の表面を共漆と線描き用の蒔絵筆を用いて薄く2度塗りかさね、周囲との調和整えた。

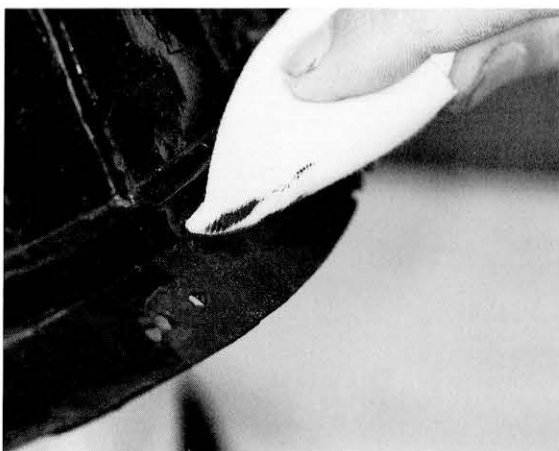
図200 隅錆
Applying *sabi* foundation to the edges

- ・手擦れで漆塗膜が再び浮き上がらないよう、塗膜の際に黒錆漆を付け、拭き上げて僅かに塗膜の隙間に黒錆漆を残した。

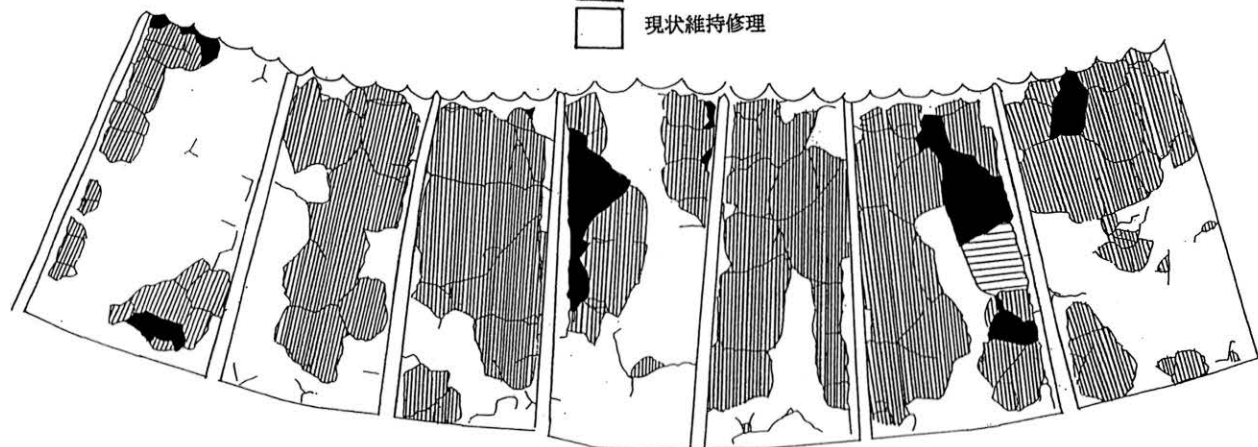
図201 黒漆喰後7間の展開図 (修復後)
Illustration of the back 7 sections
(after restoration)

復元された塗膜

保管された塗膜の貼戻し
 	錆除去を終え貼戻された塗膜
 	現状維持修理

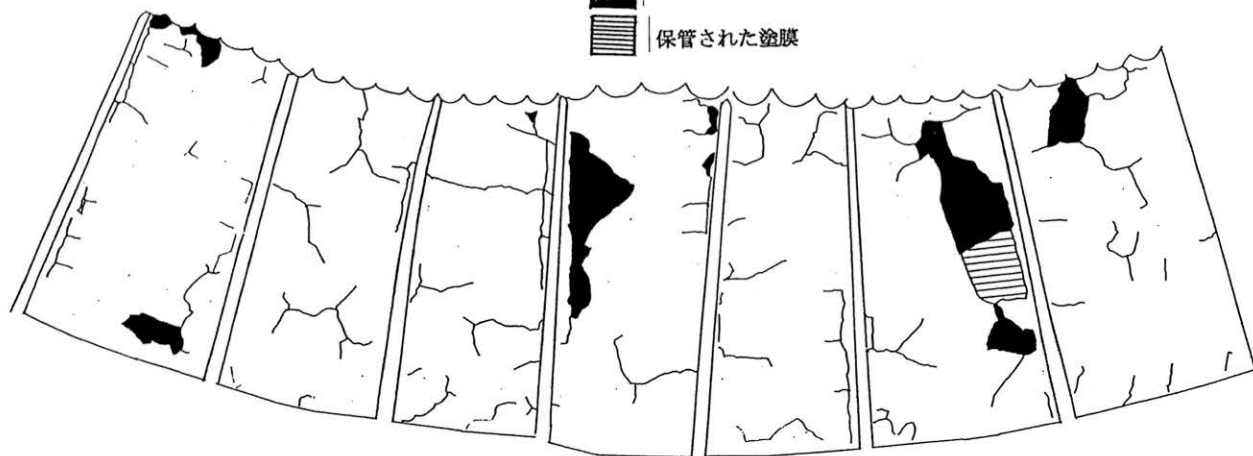
図202 黒漆喰後7間の展開図 (修復前)
Illustration of the back 7 sections
(before restoration)

修理前、漆塗膜の状態

欠失した漆塗膜

保管された塗膜
