菊文螺鈿鞍

平成11年度補助事業

品名：菊文螺鈿鞍

文化庁の事業として平成9年度からスタートした在外日本古美術品保存修復協力事業(工芸)のうち、アメリカ・メトロポリタン美術館所蔵「菊文螺鈿鞍」一背の保存修理が、平成10、11年度の2ヶ年に亘って行われ、平成12年3月末に完成した。これはその修理記録の概要である。

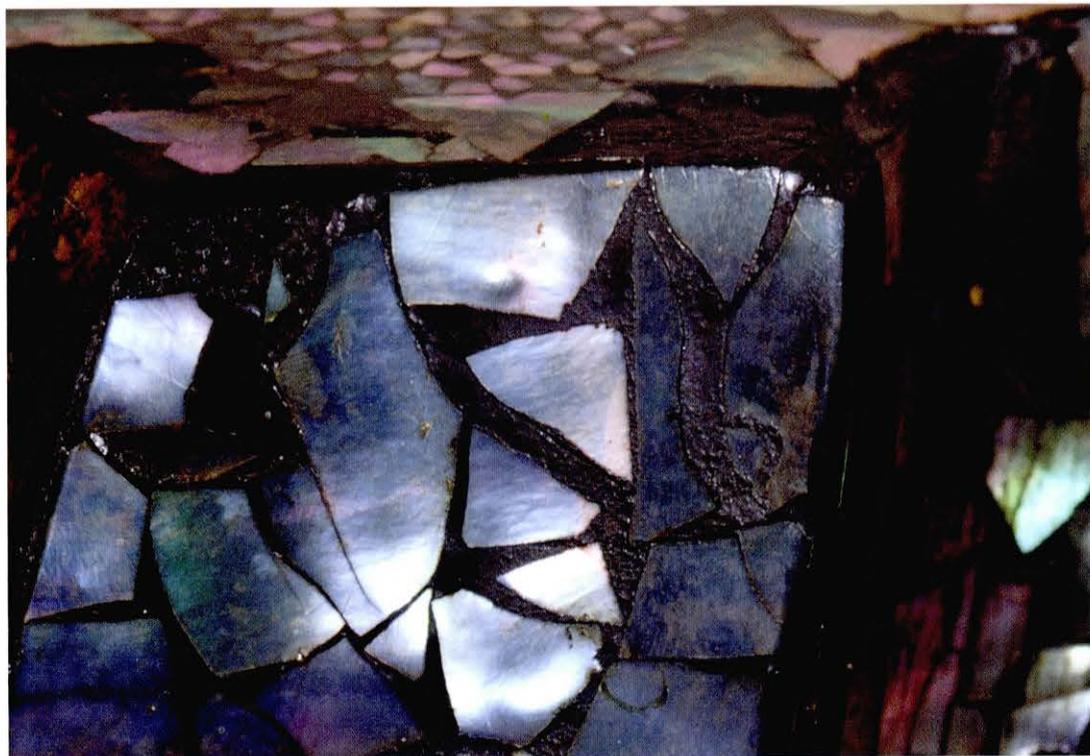
21 螺鈿の部分(修復後)
"Kikumon Raden Saddle" (detail of the *raden* parts, after restoration)

前輪、後輪、居木それぞれの受台をバルサ、コルク、シリコンなどを用いて製作した。剥離した螺鈿の空隙部分に接着用に調合した麦漆をリグロインで希釈、筆で含浸し、余分な漆を拭き取った。漆が乾燥しないうちに剥離箇所にビニールシートやプラスチック板を置き、木枠と竹や木製のヒゴを用いて部分ごとに抑えた。

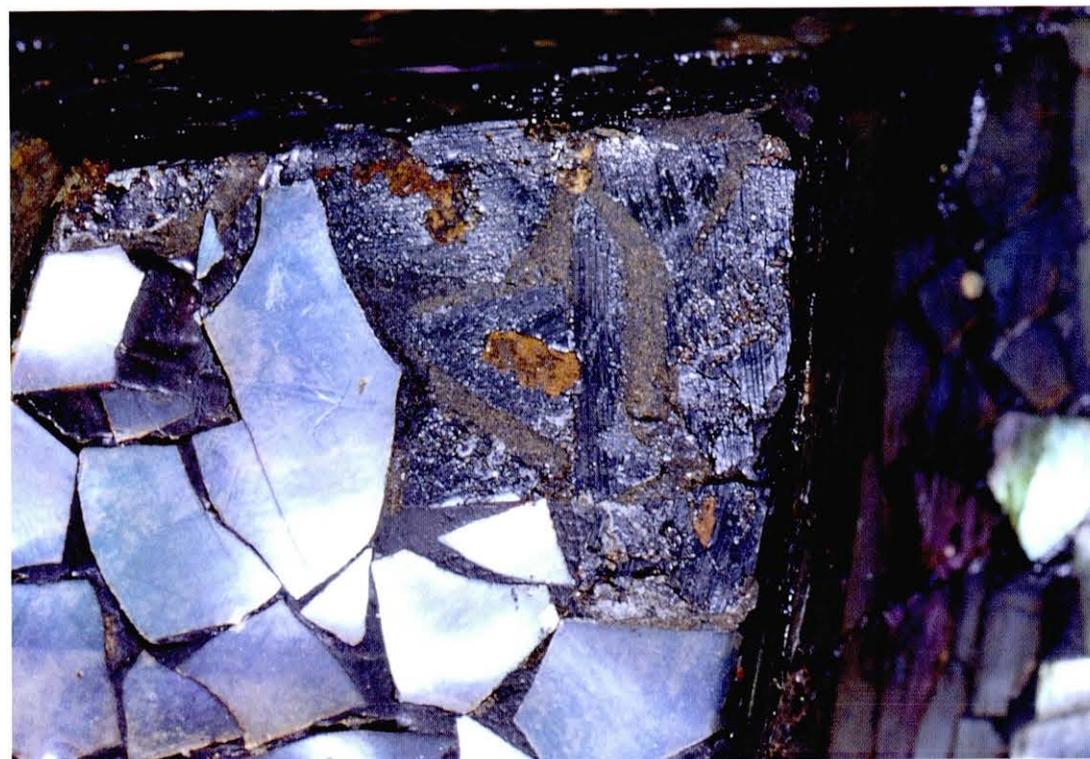
22 螺鈿の部分(修復前)
"Kikumon Raden Saddle" (detail of the *raden* parts, before restoration)

両輪と左右の居木は鞍橋を解体した状態で搬入されたが、前輪の左切り組み部分に素地の割れが認められ、すでに鉄の鏝が打ち込まれていた。鞍の全面に加飾された螺鈿は剝離や剝落が著しく、非常に危険な状態であった。また、すでに剝落した螺鈿が数多く付属していた。

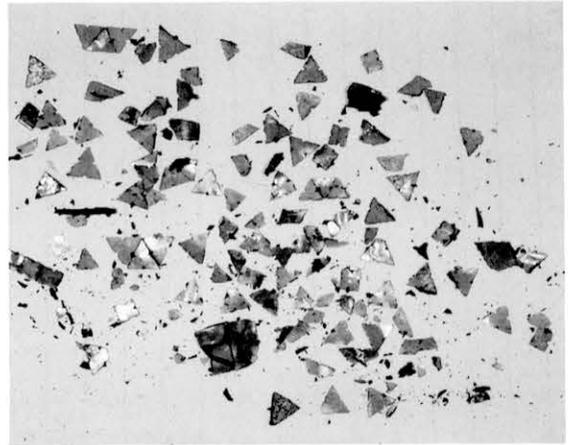
図206 付属した剥落断片
Fragments of raden and layers

照合には木製のヒゴの先に粘着シートを貼り、1片1片方向を変え検討した。その結果、剥落片のほとんどが照合できた。剥落片は剥離止めと同様の方法で麦漆で再接着した。前輪40片、後輪44片、右居木22片、左居木28片を本来の位置にもどした。

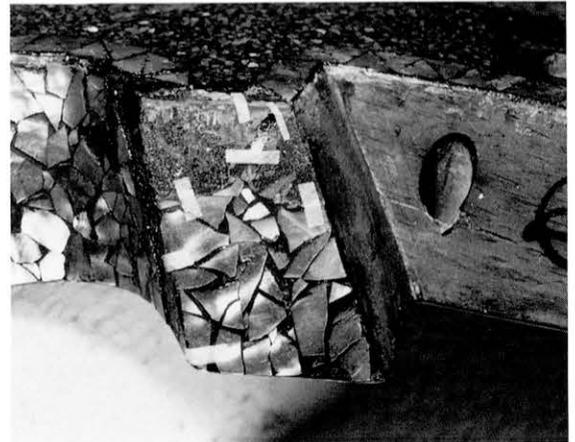
図207 螺鈿剝離部分の養生 (後輪)
Protection of lifted raden by Japanese paper

剥離していた漆塗膜や螺鈿のうち、剥落の危険のある箇所には仮止めを行った。仮止めには短冊状に切った雁皮紙を調整した澱粉糊を使って貼り、作業中での剥落を予防した。雁皮紙は剥落止めと同時にはずした。

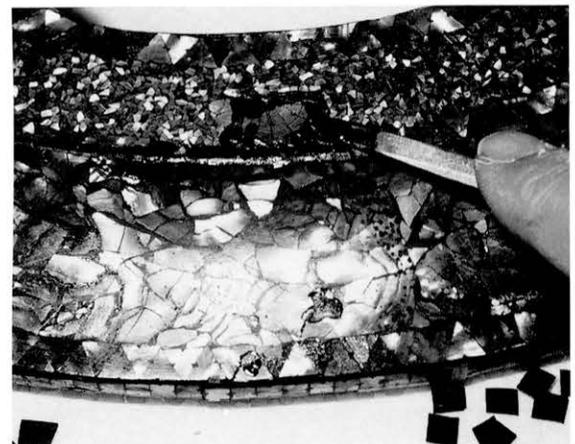
図208 剝離した螺鈿部分の麦漆の含浸
Impregnating mugi urushi into lifted raden

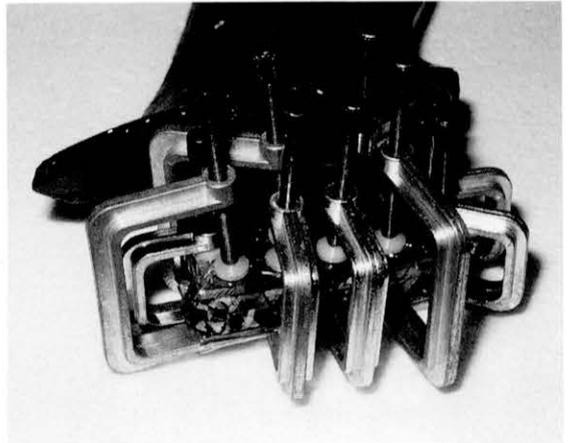
図212 螺鈿と布着せの圧着、居木先部分
Stabilizing the *raden* and cloth, the tip of seat board

居木先などの布着せの剥離部分で布が素地から浮き上がり布が余っている部分は布の周囲を刀で切り、上記と同様の漆を含浸、崩れている下地とともに小さなクランプを使いプレスした。居木の剥落止めをするため受台を製作した。受台は複雑な形状に合わせるため大麦粒をフェルトに入れ、その上から絹で包んだ袋を使用した。その他の布着せの剥離した部分は木枠と竹や木製のヒゴを用いて抑えた。切り組みの塗膜剥離部分も同様に抑えた。

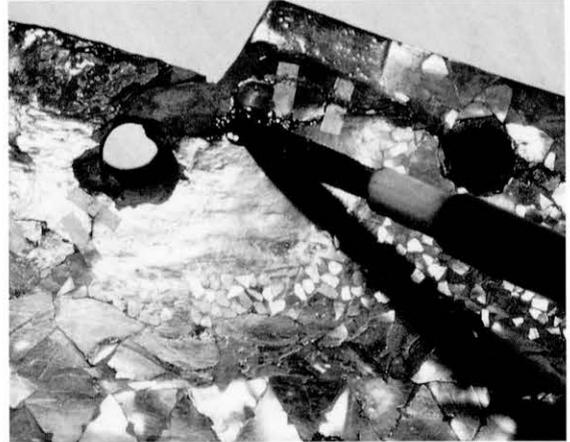
図213 素地亀裂部分の麦漆の含浸
Impregnating *mugi urushi* into cracked wooden parts

The cracks on the left joint of the saddlebow and on other parts of the substrates were impregnated with diluted *mugi urushi* and thoroughly hardened for reinforcement. Spaces in the cracks were filled with soft adhesive *kokuso* in several steps to stabilize the damaged parts.

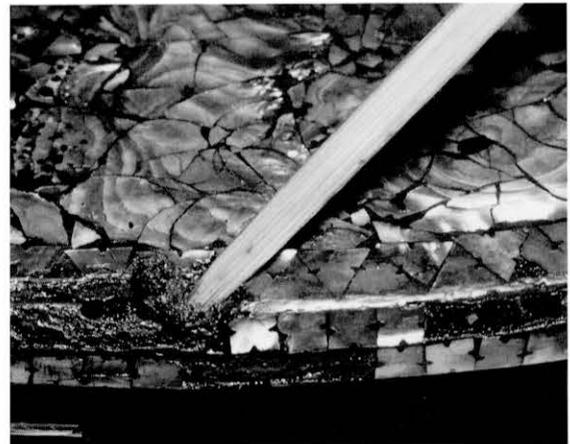
図214 虫損部分の刻苧充填 (後輪)
Filling *kokuso* into insect-damaged part

10. There was insect damage at several places. A space, which was about 30 mm wide and about 10 mm deep, was observed on the inner side of the *yamagata* of the hind bow.

虫害によって素地に空隙ができ脆弱化した部分には、調製した麦漆を含浸し、補強した。空隙部分には数回にわたって刻苧を充填し、剥落部分の形状に合わせ刻苧表面を整えた。その上に山科砥粉と生上味漆をあわせた錆下地を行い、本来の面より僅かに下げて素地の形状に戻した。螺鈿剥落面に表情を合わせるため、松煙を入れた黒漆を下地の上に薄く塗り込み、乾燥した後、かるく炭で研ぎ、摺り漆を数回行った。紐穴の虫損部分は刻苧を充填し乾燥させた後、べん先を使って周囲の色に合わせた。

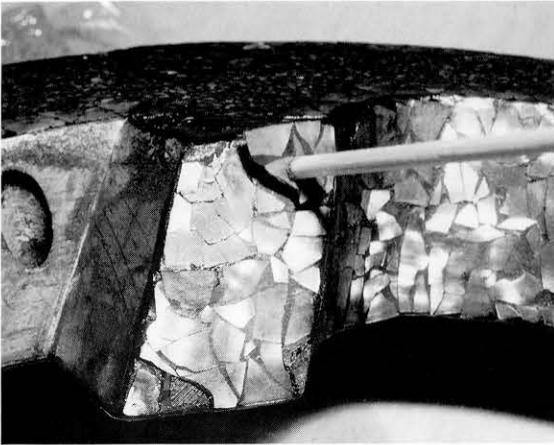
図215 螺鈿剥落断片の照合
Collation of fragments

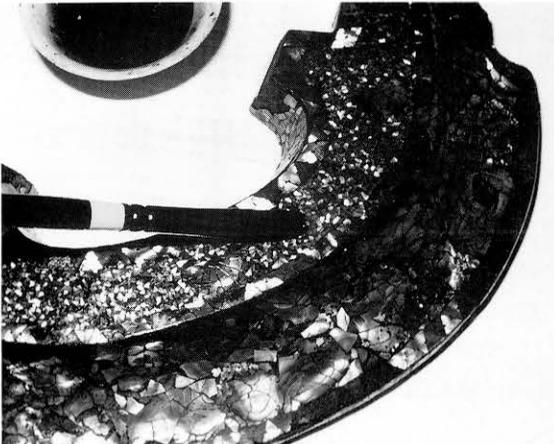
図216 劣化塗膜の強化
Consolidation of damaged film

経年変化等による塗膜の劣化の補強、活性化をはかるため、漆固めを行った。漆は透漆と生正味漆を混合し、石油系の溶剤で希釈、筆で全体に薄く塗布した後、すぐにリグロインを用いて完全に拭き取り十分乾燥させた。

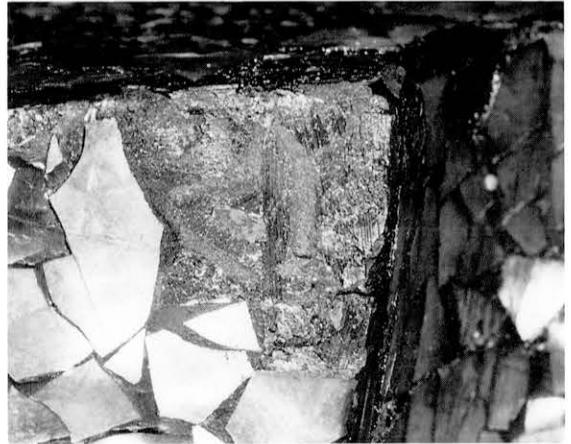
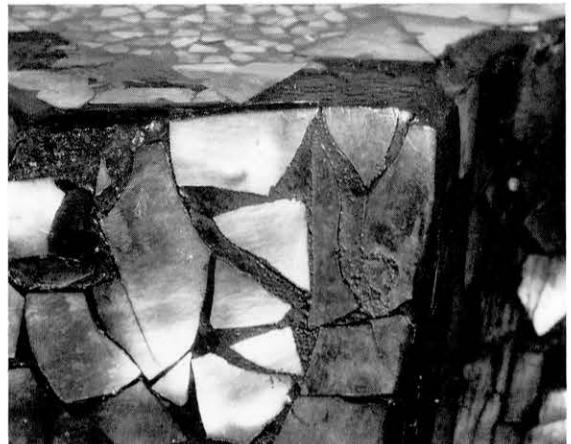
図219 螺鈿の剥離部分後輪 (修理前)
Raden that had fallen the hind bow
(before restoration)

図220 螺鈿剥落片の接着 (修理後)
Fixing a fragment (after restoration)

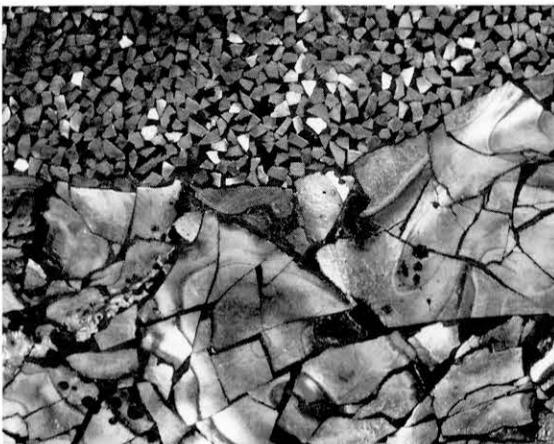
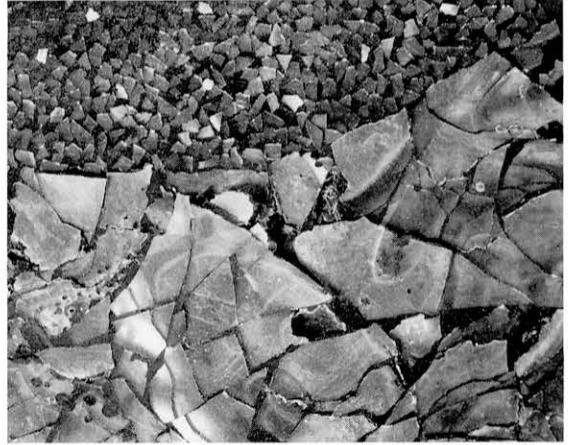
図218 螺鈿の剥離部分後輪内側 (修理後)
The lifted part of *raden*, inside the hind bow
(after restoration)

図217 螺鈿の剥離部分後輪内側 (修理前)
The lifted part of *raden*, inside the hind bow
(before restoration)

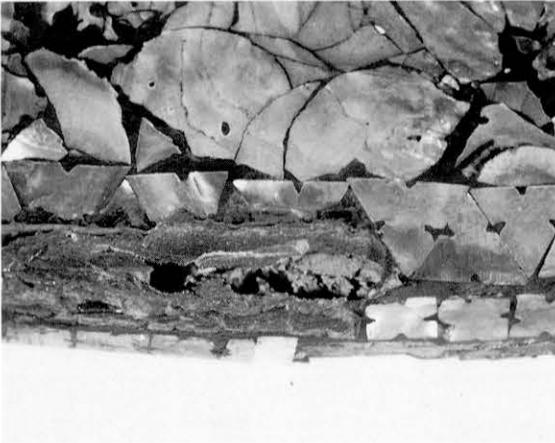
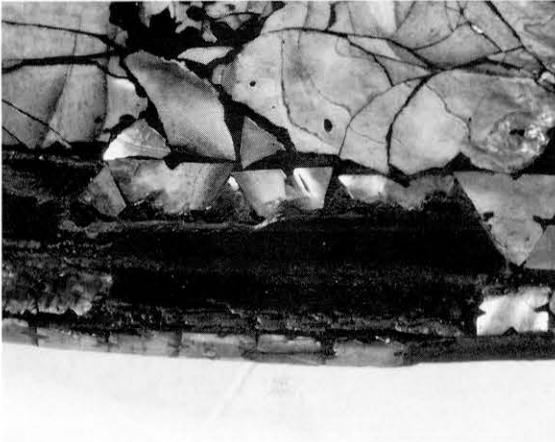
図221 後輪山形中央の虫損部分 (修理前)
The tip of the inner part of the hind bow
(before restoration)

図222 後輪山形中央の虫損部分 (修理後)
The tip of the inner part of the hind bow
(after restoration)

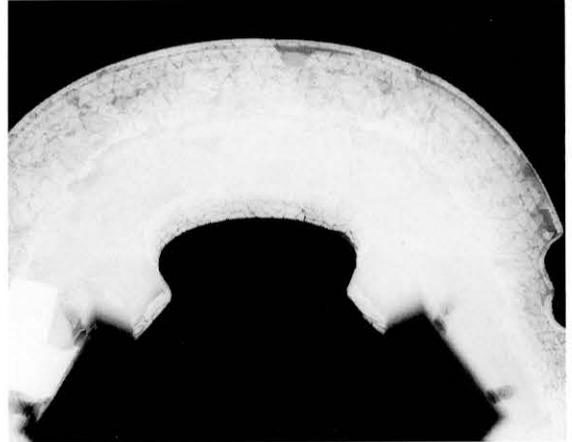
前輪、後輪は道管が荒く、比較的堅い桜材を使用しており、X線透過撮影写真の肩部分を観察すると、山形から左右の足先に向かって木目が二方向に流れている。このことから、現資料の素地には股木（木が二股に分かれている部分）を使用し、二股に削りだしているのが分かる。左右の居木は両輪の素地と異なる木地を使用するが、両輪との接合部分の観察から、縦木取りの素地を居木の表面が木表になるように木取りし、削りだしている。

図225 前輪のX線透過写真
The saddlebow, X-ray photograph

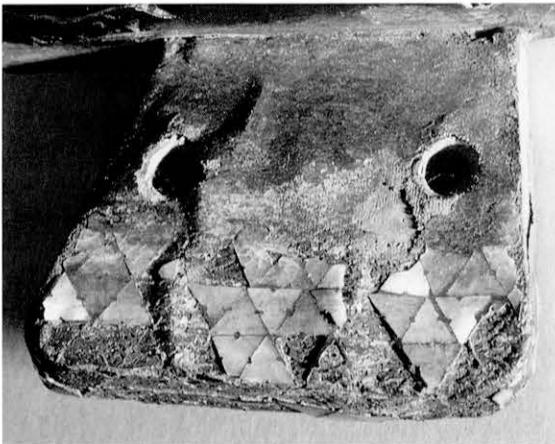
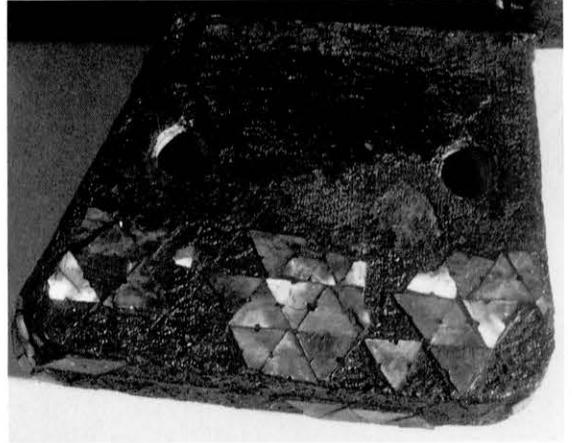
図224 螺細と布着せの剥離右居木先 (修理後)
Lifted *raden* and cloth, right seat board
(after restoration)

図223 螺細と布着せの剥離右居木先 (修理前)
Lifted *raden* and cloth, right seat board
(before restoration)

- layer at various places. As a result, the shell pieces had lost their original color.
5. Foundation layers had become separated at various places around the *raden* that had lifted or fallen. Hemp cloth that covered the substrates of the seat boards had become lifted over a large area and had become wavy.

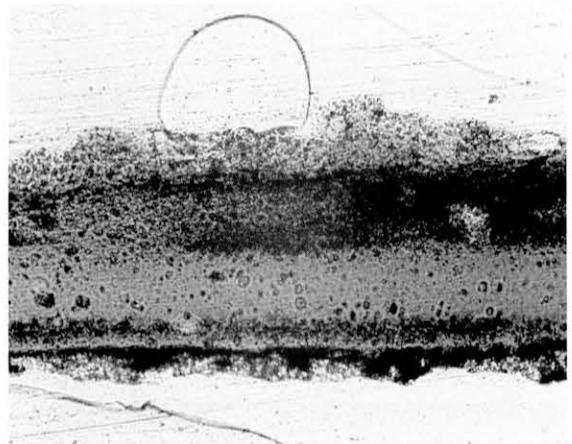
図226 塗膜のクロスセクション
The cross-section of a film

付属した剥落片のうち、修理によって位置が確認できなかった漆塗膜片。形状から、両輪の山形から爪先に向かった稜線沿いの部分で、貝の段差を埋めた下地から表面の漆塗膜までの断片。
