日吉山王祭礼図屏風

平成11年度修復事業

品名：紙本金地著色 日吉山王祭礼図 岩佐勝重印 6曲1双
所蔵：ハンブルグ工芸博物館
所蔵番号：1963.52

修復施工：有限会社 遠藤得水軒
工期：平成11年5月～平成12年3月

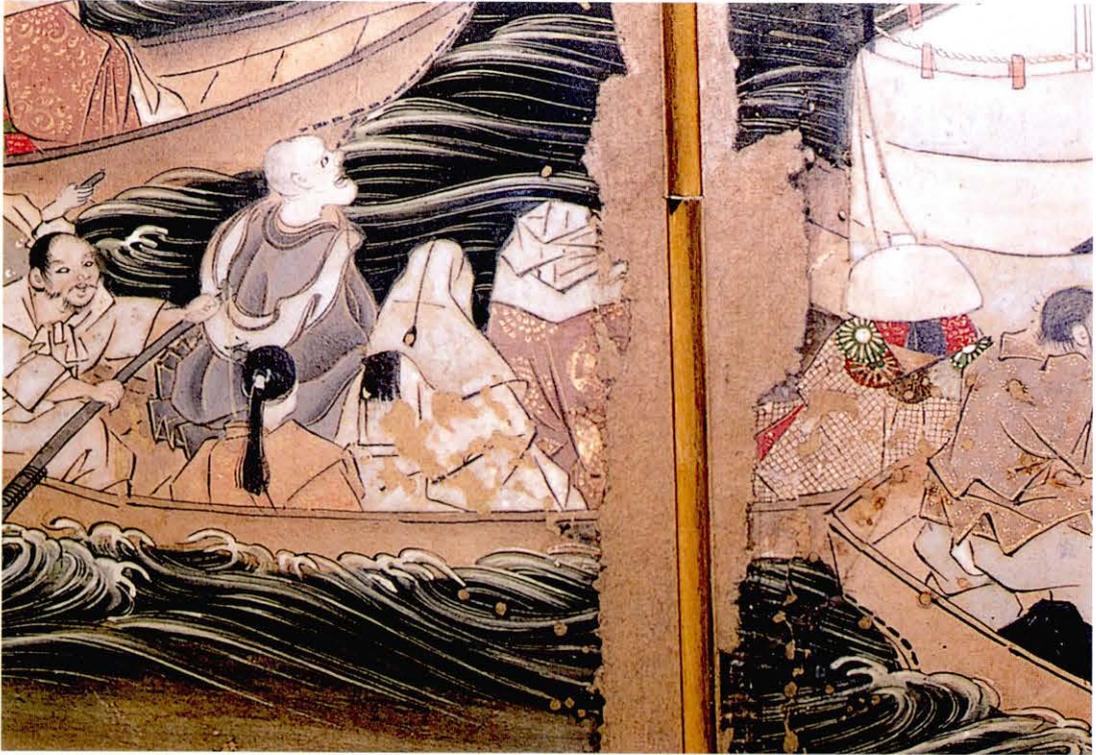
図277 地色に仕上げた新規補修紙
after restoration, detail new infillings are done in brown colored paper

補彩等が施されている箇所を部分的に再利用することについて検討した。本紙欠失部分に、茶色系に染めた紙を臨時に当てて画面全体の様子を検討した結果、地色に染めた補修の方が画面がはっきりすると判断した。そこで、旧補修紙は全て除去し、新規に茶色系の地色に着色した紙で補修することとした (図277~282)。彩色の剥落止めは、2%の兎膠水溶液で行った。

However discussion was done for re-use of old patchings, brownish colored paper showed that it much fitted as infillings of the missing parts of the panels. As the result, all of the old patchings were replaced with brown colored papers. (Photo-277~282)

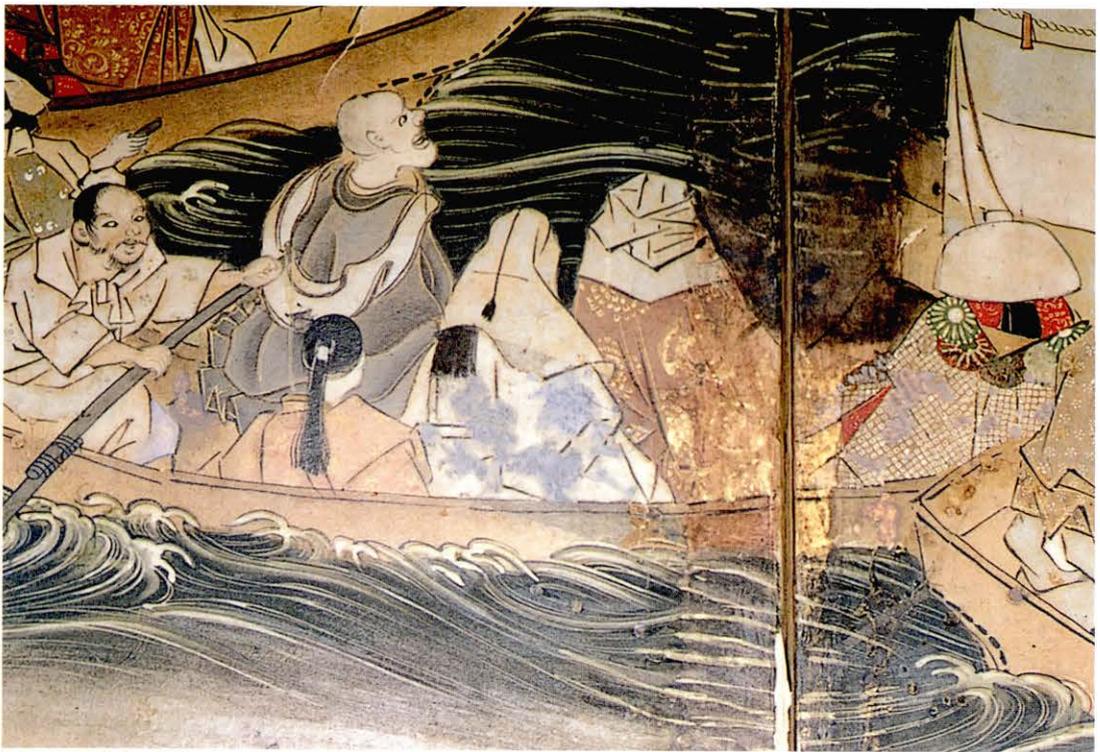
図278 旧補紙に施された補筆補彩
before restoration, detail previous patches were inpainted

尾背に沿った補修紙には補筆補彩が施されていた。左隻第3、4扇の金箔部に見られる黒い色は水と有機溶剤には溶けず、紙背に染み込んでいた。

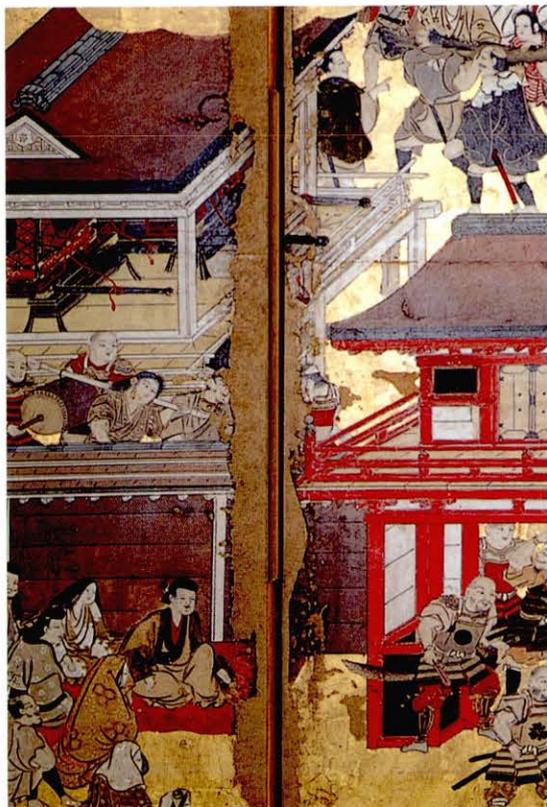
図279 地色に仕上げた新規補修紙
after restoration, detail
new infilings are done in brown colored paper

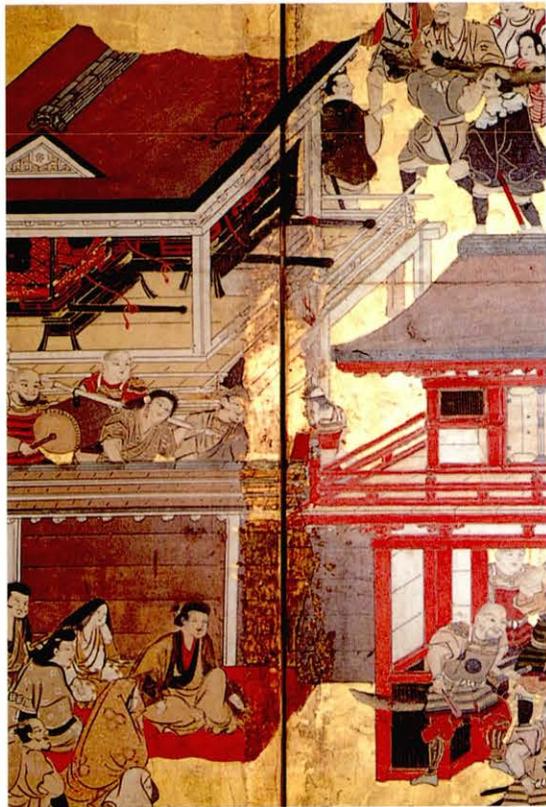
図280 旧補紙に施された補筆補彩
before restoration, detail
previous patches were inpainted

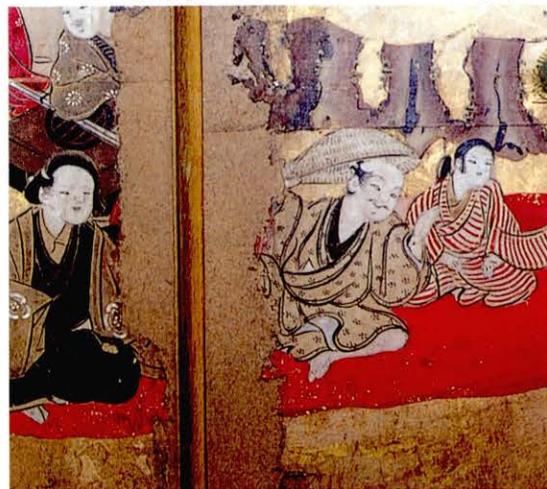
図281 地色に仕上げた新規補修紙
after restoration, detail
new infilings are done in brown colored paper

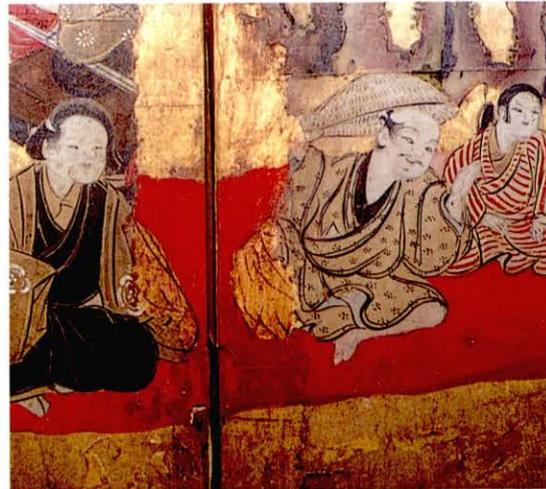
図282 旧補紙に施された補筆補彩
before restoration, detail
previous patches were inpainted

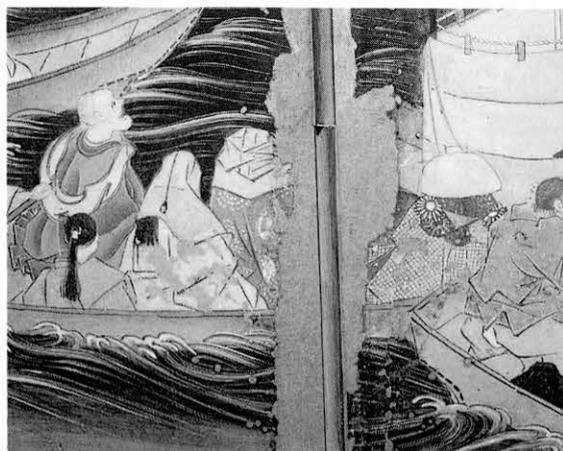
図310 地色に仕上げた新規補修紙 (修復後)
detail, after restoration
new infillings of brown colored papers

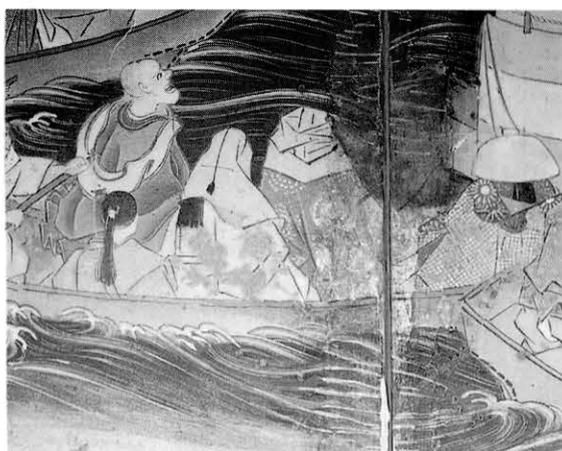
図311 旧補紙に施された補筆補彩
detail, before restoration
inpainted previous patches

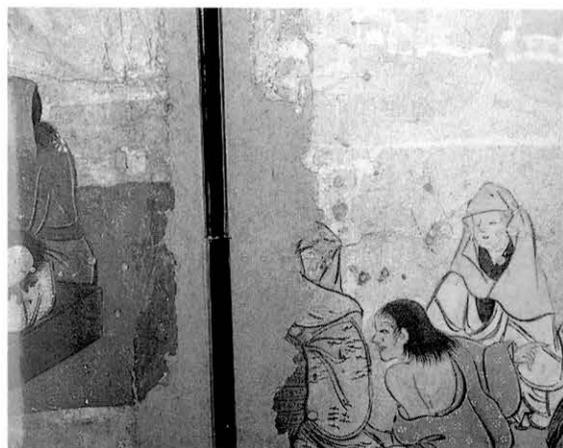
図312 地色に仕上げた新規補修紙 (修復後)
detail, after restoration
new infillings

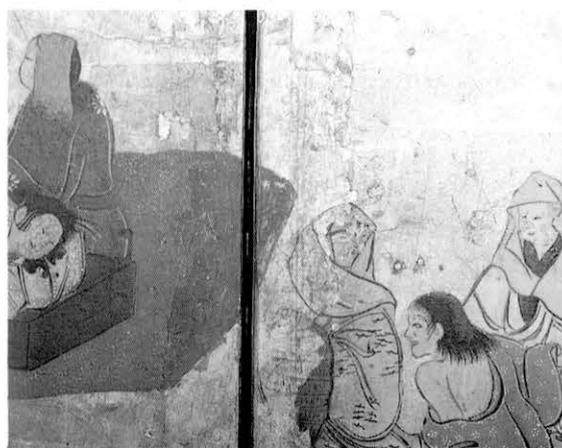
図313 旧補紙に施された補筆補彩
detail, before restoration
previous patchings

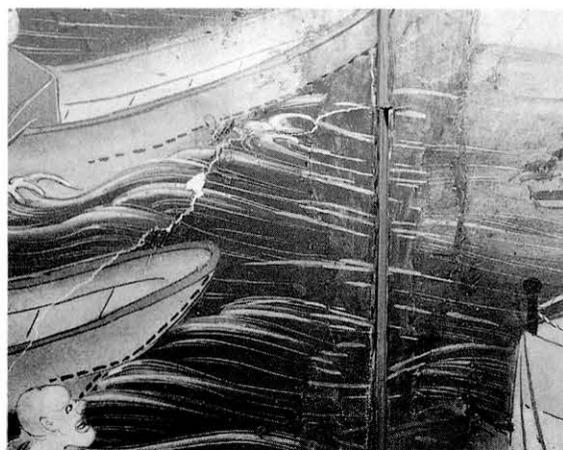
図314 亀裂箇所 (修復前)
detail, before restoration
cracks

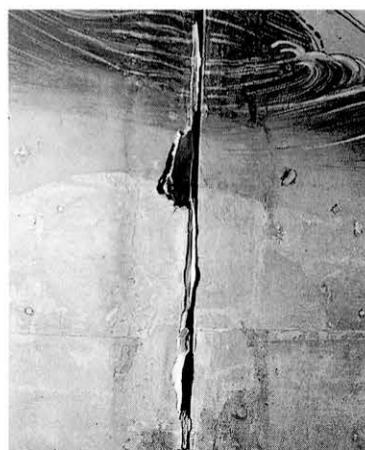
図315 亀裂箇所 (修復前)
detail, before restoration
cracks

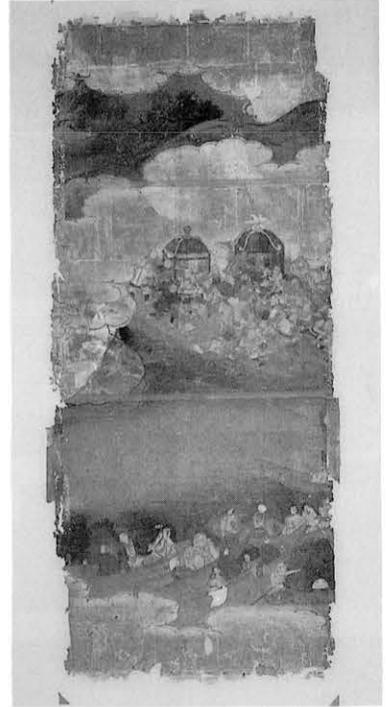
図318 雲の括り線など下描きの墨線 (修復中 第4扇裏面)
detail, during restoration reverse side of the painting of 4th panel

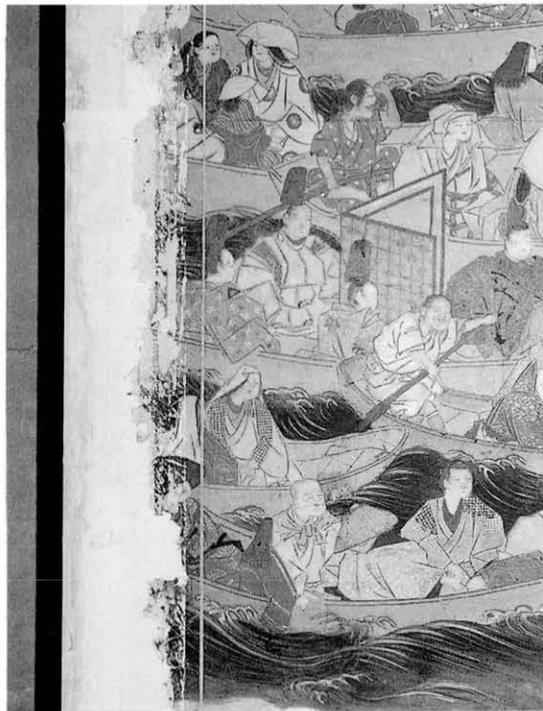
図317 縦線の部分まで縁裂で隠されていた (修復中)
detail, after restoration the painting was covered by the boader until the line indicated

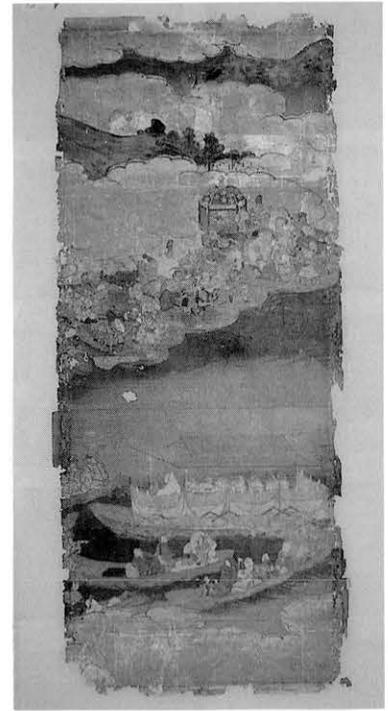
図319 雲の括り線など下描きの墨線 (修復中 第5扇裏面)
detail, during restoration revers side of the painting of 5th panel

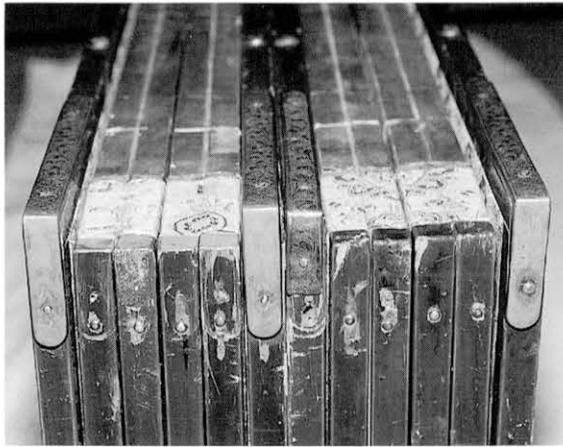
One rivet was replaced with one being bigger than the others.

図320 旧金具 右隻左下の金具は代用品（修復前）
detail, before restoration corner metal ornaments,
the second right piece is improper one.

New two ribett shaped metal fittings are applied. The other ribetts and corner fittings are re-used.

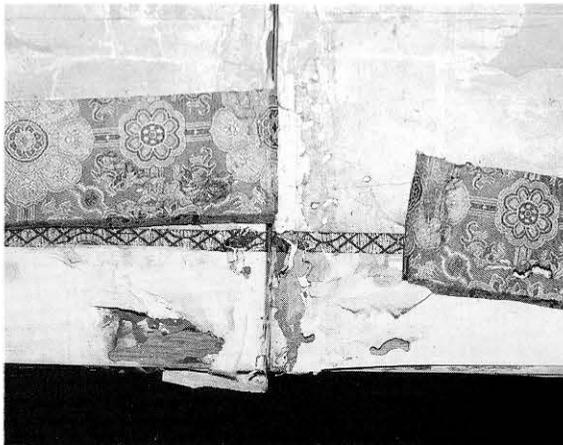
図321 縁裂の下の虫損（修復前）
detail, before restoration insect damage
