# 弁財天図

平成11年度修復事業

品名：絹本著色、弁財天図、南北朝、1幅  
所蔵：大英博物館  
所蔵番号：ADD-28

修復施工：岡墨光堂  
工期：平成11年5月～平成12年3月

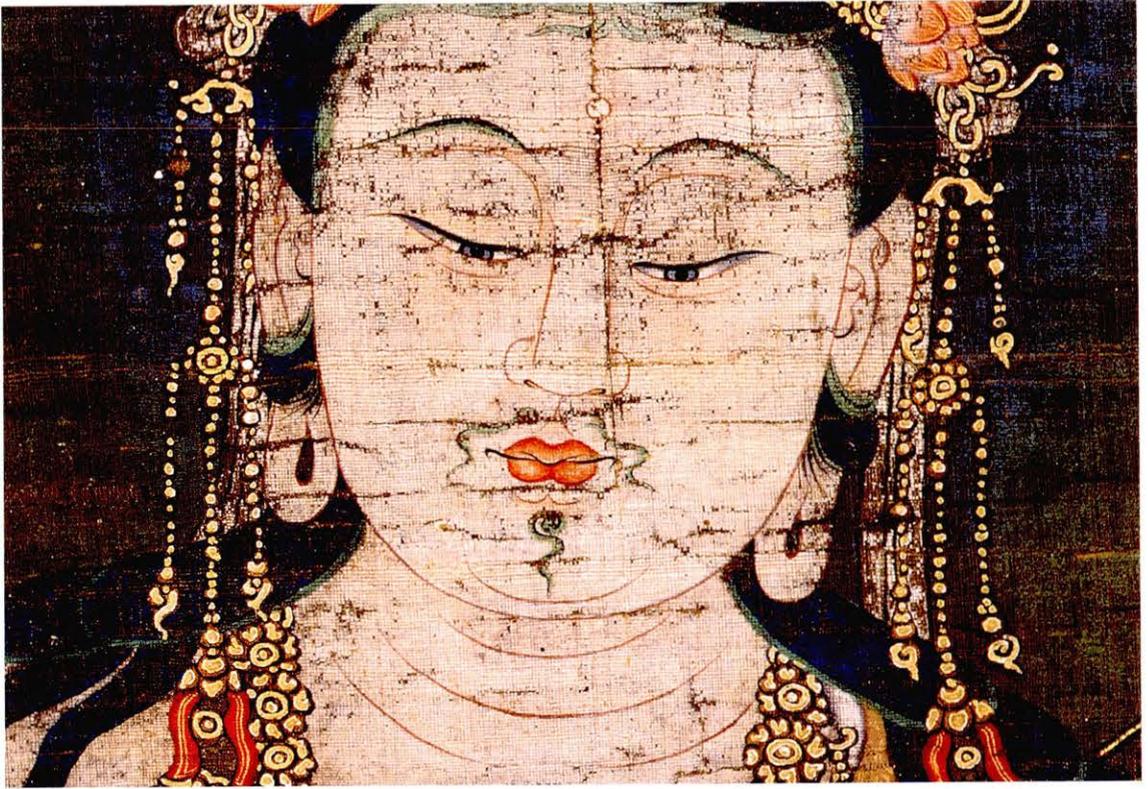
図293 弁財天図 (修復後)  
Benzaiten, detail, after restoration

画面全体にきつい横折れが多数見られる。中央の折れ山で彩色の欠失が始まっている。絹目の歪みが見られる。(図293、294、297、298)

Many severe horizontal creases were observed at the top of the creases the colors were started to be lost. Distortion of thread alignment were observed. (photo-293, 294, 297, 298)

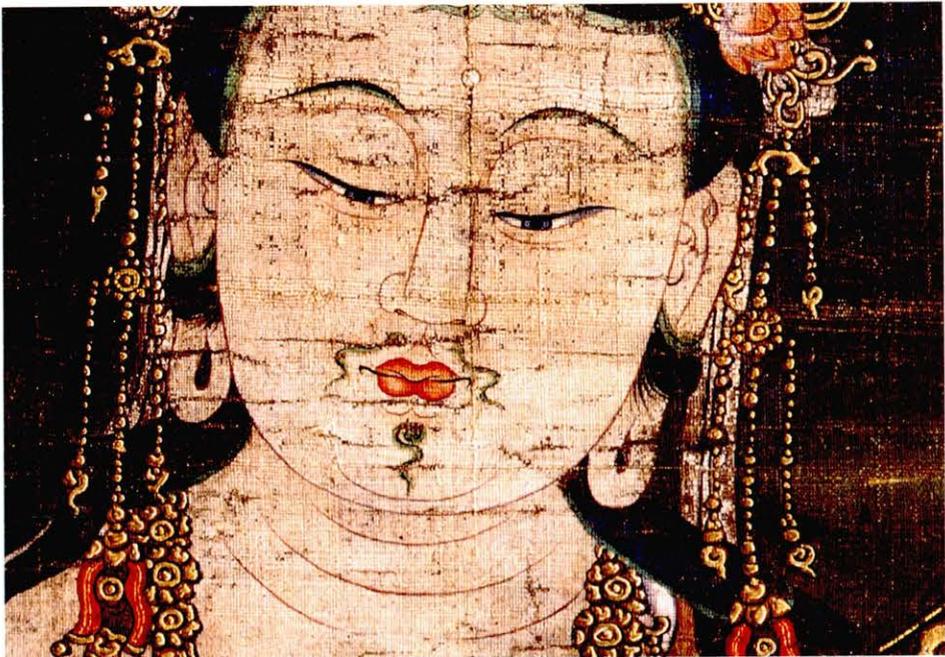
図294 弁財天図 (修復前)  
横折れの状態  
detail, before restoration horizontal creases

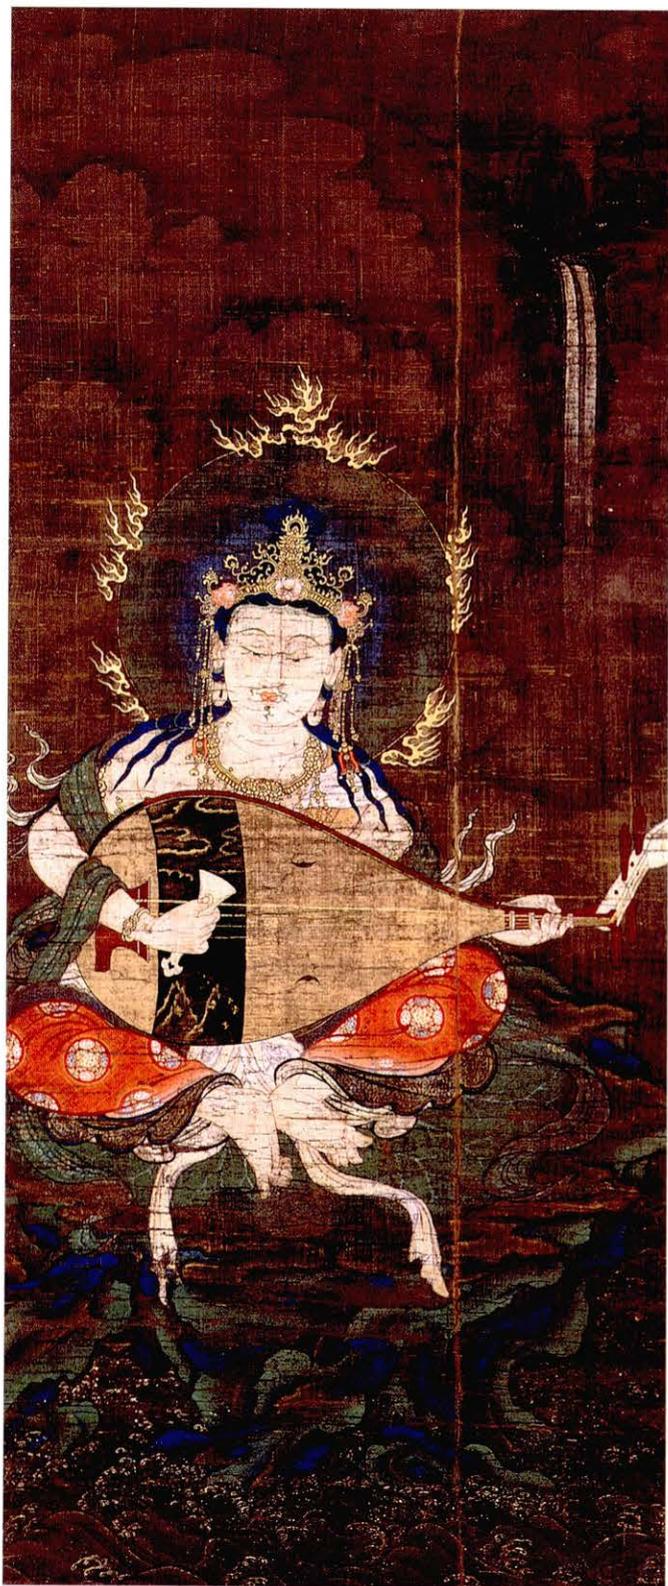
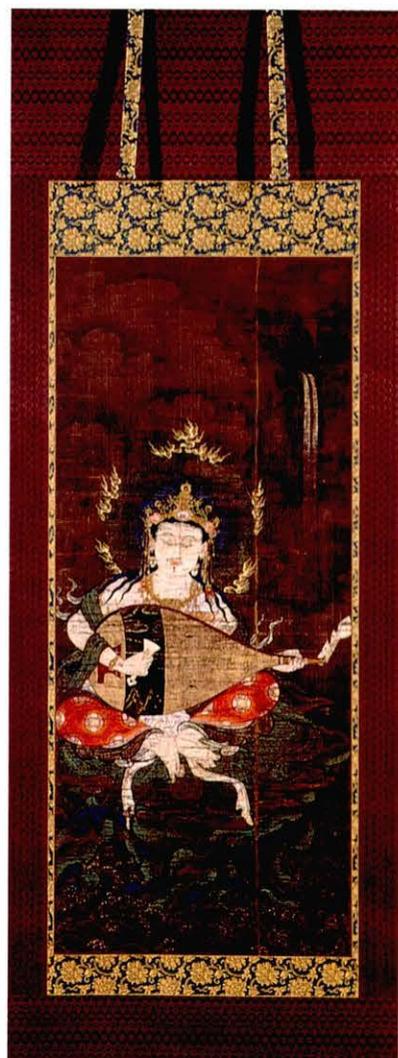
図295 弁財天図 (修復後 本紙及び全体)  
Benzaiten, painting and mounting, after restoration

修復後の形式 仏表具 2段 掛軸装 (図295)

After Treatment: Hanging scroll Butsuga style (photo-295)

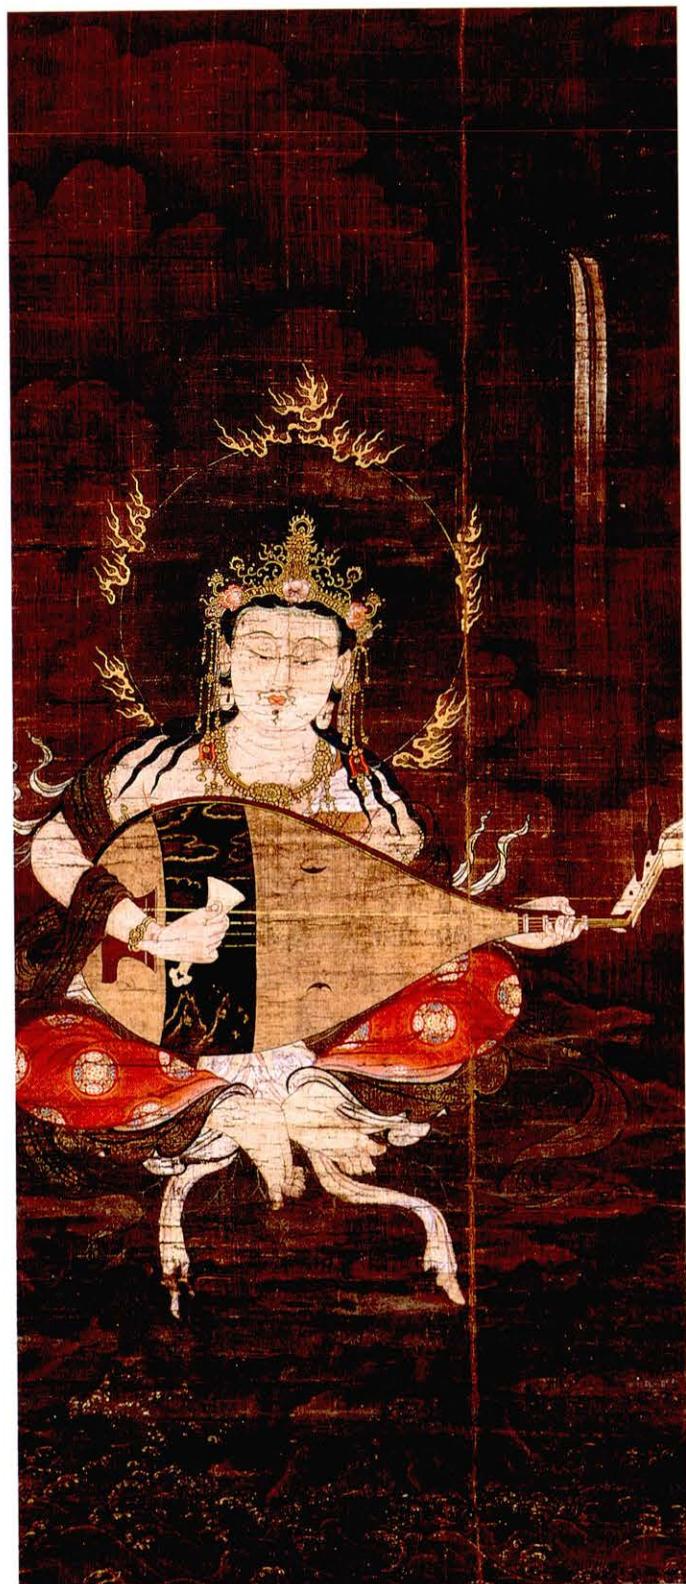
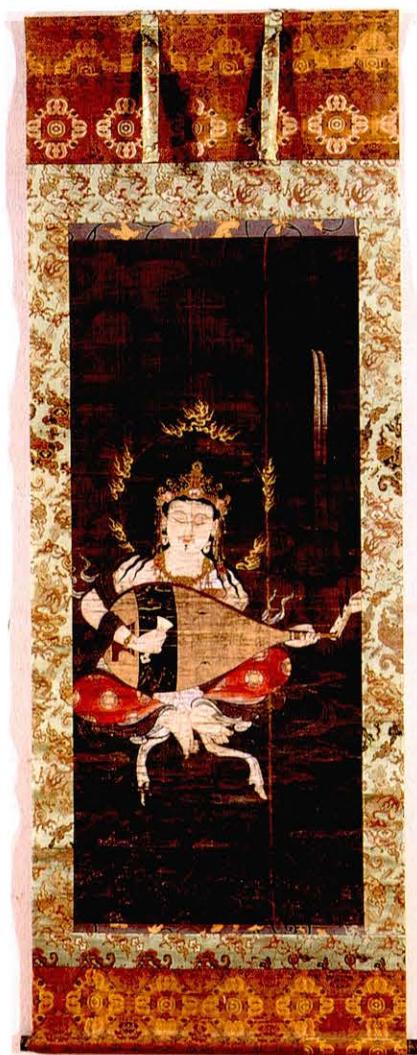
図296 弁財天図 (修復前 本紙及び全体)  
Benzaiten, painting and mounting, before restoration

修復前の形式 大和表具 3段 掛軸装 (図296)

Before Treatment: Hanging scroll Yamato style (photo-296)

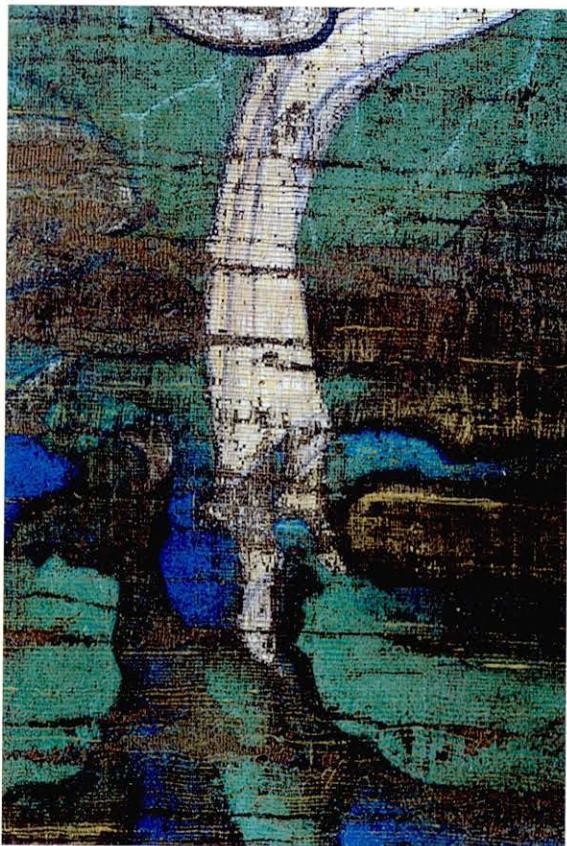
図297 改善された折れ山部分 (修復後)  
detail, after restoration

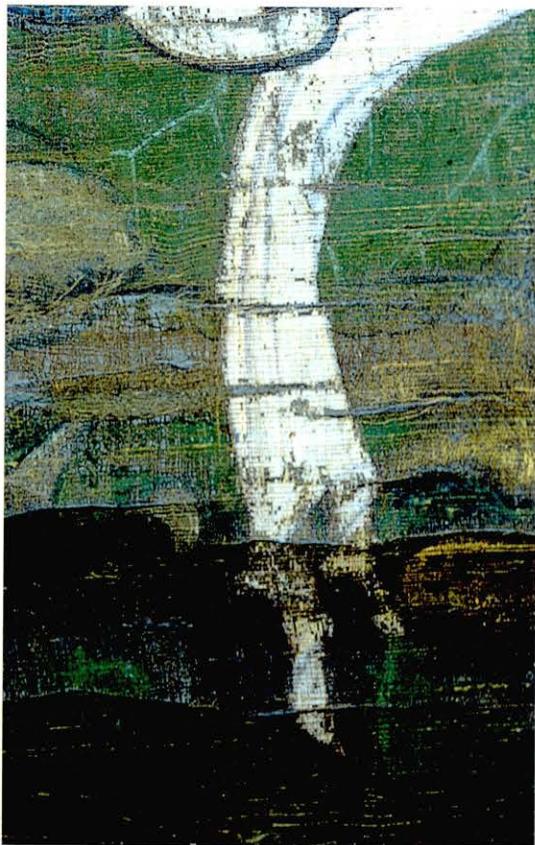
図298 折れ山に沿って絹と絵具の剥離剥落が発生 (修復前)  
detail, before restoration loses of pigments  
and/or silk were found along the creases

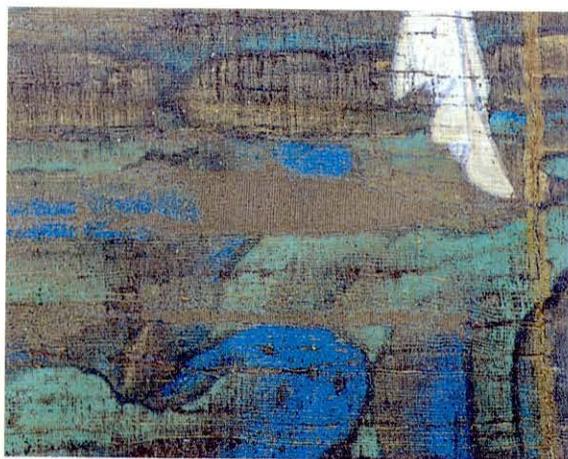
図299 改善された田補修箇所 (修復後)  
detail, after restoration silk infillings

料絹欠失箇所、黒染め紙、緑青塗布紙による補修が施されている。(図299、300)

Patchings were done by the black and green colored papers. (photo-299, 300)

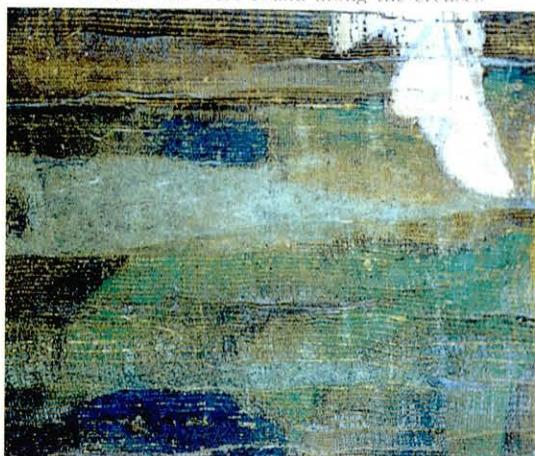
図300 裏面から当てられた補紙 (修復前)  
detail, before restoration paper patches

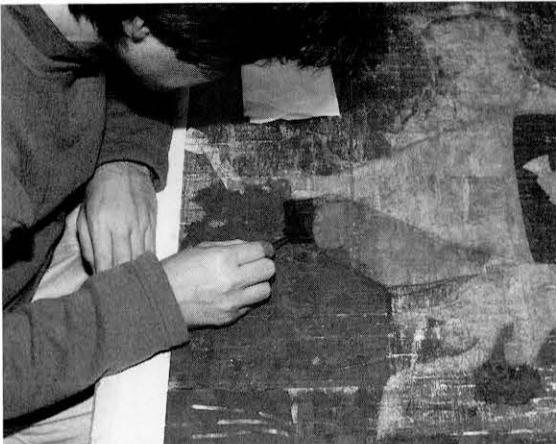
図356 旧肌裏紙の除去作業  
during restoration  
removal of lining paper

裏彩色の残存が確認されたので、旧肌裏打ち紙の除去は最小限の水を使用して行った。  
(乾式法)

画面を数層の紙で養生し、乾燥させた後、肌裏紙に小面積づつ少量の水を与えて、織紙をむしり取るようにして、紙を徐々に薄くして行き、本紙料絹の裏に施された裏彩色を動かさないよう作業する。(図356)

In order to remain the verso painting, removal of lining paper was done with minimized quantity of water. (photo-356)

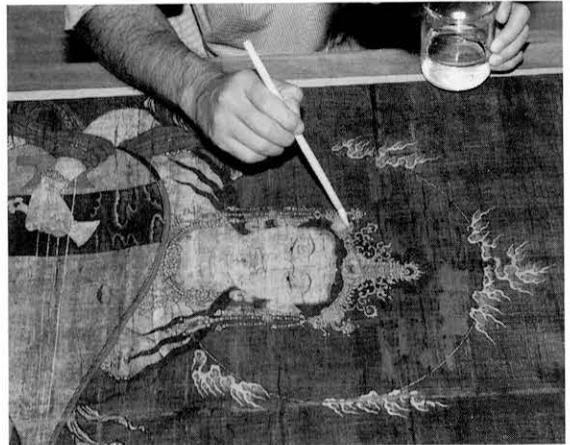
図357 膠液の塗布による彩色の剥落止作業  
during restoration  
fixing of color

本紙全面に、2～3% 兎膠水溶液を筆で塗布した。(図357)

Fixing of color was done by brushing of 2/ 3% water solution of rabbit glue. (photo-357)

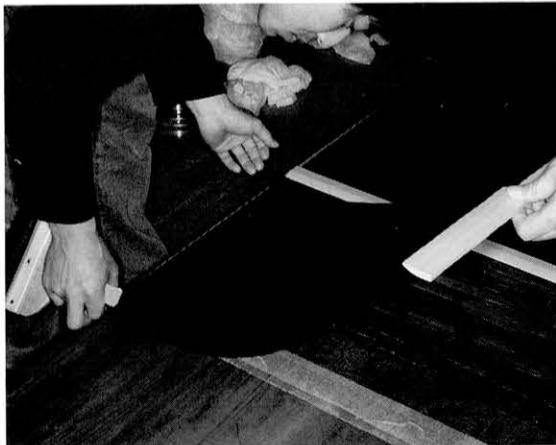
図358 新規肌裏打ち作業  
during restoration  
new lining

4) Dyeing the Lining Papers, Relining the Painting (photo-358, 359)

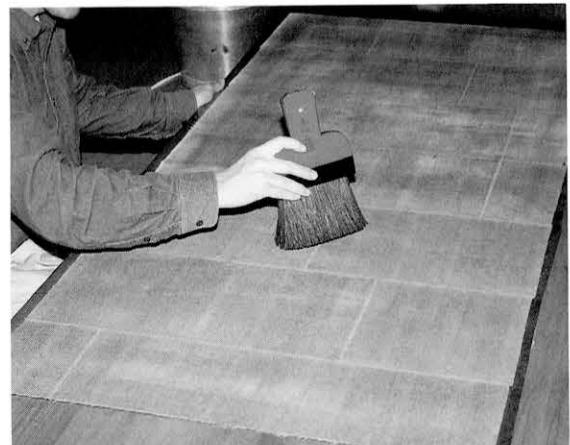
図359 新規増裏打ち作業  
during restoration  
second lining with beating brush

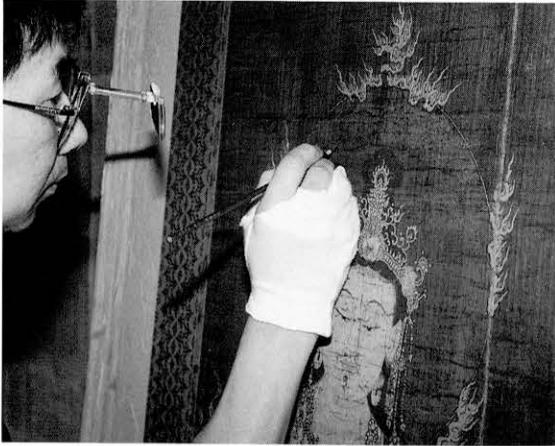
図360 地色合わせによる補彩作業  
during restoration  
toning the new silk infillings

人工劣化絹にて、料絹欠失箇所の補絹を行い、地色による補彩をした。(図360)

Infilling was done with artificially detereolated silk. It was followed by adding color to the infilled parts. (photo-360)

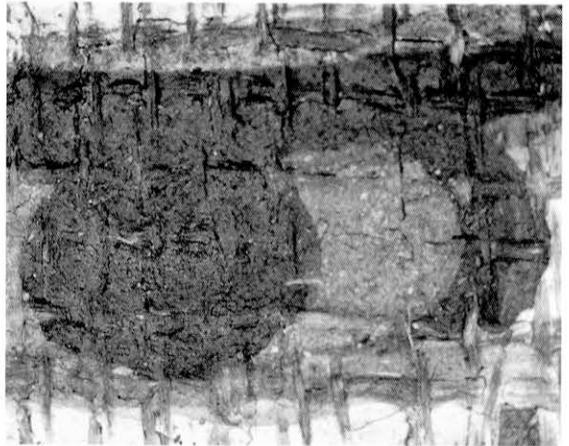
本紙の裏彩色が認められたので写真記録をした。(図363、364)

図363 左目部分の表面 (顕微鏡写真)  
surface of left eye

Verso painting was observed by microscopically from the recto. (photo-363, 364)

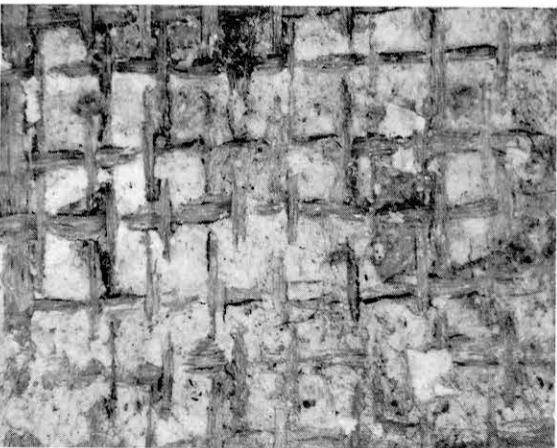
図364 左目部分の裏彩色 (顕微鏡写真)  
revers side of the left eye showing verso painting
