## 花鳥螺鈿食籠

山下好彦

品名：花鳥螺鈿食籠  
 所蔵：ベルリン東洋美術館 ドイツ  
 品質構造：木製、乾漆製、黒漆塗り、螺鈿、  
 所蔵番号：ID.25922-a

Report on the Restoration of “*Kacho Raden Jikiro*”  
in the Collection of the Museum of East Asian Art, Berlin

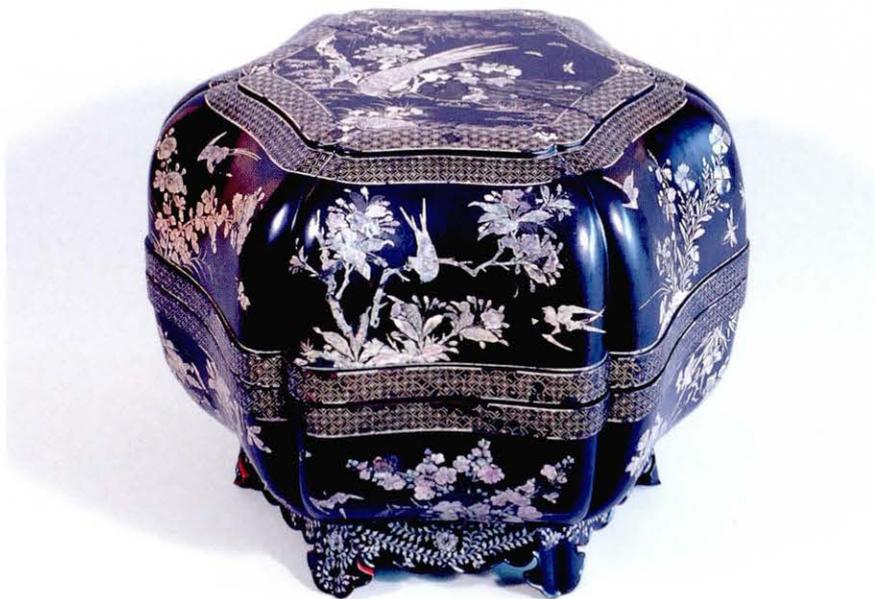
図58 「花鳥螺鈿食籠」一合 ベルリン東洋美術館所蔵 (修理後)  
“Kacho Raden Jikiro” after restoration

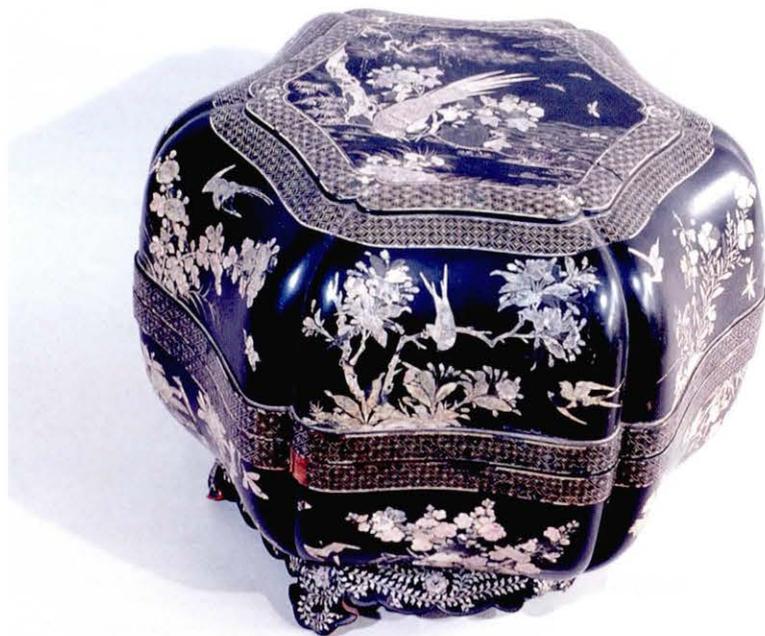
図59 「花鳥螺鈿食籠」一合 ベルリン東洋美術館所蔵 (修理前)  
“Kacho Raden Jikiro” before restoration

現資料は黒漆螺鈿の大型の食籠で、第二次世界大戦後、旧ソビエト軍によってレニングラード（現在のサンクトペテルブルグ）に持ち去られた。東西ドイツ統合以前にいったん旧東ドイツ・ライプティヒに返還、その後、ベルリン東洋美術館に所蔵されるようになった経歴がある。損傷が著しく、足が欠損し自立することが出来ない。この事は、現在の所蔵館に返還される以前の保存環境の悪さを物語っているものと考えられる。

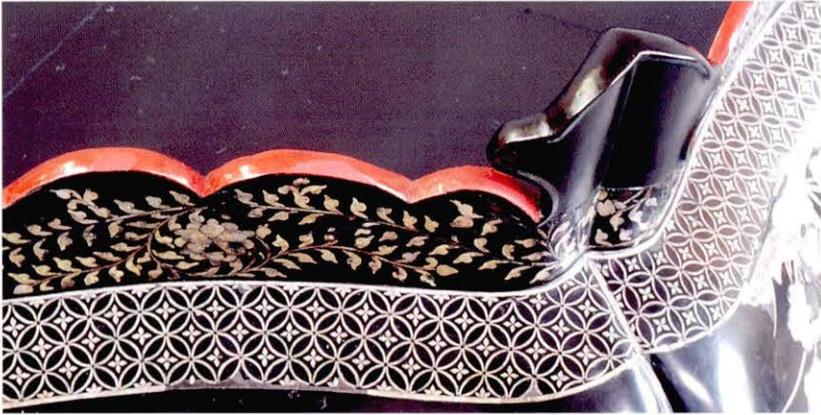
図60 高台、刎足の状態 (修理後)  
*Kodai and kuriashi after restoration*

4本の刳足を現存する2本の足と同様の技法で復元した。刳足は外側を麻布を4枚貼り重ねた乾漆で作成し、足の内側に竹（笹）と檜の薄板で補強、さらに刻苧で形を整えている。復元では、つぎの工程に沿って作業を行った。

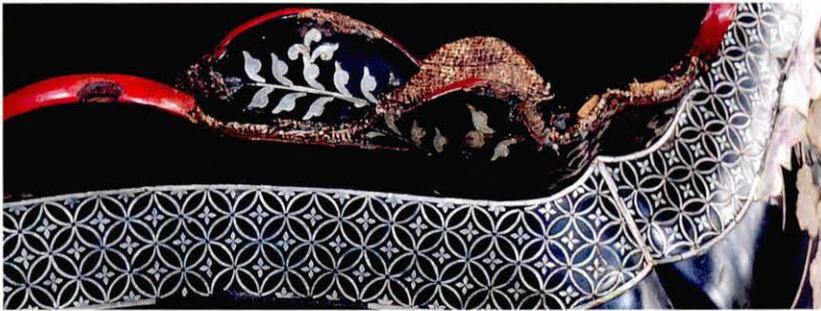
図61 高台、刎足の状態 (修理前)  
*Kodai and kuriashi before restoration*

- ⑦ 6本の刳足のうち4本が破損、欠失し、自立出来ない状態だった。また、刳足内側の木地が一部欠失していた。
- ⑧ 身の合口部分、立ち上がりの一部が2箇所欠損し、木地が露出していた。
- ⑨ 高台の一部が大きく崩れ、非常に危険な状態にあった。
- ⑩ 各所に打損や擦り傷が認められた。
- ⑪ 各所に後世修理がすでに施されていた。刳足の一部に合成樹脂による接着跡があった。螺鈿は広い面積が合成樹脂によって再接着され、周囲を下地で埋めていた。また、塗膜剥落部分に朱漆、透漆が塗り込まれていた。
- ⑫ 身立ち上がりの木地が露出した部分に朱色の補彩があった。
- ⑬ 一部に西洋塗料や朱漆の付着がみられた。

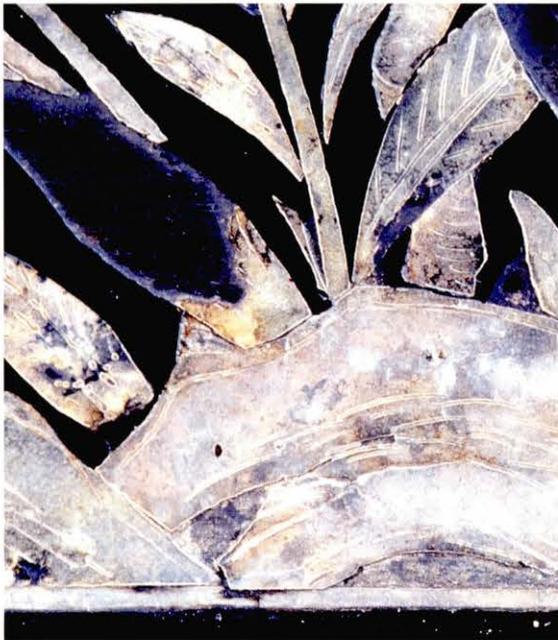
図62 螺鈿の剝離 (修理後)  
*Exfoliation of raden (after restoration)*

螺鈿の剥離箇所に粒膠を含浸、木杵（しんばり台）と竹製や木製のヒゴ（しんばり棒）を用いて圧着した。膠はサンオリエント化学社製のパール膠大王20パーセント溶液を使用した。膠には表面張力があり、含浸しにくいことから、8時間超音波発生装置で分子の鎖を切り、さらに少量のエタノールを混入した。また、膠の含浸によって貝の下に薄く塗られた胡粉が流れやすく、灰色の下地が露出することで貝の表情を変化させやすいため、膠に少量の胡粉を混ぜ含浸させた。胡粉は数種類ある胡粉のうち、最も色合いがあうものを選び、さらに、彩度をおとすため表具の修復に使用する灰汁を微量に混ぜて使用した。膠は筆を使って含浸し、余分な膠を拭き取った後、剥離した部分に合わせてビニールシートやゴムを置き、細く抑えた。螺鈿の剥落止めと同時に雁皮紙の養生を除去した。

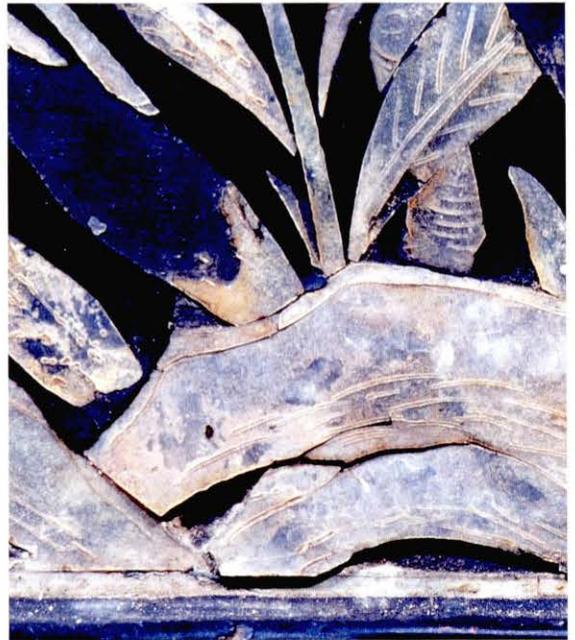
図63 螺鈿の剝離 (修理前)  
*Exfoliation of raden (before restoration)*

- ①悪い条件下で外箱もなく保管されていたと考えられ、器胎表面の一部に水が流れた跡があった。
- ②紫外線による漆塗膜の劣化が表面塗膜にみられ、細かい断文が入っていた。
- ③劣化することで本来の漆の艶が失われていた。
- ④経年変化や木地の収縮によって各素地の接合部からの割れが著しく、蓋甲板では矧ぎ目部分に歪みが生じ、素地面にずれが生じていた。
- ⑤亀裂や断文の周辺では漆塗膜が各所で剥離し、一部で塗膜の剥落があった。蓋の内側朱漆塗膜面に剥離があり、底裏の漆塗膜剥落箇所では木地が露出していた。
- ⑥素地の収縮や打損等により螺鈿のほとんどが剥離していた。また、貝素材の劣化によって貝が崩れやすくなり、真珠層間の剥離が進行することで貝の色が白色化していた。また、多くの貝がすでに欠失

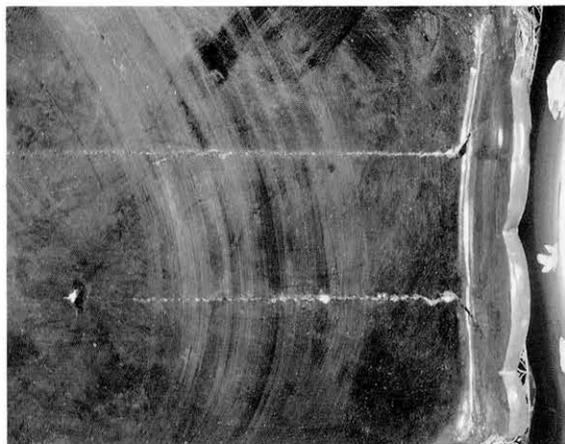
図72 底板の状態  
Condition of the bottom board

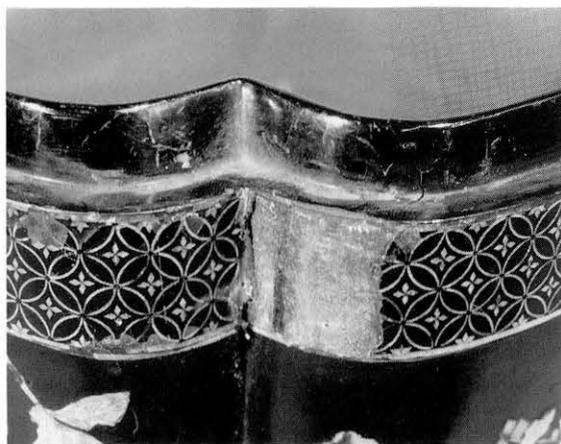
図73 身口縁部の剥落  
Lifting of the coating film on the rim of the body

欠失した部分の形状を復元した。身合口の本地欠失箇所は薄い曲物木地で形作られており、しかもちぎれてる様に損傷していた。この部分は木片で形状を合わせるのには難しいと考え、#100の麻布と刻苧で形状を復元した。欠損部分は漆下地を行い、漆を数回塗り重ね、黒部分は炭粉、朱部分は乾漆粉を蒔き、漆で艶を合わせた。身の合口部分は刻苧のみで形状を復元し、周囲に艶を合わせた。

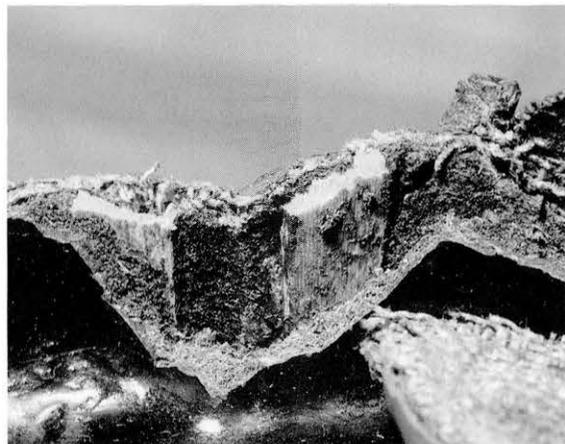
図74 剝足破損部の状態  
Condition of damage of the *kuriashi*

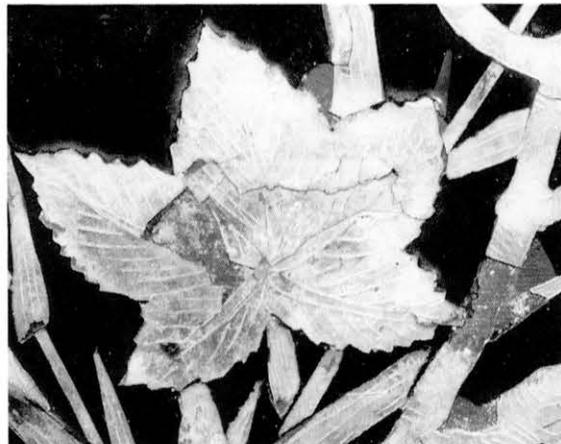
図75 螺鈿の剝離と剥落、後補の毛彫  
Lifted and fallen off *raden*, later engraving

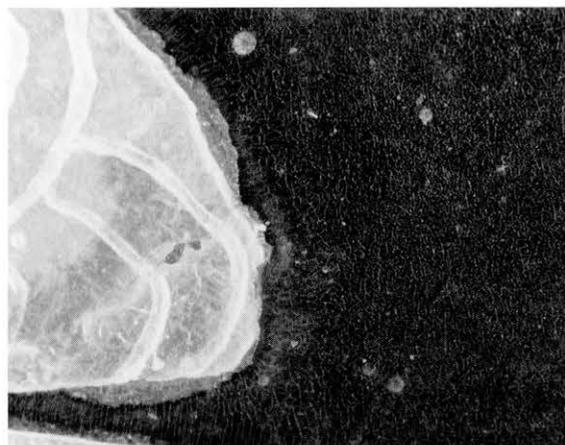
図76 螺鈿の毛彫りとマイクロクラック  
Engravings on the *raden* and minute cracks

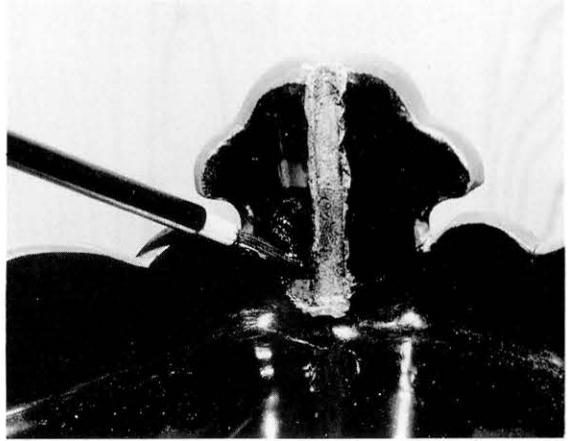
図79 麦漆の含浸 刳足亀裂部分  
Impregnating *mugi urushi* to the cracks of *kuriashi*

蓋甲板を除く各亀裂部分に接着性のある麦漆を含浸した。身合口部分や刳足の根元などの素地が動く部分では、クランプ、木棒やヒゴを使って安定させた。

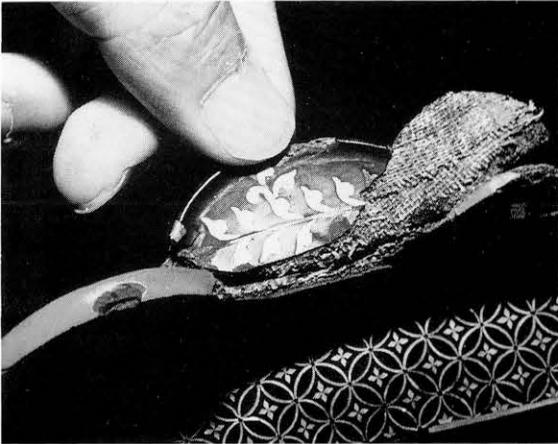
図80 高台破損箇所の取りはずし  
Removing the damaged part of the *kodai*

高台が崩れ、折れ曲がっていた部分は麻糸数本で繋がっているにしかすぎないことから、いったんこの部分を取り外した。つぎに露出した素地や下地を補強するため、麦漆を薄く希釈し含浸した。亀裂によって変形した高台を修正するため、他の高台部分をCraftResin WR-200A・Bと錫金貝で型取りした。破損した高台は内側の麻布間での剥離を接着すると同時に亀裂部分に麦漆を含浸した後、この型を使って高台の形状を修正し、クランプを使って圧着した。折れ曲がっていた部分も他と同様に作業を進め、断面に麦漆を付け、クランプと木杵とヒゴを用いて元の形状に戻した。

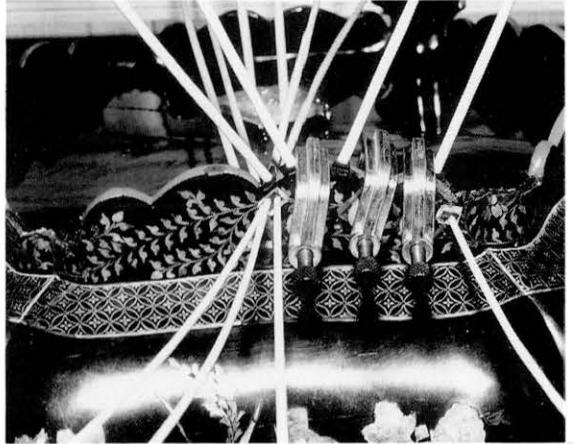
図81 高台破損箇所の接着  
Attaching the damaged part of the *kodai*

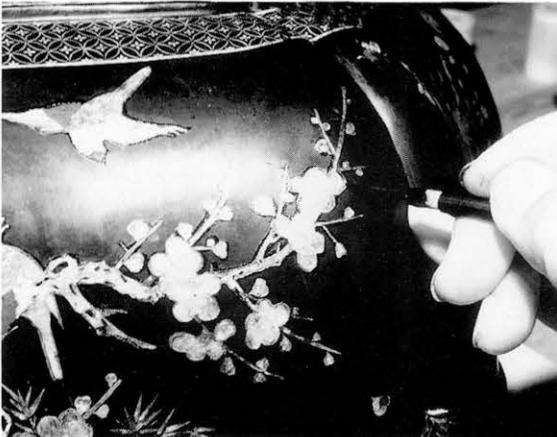
図88 剝離塗膜の補強と圧着  
Reinforcing and pressurizing the lifted coating

漆塗膜の剥離箇所に接着用に調整した麦漆を希釈、含浸し、ビニールシートをあて、木杵とヒゴを用いて圧着した。このとき、漆が貝の下に流れ込まないように注意した。

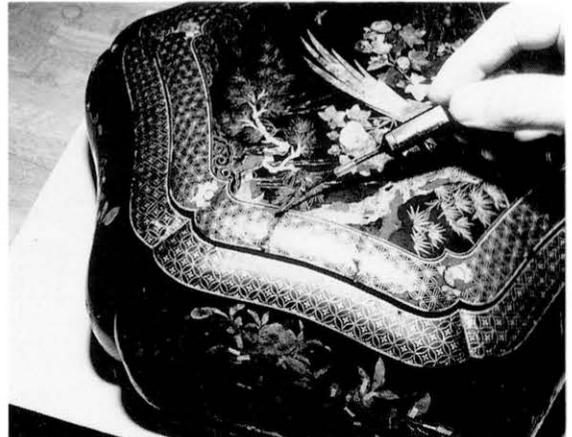
図89 素地亀裂の補強と接着  
Re-fixing and reinforcing cracks on the substrate

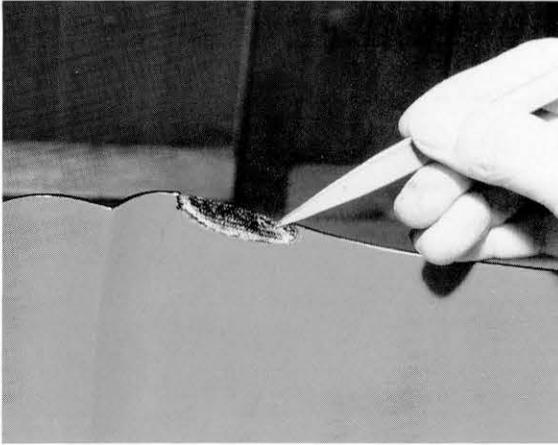
図90 素地欠失部の成形  
Shape-forming the missing parts of the substrate
