二河白道図

平成13年度修復事業

修理報告

(株)半田九清堂
半田 昌規

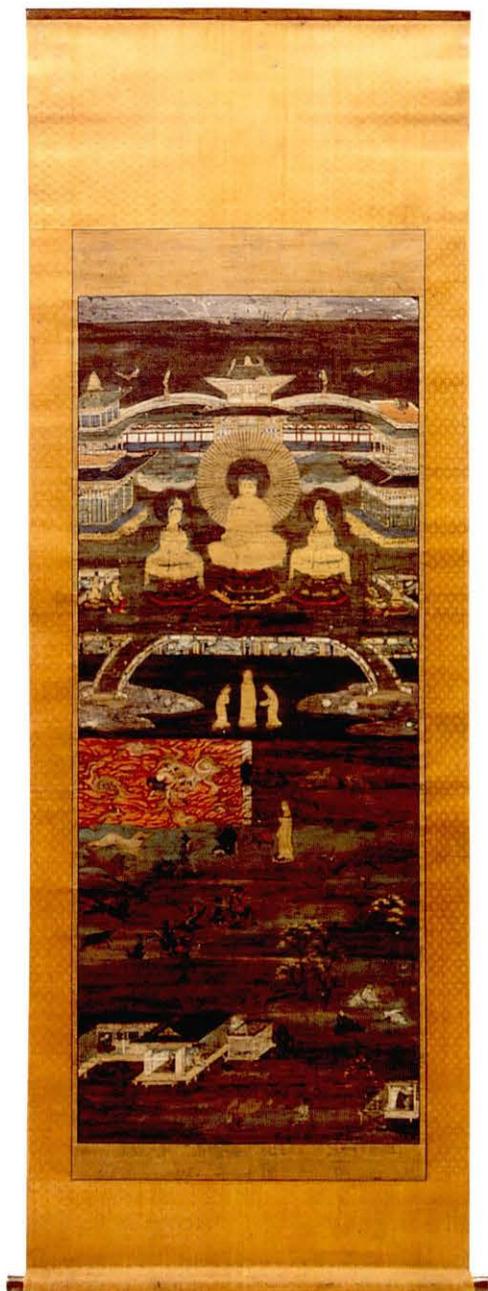
11 二河白道図 修理前
Two Rivers and a White Path <Before treatment>

1. 本紙料絹の欠失部分に肌裏紙が露出している箇所が多く見られた。
2. 本尊及び脇侍像の顔面、肉身等の欠失部分を金色で補彩している等、本紙絵絹の欠失部の露出した肌裏紙に補彩、補筆がされていた。
3. 絹目の合わない古い補絹が多く見られた。
4. 画面表面より、欠損部より大きめに充てられた補絹が見られた。
5. 古い補絹の周囲の本紙絹に剥落が始まりつつあった。
6. 細い折れ、亀裂が多数見られた。
7. 肌裏紙からの本紙の浮きが見られた。

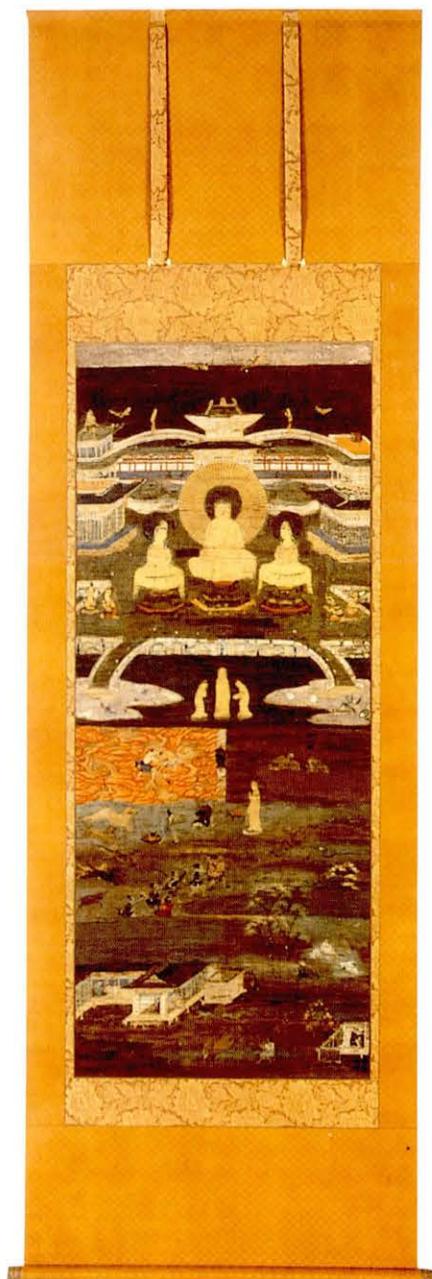
12 二河白道図 修理後
<After treatment>

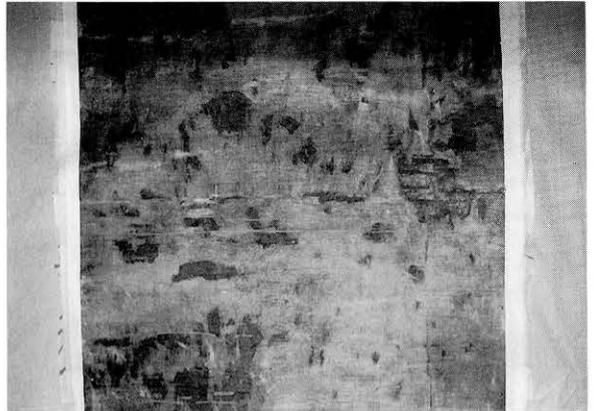
57 a 旧裏打ち紙除去 修理中 (旧増裏紙除去後 裏面より撮影)
旧増裏紙除去の際、濃い灰色の粉末の層が要因となり、接着力の弱い肌裏紙と一緒に剥がれてしまう程であった。
Removing the original back lining paper
〈During treatment〉 Photographed from verso after the removal of the original *mashiuragami*. *Hadauragami* was barely attached to the painting. When the *mashiuragami* was removed, it could be separated easily.

1. 旧肌裏紙の本紙への接着は弱く、所々に浮いている箇所があり、旧増裏紙を除去する際に一緒に剝がれてしまう程であった。
接着が弱かった要因として、旧肌裏紙と本紙との間に、濃い灰色の泥のような粒子のある、粉末の厚い層があった。裏打ち紙の境界で刷毛足が途切れている事からも、この濃い灰色の粉末は、旧肌裏打ちの糊に混入されたものと思われる。(図57a, b)
2. 幅約8mm前後の厚い紙テープ状の旧補紙が、本紙の絹が切れて隙間が空いている箇所に裏面より直接貼られていた。本紙欠失部分の旧肌裏紙に描かれていたと思われた補彩や補筆は、この旧補紙上に描かれていたものであった。
テープ状の旧補紙を残したまま新規裏打ちをした場合、旧補紙の両側直線箇所では本紙が折れると考えられるため、全て除去した。(図58a-d)
3. 旧肌裏紙と濃い灰色の粉末の層との間に折れ伏せ紙が充てられていた。
4. 旧補絹の上に厚塗りの補彩が施されていた。また、旧補絹周辺部分に補彩がはみ出している箇所があった。(図59a-i)
5. 東京文化財研究所に於いて、濃い灰色の粉末を分析した。
蛍光X線分析、X線回折分析によって、鉄とケイ素が大量に検出された。
6. 東京文化財研究所に於いて、後補の加筆された絵の具部分とその周辺のオリジナル部分の蛍光X線分析を行った。
7. 本紙欠損箇所、旧補絹箇所等の記録として損傷地図を作製した。

The cause of this condition was a gray powder that had turned into a clay-like substance. A thick layer of this substance lay between the original *hadauragami* and the painting. Because the border area of the back lining paper showed no trace of brush, it is possible that this powder had been mixed into the glue used at the time of first lining. (Figure 57 a, b)

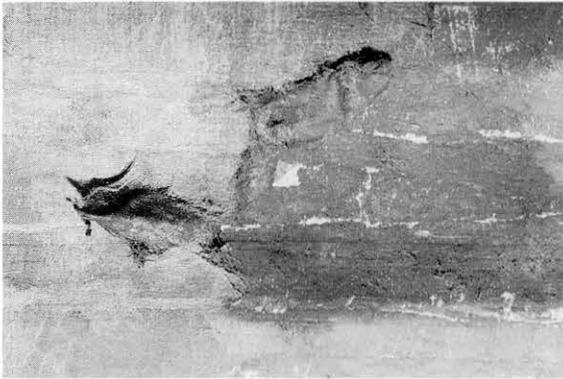
58 a 本紙に直接充てられていたテープ状の旧補紙
修理中 (旧肌裏紙除去中 裏面より撮影)
本紙に直接テープ状の旧補紙が充てられているのが確認できる。
Strips of original infill paper attached directly onto the painting.
〈During treatment〉 Photographed from verso during the removal
of the original hadauragami. The strips of infill directly attached
onto the painting can be seen.

2. Thick bands of infill paper, as wide as 8mm, were attached directly onto the back of the painting where cracks had appeared on the silk. At first, toning and additional lines were believed to have been found on the original *hadauragami* exposed through the damaged sections of the painting. However, during restoration, it was shown that they were actually done on these bands of infill paper.

Since new lining applied on top of these bands would result in the painting being creased at infilled areas, these bands of paper were all removed. (Figure 58 a-d)

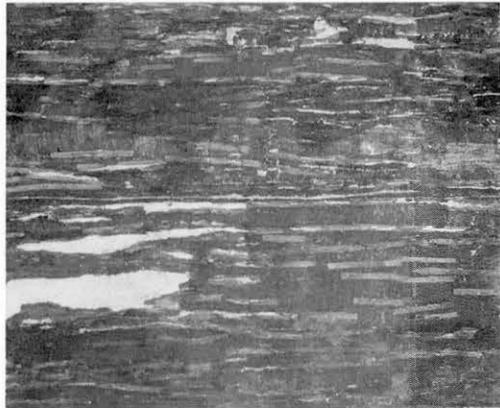
58 b 本紙に直接充てられていたテープ状の旧補紙
修理中 (濃い灰色の粉末の層およびテープ状の旧補紙の除去
後)
〈During treatment〉 After removal of the layer of dark gray
powder and strips of infill paper

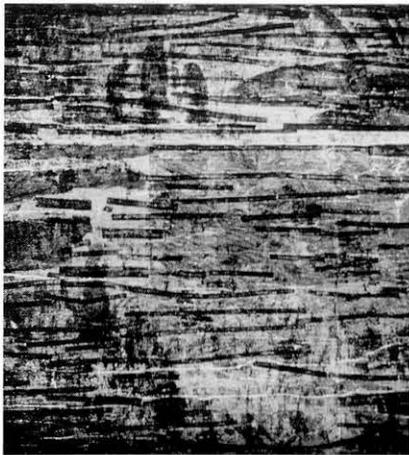
58 c 本紙に直接充てられていたテー
プ状の旧補紙 修理中 (旧肌裏紙除去後 裏
面より透過光撮影)
多数のテープ状の旧補紙が充てられているのが
確認できる。
〈During treatment〉 Photographed with trans-
mitted light from verso after the removal of
the original hadauragami. A number of strips of
infill paper are seen.

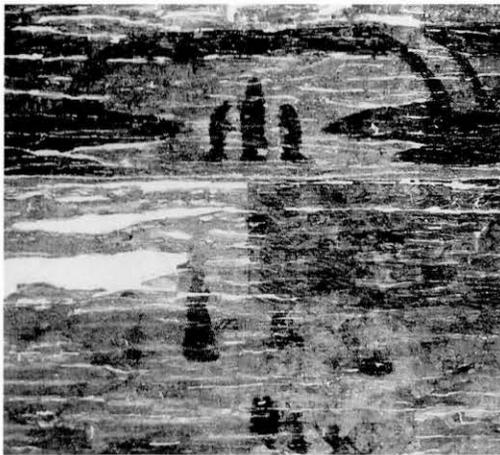
58 d 本紙に直接充てられていたテー
プ状の旧補紙
修理中 (旧補紙の除去後 裏面より撮影)
〈During treatment〉 Photographed from verso after the
removal of the original infill paper

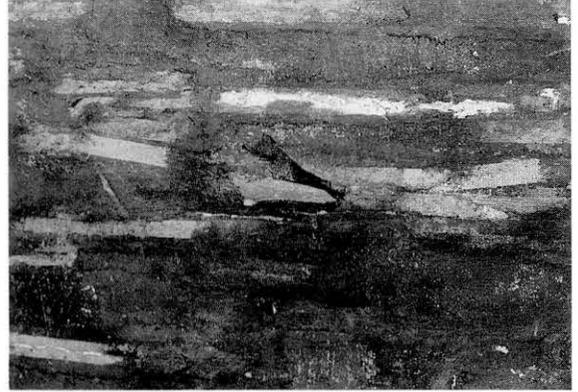
59 a 旧補彩 修理中 (旧補絹除去中 裏面より撮影)

旧補絹には厚塗りの補彩がされていた。

3. *Orefusegami* (crease reinforcement paper) were found attached between the original *hadauragami* and the layer of dark gray powder.
4. In an earlier restoration, a thick coating of toning was applied to the original silk infills. In addition, toning overlapped areas around original infills. (Figure 59 a-i)

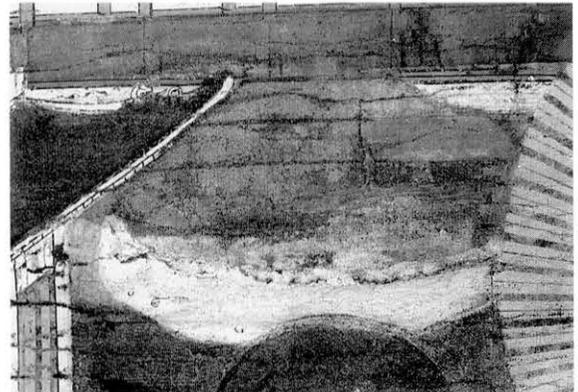
59 b 旧補彩 修理中 (画面上段)

本紙料絹が欠損している。

周囲の絵具の上にも白色絵具で補彩(オーバーペイント)されていた。
<Before treatment> Upper section of the painting. Surface silk missing. Areas of paint around the damage were also over-painted with white paint.

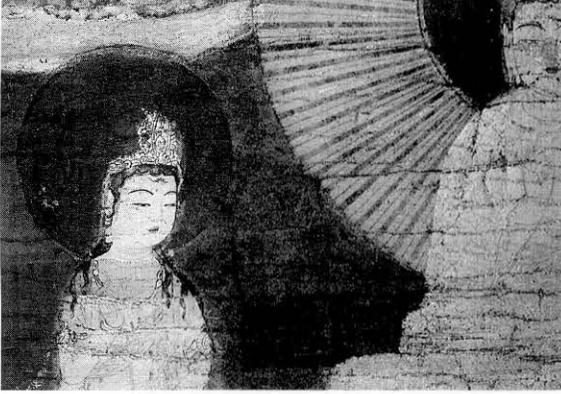
59 d 旧補彩 修理前 (画面上段)
仏の顔面などに後補が見られる。
〈Before treatment〉 Upper section of the painting. Later toning can be seen on the face and other parts of the Buddha.

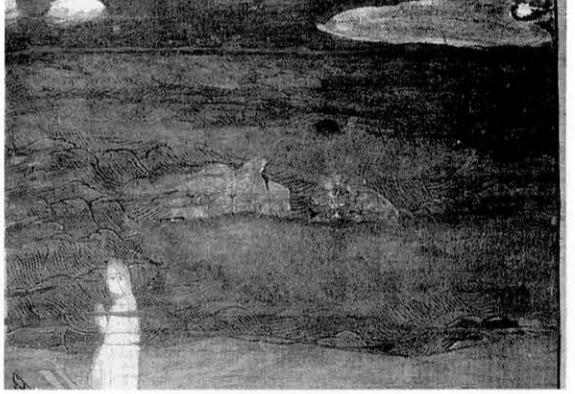
59 g 旧補彩 修理前 (画面中段)
表面から欠損部より大きめに絹が充てられている。
〈Before treatment〉 Middle section of the painting. A silk patch larger than the damaged area is attached to the surface.

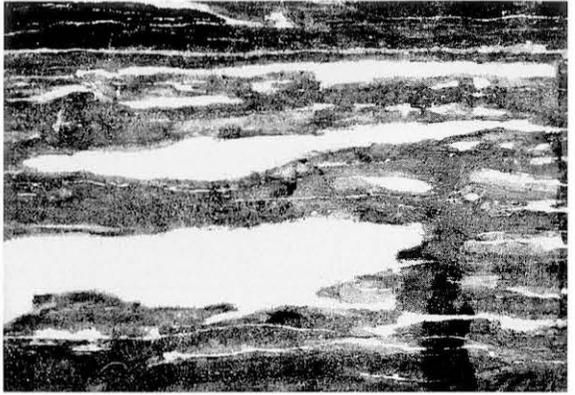
59 h 旧補彩 修理中
旧裏打ち紙および旧補絹除去後、裏面より透過光撮影
〈During treatment〉 Photographed with transmitted light from *verso* after removal of the original lining paper and infill silk.

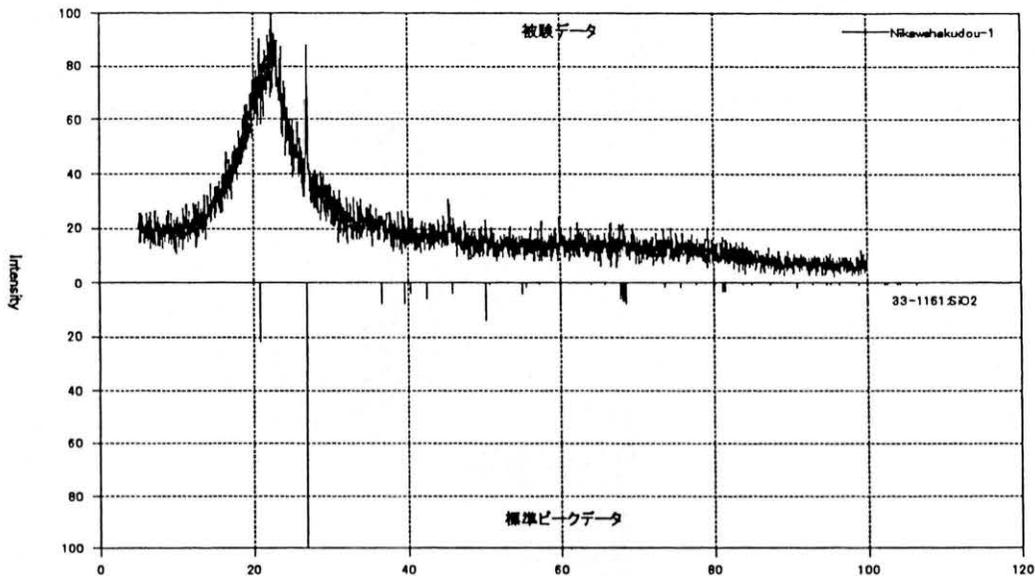
60 二河白道図 旧肌裏紙のX線回折スペクトル

た。参考試料とした楮紙からはS, Caが検出されたことから、Si, Feは暗褐色物質に由来するものであることが予想された。しかし、X線回折分析を行ったところ、図60、図61に示すように結晶性を現す明瞭な回折ピークは観察されなかった。同定できたピークはSiO₂だけであり、暗褐色物質を同定することはできなかった。蛍光X線による検出元素から考えると、結晶性の低い土壌起因の物質である可能性がある。

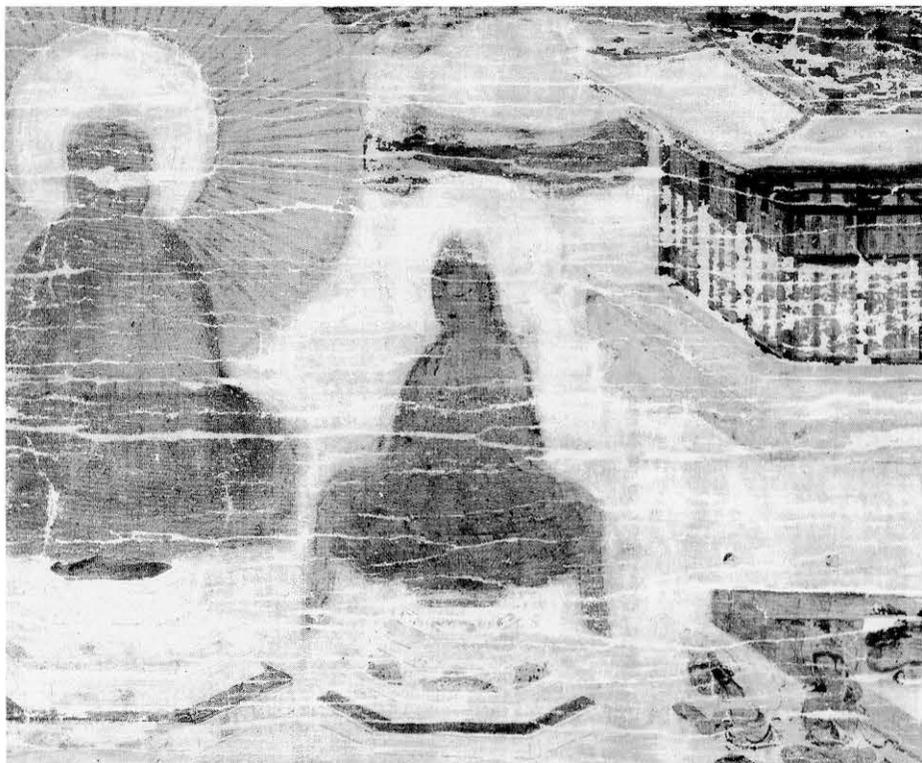
本図は浄土と此岸をほぼ等分に描き、均整のとれた構図をもっている。また緑、赤、青、白などを対比させ、視覚的にも鮮やかな絵画である。京都の光明寺、兵庫の香雪美術館など、日本にある作品に比しても遜色のない作品である。阿弥陀如来の面部や水の河の部分などに絹の欠失があり、一部図様の不明になった部分があるが（図62、63参照）、全体としては原状をよく残している。用いられた多彩な顔料については蛍光X線分析を行った。その際に至るところに鉄を検出したが、それは肌裏紙を取った際に絹の裏面からみいだされた黒い泥状の糊に起因すると考えられる（早川泰弘による本作品の「X線分析」参照）。

62 X線写真 阿弥陀如来と脇士像 東京文化財研究所・三浦定俊撮影
 X-ray, *Amida-nyorai and Attendants*,
 photo by MIURA Sadatoshi, National Research Institute for Cultural Properties, Tokyo

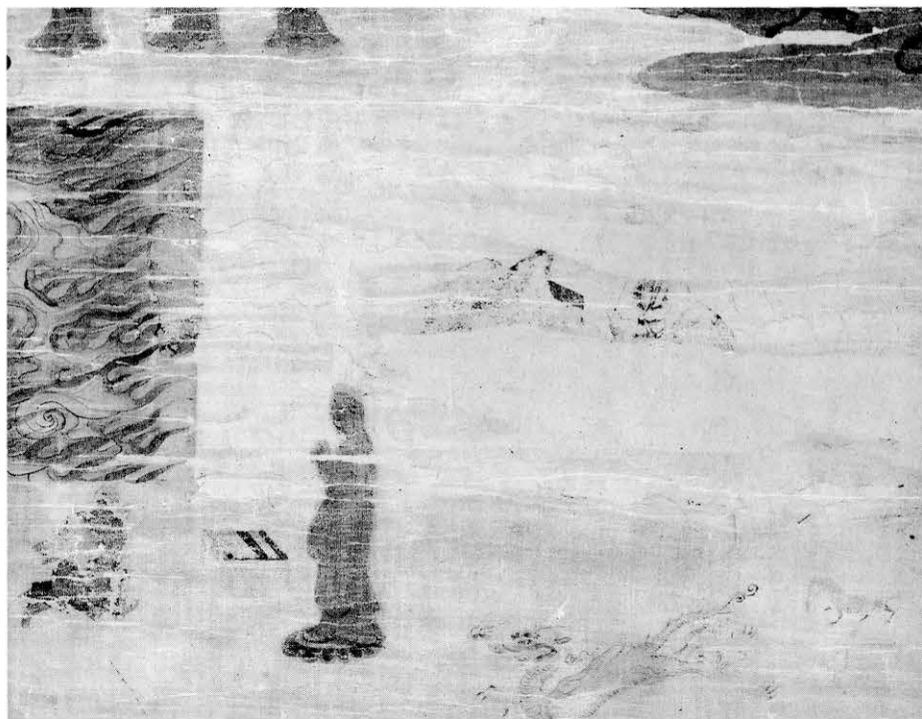
63 X線写真 水河と此岸の釈迦如来 東京文化財研究所・三浦定俊撮影
 X-ray, *Shaka-nyorai in the River of Water and the Shigan*,
 photo by MIURA Sadatoshi, National Research Institute for Cultural Properties, Tokyo
