風景蒔絵ナイフアーン

平成12・13年度修復事業

漆芸修復家
勝又 智志

On the Restoration of “*Fukei Makie* Knife-urn”
in the Collection of The Ashmolean Museum, Oxford

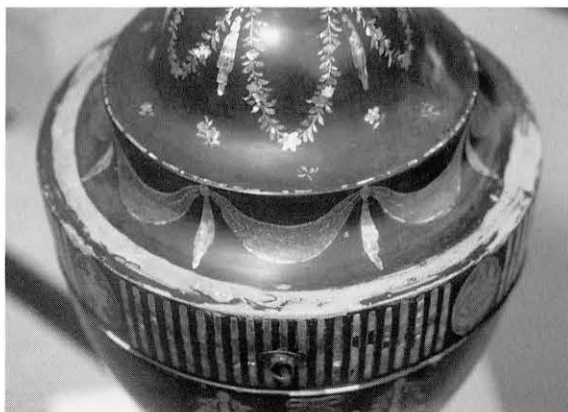
蓋正面は側板と甲板の接合部が切れ大きな段差が生じている。また、蓋背面は側板と甲板に縦方向に大きな亀裂が入る。このため充填材と思われる黄白色の下地材がほぼ全周にわたって塗膜の上を覆った状態である。

下地材はオリジナルの塗膜と同じレベルとするため耐水ペーパーによる研磨が行われており、周辺の塗膜

を激しく痛めている。(P78) (P79)

78 蓋正面の状態 修理前
Condition of the front of the lid before restoration

The dome-like section of the lid had become detached from the side panel at the front while there was a large crack on the back of the lid extending from the dome-like section to the side panel. These damaged parts had been filled and covered with yellowish white foundation. In order to make this foundation level with the original coating, water resistant sandpaper had been used, causing tremendous damage to the surrounding original urushi coating (Photos 78 and 79).

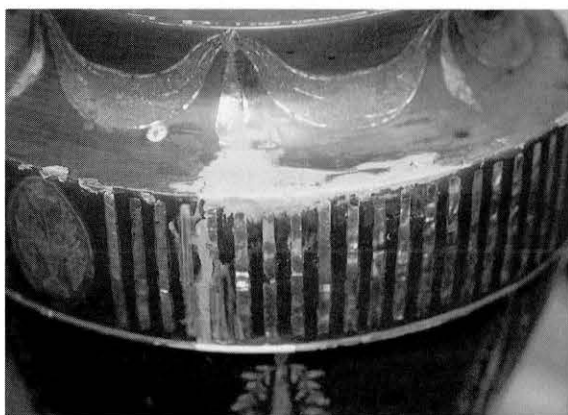
79 蓋背面の状態 修理前
Condition of the back of the lid before restoration

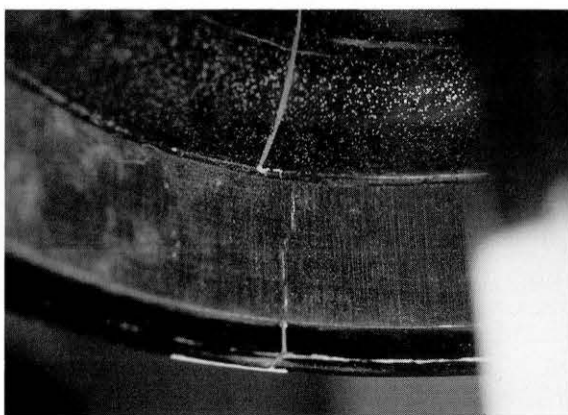
蓋裏を見ると亀裂が蓋表から貫通した状態で入り、内張されたビロードも裂けている。ビロードの端を見ると木地を固定するための黒色の充填材がはみ出している。蓋は柱と先端に取り付けられた尖塔に挟まる形で固定されているが、取り付けが不十分なため前方向に傾き、さらに柱を中心に回転して正面を維持することが出来ない状態である。(P80)

80 蓋内部の状態 修理前
Condition of the inside of the lid before restoration

When observed from the inside of the lid, the large crack at the back mentioned above had penetrated all the way inside and the velvet lining had become torn as well (Photo 80). A black material used to fill the cracks was observed along the edge of the velvet. The lid was held in place by the inner square rod mentioned earlier and the spire at the top. However, because the attachment was inadequate, the lid tilted forward. Furthermore, the lid would rotate easily and it was difficult to keep the front of the lid in line with the front of the body.

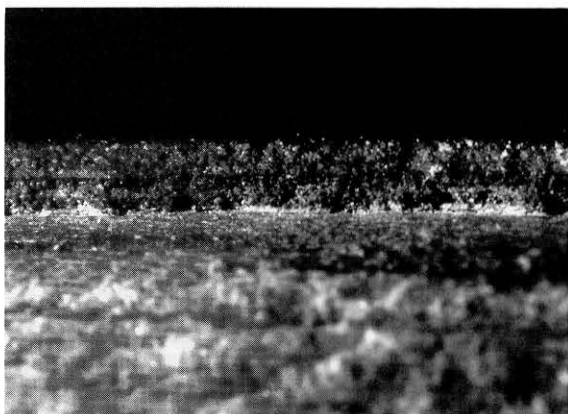
蓋下部に作られた玉縁は下地の型引きで作られているが、蓋の開閉に伴い各所で亀裂を起こしている。大きな欠損部は玉縁の形状を模して補修がされているが、ラミンと思われる木材をケミカルな接着剤で貼り付け、サンドペーパーで研磨した状態と考えられる。周辺の塗膜も同時に研磨され下地が露出している。断面が露出した下地を観察すると0.7ミリほどの下地厚に三層の粒度の違う下地がそれぞれ二回前後塗布されていることが分かる。漆下地に比較してこの下地は僅かな水分にも弱く、膠を膠着材としているものと考えられる。(P81)

81 下地断面 X5撮影
Layers of the foundation (x 5)

The rim at the bottom of the lid was made by raising the foundation and shaping it with a flat metallic board on which the outline of the rim was carved, but many cracks and missing parts had appeared in several places due to the opening and closing of the lid. Wood, chemical adhesive and sandpaper had been used to repair large missing areas by imitating the shape of the rim. For this reason, the surrounding urushi coating was also polished and the foundation was exposed. When the original foundation around the top edge of the side panel of the lid was observed, it was found that 3 layers of foundation, each with different sized particles, had been applied twice to form a foundation with the thickness of about 0.7mm. Compared with urushi foundation, this foundation is weak against moisture and for that reason is thought to have been made with animal glue (Photo 81).

18 削り落とした玉縁の復元にあたっては、本体上での作業が周辺を痛める危険が高いため、蓋側板のアーチにあわせた石膏型を作り、漆を染みこませた麻紐を二本心材として巻き付けた後、1ミリ厚の銅板で引き型をつくり数回に分けて下地を引いた。下地が所定の厚みに達した後、石膏に水分を含ませ玉縁を取り外し、彫金用の鑪で形態を整え麦漆で貼り付けた。さらに本体との隙間や不足分は刻苧で充填し、下地を篋付けし形態を整えた。(P98)

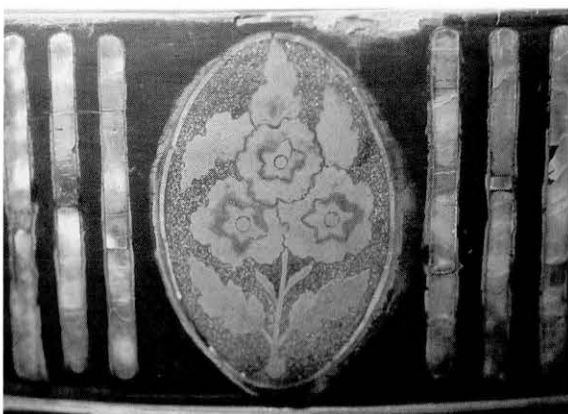
蓋の側面は艶を維持するためであろうか、過剰な磨きにより貝の際が摩耗している。また表面には白濁した被膜が厚くかぶり、貝や蒔絵の色調を鈍いものにしてる。

正面の蒔絵の人物や船など貝の部分にも同様の処理が見られる。おそらく貝の剥離の進行を止めるため、使用した修復材料が変質し白濁したものと考えられる。(P82)

82 蓋髪部 蒔絵と貝の表面に残る被膜の状態
Condition of the urushi coating on the makie and surface of raden (lid)

cloudy film that made the color and shine of the shells and *makie* dull. The same kind of treatment was seen on the shells used for the persons and the ship in the front *makie* decoration. It was assumed that the coating material used to stop the lifting of the shell pieces had degraded, changed in color and lost its translucency (Photo 82).

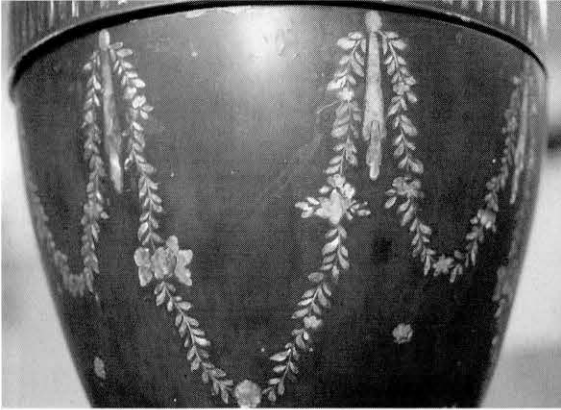
胴部は全体に塗面の退色が著しく、本来は黒色であったものが褐色に変色し、各所に縦方向に流れるような染み状の色斑が発生している。これらは塗膜の表面に結露した水分が流れ、再度乾燥するという状態が繰り返された結果ではないかと考えられる。塗膜表面を観察すると細かな断文が一面に入り、艶が失せている。このような塗膜の劣化は、手油や水などが不用意についた程度でも取り返しのつかないダメージとなりかねない。(P83)

83 胴部の塗膜の汚れ
Stain on the urushi coating (body)

The color of the urushi-coated surface of the body had faded significantly, and what had originally been black had become brownish at various places. There were also streaks running vertically. It is believed that these streaks were formed by repeated cycles of moistening, caused by dew condensation flowing down the surface of the coating, and drying. A closer observation of the urushi coating shows micro-cracks causing diffused reflection. Deterioration of the urushi coating such as this is very serious, and oiliness and moisture of the hand may cause irreparable damage, even with a slight touch (Photo 83).

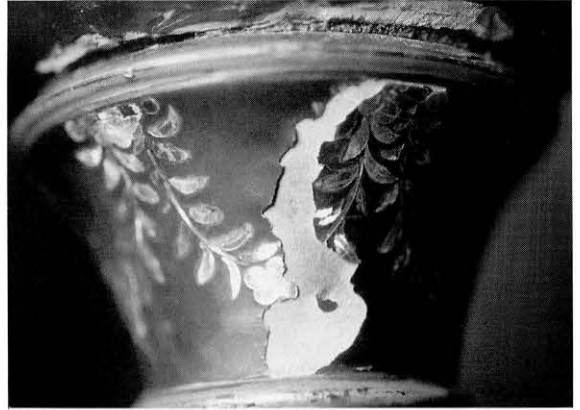
軸部は木地の乾燥に塗膜がついていけず激しく剥離している。胴部との接合部には膠が吹き出しており、結露による水分の抜けない状態が長期間継続したのと考えられる。基壇の塗膜の劣化は特に激しく、断文に加えてその隙間に何らかの汚れが食い込んだ状態が見られる。脚部は水分の影響からか、ほとんどの塗膜が下地から崩れるように剥離している。(P84) (P85)

84 軸部の塗膜剥離
Lifted urushi coating on the foot

The urushi coating on the foot had become severely lifted, since it could not keep up with the drying of the wooden substrate. At the section where the foot and the body are joined, animal glue had oozed out. It is believed that this was caused by moisture from dew condensation having accumulated here.

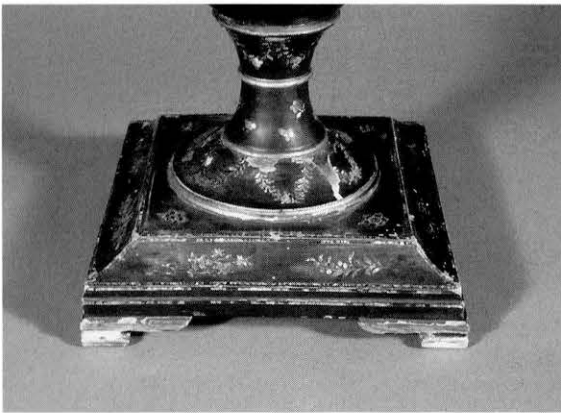
85 基台部の汚れと損傷
Stain and damage on the foot and base

The deterioration of the stand was especially drastic. There were micro-cracks and it appeared that these cracks were filled with some kind of dirt. Most of the urushi coating on the legs had become lifted, together with the foundation, from the substrate, possibly because of moisture (Photos 84 and 85).

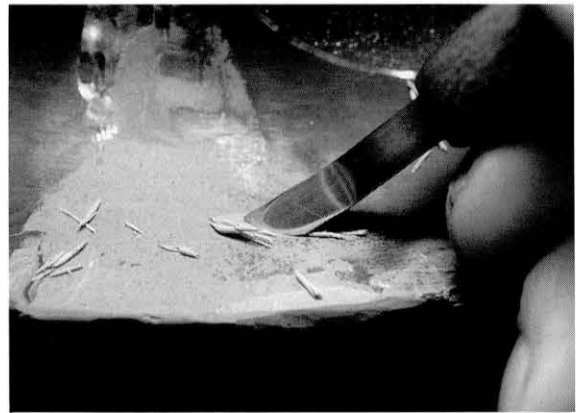
86 蓋背面の充填材の除去
Removing the filling material with a knife (back of the lid)

- 1 全体を毛棒で掃き、隅や蓋裏に残留した埃を払い落とした。
- 2 竹箆に純水を含ませた綿布を巻き付け、ごくわずかずつ汚れを落とした。
- 3 剥落の危険のある箇所には細かく切った雁皮紙を糊貼りし仮止めを施した。
- 4 蓋部に被った下地材を刀で僅かずつ削り落とした。(P86)
- 5 塗膜が現れてきたところで綿棒にごく少量の酢酸エチルを含ませ、溶けたパテ剤が広がらないように注意し、綿棒に吸い込ませるようにして表面に残った僅かな残留物を取り除いた。塗膜は細かな断文が無数に入った状態のため不用意に溶剤を使用すると溶けた材料が断文の中に入り込み、汚れを拡大する危険があるため注意が必要である。(P87)

4. Foundation material covering the cracks on the lid was scraped off, little by little, with a knife (Photo 86).
5. As the urushi coating appeared, foundation material still remaining on the surface was removed with a cotton swab slightly moistened with ethyl acetate. This was done carefully so that the solvent containing foundation material would not spread to the surrounding area. Since there were numerous micro-cracks on the urushi coating, there was a risk of the contaminated solvent permeating into the cracks. For this reason it was necessary to use the solvent carefully (Photo 87).

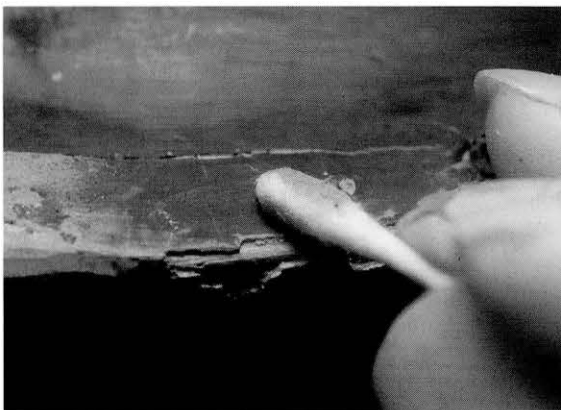
87 蓋背面の充填材の除去
Removing the filling material by ethyl acetate (back of the lid)

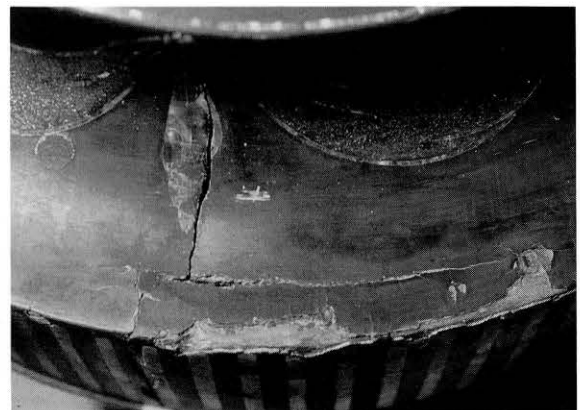
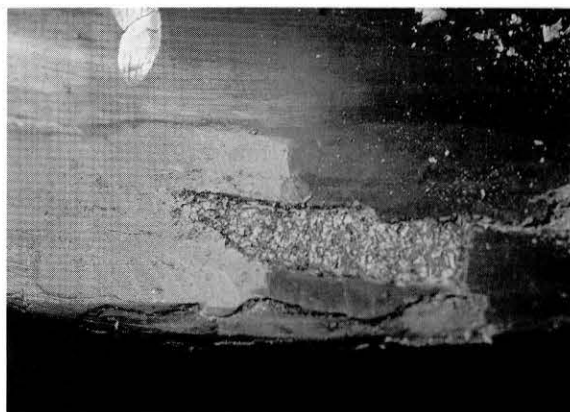
- 6 パテ剤を取り除くと黒色の充填剤が詰め込まれた亀裂が現れた。背面側の亀裂には充填されていない材料であることからパテ剤が使用される以前におこなわれた修復の際、充填された材料と考えられる。僅かに水分を含ませると表面からゆるみ始める特性があるのと、溶けると同時に独特の臭いがあり膠と考えられた。黒色の由来は何らかの顔料が含まれているというより未精製の膠を使用したものと考えられる。なおパテ材と黒色充填材は東京文化財研究所の早川典子氏に分析を依頼した。分析の結果からパテ材はガラスバルーンが含まれた充填材であり、黒色充填材は膠の可能性が高い事が判明した。(P88) (P89)

88 充填材の下から現れた亀裂
Crack found under the filling material

89 黒色の充填材
Black filling material

6. When the foundation material was removed, cracks filled with black filling material appeared (Photos 88 and 89). Since such a material was not found on the cracks at the back of the Object, it was believed that the black material had been used before the foundation material was used. Furthermore, the black material began to soften from the surface when moistened and gave off a smell. For these reasons it was thought that animal glue had been used and that the black color was caused not by a pigment but that it was the color of unrefined animal glue. The foundation material and the black filling material were analyzed by Hayakawa Noriko of the National Research Institute for Cultural Properties, Tokyo. As a result it was found that the foundation material contained glass balloon and that there was a great possibility of the black filling material being animal glue.

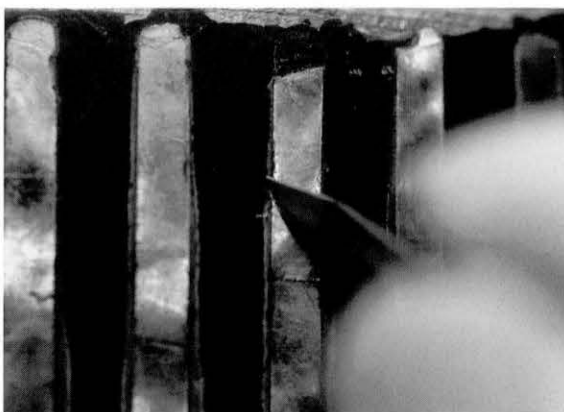
90 貝表面の汚れの除去
Removing traces of previous restoration from the surface of shell pieces

11 貝と蒔絵に固着している白濁した被膜は非常に強固で、溶剤をテストしたがアルコールで僅かに落ちる程度で、かんばしい効果は期待できなかった。このため貝の際部分に固着した固まりは刀で削り落としながら純水を含ませた綿棒で崩すようにしながら除去した。この部分についても資料を採取し分析を試みたが変質が激しく同定は困難であった。(P90)

- be obtained. So the film firmly fixed along the edges of the shell pieces was first scraped off with a knife and then removed, little by little, with a cotton swab moistened with pure water. Samples were taken of the film for analysis, but it could not be identified because of severe deterioration (Photo 90).

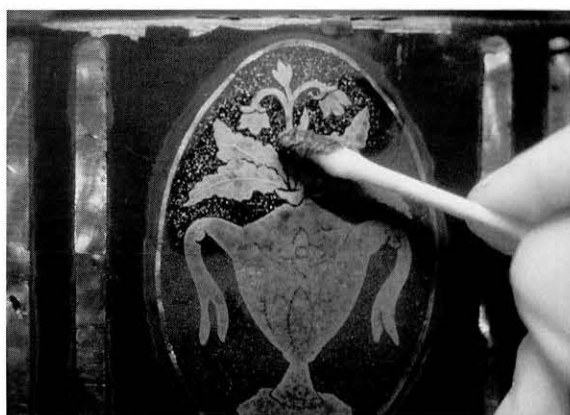
91 蒔絵表面の汚れの除去
Removing traces of previous restoration from the surface of makie

12 蒔絵部分に付着した被膜も同様に時間をかけて純水と綿棒で被膜を膨潤させながら除去した。この部分は微塵貝の仕立の上に平蒔絵を行い、さらに黒漆と金の付描としているため、摩擦による摩耗の危険が伴い、作業には最大限の神経が要求された。(P91)

12. The film on the *makie* was also removed in a similar way by softening and swelling it with pure water and cotton swab. Since this portion was decorated with *hiramakie* over *mijingai* and since there were lines drawn on the *hiramakie* with black urushi and gold, there was a great risk of wear caused by friction. So special care was needed for this operation (Photo 91).

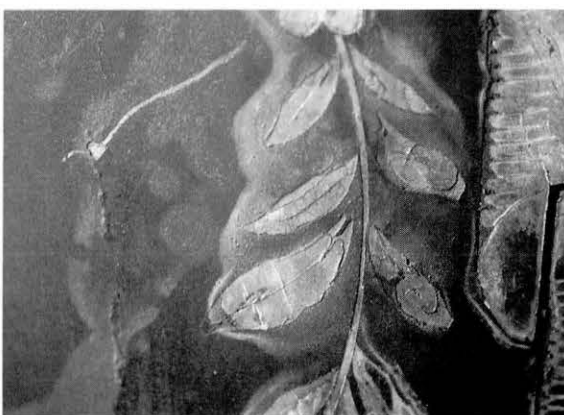
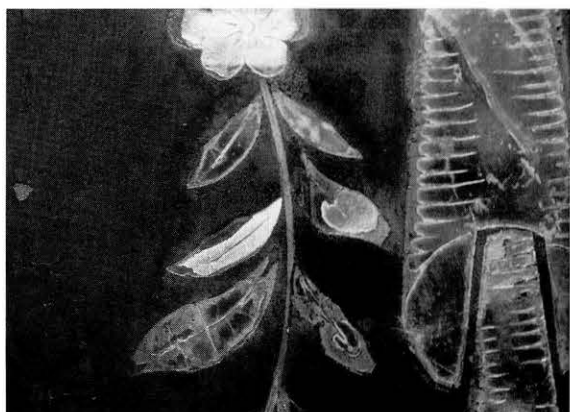
92 胴部塗膜の汚れと劣化
Removing traces of previous restoration from the urushi coating on the body and the condition of deterioration

93 固め後の塗膜の状態
Condition of the urushi coating after consolidation

13 塗膜表面の劣化に対しては黒呂色漆に生正味漆を混ぜ合わせた漆に適量の溶剤を加え、貝を汚さないよう配慮しながら、蒔絵筆で細かな断文に漆を浸透させた。この作業を漆の濃度を変えながら3回繰り返す事で艶と強度を回復することができた。(P92) (P93)

13. For the micro-cracks on the surface of the urushi coating, a solvent was added to a mixture of *kijomi urushi* and black *roiro urushi*. This mixture was impregnated carefully in doses with a *makie* brush so as to avoid the shell pieces. This operation was repeated three times, changing the density of urushi. As a result, gloss and strength of the Object were recovered (Photos 92 and 93).

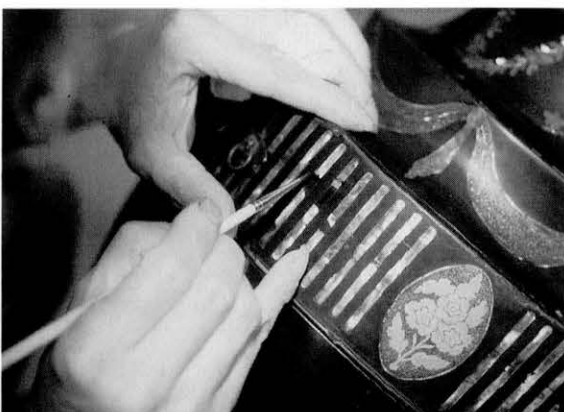
94 膠の含浸
Impregnating animal glue under the shell pieces

15 刻苧の充填により木地が安定したのを確認した後、剥落した貝の接着と塗膜の接着を行った。薄貝の接着には、湯煎した粒膠を使用し、含浸の際、僅かにアルコールを混ぜることで浸透性を高めた。(P94)

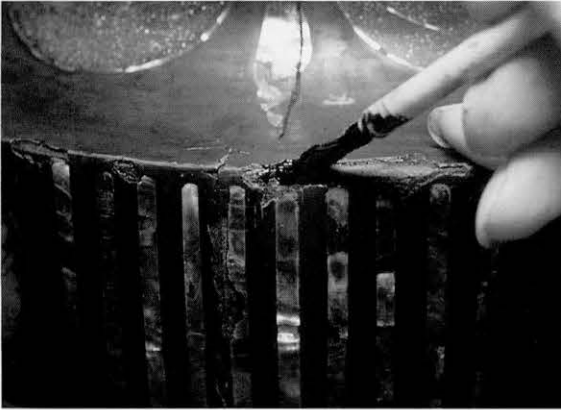
95 麦漆の含浸
Impregnating *mugi-urushi*

16 塗膜の接着には水練りした小麦からグルテンを抽出し、生漆を混合した麦漆を使用した。漆との混合の際扱いにくく、でんぷん質が抜けているだけ水分量が少なく乾きが遅くなるなど欠点はあるが肌理が細かく、溶剤に麦漆を溶いた際にも分離が少ないなど、薄い塗膜の亀裂部への含浸には有効である。(P95)

16. To fix the urushi coating, *mugi-urushi* made by adding *ki-urushi* to gluten, which is produced by kneading flour in water, was used. The disadvantages of this adhesive are that it is difficult to mix with urushi and that it takes time to dry since the lack of starch component means that there is less moisture in *mugi-urushi*. However, the advantages are that the texture is finer and that it does not separate much even when a solvent is added to it. For these reasons, it is very effective when impregnating into cracks on thin urushi coating (Photo 95).

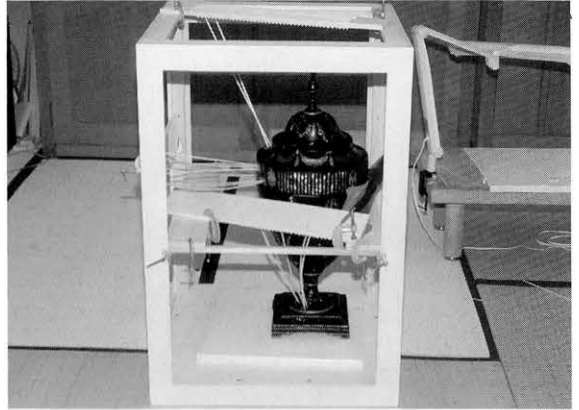
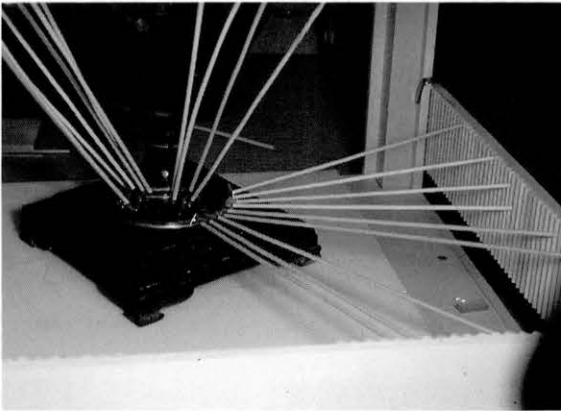
96 芯張りによる貝の接着
Press stabilizing shell pieces with *shimbari* sticks

97 芯張りによる塗膜の接着
Press stabilizing *urushi* coating with *shimbari* sticks

17 ナイフアーンの形態にあわせた木枠を制作し、この中に器物を固定させ、木製の丸棒のテンションを利用して剥離部を定着させた。非常に曲面の出入りが激しい形態のため複数の丸棒が安定した状態で固定できるよう工夫が必要であった。剥離部と丸棒の間には安全かつ確実に接着できるように、樹脂板やビニールなど4層の材質を重ねた緩衝材を挟んで押さえ込んだ。(P96) (P97)

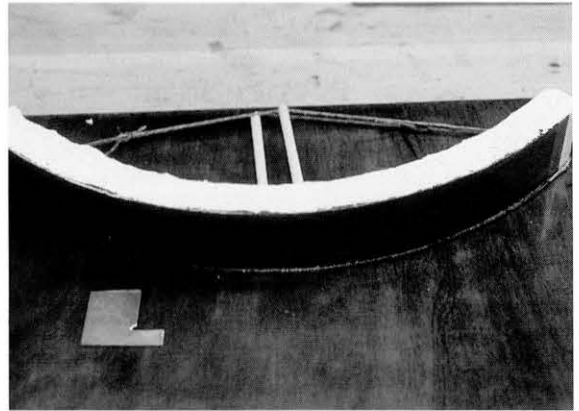
98 石膏型による玉縁の制作
Making the rim on a plaster mold

18. To reproduce the rim that had been removed, a plaster mold of the side panel of the lid was made, since working directly on the Object may cause damage. Two hemp ropes soaked in urushi were wound around the mold to form the core of the new rim. Then foundation material was applied to

the core. Next, a copper plate 1mm thick cut into the shape of the rim was used several times to make the new rim. Once the foundation had reached a certain thickness, the plaster was moistened to remove the rim. The shape of the new rim was adjusted with a metal file and *mugi-urushi* was used to attach the rim to the side panel. *Kokuso* was filled in spaces between the body and the reproduced rim. Foundation was further applied with a spatula and the shape was adjusted also with a spatula (Photo 98).

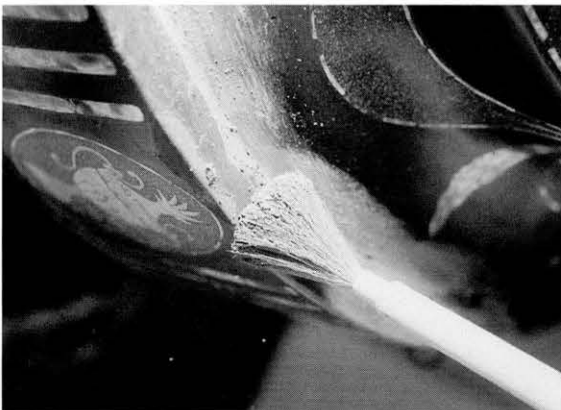
99 珩藻土による蒔地
Sprinkling diatomaceous earth

19. In the restoration of the lost urushi coating, care was taken so that the restored portion would be clearly recognizable but that it would not disturb the overall appearance. *Rose-urushi*, made of *ki-urushi* and *roiro-urushi*, was first used as *shitazuke urushi*, which serves as an adhesive. Since the urushi coating of the Object had almost no gloss, finest particles of diatomaceous earth were sprinkled with a brush to make the foundation. In order to restore the legs, the Object had to be lifted from the working stand, making the Object unstable. So extra care had to be taken (Photo 99).

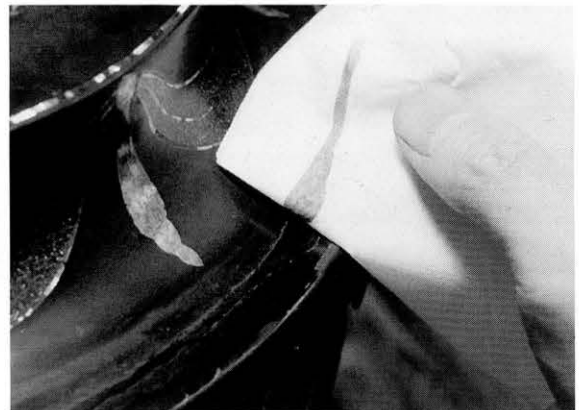
100 蒔地の固め
Consolidating the diatomaceous earth

20. Color and gloss similar to those of the original were obtained by allowing *rose-urushi* to permeate into the foundation and then absorbing excess urushi with paper (Photo 100).
