# 清水宇治図屏風

平成14年度修復事業

品名：清水宇治図屏風 6曲1双  
所蔵：ベルン歴史博物館

## 修理報告

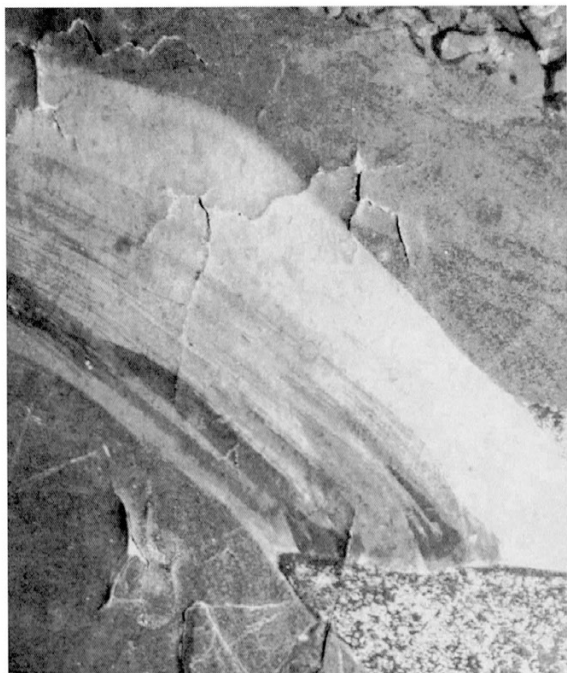
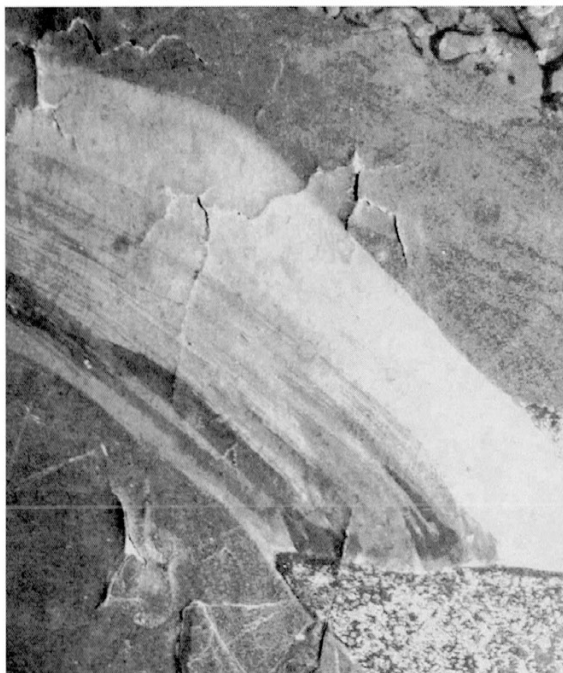
87 左隻第6扇 亀裂箇所 修理前  
Left side screen 6<sup>th</sup> panel Before restoration Sections with cracks

1. 画面全体に亀裂、断裂が多数見受けられた。過去に処置が施されている箇所も多いが、右隻第3扇の建物の屋根部分では表側から楮紙の帯を貼って補彩を施す処置が行われていた。(図87、88、89)
2. 欠失箇所の多くには既に過去の修理における補紙が施されているが、裏から当てたり表から貼ったりと複雑な状況が認められた。補紙の上に補彩、補筆が施されている箇所も多く、場所によってはオーバーペイントも見られる。(図90、91、92)

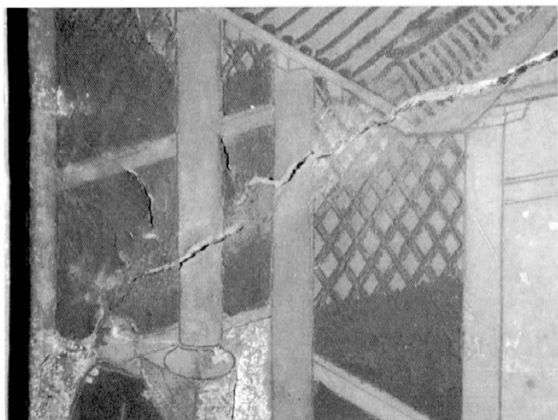
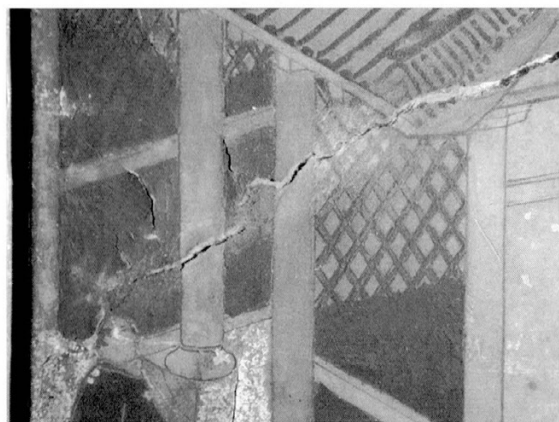
89 右隻第4扇 亀裂箇所 修理前  
亀裂の上に栞紙の帯を貼りつけて補彩が施されていたが、さらに亀裂が広がったために帯ごと切られている。この栞紙を除去すると現状で見えている補彩がなくなってしまうことから現状のままとした。  
Right side screen 4<sup>th</sup> panel Before restoration Section with cracks  
In a previous restoration, toning was painted on strips of *kōzo* paper was toned and affixed over cracked areas. However, the cracking continued and damaged the strips as well. As the removal of these *kōzo* strips would change the appearance of the painting, the current condition was maintained.

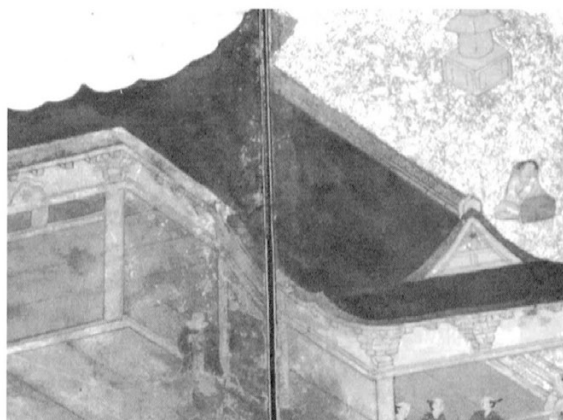
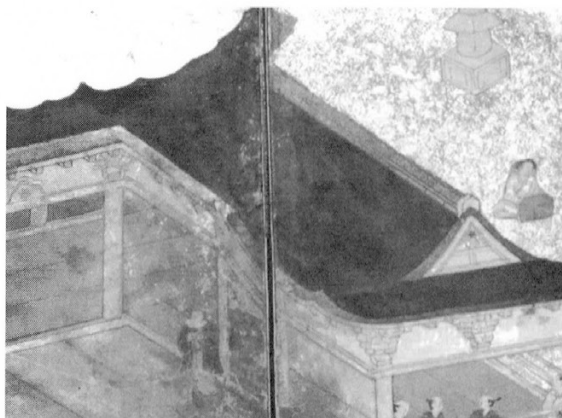
90 右隻第3扇 補紙上の補筆 修理後

左側の第3扇の框部分が欠失して補紙があてられている。補紙上には第2扇の画像に繋げるためにいびつに曲げられた線が書き加えられている。過去の修理で隣り合った図像にずれが生じたと思われる。今回の修理では、こうした改変もそのまま残した。

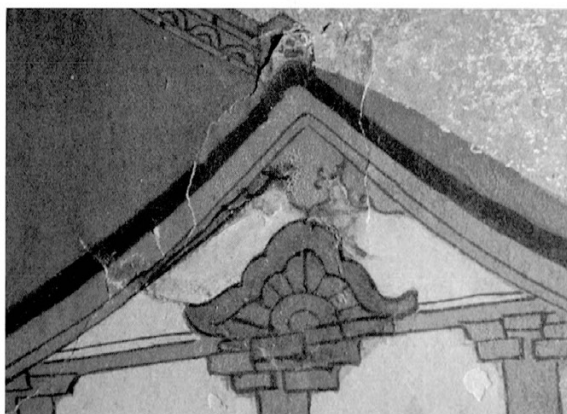
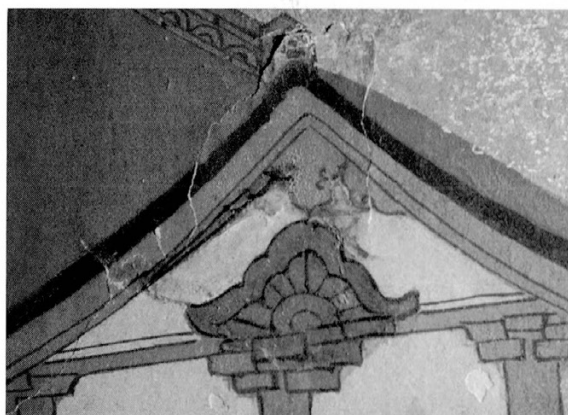
91 右隻第6扇 補紙上の補筆 修理前

補紙の上に補筆が施されているが、白い絵具が赤っぽく変色し見苦しくなっている。また、表面に透明なコーティングが施されたようになっている。

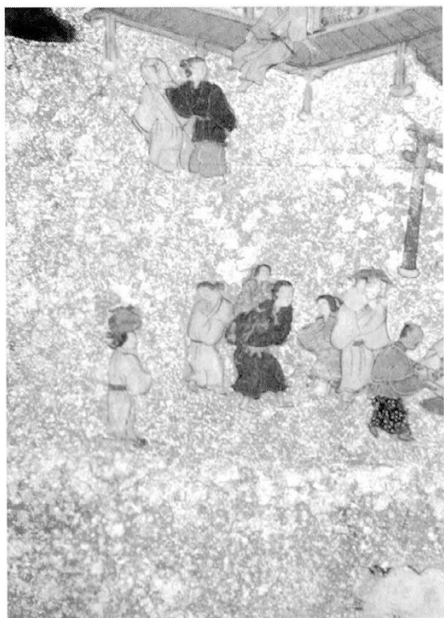
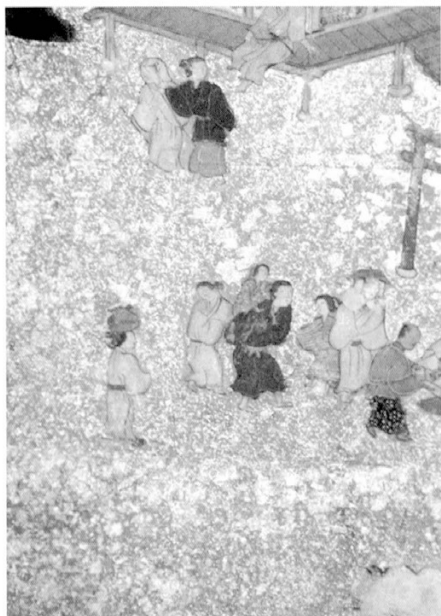
旧修理時における補紙、亀裂の繕いは重なり部分が非常に広く、厚くなった部分は擦れ等の損傷の原因となるだけでなく、料紙のバランスを崩している。(図93～98)

93 右隻第5扇 亀裂か所の旧処置 修理前  
亀裂上に補強の為に裏から帯が貼りつけられているが、必要以上に大きい。  
Right side screen 5<sup>th</sup> panel Before restoration  
Previous treatment of cracking  
Strips were pasted from the back to reinforce crack-  
ing, but they were unnecessarily large.

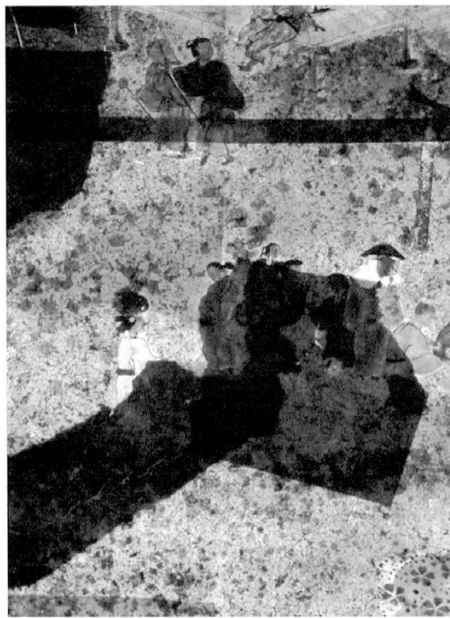
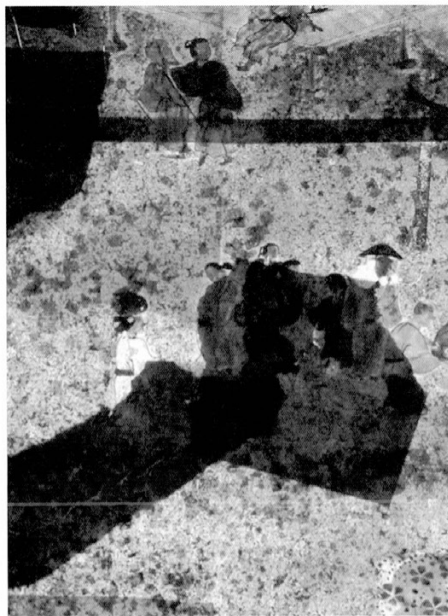
94 右隻第5扇 亀裂か所の旧処置  
旧処置除去前  
今回はこれを除去し、薄く強靱な楮紙の帯を小麦澱粉糊  
で貼り付けた。  
Right side screen 5<sup>th</sup> panel Before removing the strips  
Previous treatment of cracking  
In this restoration, these strips were removed and  
replaced with thin strong strips of *kôzo* paper with  
wheat starch paste.

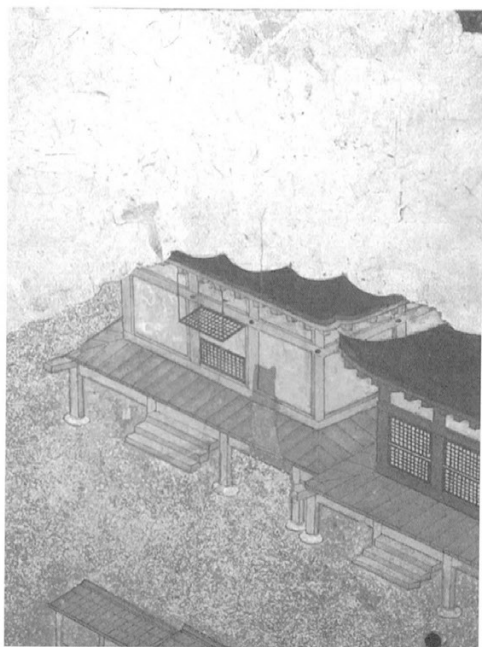
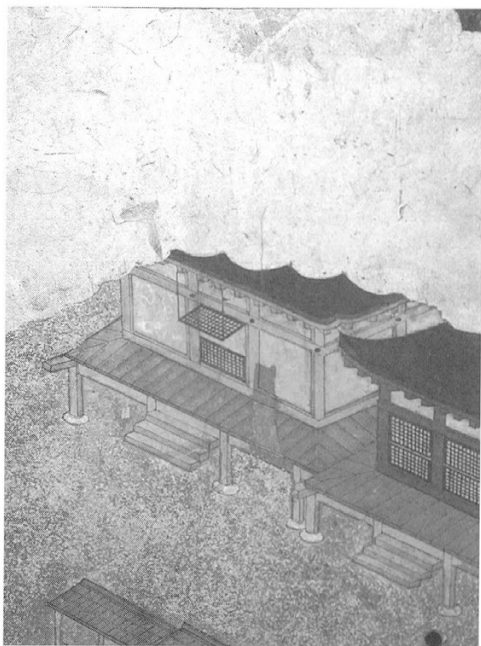
96 右隻第5扇 亀裂か所の旧処置 修理前  
欠失部に貼られた補紙がかなり大きく重なっていた。  
Right side screen 5<sup>th</sup> panel Before restoration Previous treatment of cracking  
Excessive overlapping of paper used in previous restoration.

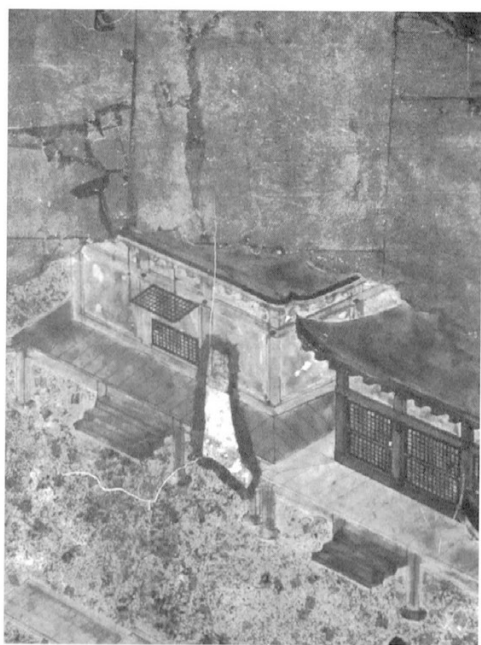
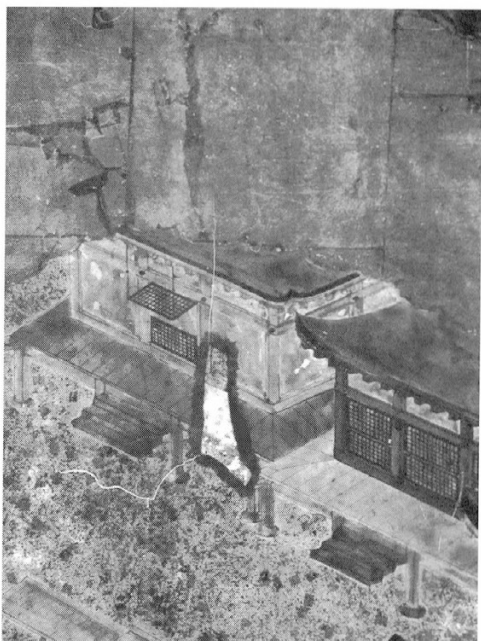
98 右隻第5扇 亀裂か所の旧処置 処置後  
糊代として必要な部分を残して削り取った。表からは、非常に雑な補彩が施されている。  
Right side screen 5<sup>th</sup> panel After restoration Previous treatment of cracking  
Overlapping areas were chamfered away to leave only what was necessary as margins for pasting. From the front, toning was done in a rough manner.

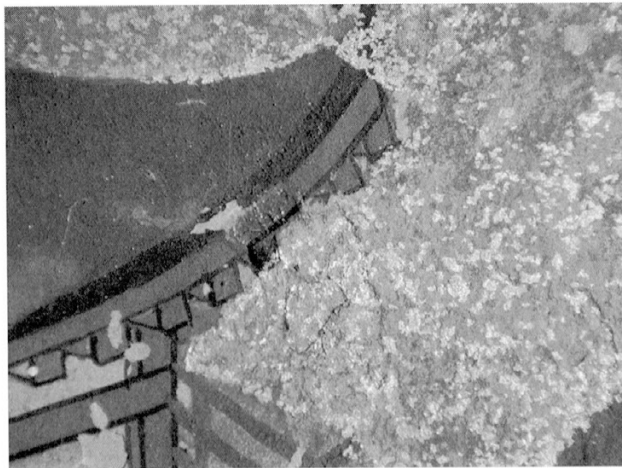
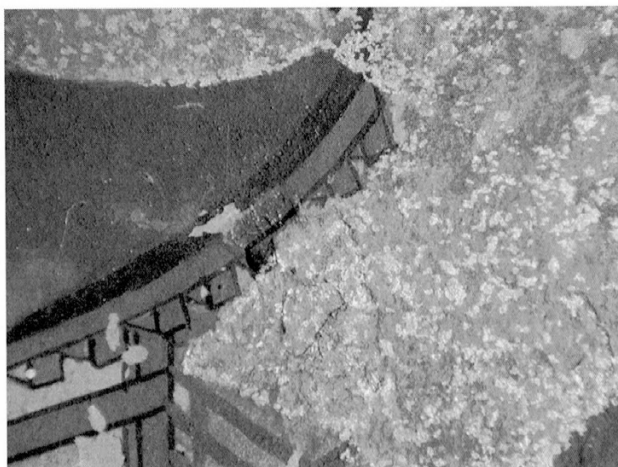
99 右隻第6扇 修理前

砂子が画像の上に載っており、画像が描かれた後で砂子が蒔かれたことがわかる。

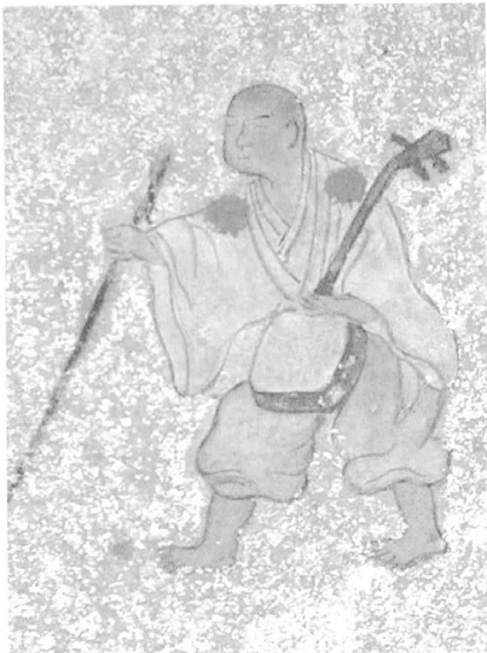
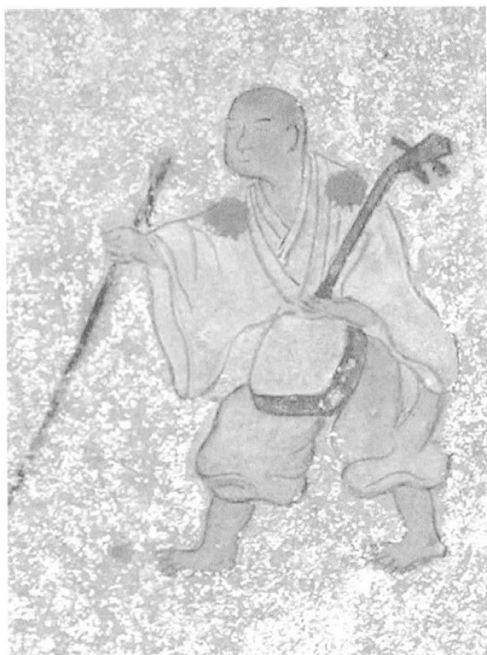
100 左隻第1扇 修理前

人物の周りを避けて砂子が蒔かれた様子がわかる。

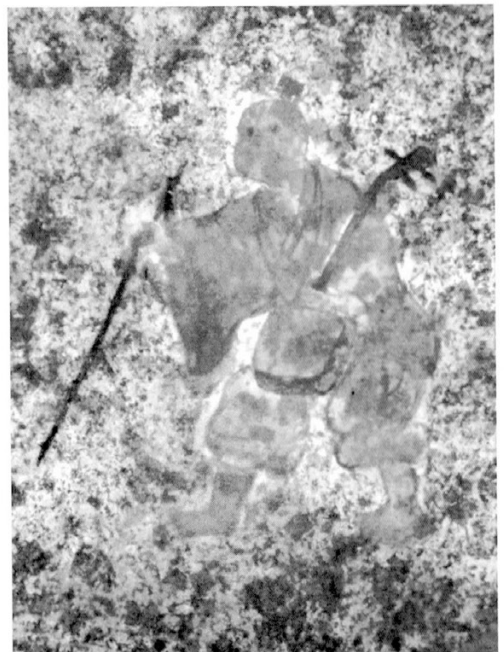
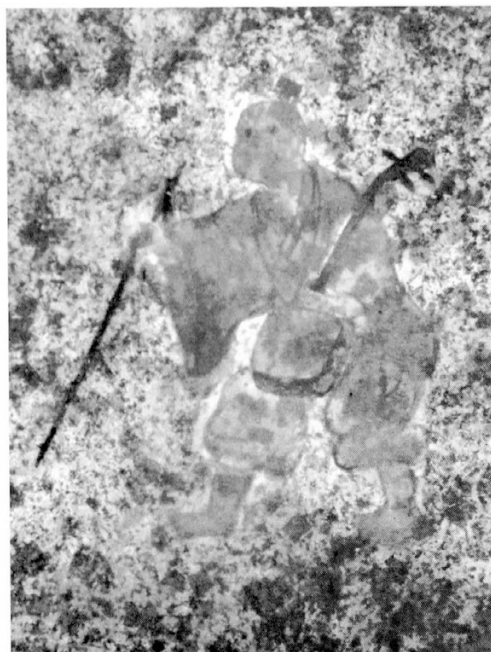
101 左隻第1扇 透過写真

透過写真では人物の中にも切箔が蒔かれているが、表面からは見えないので、画像が描かれる前に蒔かれたことがわかる。

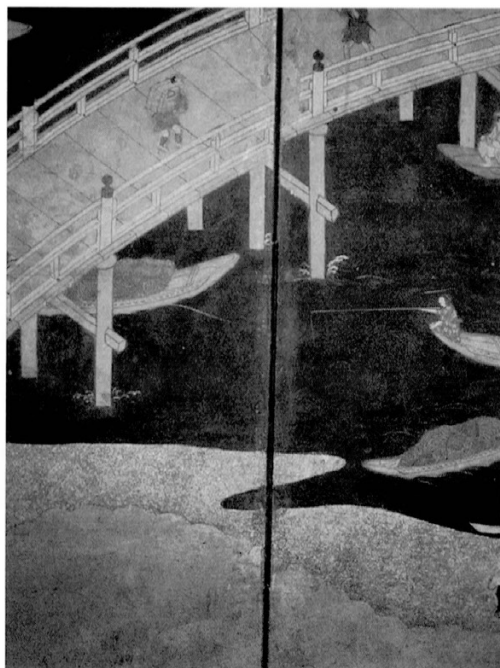
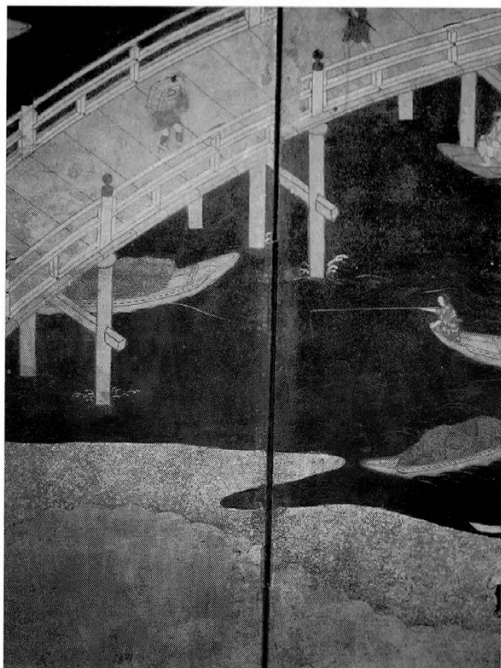
102 左隻第6扇 修理後

屏風の構造上、両面同士が擦れやすく、特に奥尾背付近では下地の板の部分がきつく擦れる。

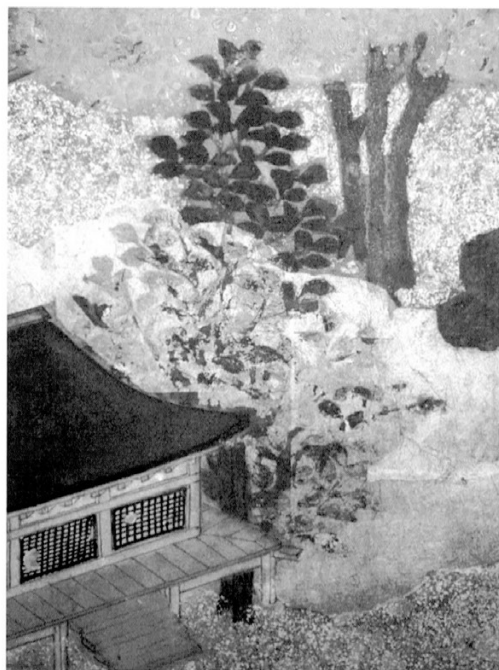
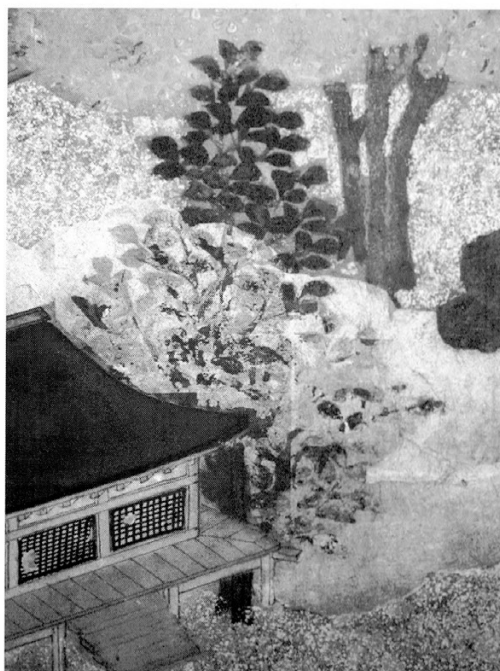
103 右隻第5扇 金箔上の緑青の剥落 修理前

金箔の上に描かれた樹木の緑青が剥落した。これは後天的な損傷劣化というよりは、絵画技法的な問題と思われる。両面全体わたって、絵具層の上や金箔の上などに光沢がある個所が多いが、どのような物質かは不詳であるが、過去に何らかの剥落止め処置が行われた結果であろう。

3%の膠水溶液にて剥落止めを行い、絵具層を強化した。

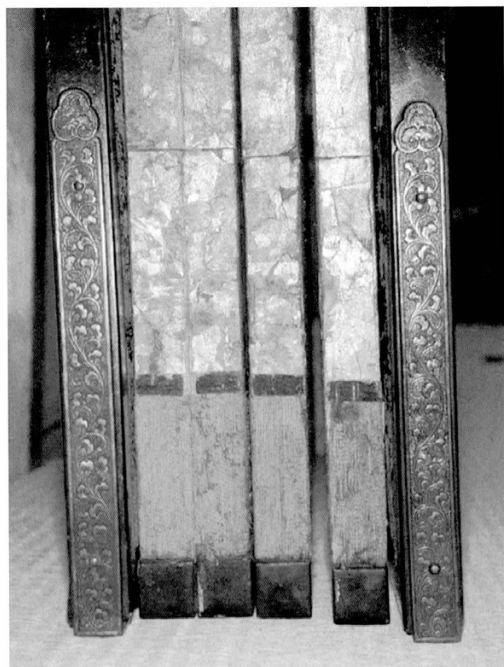
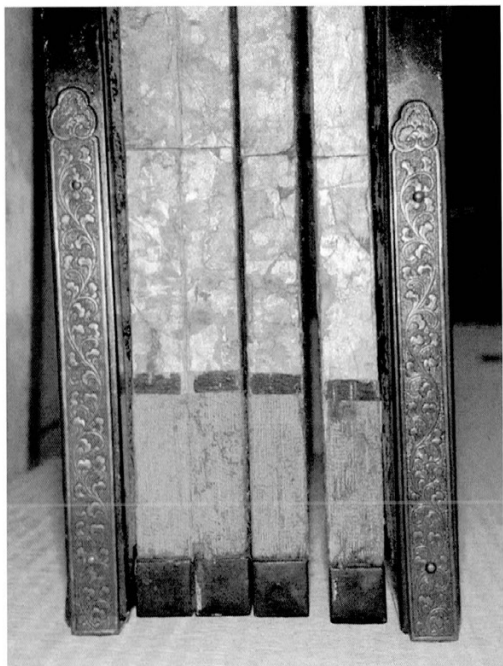
104 背隻 前尾背の断裂 修理前  
Back of the screen Before restoration Breakage on the front part of the hinged section (*mae-ozu*)

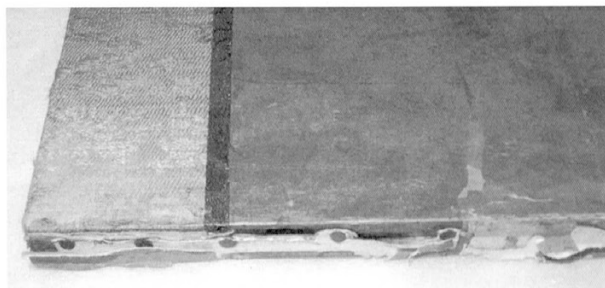
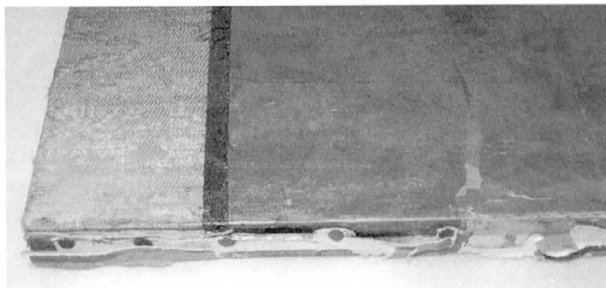
105 左隻第2扇 損傷した蝶番部分 修理前  
リネンテープやピンで応急的に補修されているが、折り畳める形にはなっていないので蝶番としての機能を果たしていない箇所もある。  
Left side screen 2<sup>nd</sup> panel Before restoration Damaged hinges  
The damage was repaired with linen tape and pins, as if temporary in nature, but without regard to the folding aspect. As a result, hinges lost ability to allow the screens to completely close.

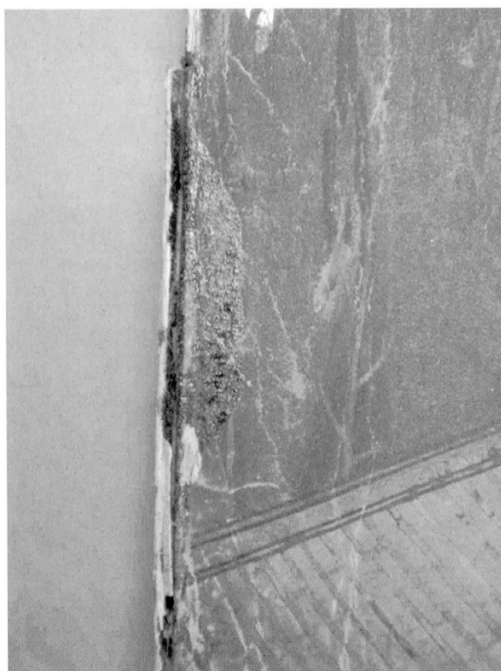
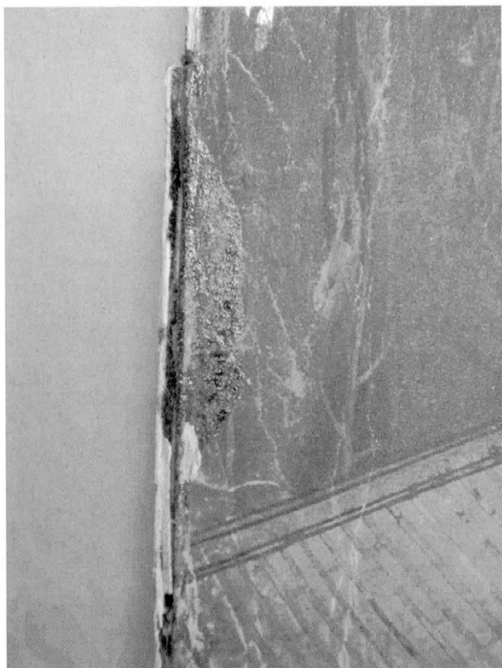
106 右隻第5扇 修理前  
蝶番の処置に使われていた接着剤が画面に付着している。硬く透明で光沢のある接着剤であったが、作業中の水分で膨潤してゆるんだので、幾分は除去できた。  
Right side screen 5<sup>th</sup> panel Before restoration  
The adhesive used in a previous restoration to treat the hinges was also applied to the painting. The result was that areas were covered with this thin, transparent, and glossy adhesive. During the restoration process, the adhesive could be softened with moisture, allowing a partial removal.

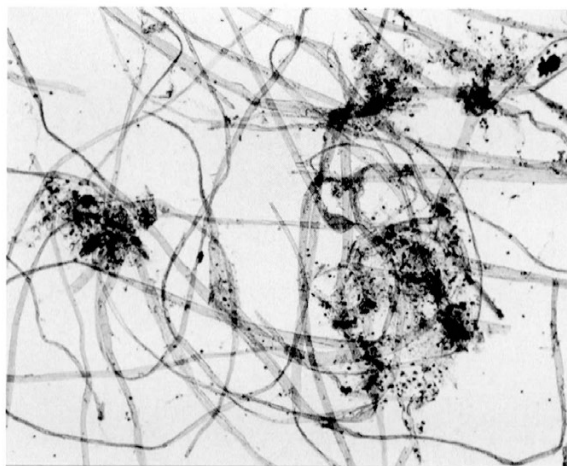
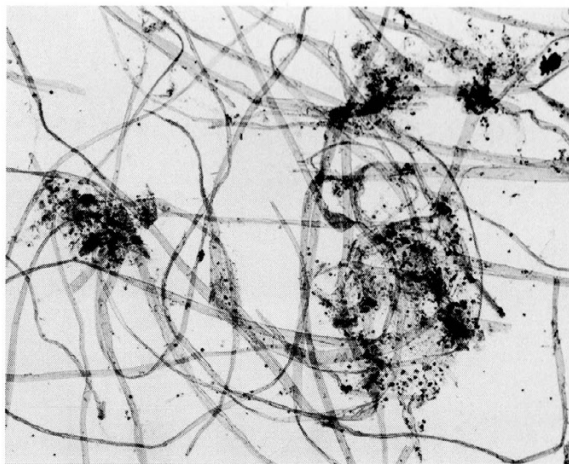
111-1 繊維組成の顕微鏡写真  
雁皮の繊維。米糊を配合しているため、染色すると青い点々が観察される。  
Microscopic photographs of the fiber contents  
Fibers of *gampi*. As it contains rice glue, *gampi* appears with blue  
dots after being dyed.
