草花蒔絵螺鈿鎌倉彫簞笥

平成13～15年度修復事業

草花蒔絵螺鈿鎌倉彫箆笥

漆芸修復家
勝又 智志

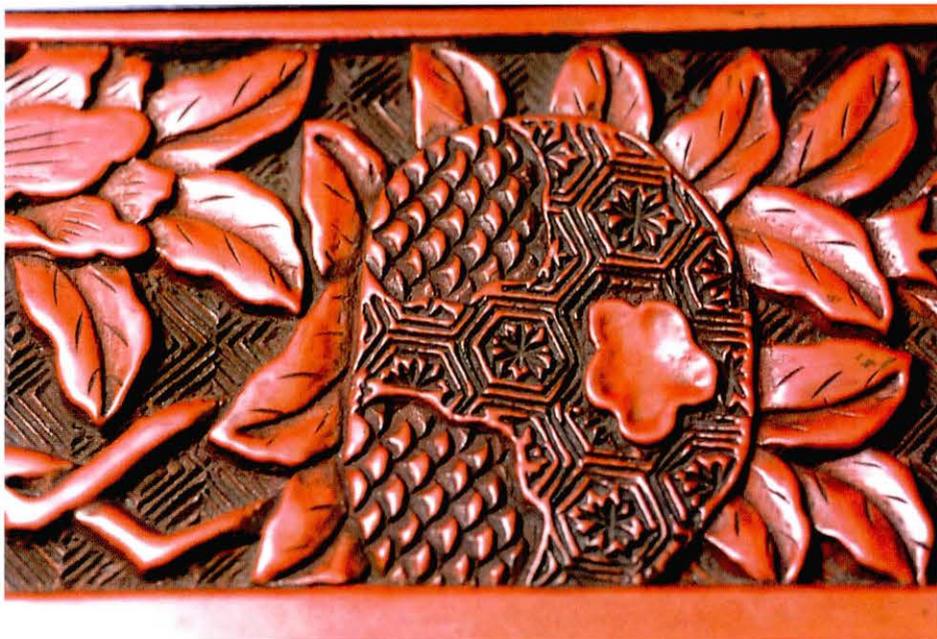
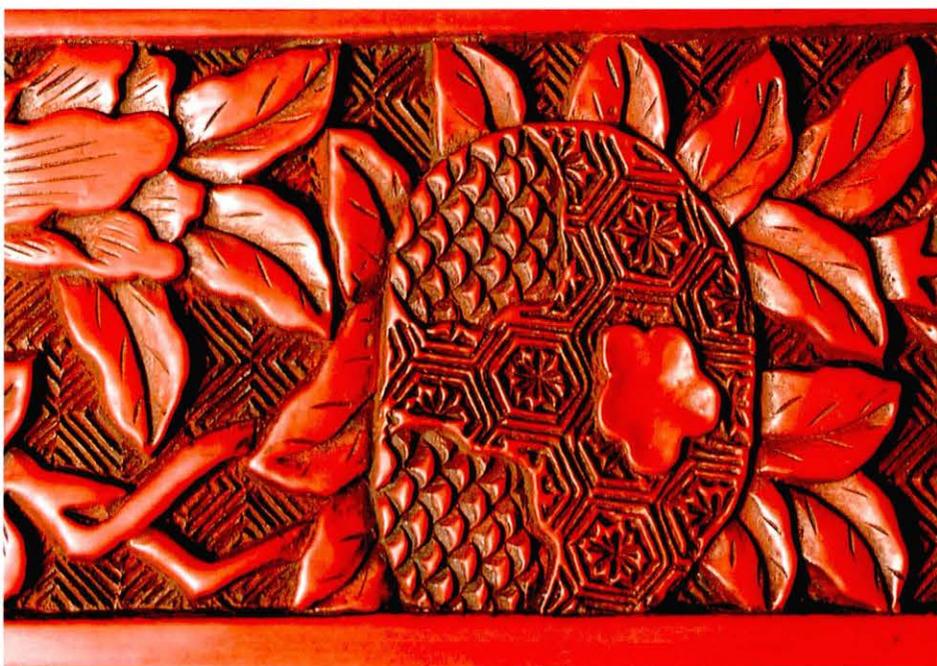
5 天板彫り部 修復前
Carvings on the top board, before restoration

6 天板彫り部 修復後
Carvings on the top board, after restoration

木彫部は各面ともに黒色の堆積物が見られた。特に天板の彫りの汚れは著しく、彫りの谷部分の形状が不明なほどであった。また、背面の彫りの峰部分には強い圧力で他の塗膜面と接触した際に付いたと思われる灰色の塗料状の付着物が各所で見られた。(図5、6)

Black deposits were found on the carvings on all the faces of the Cabinet. The carvings on the top board were especially so dirty as to make it difficult to confirm the shape of the lower part of the carvings. On the higher part of the carvings on the back face, there were traces of gray coating-material-like substance which is thought to have been left when the Cabinet came in contact with another coated object with great impact. (Photos 5, 6)

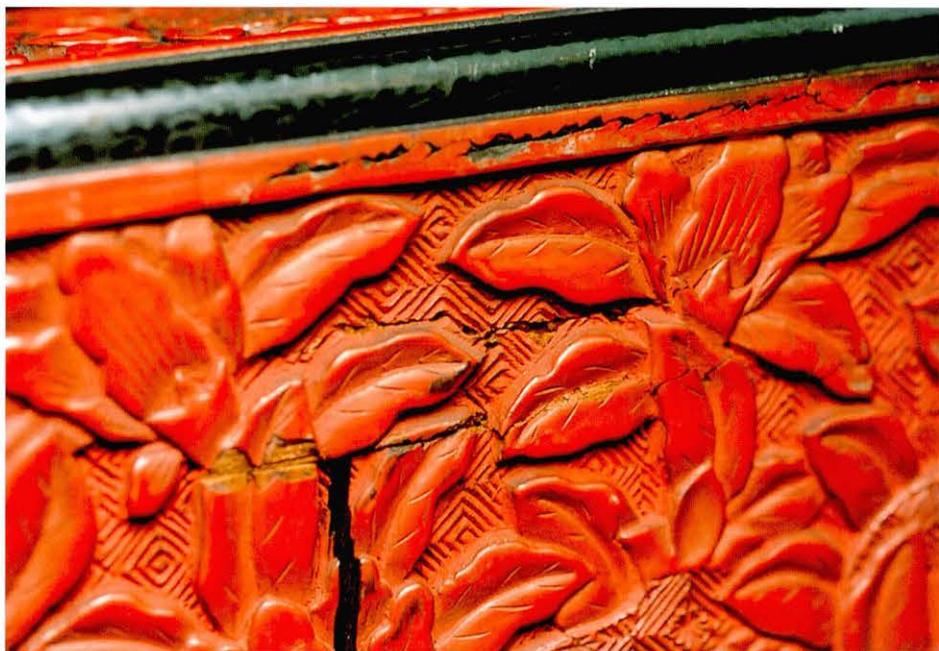
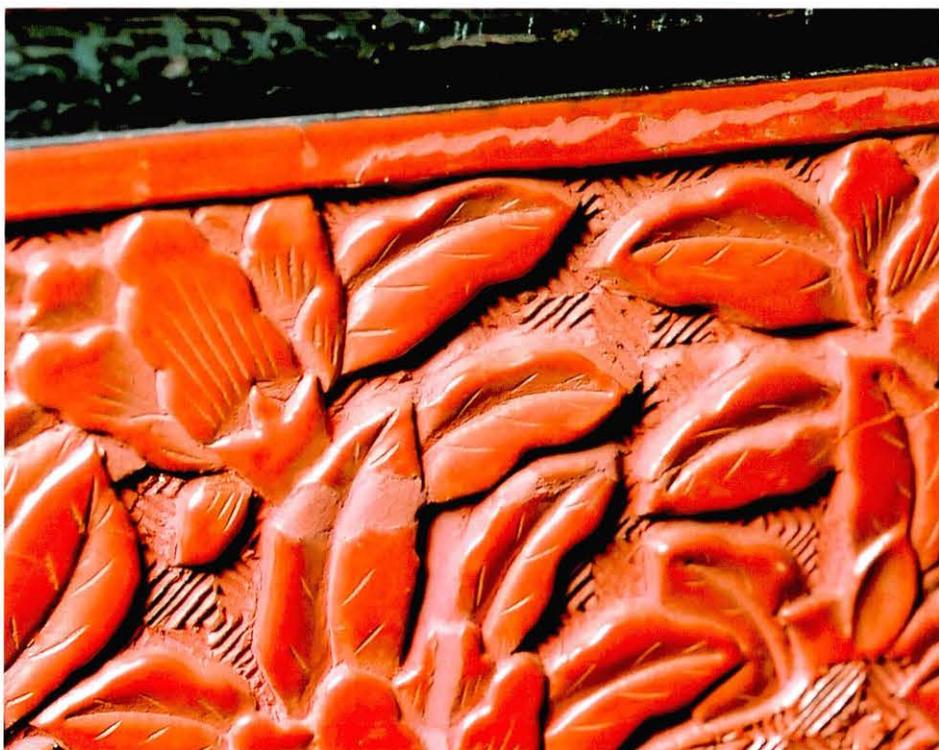
7 背面端喰部亀裂 修復前
Cracks along the *hashibami*, before restoration

8 背面端喰部亀裂 修復後
Cracks along the *hashibami*, after restoration

本資料の損傷は素地である木質の乾燥による収縮に起因しており、接合部や木彫部分に重大な亀裂が発生していた。最も大きな亀裂は背面の木彫漆塗りの部分に、背面左端より16cmほどの地点で縦方向に最大幅3mm、長さ41.5cmの亀裂が入る。左右に分断された板は右側の材が外側に1.5mmほど膨れた状態で固定されており、左右のみならず前後に広がった亀裂は実際の寸法以上に大きく見え、痛々しい状態であった。背面板には上下に木地の狂いを抑える為に2.5cm幅の端喰材が入るが、その接合面にも亀裂が入り、上方で15cm、下方で8cmの亀裂が水平方向に伸びていた。木彫部の亀裂周囲には切削が容易な柔らかな材質のためか各所で欠損が見られた。(図7、8、20、21)

Damage to the Cabinet was caused by the shrinking of the wooden substrate due to exposure to a dry condition. There were critical cracks on the joints and wooden carvings, the largest one being found on the urushi-coated carving on the back face. This crack extended vertically for 41.5cm from a point approximately 16cm from the left edge of the back face; the maximum width of the crack was 3mm. The portion of the board to the right of the crack had swelled approximately 1.5mm, causing the crack to appear painfully larger than it really was since it appeared to have widened not just to the right and left but also forward and back. A piece of board each 2.5cm wide is placed at the top and bottom of the back board, with the grain running perpendicular to that of the back board, in order to prevent the substrate from warping. So there were also cracks that ran horizontally on the portion where this reinforcement board called *hashibami* and the back board meet, 15cm at the top and 8cm at the bottom. There were also many missing parts around the cracks on the carvings, possibly caused by the soft nature of the wood. (Photos 7, 8, 20, 21)

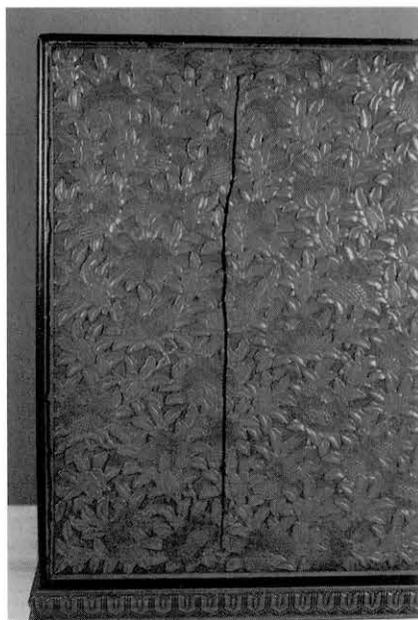
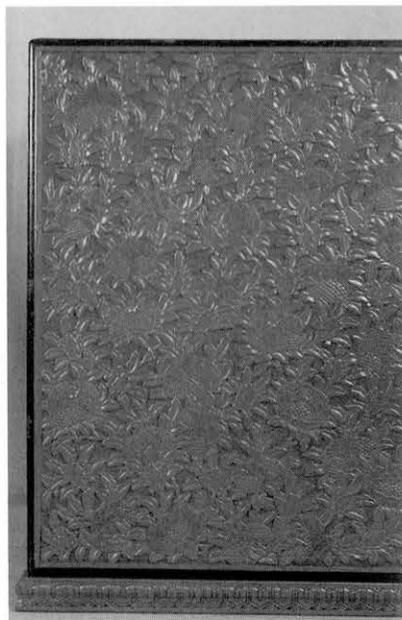
20 背面龟裂 修復前
Cracks on the back, before restoration

21 背面龟裂 修復後
Cracks on the back, after restoration

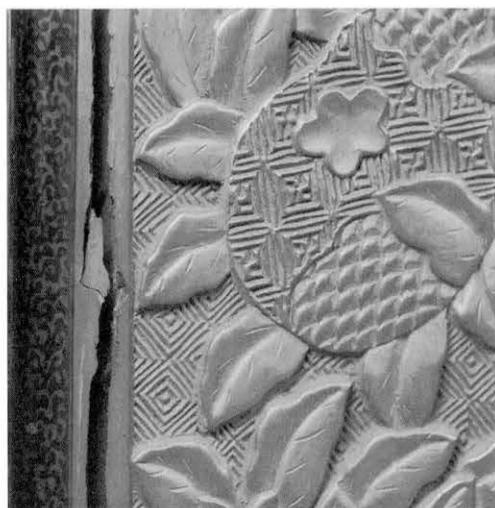
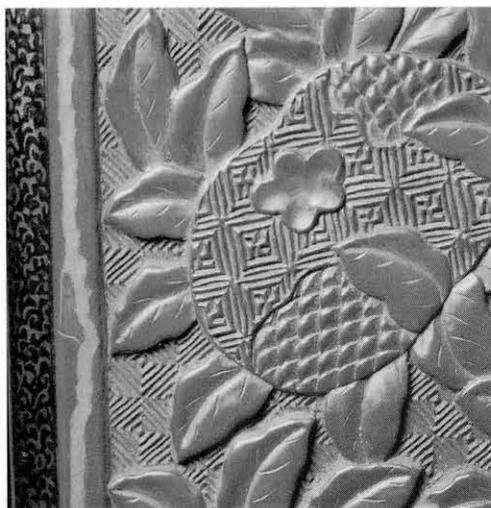
この背面板は上下左右の材に囲まれるようにはめ込まれ、縁周りの朱塗りの部分で釘により接合された後、下地と朱塗りが行われているのであるが、丁度この接合部分から天板と側板の三方で完全に切れ、台輪との間も亀裂が生じた状態であった。背面から見て左側の亀裂は大きく、最大幅3mm程に広がり、側板中央付近が大きく外側に膨らんでいた。(図22、23)

22 背面左側亀裂 修復前
Crack on the left end of the back board, before restoration

23 背面左側亀裂 修復後
Crack on the left end of the back board, after restoration

The back board is inserted into a frame-like structure composed of the four remaining boards and joined with nails. The nails and the joining edges are covered with foundation and coated with vermilion urushi to hide the nail heads. For this reason, large cracks were found on three sides of the back board (top, left and right). There was also a long crack between the back board and the base. The crack to the left, as seen from the back face, was especially large, its maximum width being approximately 3mm. This crack caused the side board to swell outward near the center. (Photos 22, 23)

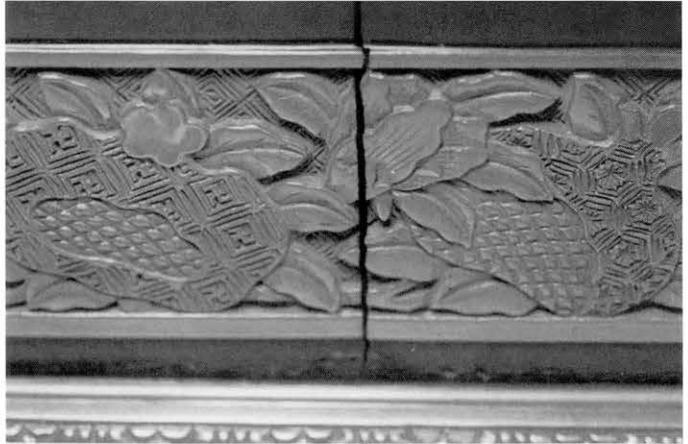
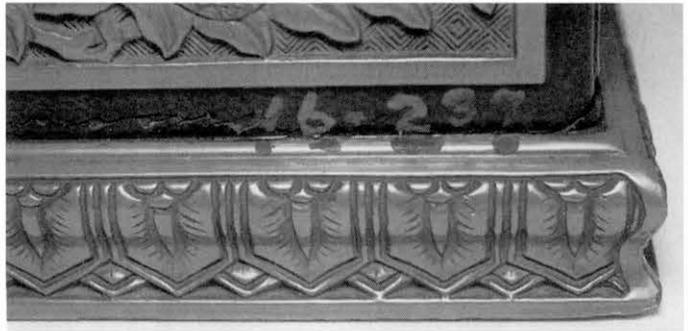
木地の亀裂は左右の側板にもおよび、両側面ともに台輪との接合部が大きく切れ、左側はほぼ中央の位置で下方より蒔絵を分断するように中心付近まで1mmほどの幅で切れていた。蒔絵が施されている黒塗りの面をよく見るとわずかに接合の跡が見え、接ぎ合わせの箇所であることが解る。右側面は背面寄りの箇所でも木彫部に縦方向の亀裂が入る。台輪と側板の寸法に1mmほどの差があり、側板のみが大きく収縮したことを示している。(図24、25)

24 左側面中央亀裂部
Crack at the center of the left face

25 左側面正面側
Left face, toward the front

There were cracks on the substrate of the right and left side boards as well. There were large cracks on the part where both side boards join the base. The one on the left board extended vertically almost to the center at a width of about 1mm severing the *makie* a little below the center. A close look

at the black coated surface on which the *makie* had been applied revealed a trace of a joining, suggesting that this is a joint. On the right board, the crack ran vertically on the carving close to the back face. There was a difference of about 1mm in the length of the base and that of the side boards, indicating that the side boards had shrunk greatly. (Photos 24, 25)

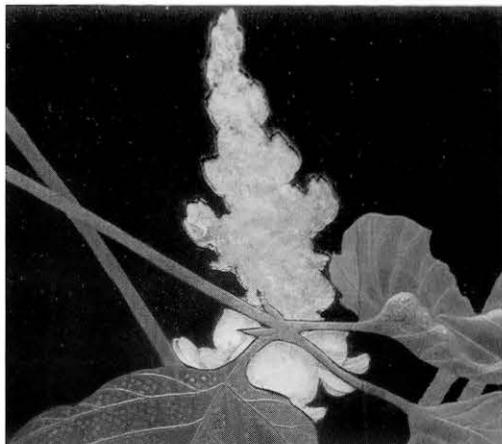
両側面と天板には蒔絵の完了後に嵌め込んだ螺鈿の欠損が見られた。左側中央には葛の花が4個の白蝶貝の厚貝を用いて表されているが、先端部分の最も大きな貝が欠失しており、薄紅色に染められた和紙が現れていた。右側面は左上部と右中央部の桜花が2つ欠損していた。左上部は貝周辺の蒔絵にも欠損が見られる上、同時に剝落したと思われる和紙がケミカルな素材で簡略に接着されていたが、変色が著しく、汚れた状態であった。右中央部の貝は、正面抽斗の奥に張り付いた形で保存されていたが、汚れが激しい上、中央部に亀裂が入った状態で付着しており慎重に取り外す必要があった。また残存する貝も一部に剝離が見られ剝落の危険があった。天板は水仙の花と枯葉の一部に象嵌の欠損が見られた。当初は剝落面が金属が腐食したような印象の灰色であったため、金属の象嵌と考えられたが、観察の結果、汚れの下に和紙の存在が認められたことから、側面同様螺鈿が象嵌されていたことが判明した。側面に比べ蒔絵自体の損傷は少ないが、汚れと腐食が著しく、注意深くクリーニングする必要があった。(図26~28)

26 左側面螺鈿欠損部
Missing *raden* on the left face

Raden shell pieces inlaid on the left, right and top faces after the completion of *makie* were missing. There is an arrowroot flower depicted with four pieces of thick mother-of-pearl inlay in the middle of the left face, but the largest piece at the tip was missing and a piece of Japanese paper dyed pink could be seen. On the right face, two cherry blossoms were missing, one on the upper left portion and the other at the center. Parts of the *makie* around the shells on the left upper portion were also missing. There was also Japanese paper, which had probably once fallen but was reattached with some kind of synthetic adhesive, but it had discolored severely and was dirty. The shell piece from the right center was found stuck and preserved in the back of a drawer, but it was extremely dirty and had cracked at the middle so that it had to be removed carefully. The remaining shell pieces had also become partially lifted and were in danger of falling. Inlays of the narcissus flower and fallen leaves on the top face were partly missing. Because the part from where the inlays had fallen was grayish, it was thought at the beginning that metal inlays had been applied. However, observation revealed Japanese paper under the grime, proving that shell pieces had been inlaid just as on the sides. The gray color was actually the color of grime that had accumulated. On the whole, *makie* had not been lost but, as with the *urushi* coating, it was quite dirty and there was much corrosion so that careful cleaning was necessary. (Photos 26-28)

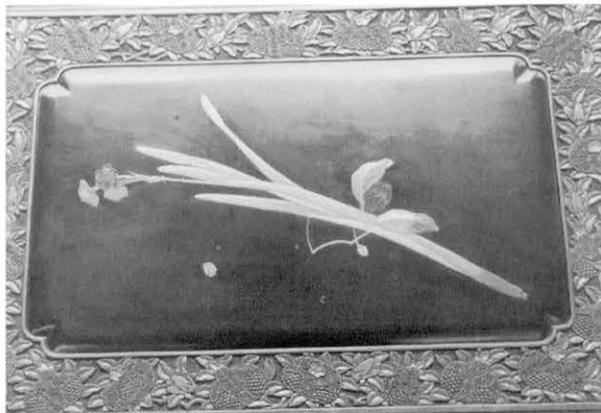
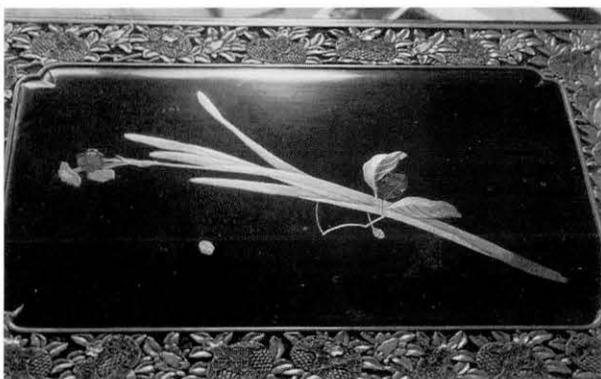
蒔絵が施された黒漆の表面には、各面ともに擦り傷や指紋が至る所に見られた。特に天板の塗膜は白濁した被膜が厚く被り艶を失っていた。また抽斗内部の塗膜もうっすらと汚れが被った状態であった。(図29、30)

29 天板 修復前
Top board, before restoration

30 天板 修復後
Top board, after restoration

Abrasions and fingerprints could be found on the black *urushi*-coated surface of all the faces where *makie* had been applied. The *urushi* coating of the top board, in particular, was covered thickly with a milky film and had lost its gloss. The *urushi* coating on the inside of the drawers was also covered thinly with grime. (Photos 29, 30)

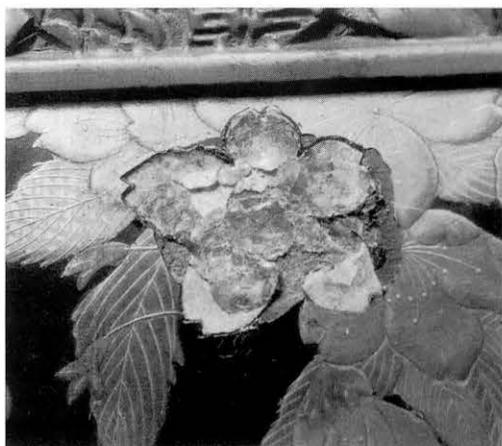
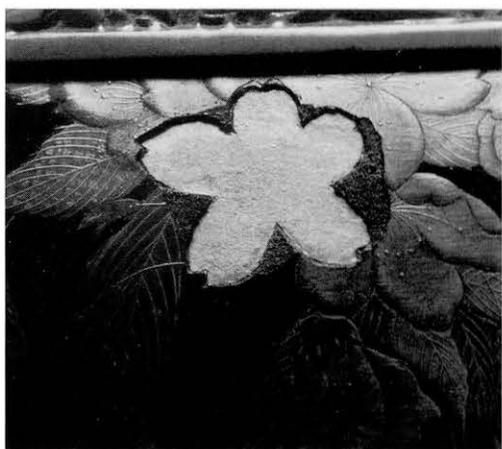
27 右側面上部螺鈿欠損部 修復前
Missing *raden* on the upper part of the right face, before restoration

28 右側面上部螺鈿欠損部 修復後
Missing *raden* on the upper part of the right face, after restoration

21. 螺鈿欠損部の周辺塗膜は、塗膜が下地ごと剥離しているため、伏せ彩色に使用した和紙を汚さぬように注意しながら麦漆を亀裂に流し込み、木枠に納め、芯張りをたて接着した。剥離部と芯張り棒の間には安全かつ確実に接着できるように、樹脂板やビニールなど4層の材質を重ねた緩衝材を挟んで押さえ込んだ。(図41)
22. 右側面上部の螺鈿欠損部は、和紙を取り除いた後、彫刻刀で下地面を整えた。剥離保存した和紙を顕微鏡で観察すると比較的繊維が細く、短い傾向にあり、和紙の中でも厚手の雁皮紙に類似した和紙であると考えられた。螺鈿欠損部は現状維持の方針で修復する予定であったが、本欠損部の状態は、鑑賞上違和感が強く感じられることから、和紙のみを復元し貼り込むこととした。厚手の雁皮紙に膠で溶いた弁柄で着色した後、剥離部である桜花の形状に切り抜き、膠を用いて接着した。(図28)

22. After removing Japanese paper from parts on the upper right face where *raden* pieces were missing, the surface of the foundation was leveled with a carving knife. Observation under a microscope of the Japanese paper that had become detached showed that the fibers were comparatively fine and short. So it is thought that Japanese paper similar to thicker *gampi* paper was used. At the start of the restoration work it was decided that maintenance of the present condition would be followed for the missing *raden* part. However, this was changed since it was feared that the appearance might be greatly impaired. Thus Japanese paper alone was reproduced. Thick *gampi* paper was colored with *bengara* that had been dissolved with animal glue, cut into the shape of cherry blossoms (the parts that had become lifted) and adhered with animal glue. (Photo 28)

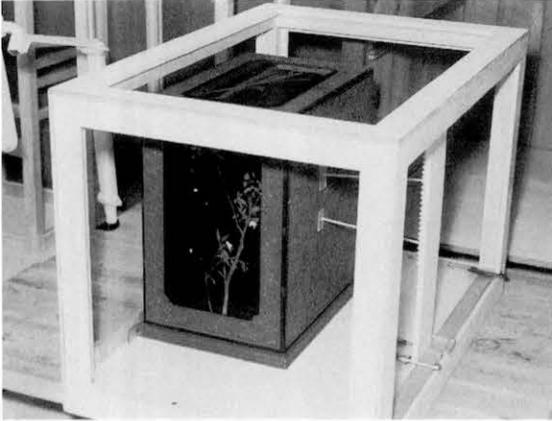
31 木枠による芯張り
Shimbari sticks and wooden frame

1. 本資料には美術館側で作成した詳細な亀裂や擦過傷および欠損部のチェックリストが添付されていたので、これに基づき現状を確認すると共に、同様の形式でリストを作り修復前の状態の検査を行った。
2. 修復前の状態を写真撮影した。
3. 亀裂部周辺に発生している塗膜や木地の剥離の内、剥落の危険があるものには、雁皮紙を短冊状に細く切った紙片を生麩糊を用いて貼りつけ、作業中の欠損の予防とした。
4. 背面板の形状を可能な限り補正するため、高湿度に調整した湿し風呂に本資料を長期に渡り保管することとした。湿し風呂の湿度を徐々に上げ、それに伴う亀裂の状態を観察し、材木の動きを把握することにつとめた。最初の三か月間は湿度を70%~75%に維持した状態で保管したが、ほとんど動きは確認できなかった。そこで湿度を80%~85%に引き上げ、さらに、木製の枠に納め背面側より丸棒を用いた芯張りを立て、圧力を加えたところ、2週間の時点で動きが見られた。背面に見られた3mm幅の亀裂は2mmに改善され、段差も僅かであるが回復が見られた。ただし、背面板と両側板の隙間には変化が見られなかった。(図31)

4. In order to readjust the shape of the back board as much as possible, it was decided to store the Cabinet for a certain length of time in a humidifying chamber set at high humidity. The humidity of the chamber was gradually raised, observing the condition of the cracks and checking the movement of wood. For the first three months, humidity was kept at 70 to 75%, but almost no movement could be confirmed. Then humidity was raised to 80 to 85%, and the Cabinet was placed in a wooden frame and pressure was applied to the back board by using *shimbari* sticks. By doing this, the wood began to move in two weeks. The 3mm crack found on the back face narrowed to 2mm and the difference in level was also reduced, although only a little. However, no change was

- seen on the cracks between the back board and the side boards. (Photo 31)
5. While humidity was being applied to the Cabinet, grime that had accumulated on the urushi coating and the carvings was cleaned. There was a thin film remaining on the black urushi coating, suggesting that some kind of coating, like shellac, had been applied. So UV fluorescence photography was taken before cleaning to identify the substance. As a result it was found that there was no trace of coating having been applied on the urushi surface. Instead, it was thought to have been a remnant of wax or some kind of material that had been applied thinly to give gloss. Grime on the black urushi, *makie* and *raden* was carefully removed by using a bamboo spatula wrapped with a cotton cloth that had been moistened with pure water and firmly wrung dry. Care was taken to make sure that moisture would not remain on the urushi coating. For grime that could not be removed with water, solvents were tested in order to select one that would be safe. Test results showed that ethanol was the best, so cotton swab immersed in ethanol was used. By gradually removing the grime in these ways, it was possible to bring back an appropriate amount of gloss to the surface. (Photo 32)

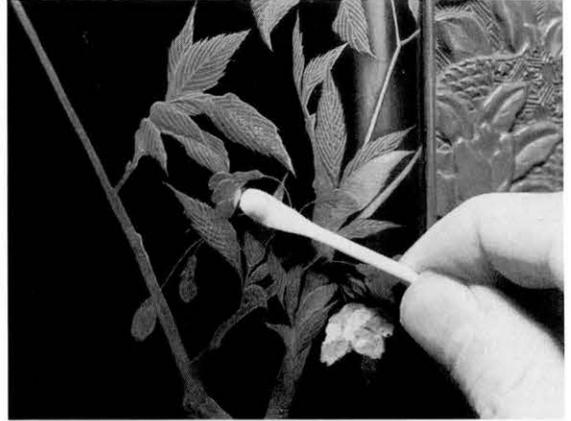
32 右側面蒔絵部 エタノールによるクリーニング
Makie on the right face, cleaning with ethanol

5. 本体への加湿の期間、塗膜及び彫りに堆積した汚れのクリーニングを行った。黒漆の塗膜には薄い皮膜が残留しており、シェラックなどの塗装が行われた疑いがあったため、掃除前に紫外線撮影を行い残留物の確認を行った。その結果、塗膜表面には塗装が行われた形跡はなく、ワックスなど何らかの艶上げ材が薄く残留したものと考えられた。黒漆及び蒔絵螺鈿の部分に対しては、純水を使用し固く絞った綿布を竹箆などに巻き付け、塗膜に水分が残らないように注意しながら徐々に汚れを取り除いた。水分で除去できない汚れに対しては、溶剤試験を行い、塗膜に対して安全な溶剤を選択した。試験の結果エタノールでの拭き取りが最も良好であったことから、綿棒にエタノールを含ませ、徐々に汚れを取り除くことで適度な艶を回復することができた。(図32)

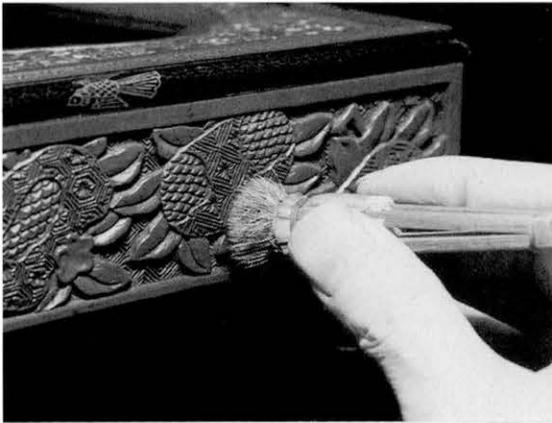
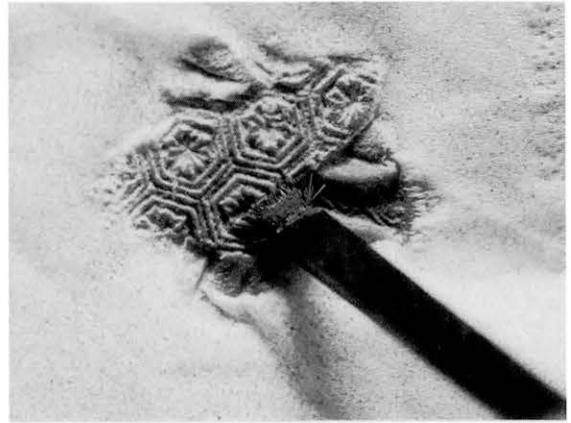
33 だるま刷毛による埃の除去
Removing dust with a brush

34 彫り谷部の汚れの除去
Removing grime from the lower part of the carving

6. 朱塗りの彫り部の汚れに対しては、まず始めに腰の強い特殊な毛棒で彫りの奥に残留した埃を掻き出した。しかし、この作業だけで堆積した汚れは除去できなかったため、薄く柔らかな紙を彫りの部分に当て、その上から僅かに水分を含ませた塗刷毛で彫りの谷部をたたき、固着した汚れを水分でゆるめながら紙の繊維に汚れを吸い取らせることで僅かずつ汚れを取り除くことができた。灰色の塗料が固着した部分は、水拭きや溶剤での除去が不可能であったので、刃先を落とした彫刻刀で塗膜を僅かずつ削ることとした。(図33、34)
7. 天板にある螺鈿の欠損跡は、灰色に変色するなど最も汚れが激しかったが、制作材料である和紙が残っている事が確認されたため、水分の使用を控え、毛棒とエタノールによる掃除のみとした。また右側面上部の桜花の螺鈿欠損箇所は接着の際使用された材料の変色と硬化のため、和紙本来のしなやかさが失われた状態にあった。当初、溶剤を用いて接着材のみを除去する事を目的として作業を行ったが、和紙が粉状に崩れる状態であったため、全て取り外すこととした。
8. 掃除後の塗膜に極薄い生漆を含浸させ塗膜の強化を行った。漆の表面は経年変化により極細かい断文が入る。この断文が光を乱反射させ艶の減少を引き起こすと同時に、塗膜に手油や指紋を残しやすく

6. Grime around the carvings of vermilion urushi was cleaned by first removing the dust that had accumulated in the lower part of the carvings with a hard brush. However, this was not enough to remove the grime that had accumulated, so a thin, soft piece of paper was placed on the carvings and a slightly moistened brush was used to tap on the lower part of the carvings in order to loosen the stubborn grime. By thus using paper as a blotter it was possible to remove the grime little by little. Because it was not possible to remove the grime with water or solvent from parts where gray coating material had been found, a blunt carving knife was used to scrape the urushi coating little by little. (Photos 33, 34)

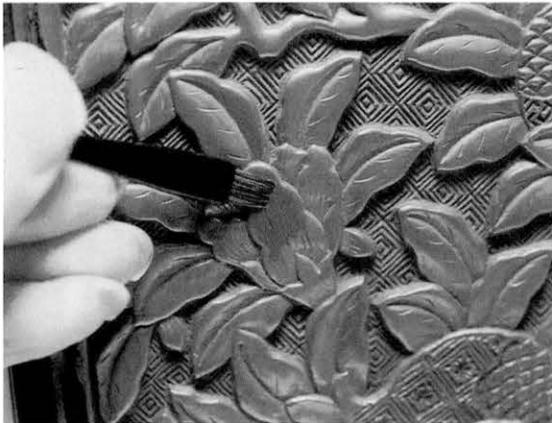
35 漆固め
Urushi-gatame

する原因になっている。このため、漆の含浸は修復の際には一般的に塗膜全面に行われる作業であるが、本資料の場合は彫りの部分の固めに特別な配慮が必要であった。それは、朱蒨の処理が蒨き放しのため、固めの際、朱の色に変色の危険があり、彫りの谷部分に浸透しないよう峰の部分に限定して固め作業を行わなければならないことであり、細心の注意を要する作業となった。(図35)

8. After cleaning, the urushi coating was reinforced by applying very thin raw urushi. With the passage of time microcracks will appear on the surface of urushi, and light deflected by these microcracks will cause the gloss to be reduced. It is also these microcracks that will cause fingerprints and oiliness of the hand to remain on the urushi coating. Thus, although in restoration raw urushi is applied over the entire surface, in the case of this Cabinet special care had to be taken for the carvings. Because raw urushi had not been applied over the *shumaki*, there was danger of the vermilion color becoming darker during this reinforcement process. Care had to be taken so as to reinforce only the higher part of the carvings and not to allow raw urushi to seep into the lower part. (Photo 35)

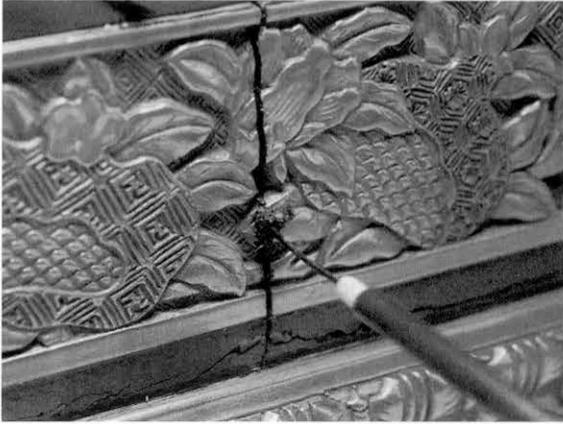
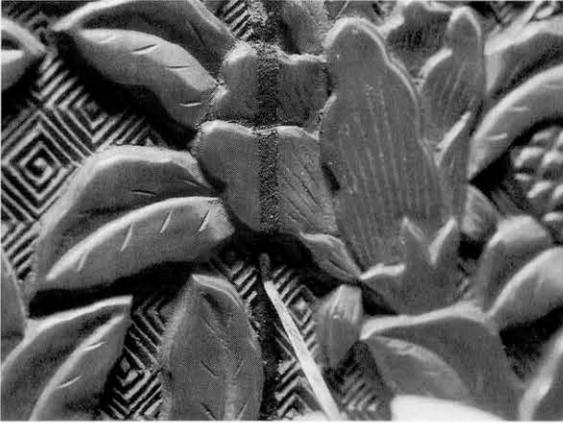
36 内部への刻苧
Impregnating *kokuso* inside

37 表面近くへの刻苧
Applying *kokuso* near the surface

10. 充填すべき亀裂の周辺を補強するため溶剤で薄めた麦漆を含浸した。
11. 麦漆に麻の繊維とエゾマツの木粉を混ぜ合わせた刻苧を作り、亀裂の発生した木地の中心部分から針を加工した鉄篋で充填した。中心部分が十分に乾燥した後、内側と外側の双方から充填するのであるが、刻苧は一度の充填で乾く厚みに限度があるため、1mm程度の厚みを限度に十数回に分けて充填することとなった。中心部分は接着力が求められるため麦漆の量を多めにし、長めの麻の繊維を多用した。また、塗膜表面に近くなるに従ってより細かな木粉を使用するなど、深さによって刻苧の成分を変えて充填を行った。(図36)

12. 充填による大まかな形状が完了した後、彫金用の鑪を用いて彫りの形状に合わせて形を整えた。地文など細かな部分の復元は避けたが、実や葉などは鑑賞の妨げとならないよう形状のつながりが判明する程度の復元を行った。(図37)
13. 亀裂部の表面を整えるため、麦漆を檜篋で篋付けした。
14. 表面を名倉砥石で空研ぎした後、蒨絵筆で透漆を塗った。

10. *Mugi urushi* diluted with a solvent was impregnated in order to reinforce areas around the cracks that would then be filled with *kokuso*.
11. *Kokuso* was made by adding hemp fibers and sawdust of spruce wood to *mugi urushi*. This was filled into the largest crack on the back board with an iron spatula made by processing a needle. After the urushi in the mid-portion of the crack had hardened sufficiently, *kokuso* was filled again from both sides of the board. However, since there is a limit to the thickness of *kokuso* that would dry at one application, *kokuso* was applied repeatedly ten or so times at a thickness of about 1mm each time. Because adhesion is required around the middle, more *mugi urushi* and a great amount of longer hemp fibers were used. In addition, finer sawdust was used for *kokuso* filled in areas closer to the urushi coating surface. In this way, the components of *kokuso* were adjusted according to the depth to be filled. (Photo 36)

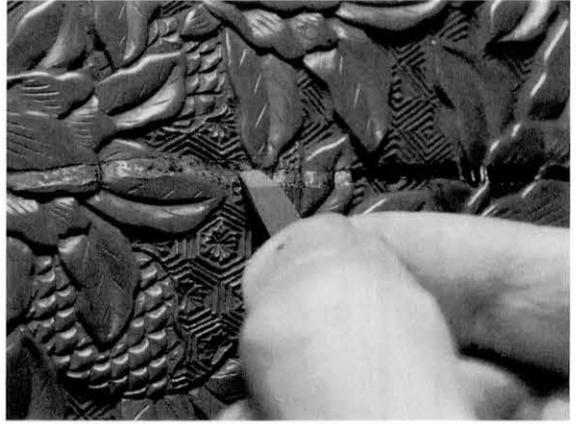
38 名倉砥石による表面処理
Grinding with Nagura whetstone

15. 再度表面を名倉砥石で空研ぎを行い表面の仕上げに備えた。(図38)
16. 背面の亀裂部周辺は、彫りの峰部分の朱塗と谷部分の朱蒨の二つの処理で仕上げられているが、充填部分は本来存在しない部分であることから、亀裂の修復部分全体を朱蒨の仕上げとすることとした。これは、朱蒨の方が塗に比べ彫りの形状が柔らかく見える上、色の主張が弱められることから、鑑賞の妨げとならないと判断した結果である。

15. The surface was once again dry ground with Nagura whetstone for a finish touch. (Photo 38)
16. Originally, the areas around the cracks on the back face were finished with a coating of vermilion urushi on the higher part of the carvings and *shumaki* on the lower part. But since parts filled with *kokuso* were parts that did not originally exist, it was decided to apply *shumaki* there. The reason for this measure was that when compared to using coating, this would not impair the overall appearance since the form and color of the carvings would be less conspicuous.

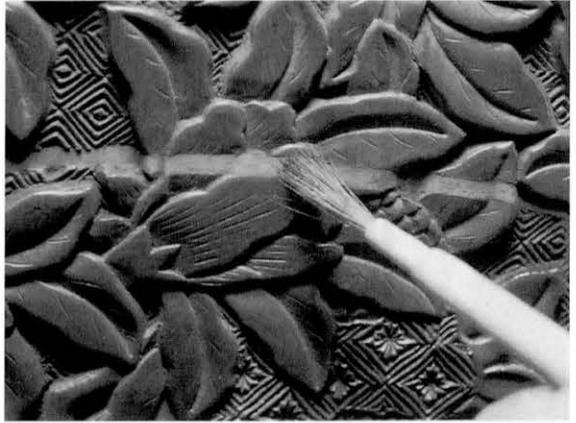
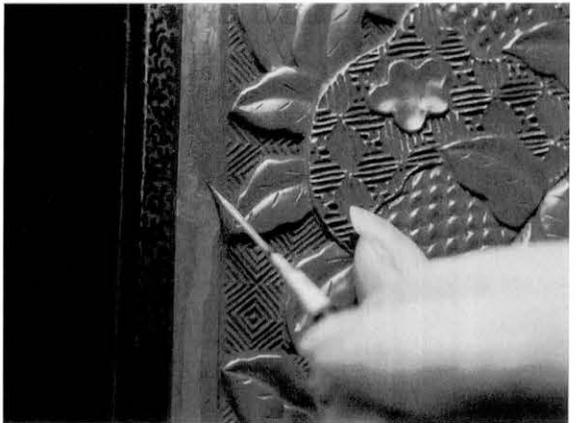
39 毛棒による朱粉蒔き
Shunaki using a brush

40 朱粉の固め
Consolidating vermilion pigment

18. 名倉砥石で表面の歪みを整えた修復箇所、蒔絵筆を用いて透漆を薄く地塗り、毛棒を用いて朱粉を蒔き詰めた。形状が複雑なため地塗りに時間を要し、漆の乾きを考慮すると一度に蒔ける範囲はおおよそ10cmであった。また周辺の彫りに朱粉が散らないよう配慮する必要があり、相応の時間を要する作業であった。(図39)

19. 乾いた朱粉の表面に溶剤で薄めた透漆を染みこませ、再度朱粉を蒔き詰めた。
20. 朱蒔を終えた修復箇所の周辺に残留した朱粉を毛棒で払いのけ、溶剤で薄めた透漆を極薄く塗り込み、余分な漆を雁皮紙で吸い取り、朱粉の固めとした。この作業を数回繰り返すことで漆固有の色味である褐色が朱粉に浸透し、周辺との色相に違和感のない状態をつくりだすことができた。(図40)

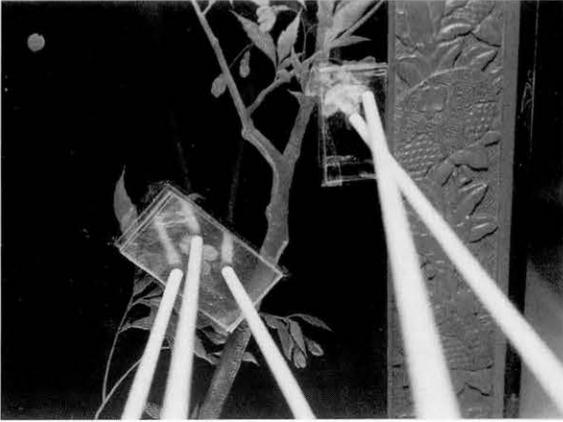
41 螺鈿欠損部への芯張り
Shimbari on the missing *raden* part

21. The urushi coating around the missing *raden* pieces had become lifted together with the foundation. So *mugi urushi* was impregnated into the cracks, taking care not to stain the Japanese paper that had been used to apply color to the back of the shell pieces. The urushi coating was then press-stabilized by using *shimbari* sticks. Four kinds of plastic sheets were placed between the lifted portion and the *shimbari* sticks as buffering material so that the urushi coating might adhere safely and firmly. (Photo 41)

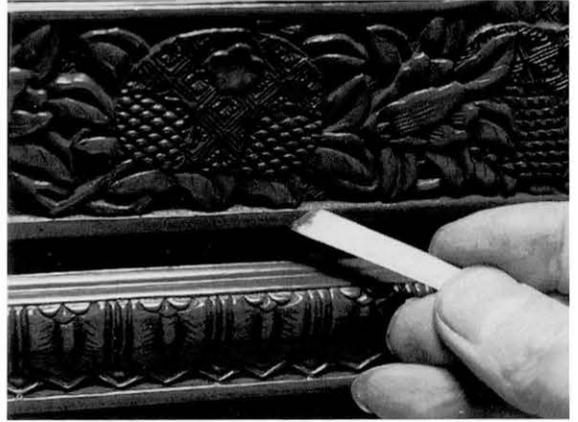
44 亀裂部への際錆
Applying *kiwasabi* on the cracks

26. 最後に、朱蒔の際使用した顔料に麦漆を練り込んだ下地を作り、朱塗りの部分の細かな亀裂や木地の接合部分の隙間に小さな檜箆を用いて充填した。また、黒漆面や蒔絵部には、水練りした微細な砥粉に黒漆を混合した下地を塗膜の際や破損した蒔絵の際に同様に充填し、柔らかな紙で拭ききることで極微量の下地材を残留させ、塗膜剥離の再発防止とした。(図44)
27. 修復終了後、桐材で保存箱を製作した。気密性を高めるため開口部を側面とし、滑りの良い檜材を組み込んだ底板を使用し、重量のある本体を容易に納められるよう考慮した。また、多少の湿度変化に対応できるように内部に60%に調整した調湿材を2個組み込んだ。(図45)

26. Finally, foundation material was made by kneading *mugi urushi* and the pigment that had been used for *shumaki*. This was used to fill fine cracks on the vermilion-coated surface and gaps between the joints of the substrate. A small spatula made of cypress was used. For the black urushi surface and the *makie* parts, foundation material made of fine *tonoko* powder kneaded with water and mixed with black urushi was used. This foundation material was applied to the edges of the urushi coating and of damaged *makie*. Then it was wiped off with a piece of soft paper. By doing so, it was possible to apply a very small amount of foundation material and thus to prevent the urushi coating from becoming lifted again. (Photo 44)

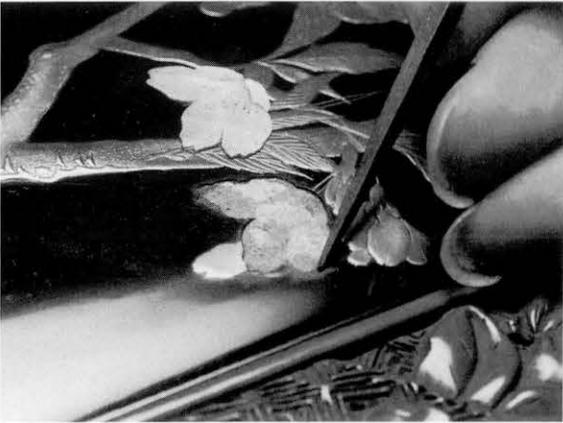
42 螺鈿欠損部の形状修正
Correcting the shape of the missing *raden* part

23. 剥離し保存されていた桜花形の貝剥離部は、剥離面に和紙が残っているものの、隅の部分がせり上がり平面が崩れているため、現状では貝を貼ることが出来ないと判断されたため、隅の和紙の一部を削り落とすこととし、不足部分には刻苧を充填し、接着面を整えた。表面が剥離し和紙の地色が露出した部分は弁柄で着色し、鏝で周辺の塗膜の形状を整えた後、膠を貝の背面に付け、指で軽く押さえ込み接着した。(図42)

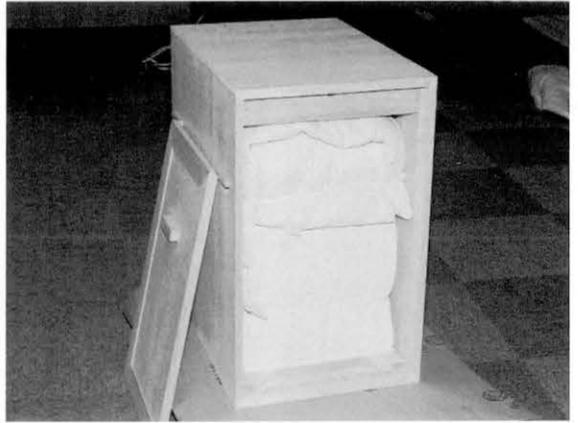
45 保存箱
Storage box

27. After restoration was completed, a storage box was made of paulownia. To allow for greater air tightness, the opening was made on the side. On both long ends of the bottom board of the box, rail-like pieces of oak were attached. Similarly, rail-like pieces were attached to the long sides of a board on which the Cabinet would be placed. In this way the board could be made to slide in and out of the box, thus making it possible to place the heavy Cabinet into the box easily. In addition, two humidity-controlling agents adjusted at 60% Rh were placed inside in order to respond to slight changes in humidity. (Photo 45)

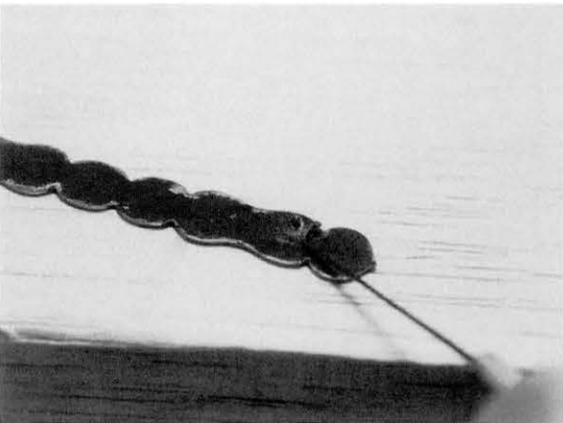
正面鍵金具は右扉の金具の左端にあるプレート状の飾り金具が欠落し保存されていた。この金具裏には2個の突起があり鍵金具本体に嵌るように作られていたが、片側の突起が折れ機能しない状態であった。また右扉の内蝶番の組み付けが悪く扉にがたつきが見られ、閉じた状態で僅かに左に傾いてしまう傾向がある上、鍵が失われているため施錠ができず、扉が常に開いてしまう状態であった。また、右扉の鍵金具は2本の釘が欠損し、左扉背面の差込式の止め金具の釘は4本の内下の2本が欠損し、後補の鉄釘が代用さ

43 金具欠損部の復元
Reproducing the missing metal covering plate

As for the lock and key on the front of the Cabinet, the metal covering plate on the left edge of the right half of the lock and key had fallen, but it had been preserved. There were supposed to be two projections on the back of the plate that would have been used to hold it in place, but one of them had been broken. In addition, the hinge on the right door was not attached properly so that the door was unstable and would tilt slightly to the left when closed. Moreover, because the key was missing the door could not be locked; it would open all the time. Two nails were missing from the lock and key on the right door. Iron nails had been used at a later repair to replace the missing two lower nails of the four nails used to attach the stopper at the bottom on the back side of the left door.

24. 保管されていたプレート状の飾金具を鍵金具に取り付けるにあたり、右扉の鍵金具を取り外した。また、金具の背面にある2本の突起部分の内、破損している上方にある突起部分をエポキシ樹脂で盛り上げ、本体に嵌るように復元した。この扉は本来であれば、鍵穴に差し込まれた鍵が扉のつまみを兼ねているのであるが、鍵が失われているため、この飾金具がその代用として扱われ破損したものと考えられた。今後も同様の使用が考えられることから、鍵金具への接着は強固なものとする必要があり、エポキシ樹脂で接着固定した。欠損した釘は4本あり、本体と同様赤銅の煮上げ色である黒色であったが、修復においては真鍮製の釘に漆下地を焼き付けることで黒色に色付けし、その代用とした。(図43)

24. In order to return the metal covering plate to its original position, the metal fitting of the lock and key was first removed. Of the two projections on the back of the metal covering plate that were used to hold the plate in place, the upper one that had broken was reproduced by using epoxy resin. Normally, the key placed in the keyhole would also serve as the knob of a door. But because the key was missing, it is thought that the covering plate had been used as a substitute and that this

is the reason for the damage. Since it was thought that the door would be shut and opened in a similar way after restoration, it became necessary to adhere the lock and key firmly. So epoxy resin was also used here. There were four missing nails of the same black heated-copper color as that of the body. But in restoring them, brass nails were used. These nails were coated with urushi foundation before being heated to produce black-colored nails. (Photo 43)
