伝狩野山楽筆 四季耕作図屏風（田植え・灌水）

修理報告

Scenes of Rice Cultivation: Spring and Summer attributed to Kano Sanraku

Treatment report

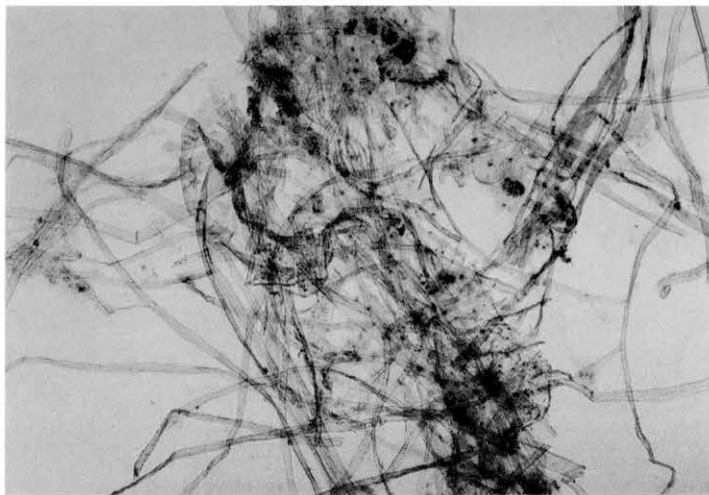
図39 紙質調査写真（雁皮）
Photograph taken to examine
paper quality (gampi paper)

料紙：雁皮（高知県立紙産業センター調べ）（図39）

Paper: *gampi* (examined by Kochi Prefectural Paper Technology Center) (Fig. 39)

紙質調査写真に基づき、前年度と同じく雁皮70%・楮30%の補修紙を作成し、欠失箇所にも補紙を施した。

Based on photographs taken to examine the quality of paper, the same infill paper like the one used last fiscal year (70% *gampi*, 30% *kōzo*) was prepared and affixed to the missing sections.

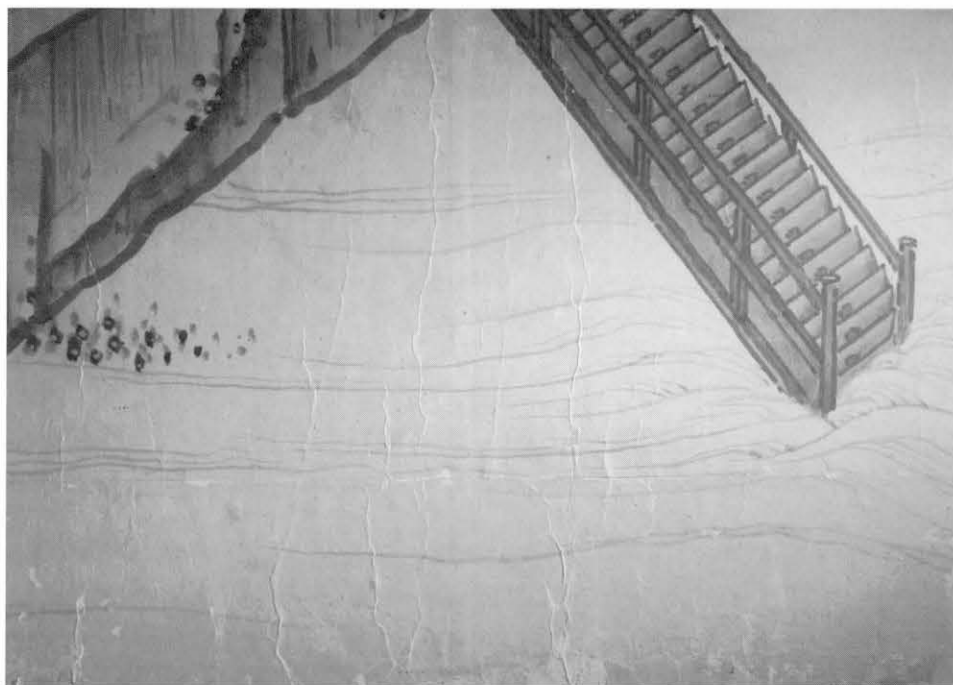
- ・ 絵具層の剥離・剥落が見られる。
- ・ 本紙と裏打紙の糊離れが生じている。(図46、47)
- ・ 虫損等による本紙の欠失が見られる。(図48、49)
- ・ 本紙紙継ぎ部分の糊離れとそれに伴う本紙料紙の欠失が見られる。(図50、51)
- ・ 蝶番、尾背部分にいたみが生じている。
- ・ 下地からの本紙の浮きが見られる。
- ・ 本紙表面全体への汚れの付着が見受けられる。

図46 修理前 本紙と裏打紙の糊離れ

Before treatment. Separation of painting from lining paper due to the weakening of the adhesive.

- There is flaking and peeling of paint layers.
- There is separation between the painting and the lining paper due to the weakness of the adhesive. (Fig. 46, 47)
- There was visible insect damage in the painting's paper support. (Fig. 48, 49)

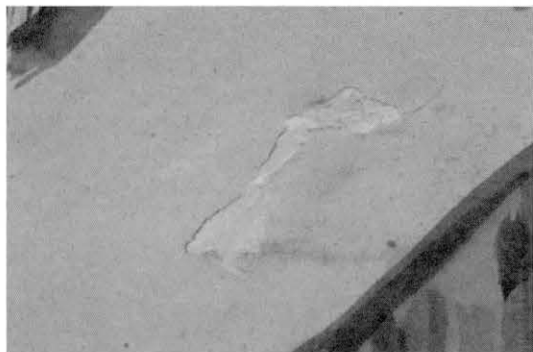
図48 修理前 虫損等による本紙の欠失
Before treatment. An area in the painting damaged by insects.

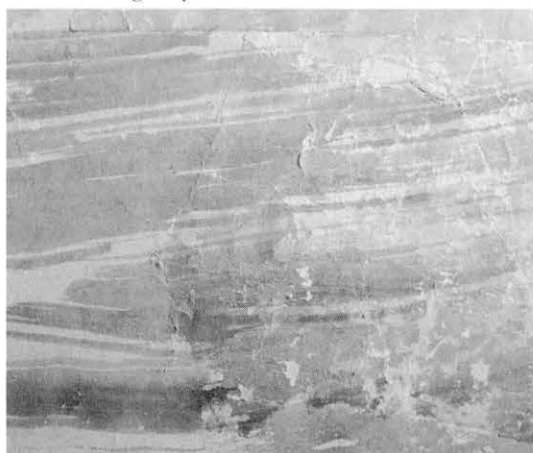
図50 修理前 糊離れとそれに伴う本紙の欠失
Before treatment. Damage to the painting caused by the weakening of the adhesive.

- There is weakening of the adhesive along the paper joint sections of the painting that resulted in damage to the painting. (Fig. 50, 51)
- Parts of paper and hinged areas are damaged.
- Some parts of the paintings have separated from the core.
- Soiling found throughout the surface of the paintings.
