# 十一面観音菩薩像

平成15年度修復事業

# 修理報告

(有)山口墨仁堂  
山口聰太郎

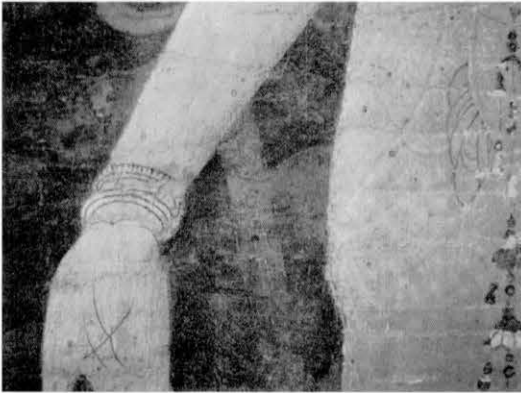
観音像の肉身の金泥部分に施された補絹には、厚く金泥が塗り込められていた。除去する場合には、オリジナル部分を傷つける恐れがあるため、除去せずそのまま残した。(図59~64)

図59 修理前。金泥を盛り上げて補彩してある。  
Before treatment. The gold paint was thickly reapplied.

In the silk material that was used to mend the body area of the Kannon painted in gold, a thick layer of additional gold paint had been applied. To attempt to remove it ran the risk of damaging the original painting, and therefore the area was left untouched. (Images 59-64)

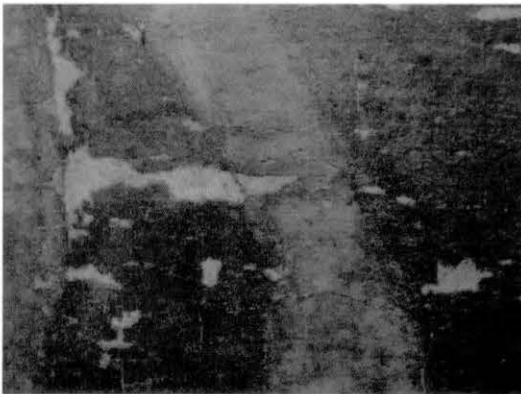
図60 補絹後の状態。手首にある旧補絹部分は、表から厚く金泥が塗り込められているため、除去困難であり、そのまま残した。

After mending. Because there was a thick layer of gold paint in the area around the wrist that was mended in the past, it was difficult to remove, and therefore was left untouched.

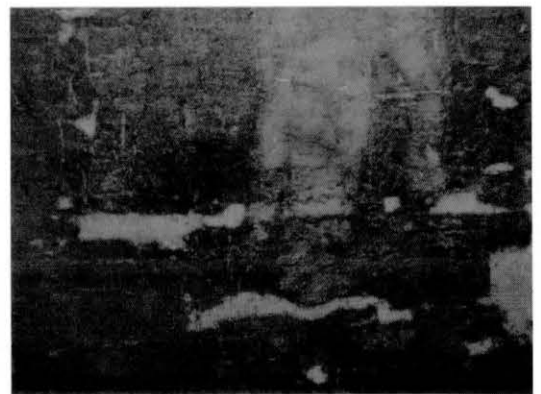
図62 補絹後。指先に旧補絹を残す。  
After mending. Previous mending around the fingertips was left untouched.

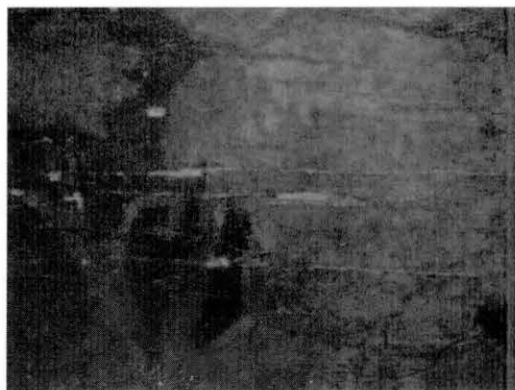
図64 補絹後。頬の部分に旧補絹が残る。  
After mending. Former mending job is left  
around the cheek area.

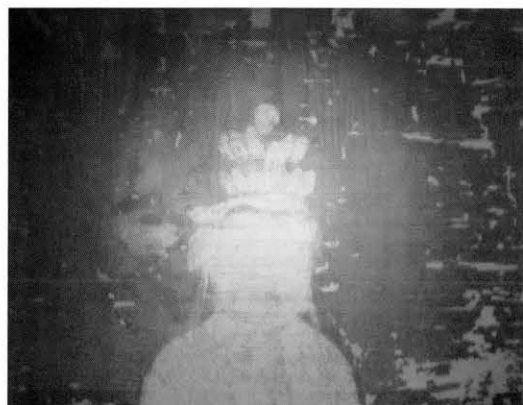
図65 赤外線写真。木紙裏面に下書きの線を発見した。  
Infrared photograph. Lines of a rough sketch were found  
on the reverse side of the painting.

##### 3. Lines used to create a rough sketch were found on the reverse side of the painting.

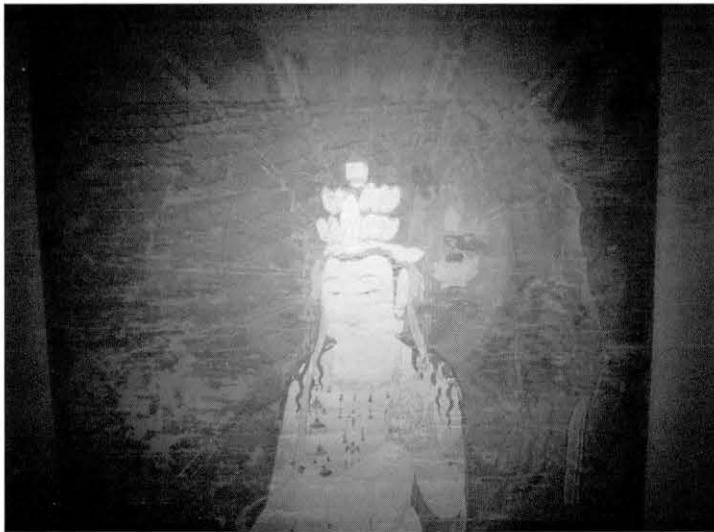
水平線部分と光背中の一部分が、裏彩色が無くなっているかのように、透けていた。状態を記録するため、写真撮影を行った。(図69～76)

図70 赤外線写真。頭部右側が、自然光の中では透けて見えていた。  
Infrared photograph. In natural light, the right side of the head had looked transparent.

Infrared photography taken before treatment shows that an image resembling a mountain had been drawn in the area where the halo had faded.

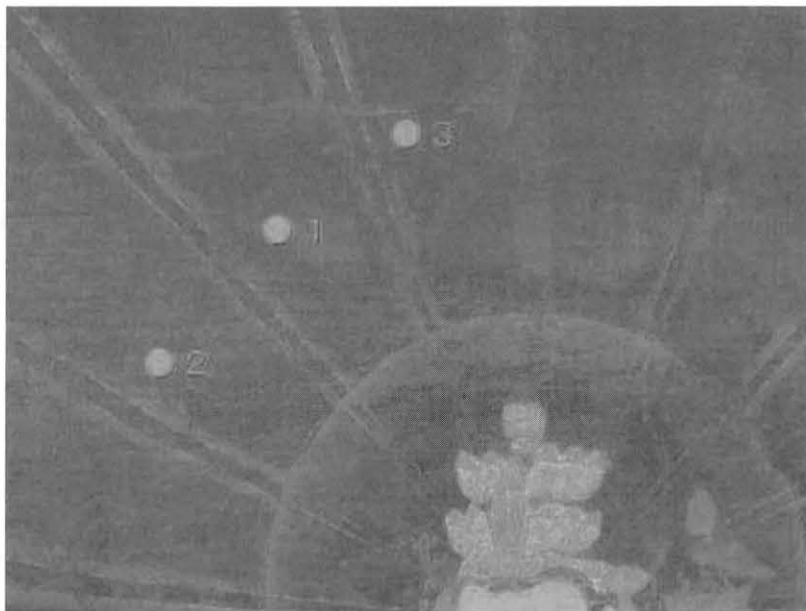
修理前の赤外線写真から、光背内の透けている部分は、山のような絵が描かれていた。水平線の部分は、裏面の顕微鏡写真から、絵具がほとんどのっていないことがわかった。

図71 水平線部分。  
顕微鏡撮影を行ったポイント。  
Horizon. A photomicrograph was  
taken.

In the horizon area, a photomicrograph taken from the reverse side showed that almost no paint remained.

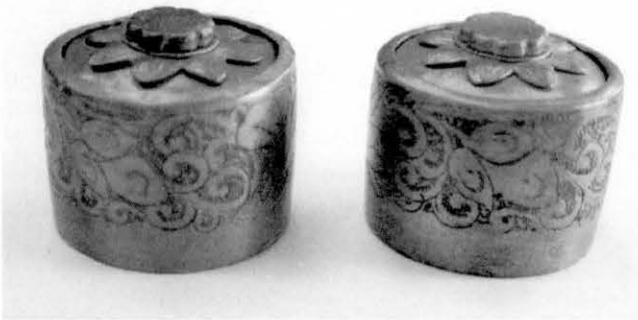
図80 金具 修理後にクリーニングした。  
Metal fittings, after treatment. Have been cleaned.

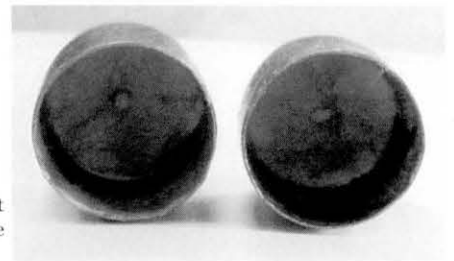
図82 金具 修理後。側面と天の部分が取り外せる構造だった。  
内側から楮紙で側面と天を接着した。  
Metal fittings, after treatment. They were made in such a way that  
the side and top parts could be removed. The sides and top were  
joined from the inside with *kozo* paper.
