源氏蒔絵螺鈿化粧箱

平成15年度修復事業

漆芸修復家
山下好彦

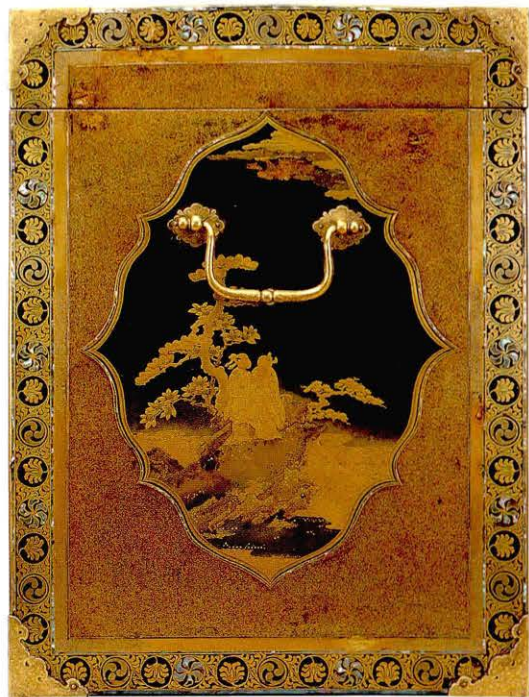
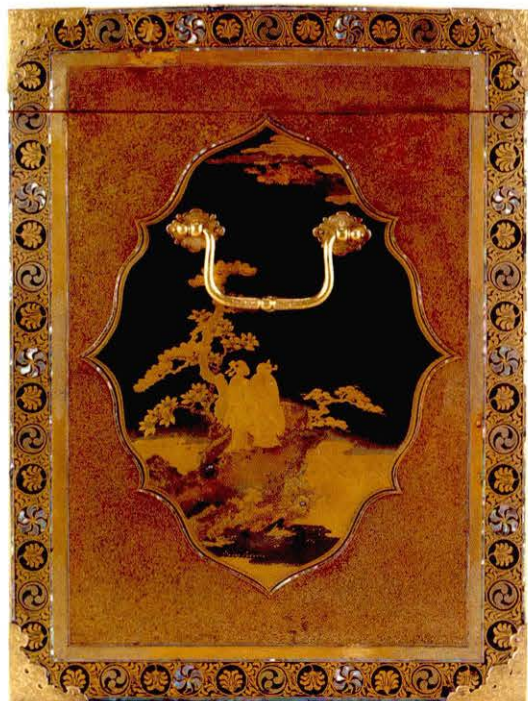
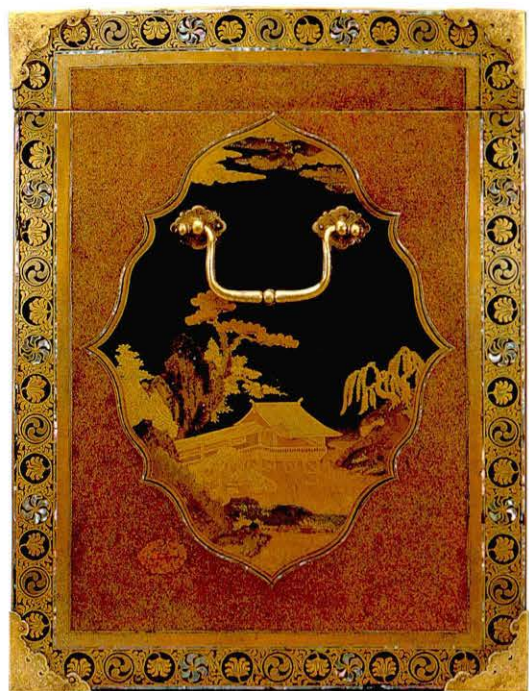
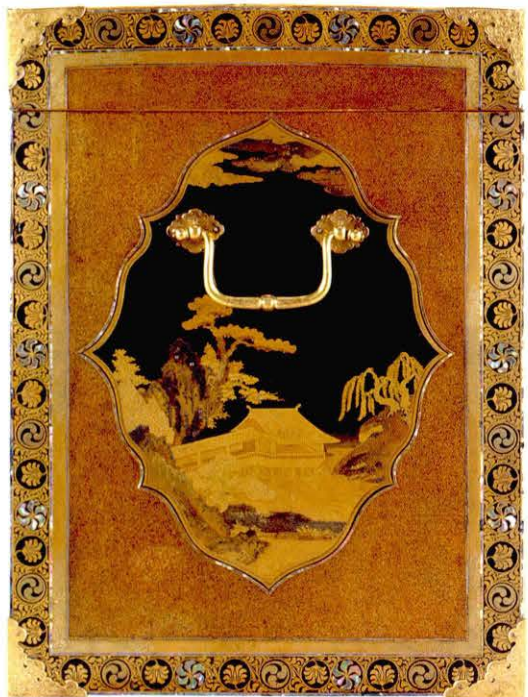
7-1 側面 修理前
Side, before restoration

7-2 側面 修理後
Side, after restoration

7-3 側面 修理前
Side, before restoration

7-4 側面 修理後
Side, after restoration

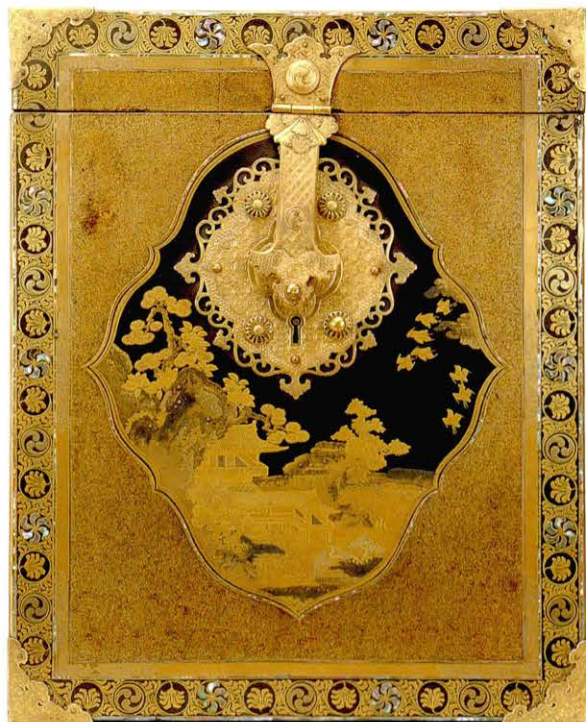
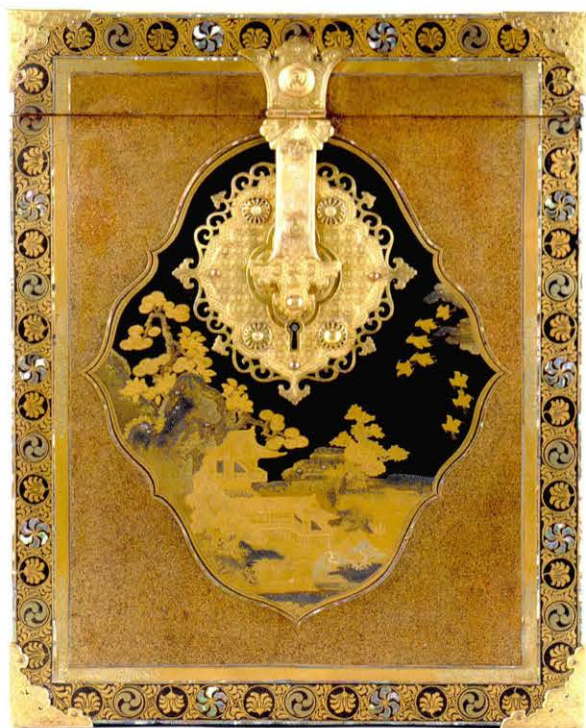
8-1 正面 修理前
Front, before restoration

8-2 正面 修理后
Front, after restoration

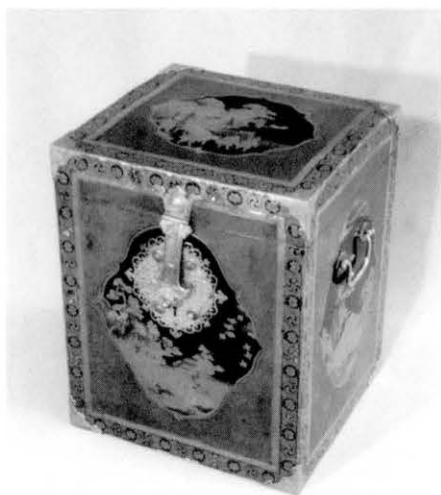
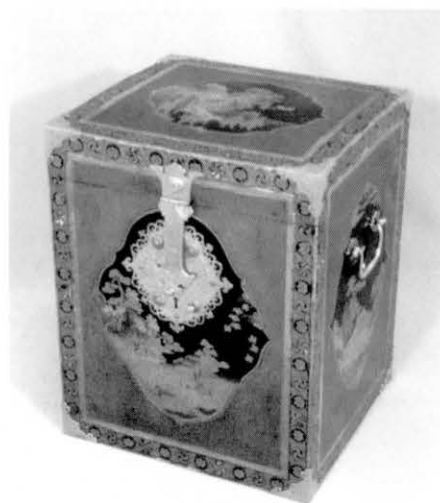
図67 修復前
Before restoration

図68 修復後
After restoration

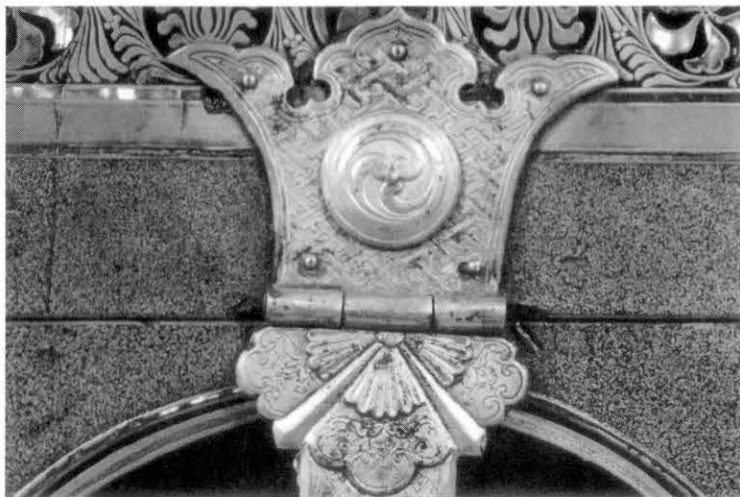
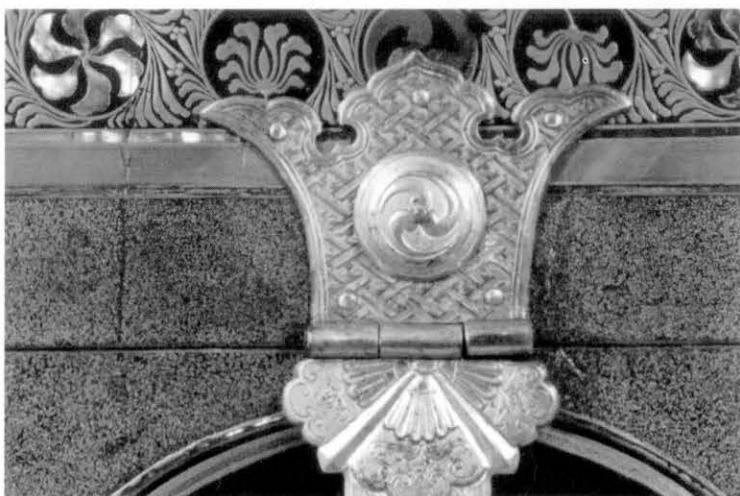
図69 錠金具部分 修復前
Metal lock before restoration

図70 錠金具部分 修復後
Metal lock after restoration

西洋の修復材料は口縁部周辺に緑色の塗料が薄く付着、これは、内部を改装した時のピロードの接着素材と考えられる。口縁部の蒔絵剥落部分には金色の塗料を塗り込んでいた。錠金具（図69、70）、提げ金具、隅金具などはすべていったん取り外して修理が行われたものと考えられ、釘を緑色のワックスで再接着し、銅釘の欠損部分は真鍮釘を新たに新補していた。蓋の錠金具は曲がって付けられ、新補の釘は蓋裏で打ち曲げられていた。打ち曲げるのにハンマーを用いたものと考えられ、蓋裏の素地がへこんでいた。隅金具は釘で止めるだけでなく金具自体を修理材料で接着、蓋正面右の隅金具は、金具の方向が本来の方向から間違っけて付き、本体からずれていた。提げ金具には黒い塗料が付着していた。銀の露玉の剥落箇所は西洋塗料が塗り込まれ、右側面上部の雲は西洋塗料で新たに描かれていた。底裏面には所蔵番号を書き込んだ上から透明な塗料を塗り込み、その材料が底面全体に付着していた。

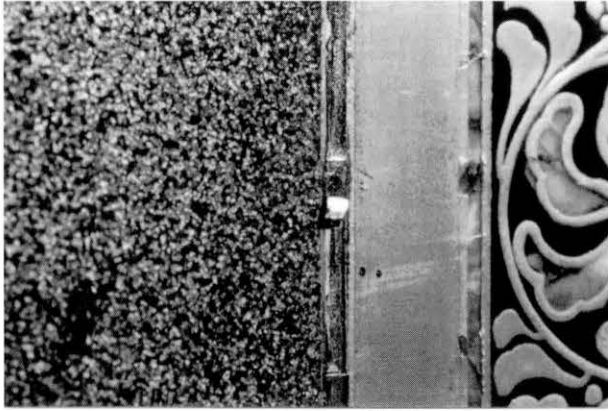
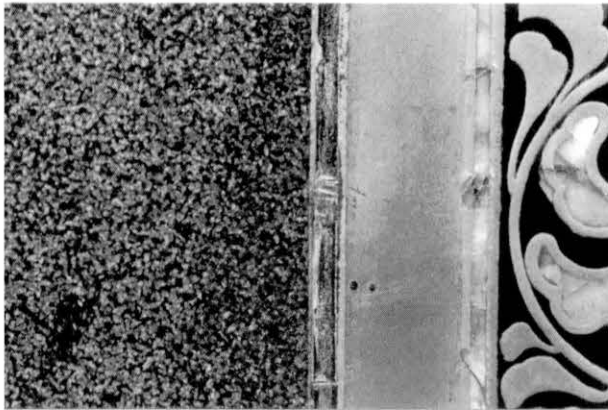
図71 平文剥離部分 修復前
Detached hyomon before restoration

図72 平文剥離部分 修復後
Detached hyomon after restoration

修理箇所以外の保存状態は、埃や汚れが資料全面に薄く被っていた。紫外線や経年変化によって漆の劣化が進行し、漆塗膜には細かい段文が入っていた。梨地の部分の塗膜はやせて変色し、金粉が露出していた(図71、72)。素地の亀裂が蓋板裏側の側板との接合部および蓋板と底板に数条入り、危険な状態であった。錠金具の上部には剥落があり、下地が露出していた。また、蝶番の釘の周辺に亀裂と剥離があり、提げ金具の周囲では一部で黒漆塗膜が剥落していた。貝が素地の収縮によって各所で剥離、貝は一部で割れ、表面から突出していた。貝の剥離は縦のボーダーに集中していた。背面の平文が完全に剥離し、危険な状態であった。全体に打損が各所にある他、蓋裏朱漆部分に水が流れたような跡がり、一部で朱漆が変色していた。

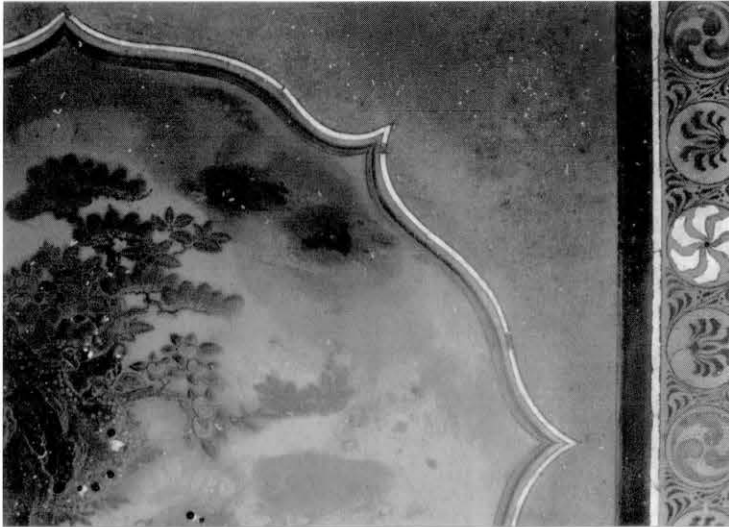
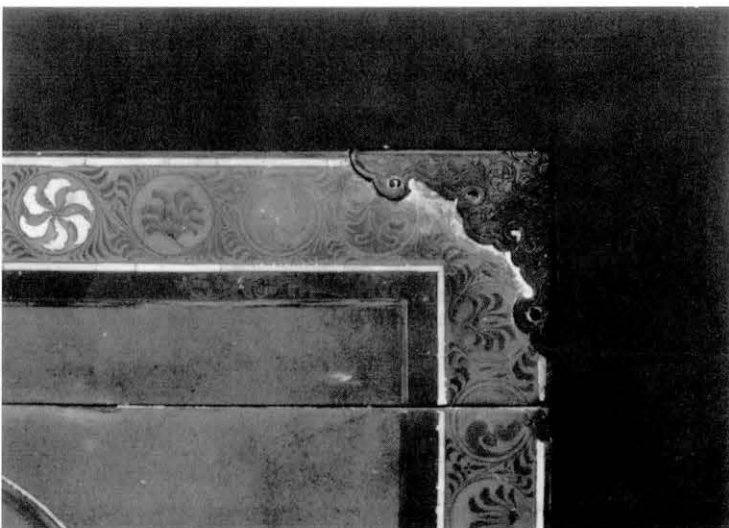
図78 後世修理部分発光写真 修復前
UV photograph of the part of a past restoration, before restoration

図79 後世修理部分発光写真 修復前
UV photograph of the part of a past restoration, before restoration

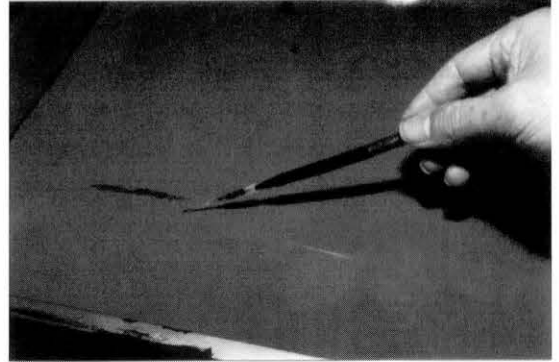
図83 内亀裂の接着
Adhering the cracks on the lid

蓋と底板には素地に亀裂が進行しており、危険な状態にあった。特に、蓋裏には甲板に亀裂が2条あるが、蓋表にはまだ亀裂がでていないことから、螺鈿などの剥落止めよりも先に優先して素地を接着した。亀裂箇所にはリグロインで希釈した麦漆を含浸した。余分な漆は溶剤で完全に拭き取り、十分乾燥させた。底板の亀裂箇所は内側にビロードが貼られていることから、漆が内側に回らないように十分注意した。亀裂の補強は2度行った。十分に乾燥後、空隙のあった底板の亀裂部分にやわかい刻苧を充填し素地を完全に接着した。

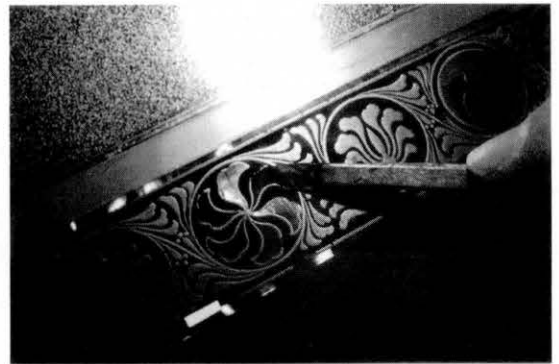
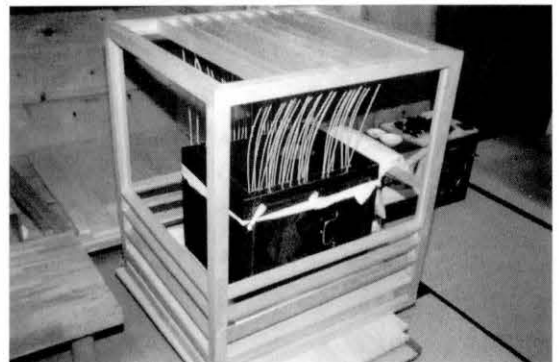
図84 螺鈿剥離部分の膠含浸
Impregnating animal glue into parts of detached *raden*

図85 螺鈿の剥落止め
Reattaching detached *raden* pieces

はじめに、螺鈿剥離部分の圧着作業をするため、化粧箱に合わせた木枠を作製した。各面の木枠には移動可能な棧を設け、修理箇所に対店できるような構造にデザインした。剥離した貝は表面から突出し、部分的に割れている部分があり、修理で平滑にすることは出来ないことから、剥離した貝が今後剥落しないようにするに留めた。剥離した貝に湯煎した16~20%粒膠水溶液に少量のエタノールを加え含浸し、余分な膠は拭き取り、竹ヒゴや木製棒を用いて圧着した。膠が含浸しにくい部分は事前にエタノールを含ませ含浸しやすくした。圧着には貝の上にサランラップとプラスチックシートを置き、貝を傷めないようにした。

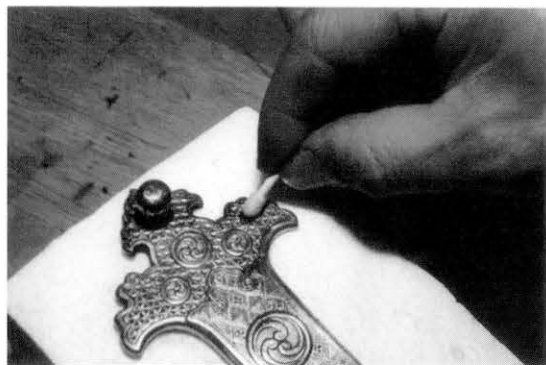
図86 錠金具のクリーニング
Cleaning the metal lock

金具はすべて銅製の金鍍金で、フランス・ベルサイユ宮殿のトリアノン宮にある類品から隅金具の一部に黒がさされていたと考えられる。しかし、すでにその表情は失われていた。修復のはじめに取り外した隅金具の裏側には西洋の塗料が付着、一部で緑青錆がふいていた。また、金具をとめていた釘先には緑色のワックスが付着していた。この塗料とワックスは後世修理で金具を取り外し、再度取り付けるときに隅金具が外れないようにした処置と考えられる。塗料と緑青錆、ワックスを綿棒にアセトンやTHFを含ませ取り除いた。隅金具表面の汚れも同様の溶剤で軽く拭き取った。錠金具には汚れの他に表面に漆が各所に付着しており、その漆をさらに除去しようとした痕跡があった。特に蓋の錠金具は強く磨きなおされており、表面の金鍍金が薄くなって入る部分があった。金具の漆は出来る限り竹箆で取り去り、隅金具のクリーニングと同様の溶剤で軽く拭き取った。

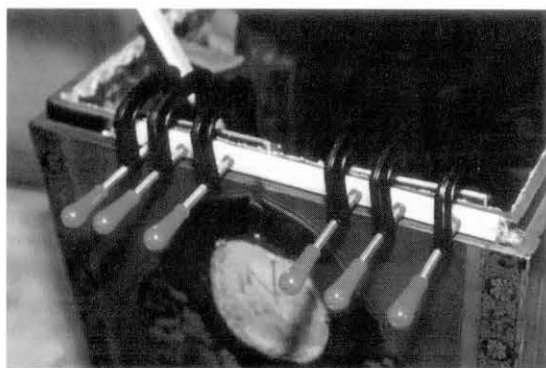
図87 漆塗膜の剥落止め
Reattaching detached urushi coating film

黒漆塗膜の剥離はボーダーの貝の周囲と口縁部分、蝶番周辺に集中していた。剥落止めにはリグロインで希釈した麦漆を使用した。貝の周囲の漆塗膜の剥離部分は貝の色合いを考え、貝の下に漆が回らないように十分注意した。口縁部分や蝶番周辺も同様に調整した麦漆を含浸し、口縁部分は剥離箇所にはシナ合板とゴムを置き、クランプで圧着、蝶番周辺は木枠とヒゴを用いて剥落止めした。

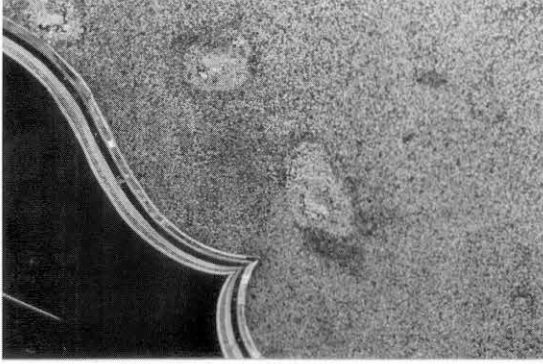
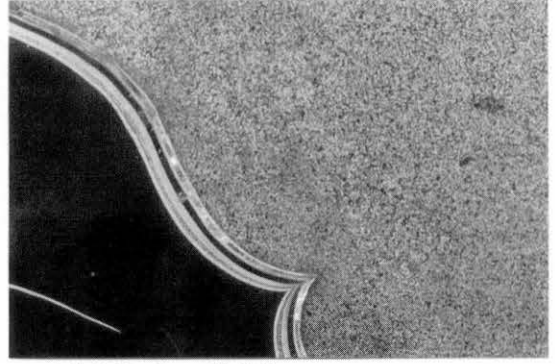
図88 後世修理部分 修復前
Traces of a past restoration, before restoration

図89 後世修理部分 修復後
Part where traces of a past restoration was found, after restoration

復元箇所は後世修理いったん取り外し、下地を整えた。側面の各面にある後世修理の梨子地部分は、下にオリジナルの蒔絵がある可能性があることから慎重に除去した。除去には先端を切れなくした彫刻刀等を用い金属粉を除去し、漆はクリスタル#2000を使って除去した。梨地の後世修理は打損部分を繕ったもので、下地が露出した部分を中心に行ったものと考えられ、正面左の復元箇所以外では下の蒔絵はなくなり、周囲の蒔絵もすでに失われていた (図88)。蓋甲板打損の後世修理部分は何度も漆が塗り重ねられ、全体に摺り漆が被っており、はじめに斑に被った摺り漆を除去するところから始めた。蒔絵部分の保護のためパラロイドB72の無水エタノール9対純水1の20%溶液を筆で蒔絵の上に直接描き乾燥させた。摺り漆の除去には細かくつぶした砥石粉と水を含ませた鹿皮を使って丁寧に取り去った。何度も塗り重ねた漆部分はクリスタル#2000、#3000を使って慎重に研いで除去した。凹んだ打損中の漆も全て取り除いた。
