# 和歌浦蒔絵十種香箱

平成15・16年度修復事業

On the Restoration of “Wakaura *Makie* Incense Box”  
in the Collection of the Peabody Essex Museum

MATSUMOTO Tatsuya  
Urushi Conservator/Artist

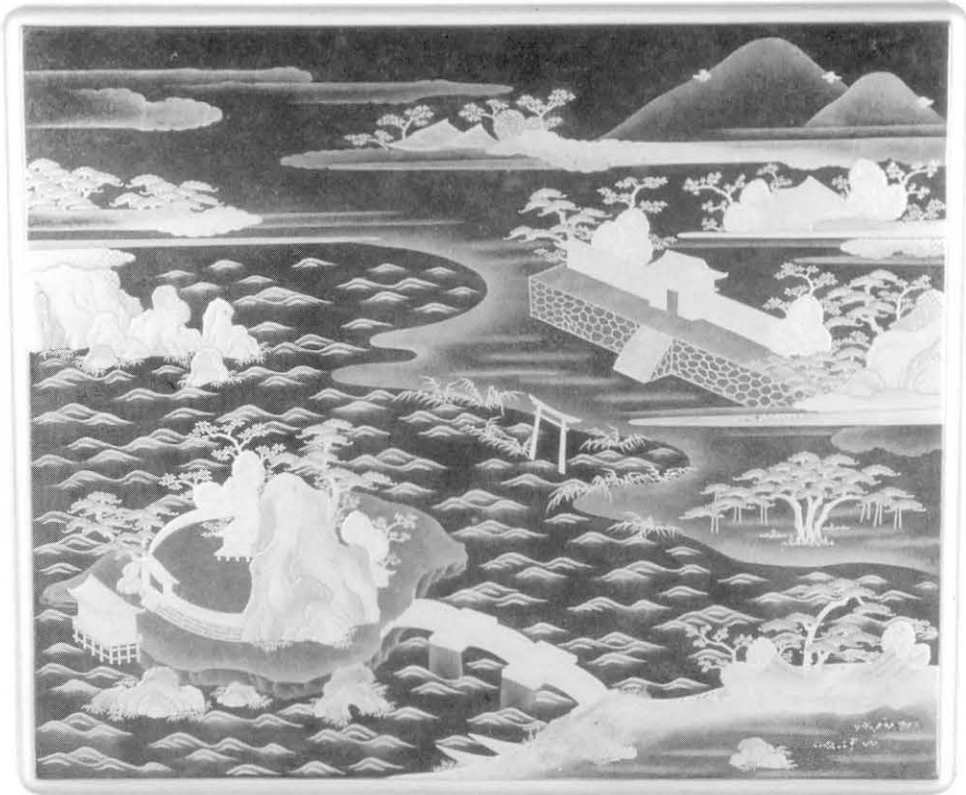
図2 蓋甲板 修復前  
Top board of the lid, before restoration

- ・箱は長年、紫外線の入る場所に展示されていたらしく、甲板（図2）と正側面そして左右側面の漆塗膜の劣化が激しく、壁側に置かれていたと思われる面は劣化が少ない。
- ・身の上段は前後が逆さに長年展示されていたと思われ、正しい方向に直すと蓋と身の下段の漆塗膜の劣化状態に違いがある（図4・5）。
- ・箱の表面には、艶出しのために塗った塗料が劣化して黄色く変色し、塗膜には細かな断文が入り艶のない状態である。

- It seemed that the object was exhibited for a long time in a place where it was exposed to ultraviolet rays. For this reason, the urushi coating film of the top board (Fig. 2), the front board, and the left and right side boards had deteriorated severely, while the side which seemed to have been placed on the side of the wall had not deteriorated so much (Figs. 4, 5).

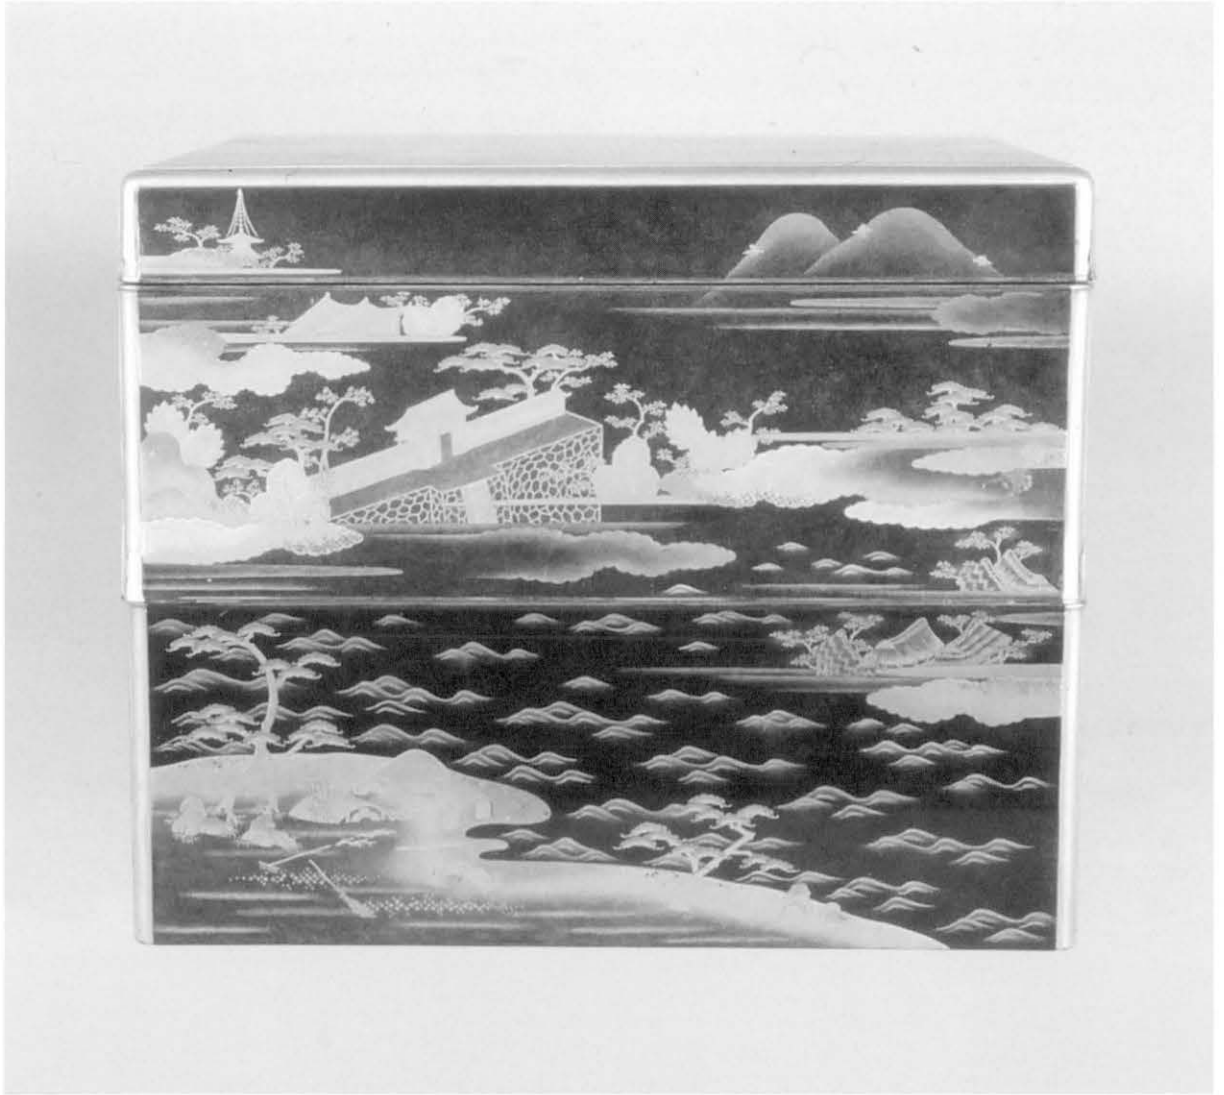
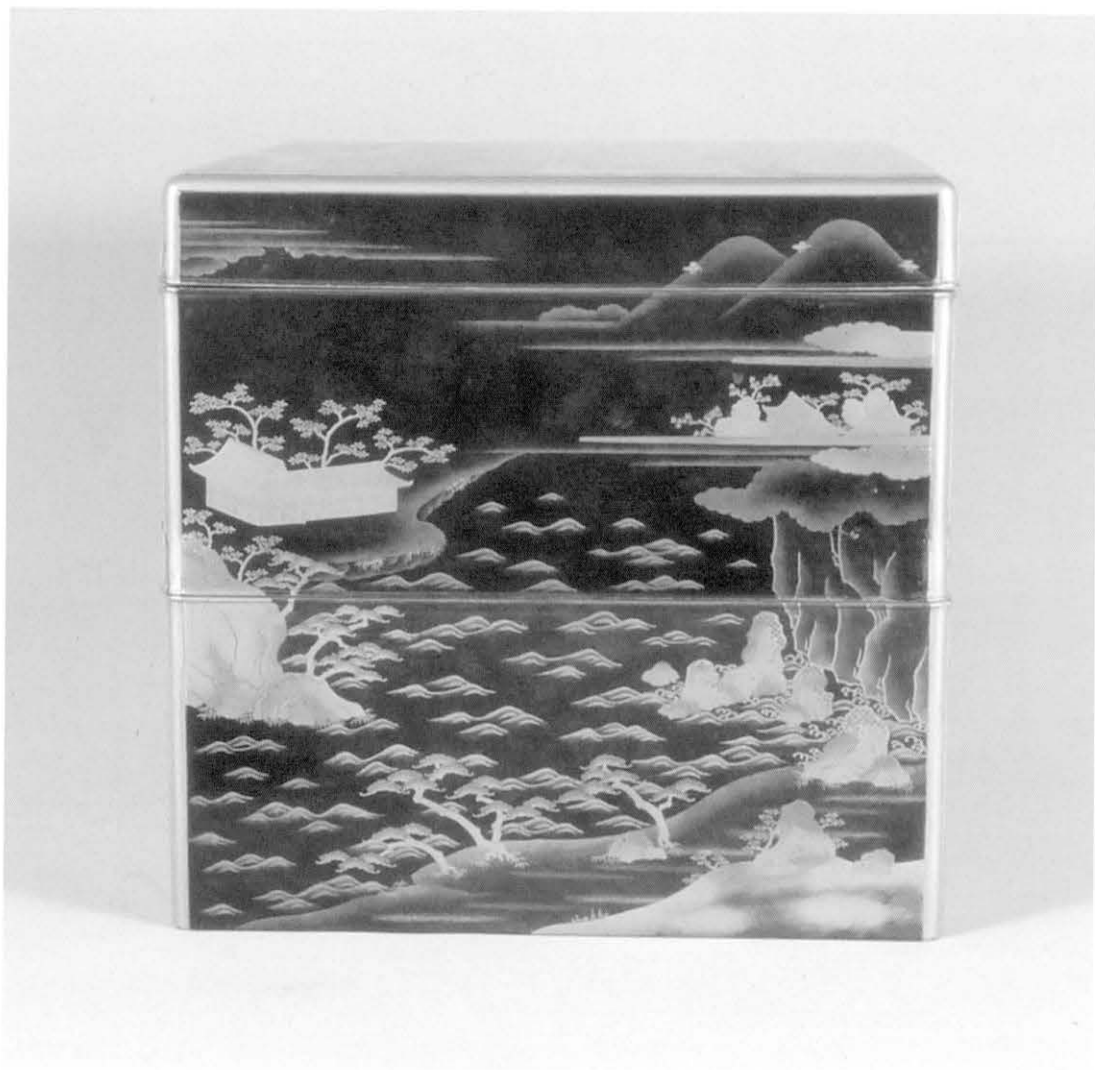
图4 正侧面 修復前  
Front, before restoration

图5 右侧面  
Right side, before restoration

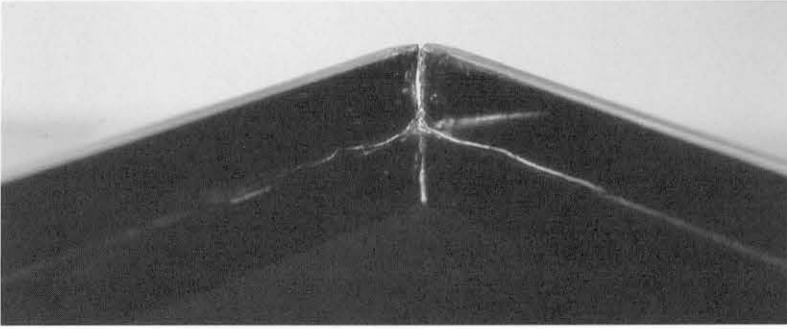
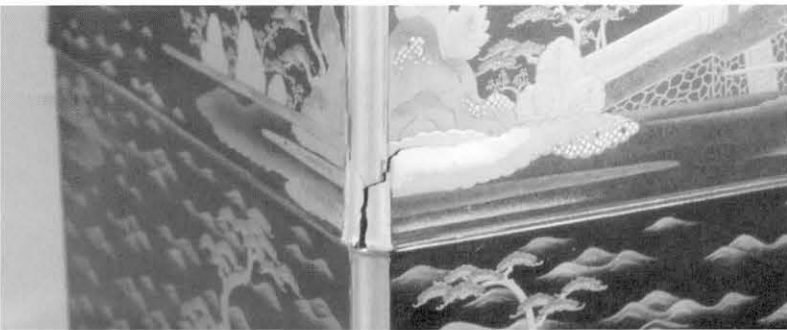
図6 身の上段内側 亀裂部分  
Corner of the upper tier of the body seen from the inside, cracked portion

図7 身の上段角 亀裂部分  
Corner of the upper tier of the body seen from the outside, cracked portion

- ・蓋の側面角には、木地接合部と思われる箇所にて亀裂が入り（図6・7）、後世修理で直された形跡がある。
- ・身の上段の正面左側角には、大きな亀裂が入り2<sup>ミ</sup>程透間が開いている。亀裂は角から側面に広がり、木地が反り返って拡大する恐れのある危険な状態である。この亀裂部分は後世修理されていた。
- ・身の下段角の玉縁及び立上り部分には打損による欠損がある。
- ・身の下段の内側見込み部分には、木地の接ぎ合わせ部分と思われる箇所にて8<sup>ミ</sup>程の亀裂がある。
- ・身の上段の側面には、後世修理時に付いた指紋の跡がある。

- There was a large crack on the front left corner of the upper tier of the object causing a gap of approximately 2mm. This crack extended from the corner to the side and there was a great risk of the substrate warping and the crack extending further. This crack had also been restored (Figs. 6, 7).

本資料の角部及び塗膜の亀裂は、乾燥による木地の収縮が原因であると推測できるため、資料全体を加湿保存し柔軟性を取り戻す作業が必要になった。本資料を加湿した小箱に長期保存し、木地が柔軟になってから端金で微力の圧力をかけて強制し、反り返った部分を戻す作業を行った。木地強制は、一歩間違えると木地構造を崩壊する恐れがあるため少しずつ慎重に行った結果、作業は2ヵ月に

蓋及び身の上段角部分の亀裂は、四角に及んでいたため同時に作業する必要があった。圧着は本資料を木枠内に固定して、竹ひごの弾力を利用した芯張り技法で行うことにした(図13・14)。

Since cracks had been found on all four corners of the lid and the upper tier, it was necessary to work on all these at the same time. It was decided to place the object in a wooden frame and to use the flexibility of bamboo *shimbari* sticks in order to press-stabilize (Figs. 13, 14).

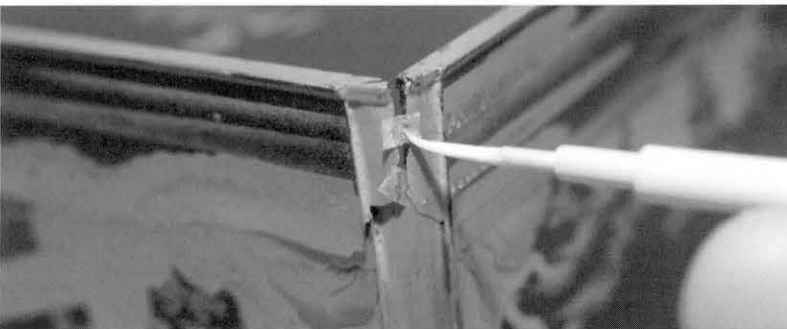
図8 仮り止め養生  
Temporary facing

本資料の亀裂部分の周辺塗膜は、剥落する恐れのある危険な状態にあるため、細かく切った雁皮紙を生麩糊にて仮止め養生し作業中の剥落を防止した。(図8)

Since the coating film surrounding the cracks was in danger of being dislodged, it was temporarily faced by using thinly-cut strips of *gampi* paper adhered with wheat starch paste in order to prevent it from becoming detached during restoration (Fig. 8).

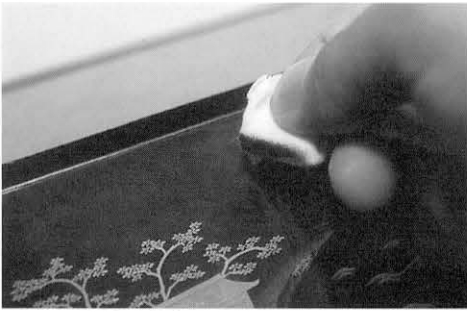
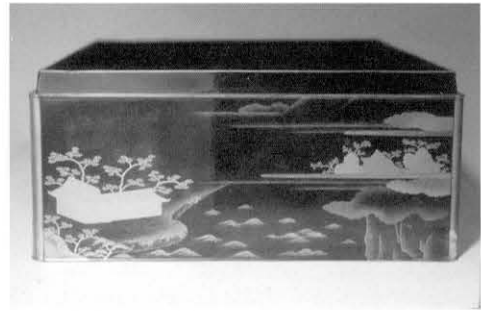
図9 塗料除去作業  
Removing deteriorated restoration material from the coating film

図10 塗料除去作業中  
Object before and after the removal of deteriorated restoration material (left—after removal; right—before removal)

本資料は、艶のなくなった漆塗膜の復元のために塗られた塗料が劣化し、塗膜表面が黄色く変色していた。表面の漆塗膜には細かな断文があり、強い溶剤を使うと蒔絵部分に影響を与えるため、極力弱い溶剤を試してみた。結果、純水だけでは反応がなく、純水に少量のエタノールを加えただけで塗料は解けだした。従って、塗料の除去は綿布に少量の純水とエタノールを含ませて行った。(図9・10)

The coating material that had been applied to the object in a previous restoration to restore luster to the original coating film had deteriorated, causing the surface to become yellowish. There were microcracks that could not be seen with the naked eye on the surface coating film. Since the use of a strong solvent would affect the *makie* decoration, comparatively weak solvents were tested. It was found that pure water alone was not effective; when a small amount of ethanol was added to pure water, the coating material began to dissolve. So a cotton cloth moistened with a mixture of water and ethanol was used to remove the coating material.

On the part of the object where the urushi coating film on the surface had been severely affected by ultraviolet rays, not only the coating material but also the urushi coating film began to dissolve, causing the gold powder of the *makie* to become exposed. The greatest of care was taken to remove the deteriorated coating material (Figs. 9, 10).

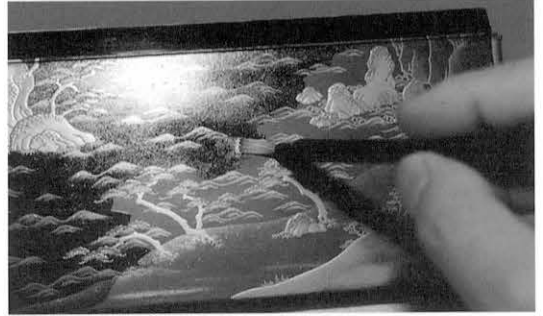
表面塗膜に塗られた塗料を溶剤で除去したところ、一部分の漆塗膜は紫外線による劣化が激しく、艶の無い状態であった。特に身の上段の左側面は、黒漆地に薄蒔きされた金粉が辛うじてくっついている危険な状態であった。

図11 漆固め(塗膜強化)  
Urushi-gatame (reinforcement of the coating film)

漆固めは塗膜表面の細かな断文に漆を含浸し、塗膜強化と艶を取り戻す為に行った。漆固めに使用した漆は、本地呂漆+梨子地漆+生正味漆を5対4対1の割合で配合し、石油系溶剤のクリンソルGで4倍に希釈し平筆で塗膜の断文に染み込ませた。塗膜の状態によって配合する漆の分量や溶剤の希釈濃度を変え、8～10回程度漆固めを行った。この際、含浸した漆は断文に吸わせるだけにして、切金や高蒔絵部分には残留の無いよう丁寧に溶剤で拭き取った。なお、塗膜の劣化が少ない部分は2～3回程度の漆固めに留めた(図11)。

*Urushi-gatame* was done by impregnating urushi into the microcracks on the urushi coating film in order to reinforce it and to return a little luster to it. For this process, *kijiro urushi*, *nashiji urushi* and *kijomi urushi* were mixed at a ratio of approximately 5 : 4 : 1. This was then diluted four times with a petroleum-based solvent, Cleansol G. A flat brush was used to apply this to the microcracks. The amount of urushi and the degree of dilution were adjusted according to the condition of the coating film. *Urushi-gatame* was repeated 8 to 10 times. It was made sure that the impregnated urushi would be absorbed into the microcracks only, and excess urushi was carefully wiped off with a solvent so that none would remain on the *kirikane* or the *takamakie* decorations. *Urushi-gatame* was done only 2 to 3 times on places where the coating film had not

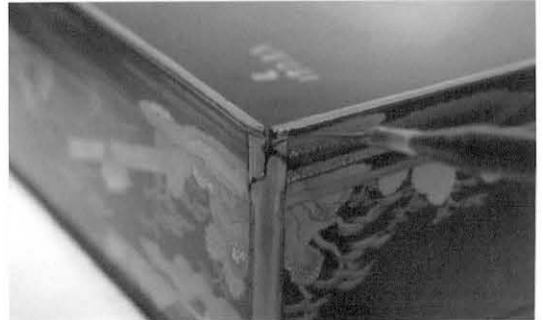
図12 麦漆含浸  
Impregnating mugi-urushi

亀裂部分の接着は、反り返った塗膜を接着するため強力な接着剤が必要となった。接着剤は、グルテンの量を多くした小麦粉に生正味漆を練り合せ、接着力の強い麦漆を使用した(図12)。

A strong adhesive was necessary in order to adhere the coating film that had become warped around the cracks. For this, wheat flour with more gluten was kneaded with *kijomi urushi* to make *mugi-urushi* having stronger adhesiveness (Fig. 12).

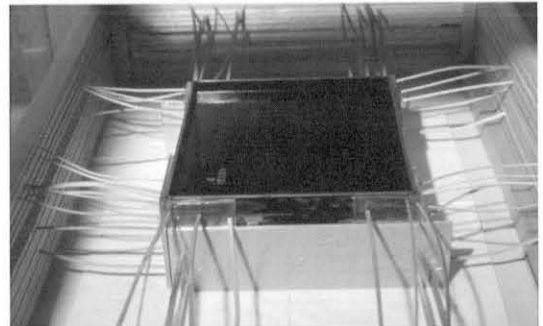
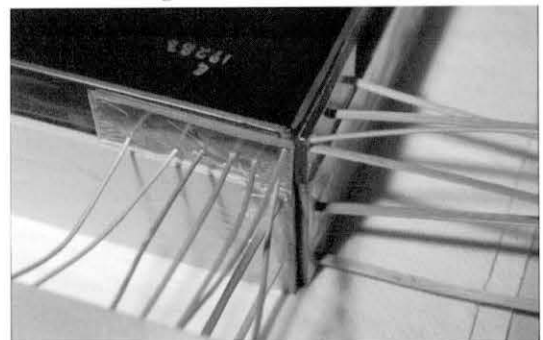
図13 芯張り 圧着  
Press-stabilizing with shimbari sticks

図14 芯張り 圧着  
Press-stabilizing with shimbari sticks

本資料の木地は非常に薄く造られているため、竹ひごの圧力を掛け間違えると木地が崩壊する危険性があった。木地構造を充分考慮し、竹ひごで押さえる位置や圧力の強さに配慮しながら圧着作業をすすめた。圧着状態を3週間ほど維持し、麦漆が完全に乾き絞まるのを待って本資料を木枠から外した。

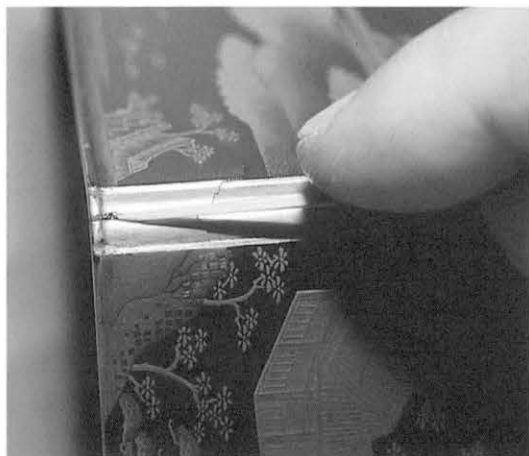
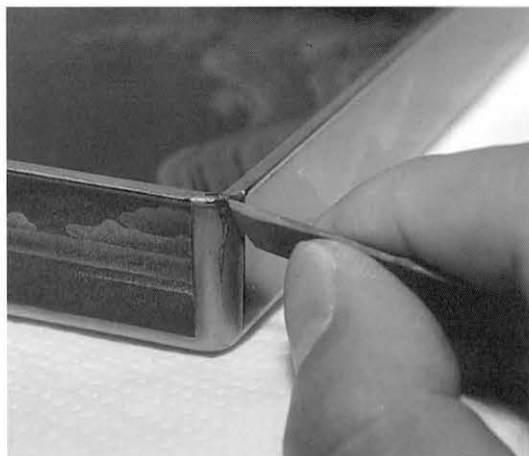
図15 刻芋充填  
Filling with *kokuso*

図16 刻芋付け部分 研ぎ  
Grinding *kokuso* part

塗膜の欠失した部分は、刻芋で形状復元を行った。刻芋は、刻芋用に調整した麦漆に楠材の木粉と麻の繊維を細かくした粉を混ぜ合わせ、珪藻土を焼いた地ノ粉を加えて作り、欠損部の形状が整うまで数回充填し復元を行った。形状復元した部分は、砥石や鑢で刻芋肌を整えた（図15・16）。

Parts of the coating film that had been lost were reproduced with *kokuso*. *Kokuso* was made by mixing camphor wood sawdust and finely cut hemp fibers to *mugi-urushi* adjusted for *kokuso* and adding *jinoko* (baked diatomaceous earth). *Kokuso* was applied in several thin layers to the missing parts until the original shape was reproduced. The reproduced portions were finished with a whetstone or a file (Figs. 15, 16).

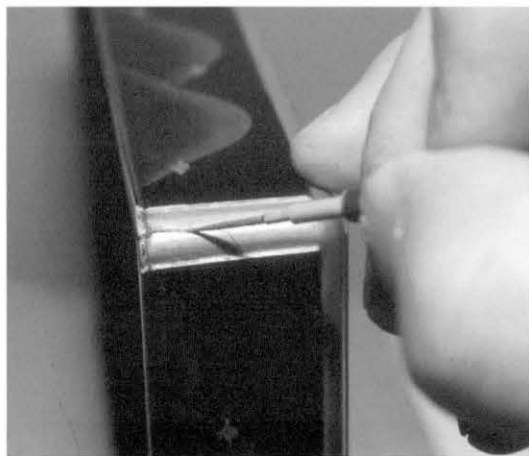
図17 際錆及び金錆  
Applying *kiwasabi* using gold *sabi*

蒔絵の損傷部分の際錆は、木地呂漆と梨子地漆に微粒子の黄砥の粉（砥の粉を水簸して作った粉）と数種類の金粉を混ぜ合わせた金錆を施し、亀裂部分を目立たなくした（図17）。

*Sabi* for *kiwasabi* for damaged portions of *makie* was made by mixing very fine yellow *tonoko* and several kinds of gold powder so that the restored portions would not be conspicuous (Fig. 17).

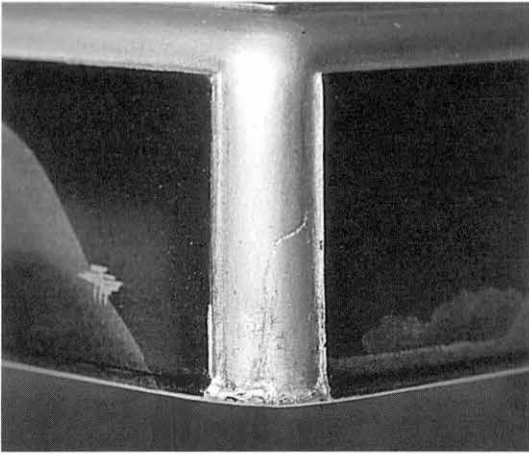
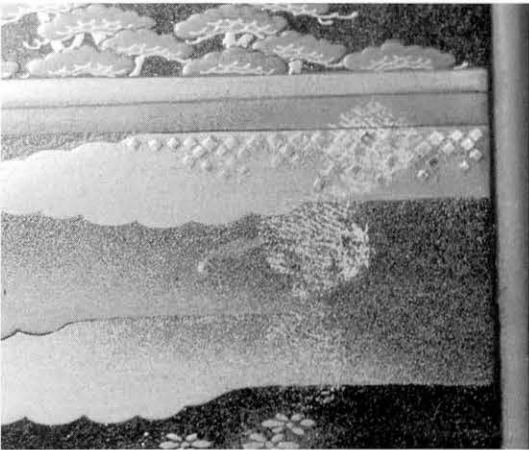
図18 亀裂部分 修復前  
Cracked portion, before restoration

図20 亀裂部分 修復前  
Cracked portion, before restoration

金錆を施した損傷部分をより目立たなくするため、金消粉で金地復元を行った。損傷部分に梨子地漆を薄塗りし、漆の乾きを待って真綿で金消粉を施した。なお、金消粉を施すだけでは目立ちすぎるため、梨子地漆を数回復元した部分に漆固めを行い、周辺塗膜との調和をとった。

In order to make the restored portion where gold *sabi* had been applied less conspicuous, gold *keshifun* was sprinkled. For this, *nashiji urushi* was applied very thinly to the restored portions, and a type of gold powder called *keshifun* was applied with silk floss just before the urushi hardened. Since gold *keshifun* alone would be too conspicuous, *nashiji urushi* was used several times to consolidate the restored portions and to match these portions with the surrounding

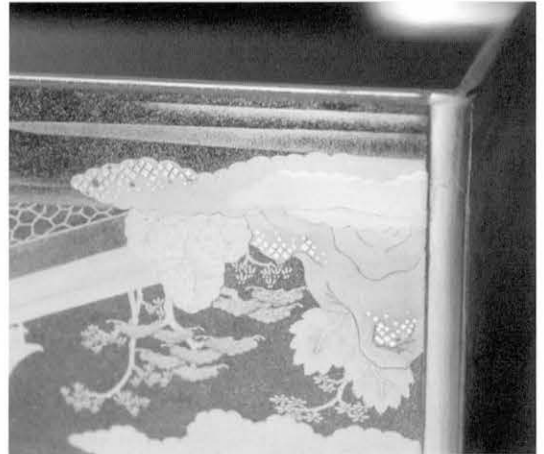
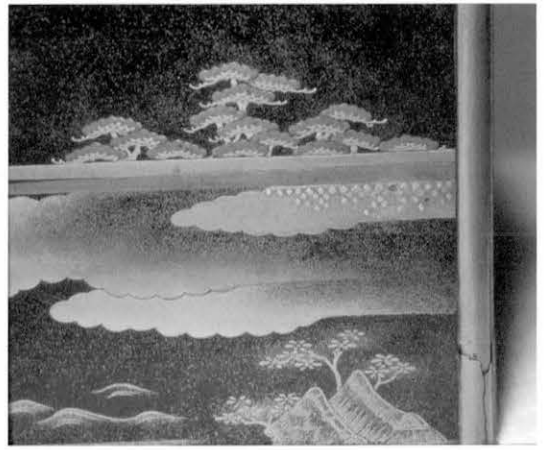
図19 亀裂部分 修復後  
Cracked portion, after restoration

図21 亀裂部分 修復後  
Cracked portion, after restoration

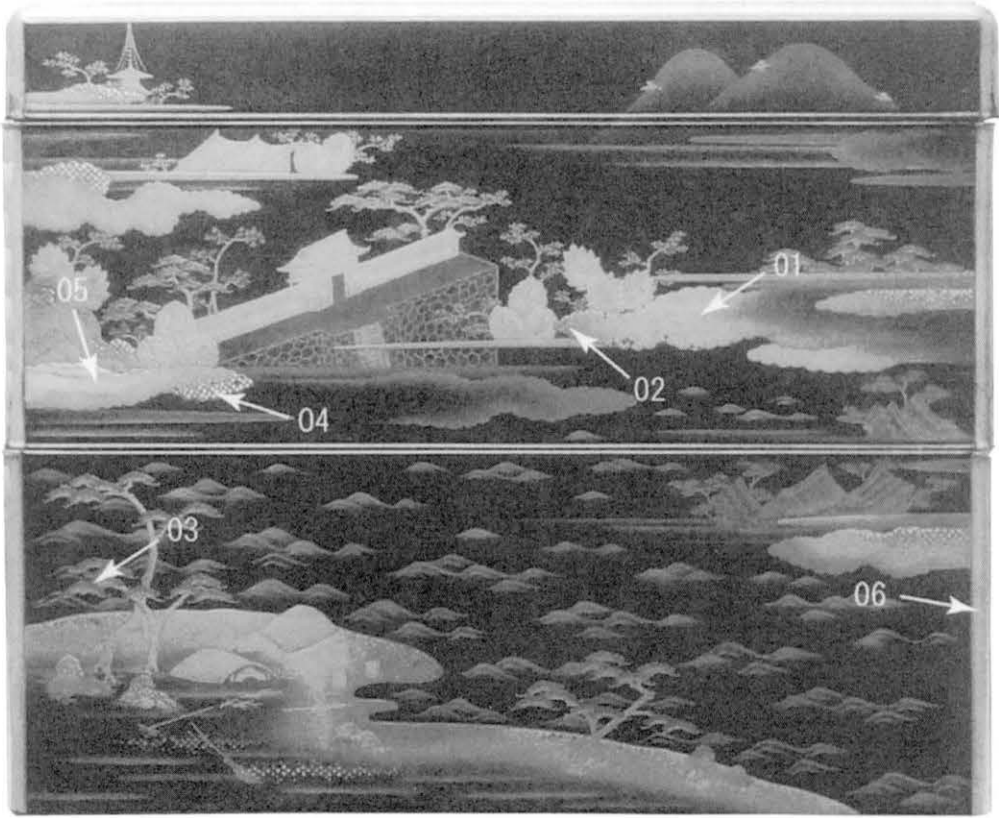
图26 荧光X线测定位置  
X-ray fluorescence, measuring points

本資料には数種類の蒔絵粉と金属材料が使われている。そのうち、雲、松の枝、切金、唐戸面、そして雲部分にある後世修理箇所について蛍光X線分析を行った。

雲部分には、異なる2種類の蒔絵粉が蒔かれている。先端部分に蒔かれた粉は、Au74%、Ag21%、Cu5%程度の組成で、所謂、青金粉が使われている。この粉は、波、岩山、州浜、松などにアクセントとして使われている。

分析の結果、金に10%程度の銀が含まれていることが確認された。現状の切金は、少し赤味があった色をしていることから、金に含まれた銀の錆化によるものと思われる。

分析の結果、金の純度はオリジナルの金に近いが、銅が全く含まれていないことから異なる材料である。修復の際、オリジナルの蒔絵粉を除去し、新たに蒔絵したと推測できる。

Several kinds of *makie* powder and metals were used in the manufacture of the object. Of these, X-ray fluorescence analysis was conducted of the materials used on the clouds, branches of pine trees, *kirikane* decoration, *karatomen*, and a trace of past restoration found on a cloud.

XRF analysis confirmed that the gold *kirikane* contains approximately 10% silver. Since the color of the *kirikane* today is slightly brownish, it is believed that this is due to the oxidation of the silver contained in the gold alloy.

XRF analysis showed that the purity of gold used in the restoration is very close to that of the original gold decoration, but because there is no trace of copper it is different from the original. It is assumed that the original *makie* powder was removed at the time of a previous restoration and sprinkled with new powder.
