# 鳥図屛風

平成17年度修復事業

# 修理報告

(株)岡墨光堂 君嶋隆幸

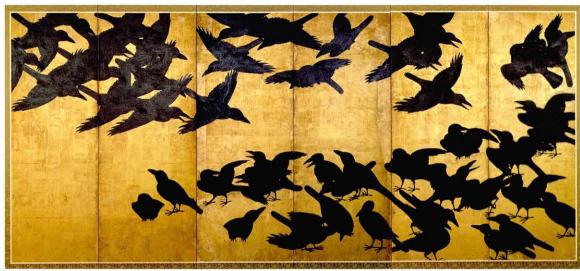
11-1. 鳥図屛風 修理前 (シアトル美術館) Crows 〈Before Treatment〉 (Seattle Art Museum)

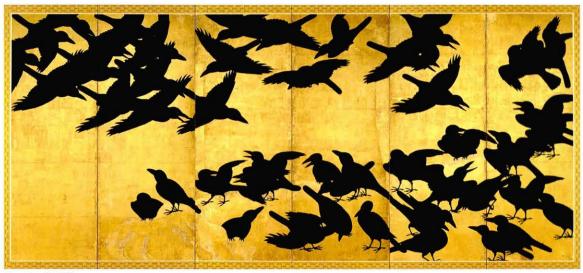
12-1. 修理後 〈After Treatment〉

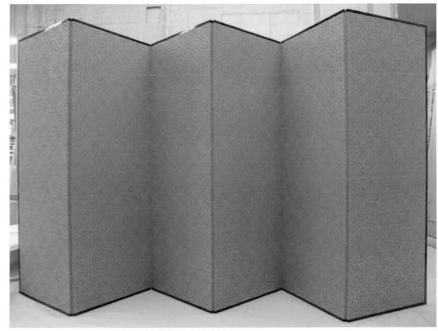
図12 修理後 裏貼唐紙 Fig. 12 After treatment. Karagami on verso.

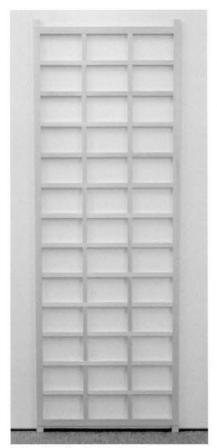
図13 修理前 新調した下地 Fig. 13 Before treatment. Newly prepared inner wooden core.
