# 源平合戦図屏風

平成 18 年度修復事業

品名：源平合戦図屏風  
所蔵：オーストリア応用美術館

# 修理報告

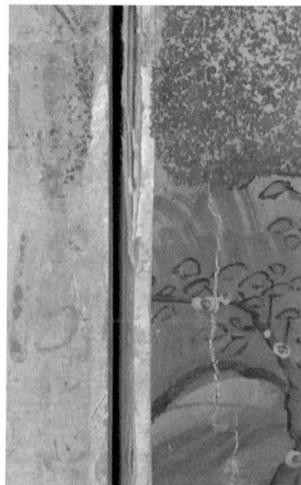
図1 修復前 第1扇奥オゼ上部  
Fig. 1 Before treatment: Top part of the back hinge on the first panel

- (1) 台紙である金箔押し紙の破れ・欠失・擦れ等による金箔の欠失が確認できた。特に台紙の割れ・破れはオゼ付近に多く見られた。(図1, 2)
- (2) 本紙に着色されている絵具の欠失・擦傷が確認できた。特に緑色顔料に関しては、擦傷・剥落を多数確認できた。(図3, 4)
- (3) 第4・5扇本紙中央に突き傷が確認できた。(図5, 6)
- (4) 第2扇左下部に本紙の欠失が確認できた。(図7, 8)
- (5) 本紙に多数の染みが確認できた。  
染みは散見し、金箔・絵具層を茶色く変色させていた。特に前オゼ付近は黒く変色し、第5・6扇中央には広範囲に及ぶ茶色い染みが確認できた。(図9, 10)
- (6) 紙蝶番の破れ・損傷が確認できた。
- (7) 台紙の四方に隅じわ(斜めに盛り上がった皺)が見られた。
- (8) 縁裂の糊浮きが多数確認できた。

(1) There were losses, tears, and abraded areas in the gilt mounting paper. Damage to the mounting paper, such as numerous cracks and tears, was found, particularly in the area around the hinges. (Figs. 1, 2).

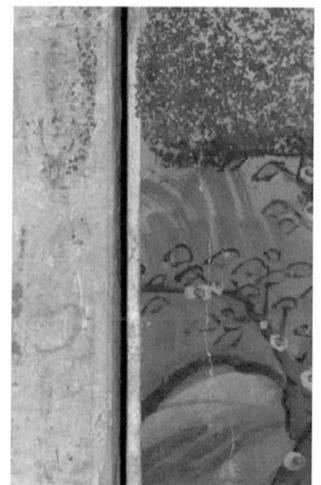
図2 修復後 オゼの破れを繕い、補修した。  
Fig. 2 After treatment: The torn hinge was mended and reinforced.

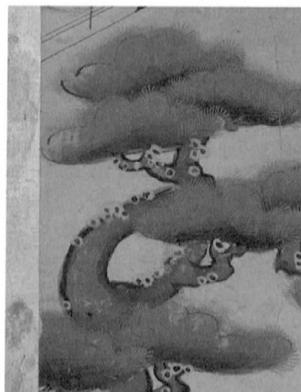
図3 修復前 第3扇左中央  
Fig. 3 Before treatment: Left center area of the third panel

(2) Some of the pigments applied to the painting were missing or damaged due to abrasion. The green pigment in particular was found abraded or actively flaking in many places (Figs. 3, 4).

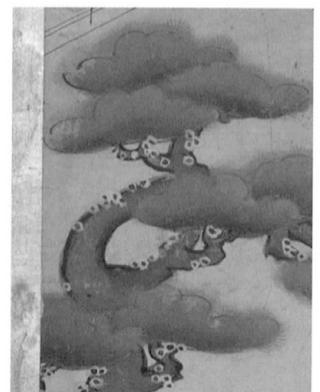
図4 修復後 剥落止めを施し、被害の拡大を防いだ。  
Fig. 4 After treatment: The paint layer was consolidated to prevent further damage.

剥落止めには、チョウザメ膠水溶液（ロシア産パレット）、粒膠水溶液（TSS粒膠新田ゼラチン）を損傷度合いや、絵具に合わせ使用した。

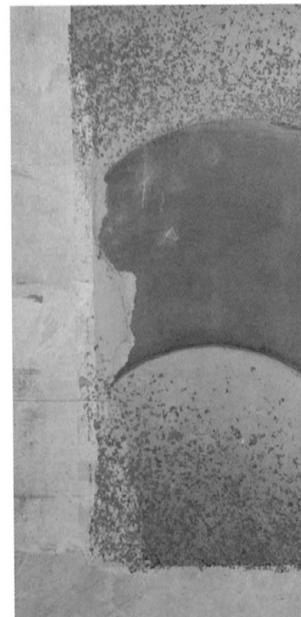
図7 修復前 第2扇本紙左下部本紙欠失箇所の上に銀砂子が撒かれていた。

Fig. 7 Before treatment: Bottom left area of the second panel. Silver leaf had been sprinkled over a missing area of the painting.

(4) Part of the painting was missing at the bottom left hand area of the second panel (Figs. 7, 8)

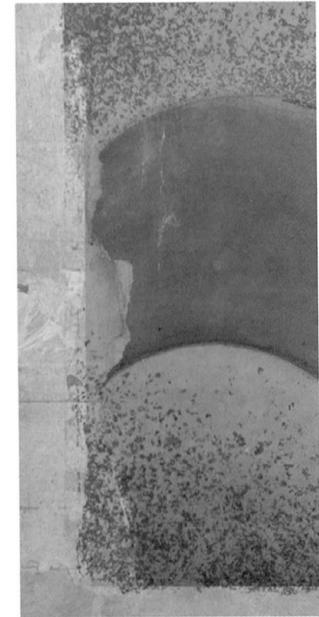
図8 修復後 欠失箇所には糊は施さず、現状のままとした。

Fig. 8 After treatment: The missing area was not mended but left as is.

只、本紙の四辺に生じている欠失箇所に関しては、金箔押し紙の台紙が露出し、銀砂子が撒かれている箇所が多い。この様な箇所に繕いを施すと、返って目立ち、違和感が生じると想像された。

東京文化財研究所担当者と協議した結果、台紙に貼り込まれている部分であるため、捲り上げるなどの処置はしない事や（修復方針5）これ以上損傷が広がり難い等の理由を含め、現状のままとした。

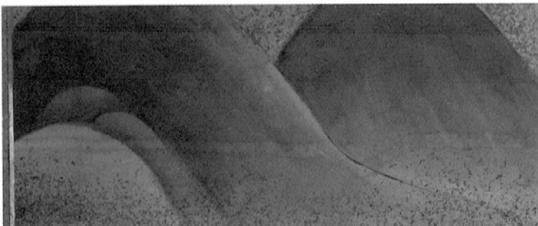
図9 修復前 第6扇上部本紙を横断するように染みが生じていた。

Fig. 9 Before treatment: Top area of the sixth panel. A stain was found running across the painting.

The stains were found scattered here and there, causing the gold leaf and paint layer to turn brown. The areas around the front-facing hinges in particular had turned black. Brown stains were found in a large area running across the fifth and sixth panels (Figs. 9, 10)

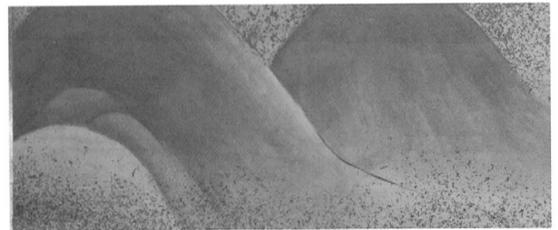
図10 修復後 染みが少し薄くなった。

Fig. 10 After treatment: The stain is somewhat lightened.

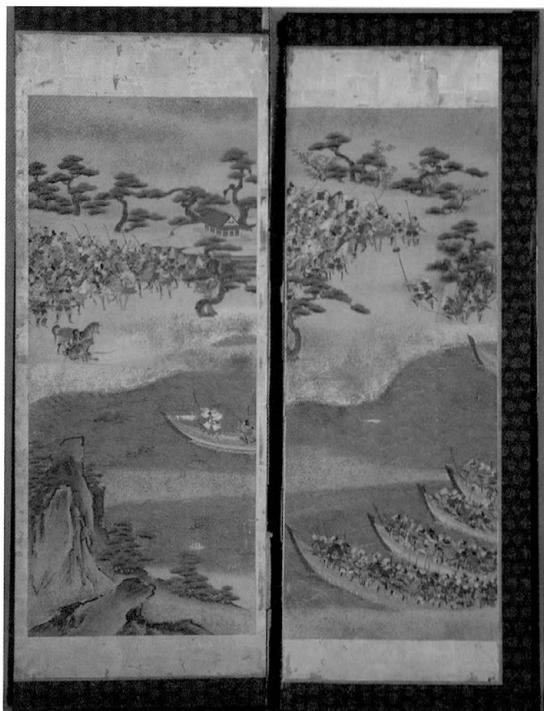
- (1) 第1・2扇間の蝶番が完全に破れ、屏風の形態を維持することが困難になっていた。  
蝶番の破れに伴い、縁裂の破れを併発していた。(図11, 12)
- (2) 台紙である金箔押し紙の破れ、虫害による欠失、擦れ等による金箔の欠失が確認できた。台紙の割れ・破れは特にオゼ付近に見られた。(図13, 14)
- (3) 本紙に着色されている絵具の剥落・擦傷が確認できた。特に青色顔料に関しては、擦傷・剥落を多数確認できた。
- (4) 本紙に多数の染みが確認できた。  
染みは散見し、金箔・絵具層を茶色く変色させていた。特に前オゼ付近は黒く変色しているのが確認できた。
- (5) 第1扇本紙中央右に突き傷が確認できた。
- (6) 縁裂の糊浮きが多数確認できた。

図11 修復前 第1・2扇全図 蝶番が切れ、1扇が完全に離れていた。  
 Fig. 11 Before treatment: The entire images of the first and second panels. The hinges and the first panel were completely detached.

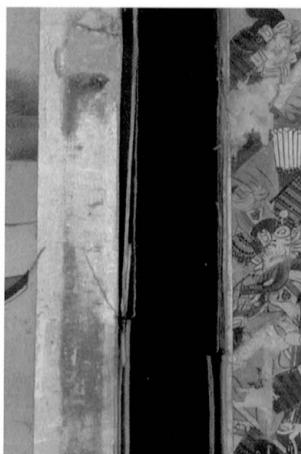
図13 修復前 第1・2扇奥オゼ上部  
 Fig. 13 Before treatment: Top of the back hinge of the first and second panel.

(2) Parts of the gold leaf mounting paper were found torn or missing due to insect damage or abrasion. Many cracks and tears on the mounting paper were found particularly in the area around the hinges (Figs. 13, 14).

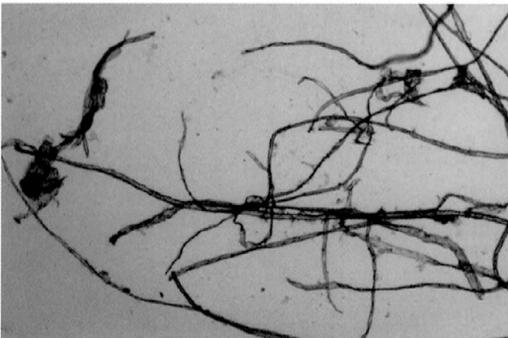
図 18 本紙料紙繊維 顕微鏡写真

高知県立紙産業技術センターに依頼し、本紙・台紙料紙の繊維組成試験（JISP8120 による）を依頼した。試験の結果、本紙は竹、台紙は雁皮（添料として土を確認）であることが確認された。（図 18, 19）

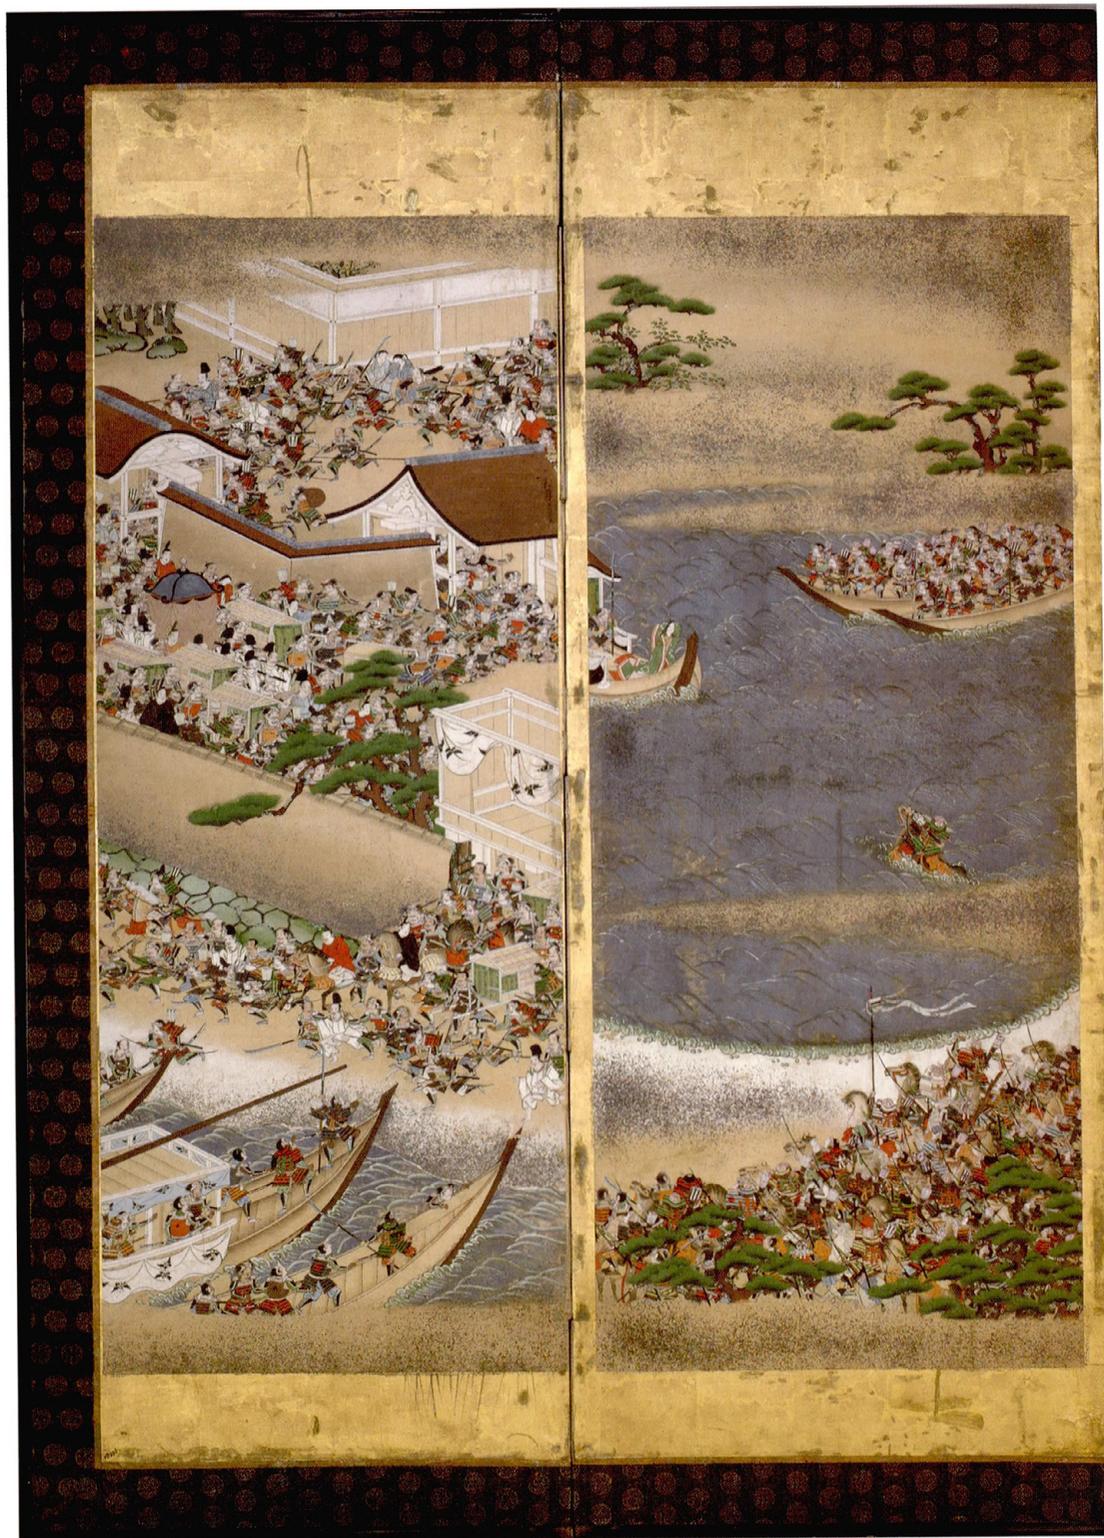
3. 修理前 第5・6扇全図

Before treatment: The entire images of fifth and sixth panels of *Naval Battle of Yashima*
