洛中洛外図屏風

修理報告

(株)墨仁堂
山口聰太郎

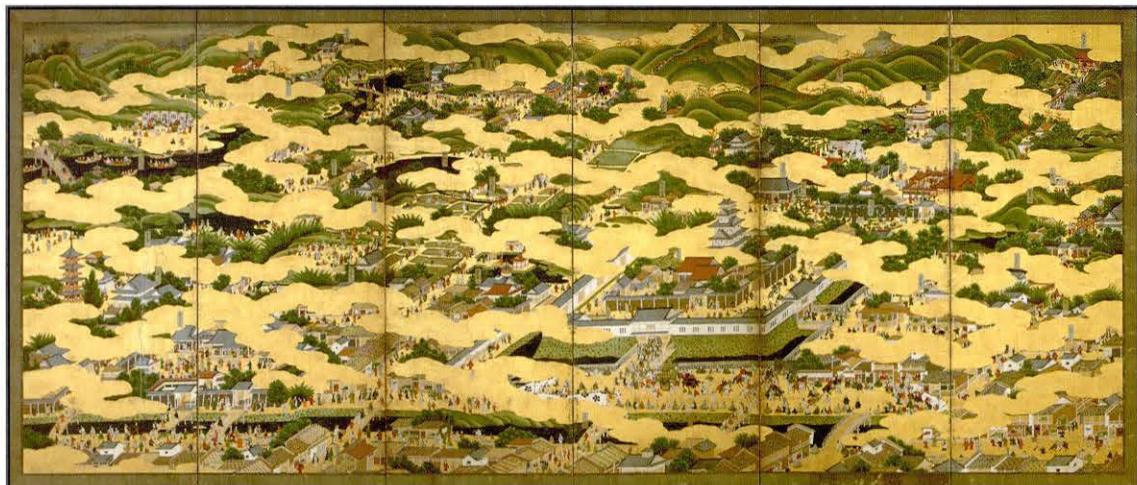
5 - 1. 洛中洛外図屏風 修理前 (ロイヤル・オンタリオ美術館)

Views of Kyoto and Its Environs (Before Treatment) (Royal Ontario Museum, Toronto)

第12扇の画面中央に非常に大きな破れが見られた。ほぼ画面の2分の1程度の縦の破れは、過去の応急処置によって、亀裂の小口が止められていた。大きな亀裂であることから、亀裂の左右に引っ張られて歪み、画面の表面は波打っていた。

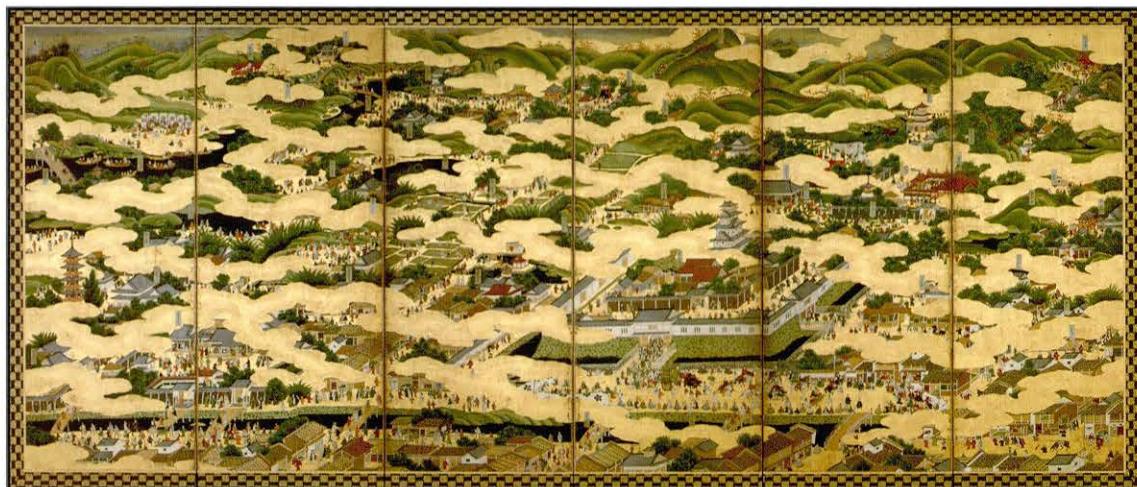
6 - 1. 修理後

(After Treatment)

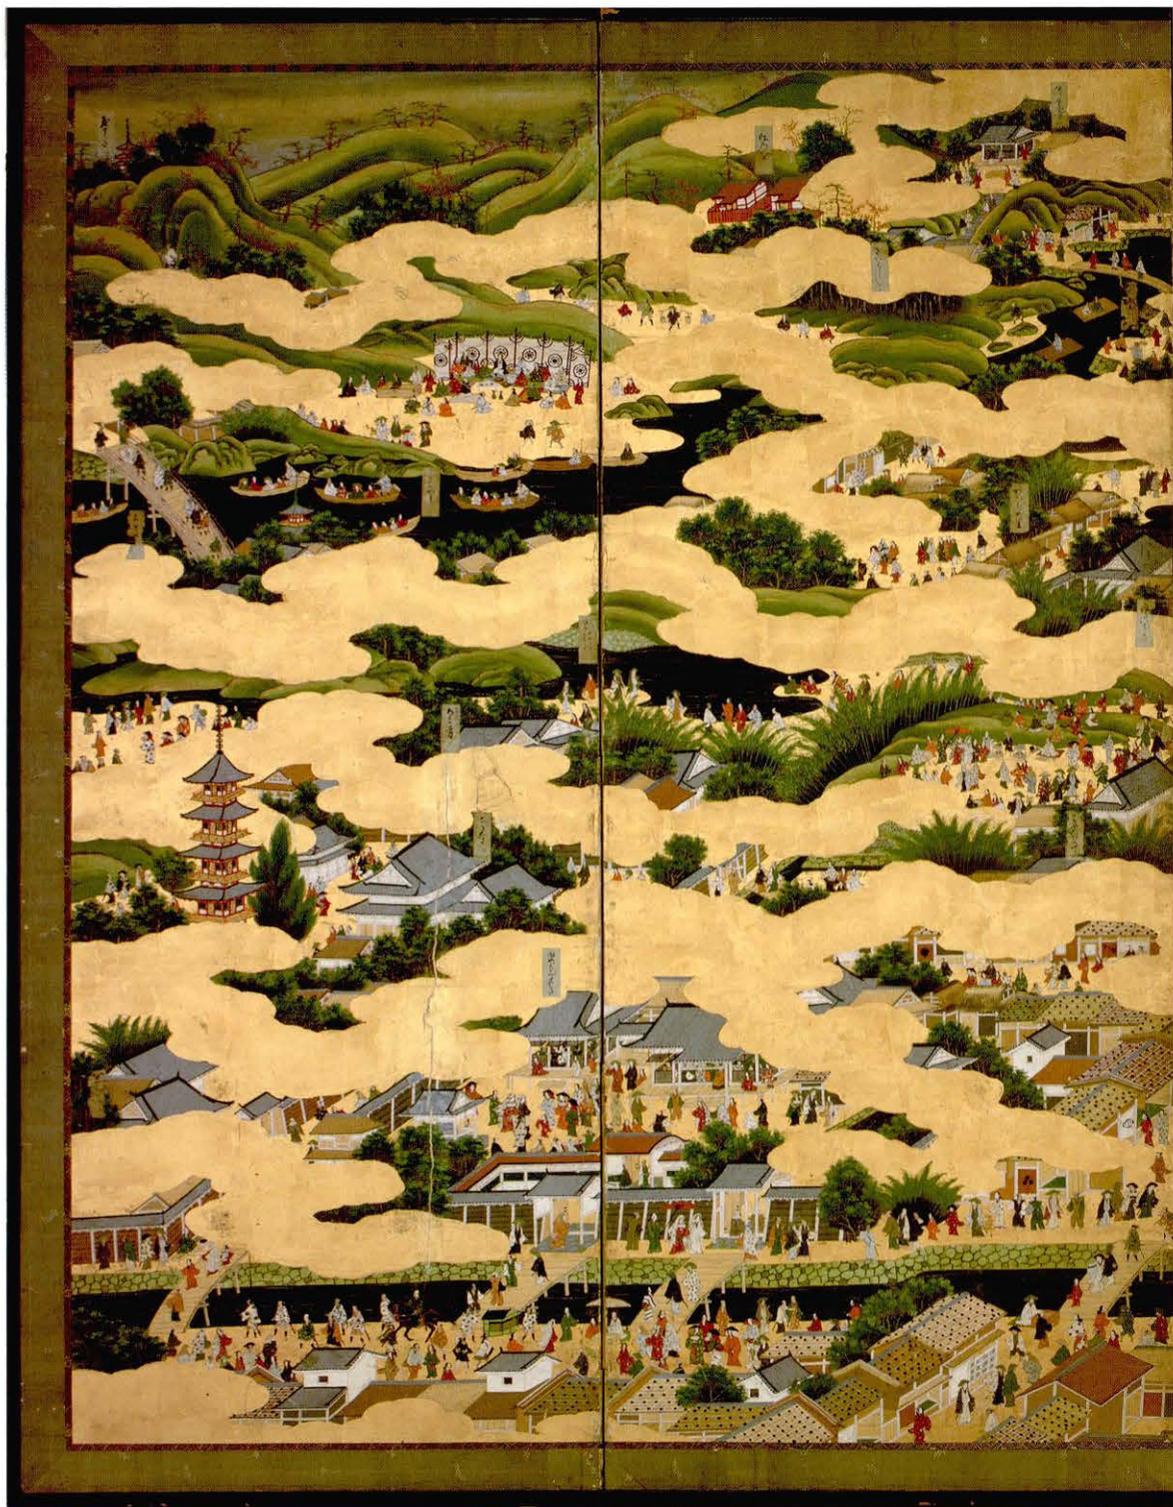
7. 修理前 左隻第5・6扇

Before Treatment: The entire images of fifth and sixth panels of left screen

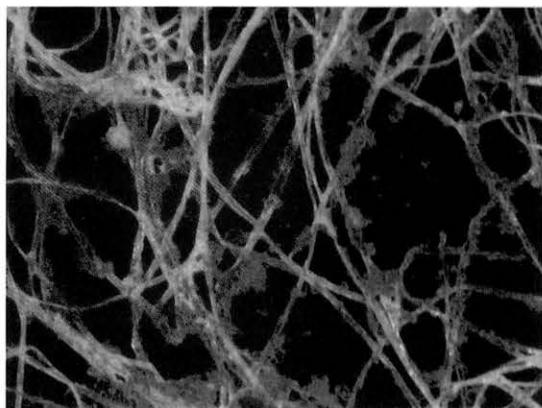
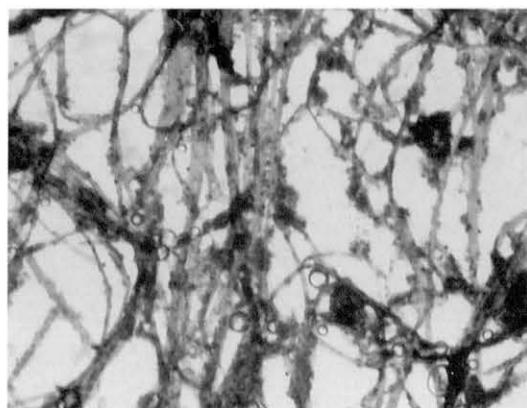
水の吸水はゆっくり、繊維の分散は困難。巾の広い扁平な雁皮紙に、糊化した米澱粉を多量に塗布した。

図1 洛中洛外図屏風の繊維

図2 洛中洛外図屏風の繊維 C 染色液染色

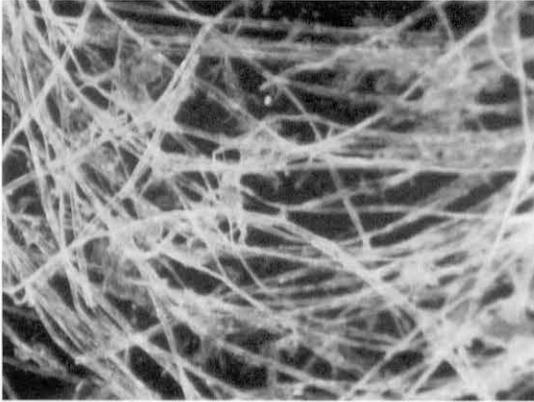
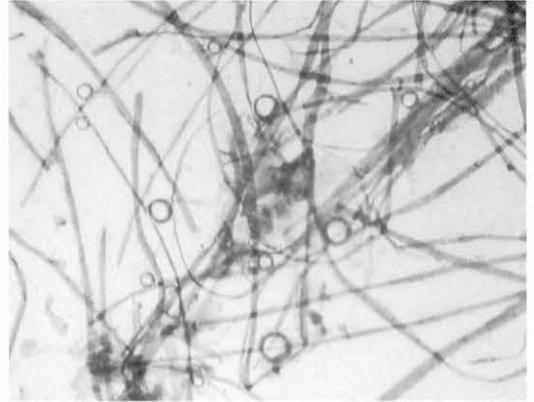
図3 洛中洛外図付箋の繊維
Fig. 3 Fiber sample from the paper tags on Rakuchu Rakugai-zu

図4 洛中洛外図付箋の繊維 C 染色液染め
Fig. 4 Fiber sample from the paper tags on Rakuchu Rakugai-zu C-stain solution

よく洗滌された雁皮の紙にニカワが塗布されている。

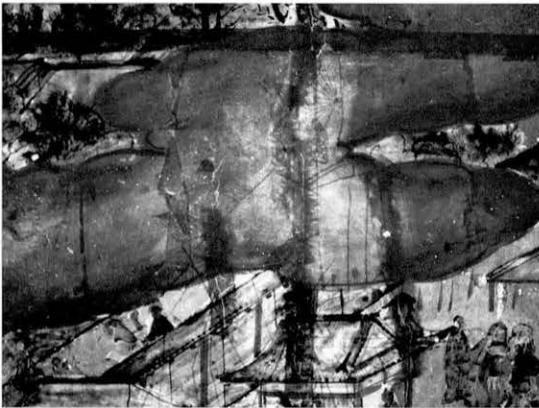
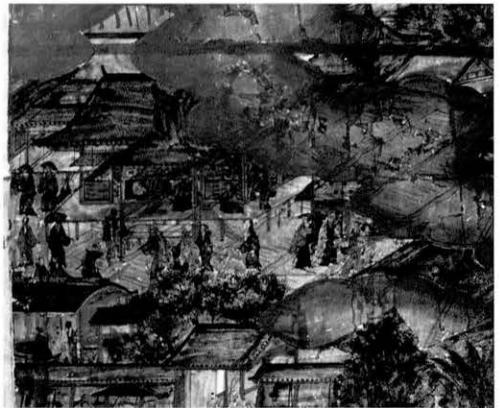
肌裏除去後、透過光をあてると、絵具層の下に本紙とは全く違う絵が描かれている部分があることがわかった。

図5 第12扇
Fig. 5 Twelfth panel

図6 第11扇
Fig. 6 Eleventh panel

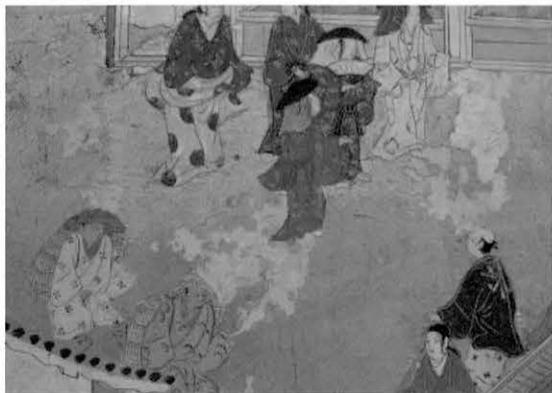
図7 修理前
Fig. 7 Before treatment

修理前は金色の補修紙が当たっていた。しかし、それらは過去の修理の際に肌裏紙を取り替えず、そのままその上に金色の補修紙を当てた状態であった。よって、補修部分と周囲の本紙との凹凸のバランスが悪く目立っていた。よって、担当者・所蔵者と協議の上除去することとした。

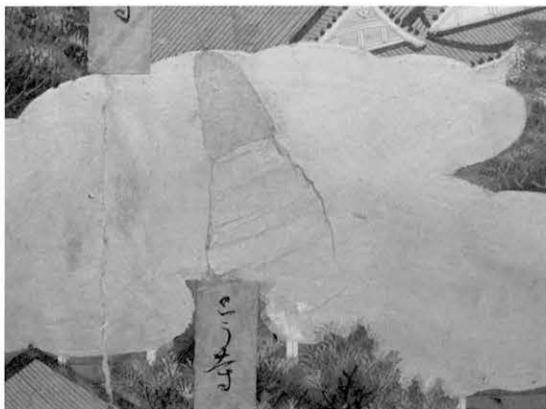
図9 修理前
Fig. 9 Before treatment

第12扇中央に大きな亀裂があり、その上には大きな金紙による補強が画面の上から当てられていた。美観を損ねることから、除去することとした。

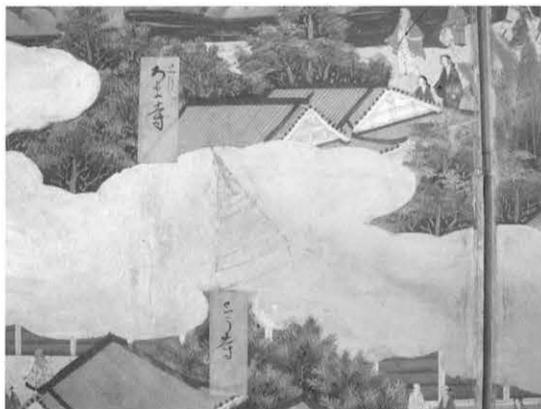
図10 修理後 表の金の補強紙を除去した
Fig. 10 After treatment The gold mending paper on the front was removed

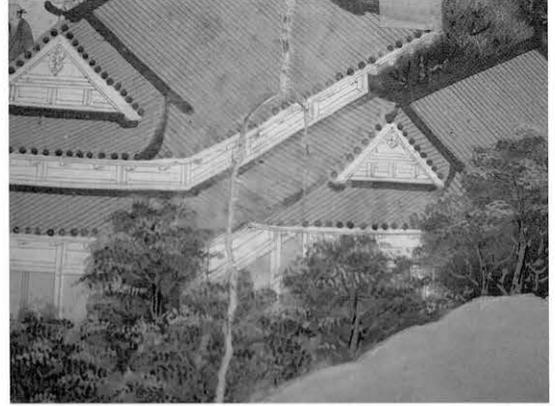
図12 修理前
Fig. 12 Before treatment

第12扇中央に大きな亀裂があった。裏面から当てられている補強紙を除去し、表の絵の繋がりを見ながら、再度亀裂を繋ぎなおした。亀裂部には細く切った美濃紙の帯を二重に重ねて補強とした。
