山水人物蒔絵箆笥 (スペイン国立装飾美術館)

Makie Decoration Cabinet with Landscape and Human
(Museo Nacional de Artes Decorativas)

平成 17・18 年度修復事業

On the Restoration of *Makie Decoration Cabinet with Landscape and Human* in the Collection of Museo Nacional de Artes Decorativas

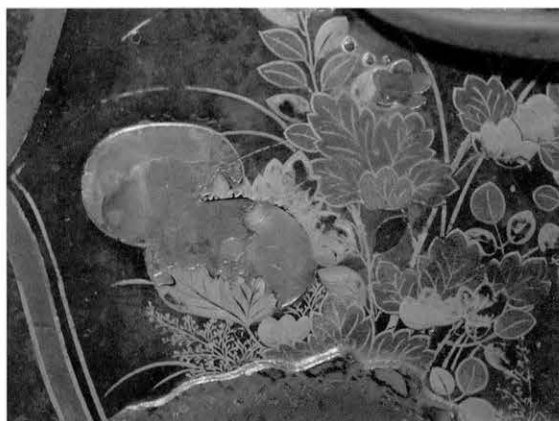
図8 右側面 貝裏に朱漆を塗った伏彩色
Fig. 8 Right side, *fusesaishiki* using vermillion urushi on the back of the shell pieces

- There were cracks on the part where the top board and the right side of the Cabinet join.
- *Raden* shell pieces on the right side to which *fusesaishiki* had been applied had become lifted or lost and the vermilion urushi used for *fusesaishiki* had become exposed on parts where the *raden* had been lost (Fig. 8).

The Cabinet was placed in a wooden frame and the lifted coating film was press stabilized by *shimbari* method using the resiliency of thin bamboo sticks. *Nikawa* (animal glue) was used to adhere the lifted *raden* pieces on the left side of the Cabinet (Figs. 23, 24).

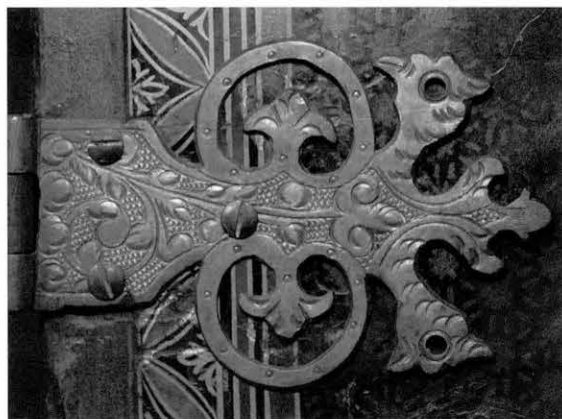
図11 後補(ヨーロッパ製)の蝶番金具
Fig. 11 Hinge (European), a later addition

- There were cracks around the joints of the substrates of the left and right door panels (Figs. 12, 14).
- The six hinges on the left and right doors were later additions, and nail holes belonging to the time of original manufacture were observed on the coating film underneath the hinges (Figs. 11, 25).

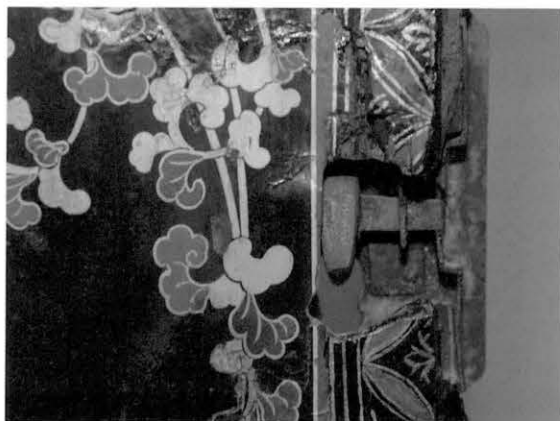
図 12 扉裏 損傷部分

- ・箆筒の内外全体には、後補の塗料が塗られ全体が黒ずんで見える。
- ・正面扉の文様は擦れて欠失した部分が多く、特に高蒔絵部分は欠損が多い。
- ・両扉の端喰部分や素地の接ぎ目と思われる部分の内外に、亀裂が入っている。(図12.14)
- ・正面扉の左右6個の蝶番は後補であり、蝶番下の塗膜には制作当初の釘穴が確認できる。(図11.25)
- ・正面右下の隅金具は後補であり、残り3ヶ所の隅金具は付いていない。
- ・両側面の天板角部分の塗膜は欠損が多く素地が露出し、周辺塗膜は剥離し剥落の恐れのある危険な状態である。(図13)
- ・天板部分の文様は擦れて欠失しているが、文様の置目や高上した下地の形跡が確認できる。
- ・右側面の天板と側面板の素地接合部や端喰部分に亀裂がある。
- ・右側面の伏彩色された螺鈿は剥離、剥落があり、欠失した部分には伏彩色の塗料が露出している。(図8)

Fig. 12 Inner side of the door panel, damaged part

本資料の左右扉には、素地の接合部に亀裂が多くあり、一部は鉄釘で補強されている箇所があった。圧着に使用する接着剤は、グルテンの量が多い小麦粉を水練りし、生正味漆を練り合わせた麦漆を使用した。圧着は、端金やクランプを使用し作業を行った。(図 21. 22)

There were many cracks on the joints of the substrate of the left and right door panels of the Cabinet, and in some places iron nails had been used for reinforcement. *Mugiurushi* (raw urushi mixed with flour having a high gluten content that had been kneaded with water) was used as an adhesive. Bar clamps and clamps were used for press stabilizing (Figs. 21, 22).

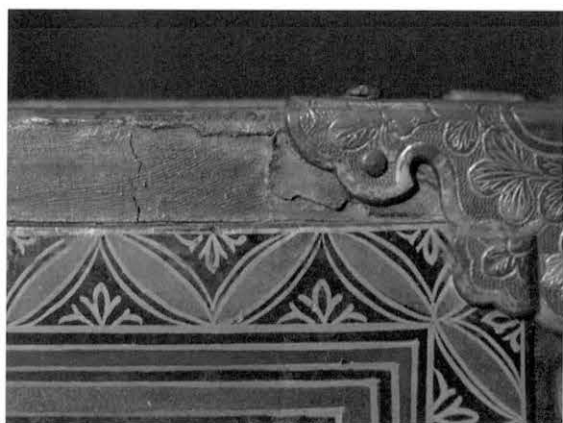
図 13 金具周辺 塗膜損傷部分

Fig. 13 Area around a metal fitting, damaged coating film

- The front lower right corner metal fitting is a later addition; there were no corner metal fittings on the other three lower corners.
- Much of the coating film at the junction of the top and side panels was missing and the substrate had become exposed. The surrounding coating film had become lifted and there was a great risk of further losses (Fig. 13).

亀裂部分の戻しきれない隙間や塗膜の欠損部分には、麦漆に楠材の木粉や麻の繊維を混ぜ合わせ、珪藻土を焼いた地の粉を加えた刻苧を形状が整うまで数回充填し復元を行った。なお、本資料の時代性や周辺塗膜の損傷が烈しいため、刻苧の充填は必要最小限に止めた。形状復元した部分は、砥石や鋤で刻苧肌を整えた。(図 26, 27)

Kokuso was used to fill the gaps on the cracks that could not be rejoined and the missing areas of the coating film. It was applied several times until the desired shape was obtained. *Kokuso* was made by mixing sawdust and hemp fibers to *mugiurushi* and adding *jinoko*, or baked diatomaceous earth. Since the overall atmosphere created by the passage of time and the coating film around the cracks and the missing areas were severely damaged, application of *kokuso* was kept at a minimum (Figs. 26, 27).

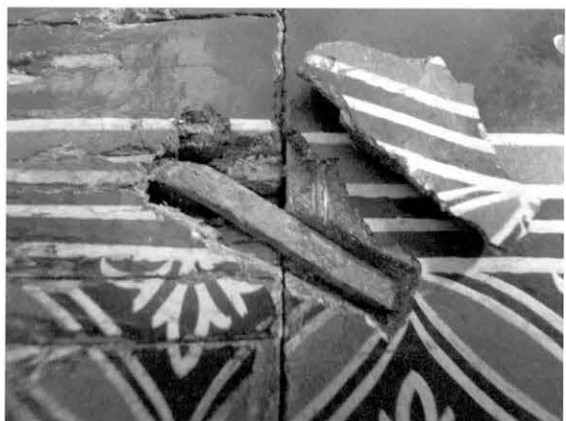
図 14 木地接合部に打たれた制作当初の釘（錠）

Fig. 14 Original nail used to join the joints of the wooden substrate

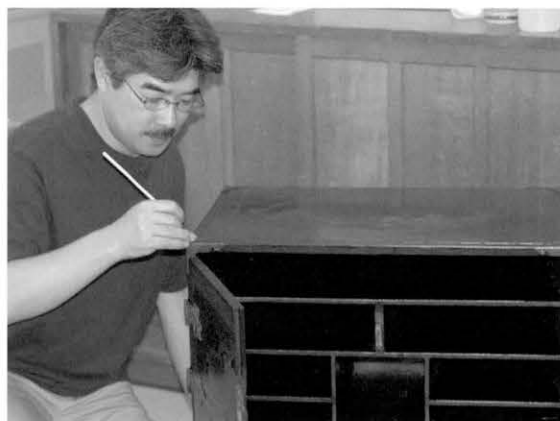
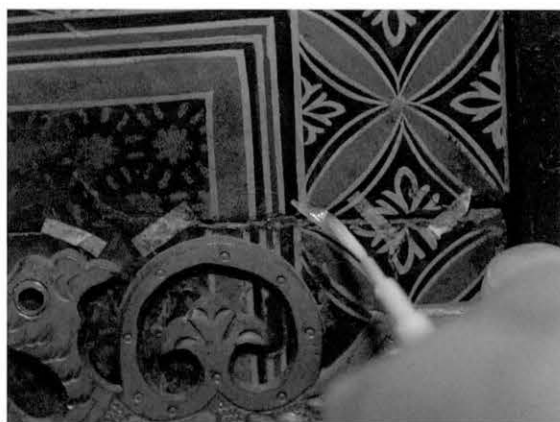
図 15 塗膜剥離部分 仮止め養生

図 16 亀裂部分 仮止め養生

本資料の亀裂部分の塗膜周辺は、作業中剥落しそうな危険な状態にあるため、細かく切った雁皮紙を糊貼りし塗膜の剥落防止を行った。（図 15. 16）

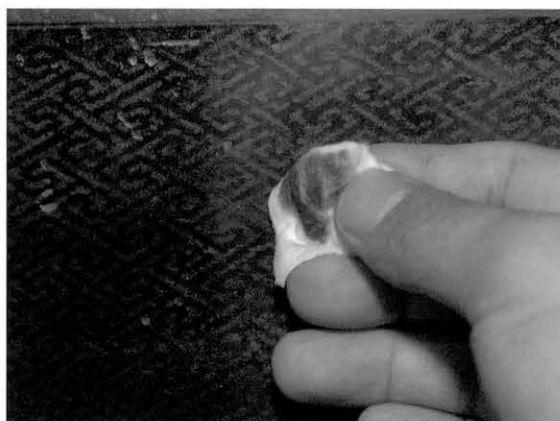
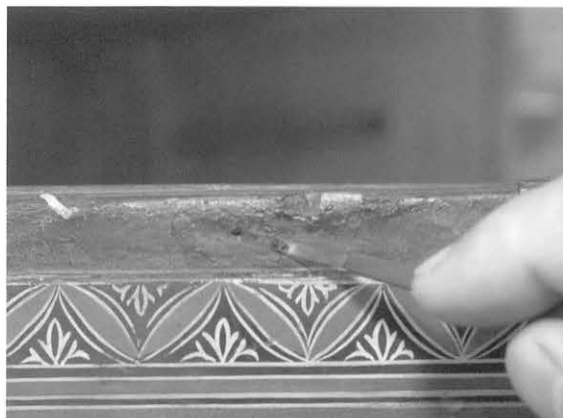
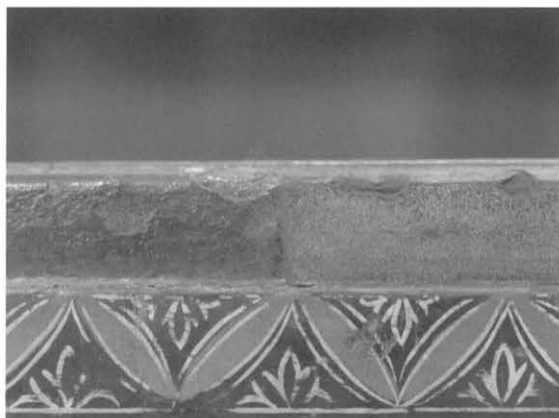
図 17 表面塗膜に塗られた塗料除去

図 18 表面塗膜に付けられた塗料除去

図 19 塗料除去 (左 除去前、右 除去後)

- Some coating material had been applied to the entire surface of the Cabinet during a past restoration so that the whole Cabinet appeared blackish.

Some coating material had been applied several times to the Cabinet in order to reproduce the original urushi coating film that had lost luster due to ultraviolet rays and the passage of time. Cracks were filled and damaged coating film was impregnated with the same material. Since it would have been difficult in such a condition to use urushi for restoration, it became necessary to remove this coating material. After testing several types of solvents, it was found that a weak solvent would not be effective in removing the coating material. Thus, a slightly strong solvent, Tetra-Hydrofuran (THF) was used. It was applied to the surface of the coating material with a small brush. Once the coating material had become soft, it was removed by using a cotton cloth moistened with ethanol. Where the coating material had been applied thickly, a spatula or a knife was used to carefully scrape off the softened coating material, making sure not to damage the urushi coating film. It took approximately 10 months to completely remove the coating material from the Cabinet (Figs. 17 – 19).

塗料除去には、数種類の溶剤を試した結果、弱い溶剤では反応がなく、少し強い溶剤であるテトラヒドロフラン (THF) にて除去を行った。除去は、テトラヒドロフランを筆に含ませ塗料面に塗布し、塗料が軟化した後、エタノールで残った塗料を綿布にて拭き取った。なお、厚みのある塗料は、溶剤で軟化した塗料を篋や刃物で漆塗膜を傷付けないよう細心の注意を払い除去した。本資料全体の塗料を除去するには、約 10 ヶ月の期間を要した。(図 17~19)

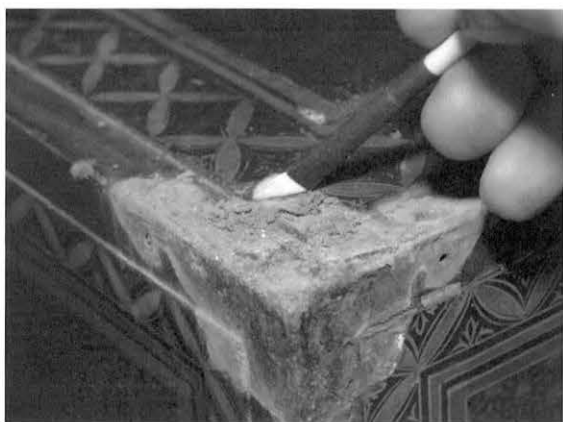
図 20 隅金具下 埃の除去

Since the cracks and other damage to the Cabinet had spread under the metal fittings, it became necessary to remove them. All the metal fittings other than the lock on the right door and the corner metal fitting of the front lower left corner were removed and stored (Fig. 20).

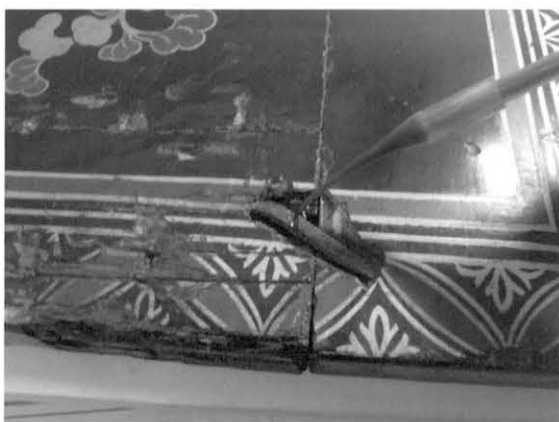
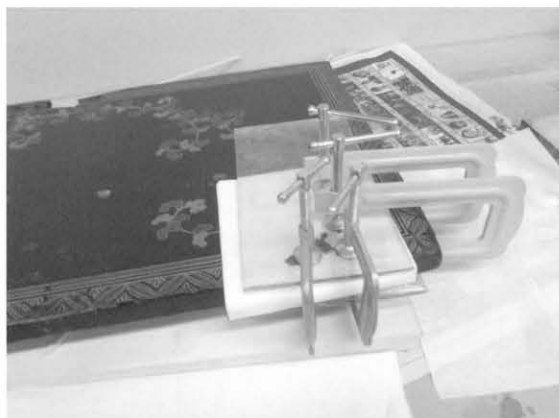
図 21 亀裂損傷部分に麦漆含浸

図 22 クランプによる圧着

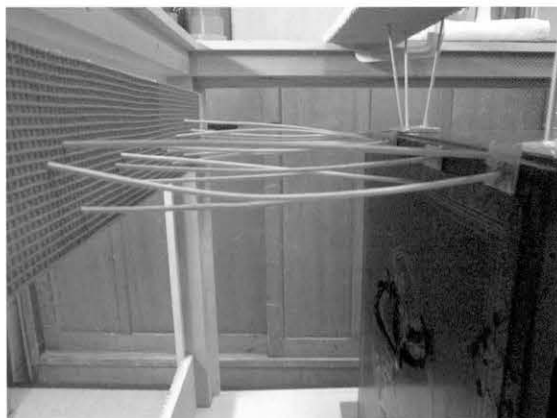
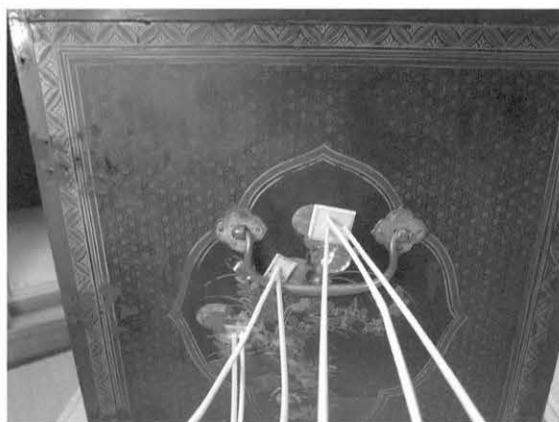
図 23 竹ひごによる塗膜圧着

図 24 貝の剥離部分に膠を含浸し芯張り圧着

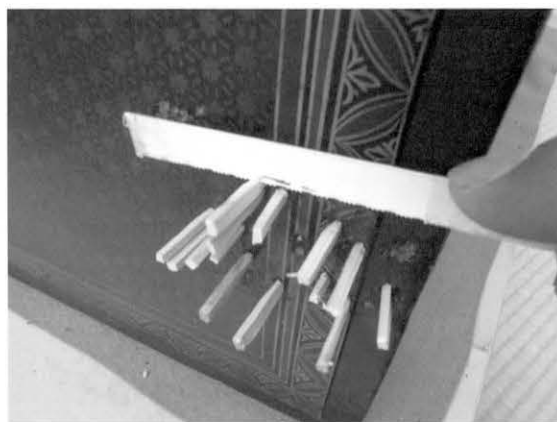
図 25 後補の釘穴に埋木

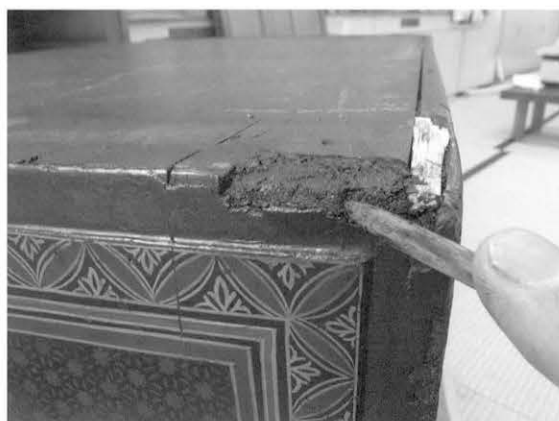
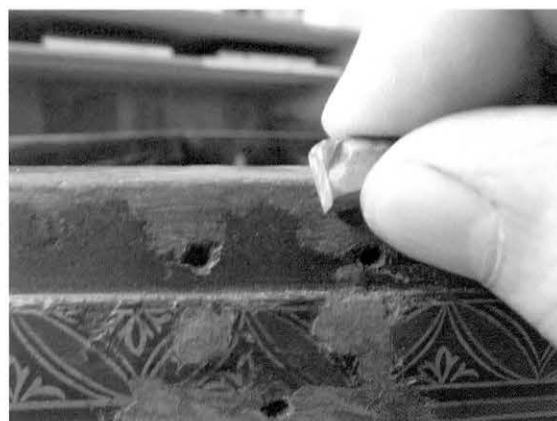
図 26 角欠損部分に刻字充填

図 27 刻字部分の研ぎ

Parts where the shape had been reproduced were finely smoothed out with a whetstone and a file.

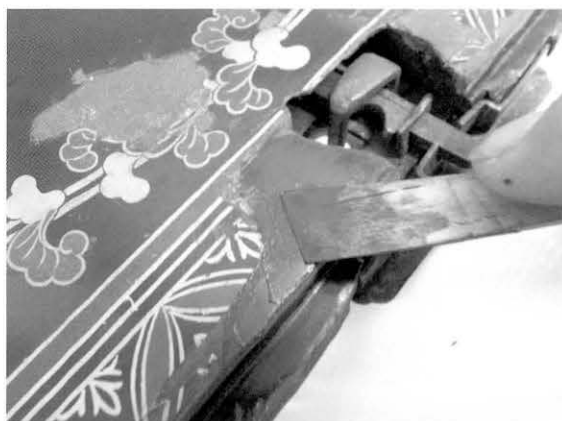
図 28 錆付け(際錆)
Fig. 28 Sabitsuke (kiwasabi)

In order to prevent further lifting of the coating film by abrasion, *kiwasabi* was applied to the parts where the shape had been reproduced and to parts where the coating film had become lifted. For this, *sabi urushi*, which was made by mixing fine *jinoko* kneaded with water to *roiro urushi* and *kijomi urushi*, was used (Fig. 28).

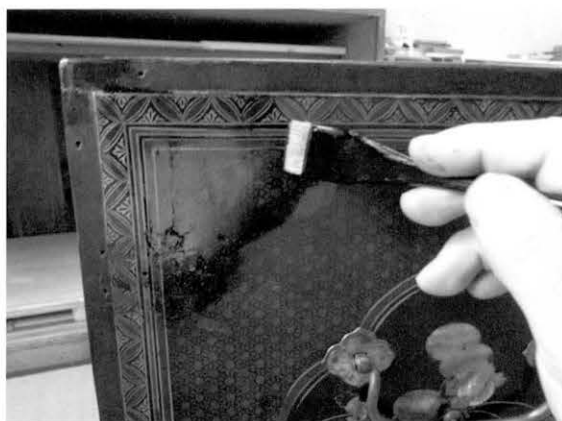
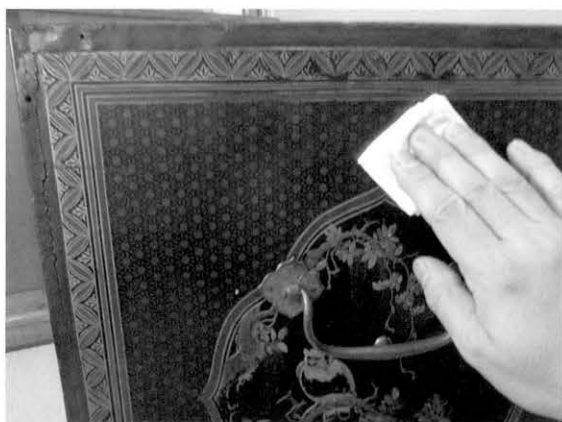
図 29 漆固め(塗膜強化)
Fig. 29 Urushigatame (reinforcing the coating film)

図 30 漆固めの拭き取り
Fig. 30 Wiping off urushigatame

In order to bring back the luster of the coating film and to consolidate the restored parts, *urushigatame* was done again. For this, *kijiro urushi* and *nashiji urushi* were mixed at a ratio of 3 : 7 and diluted with a solvent. Since the condition of damage differed from place to place, the concentration of the solvent was adjusted and consolidation was done from four to six times. Excess urushi was wiped off carefully so that none would remain on the *takamakie* parts or on the *raden* (Figs. 29, 30).

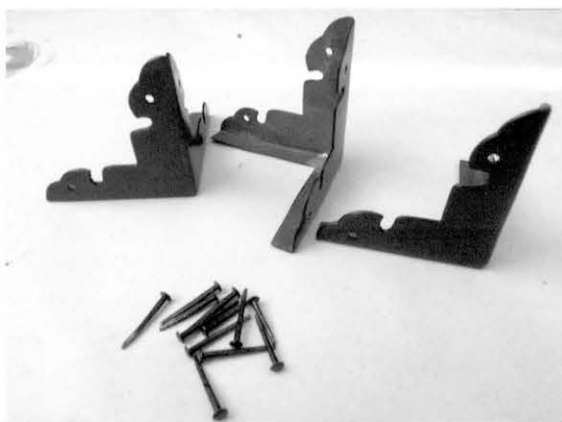
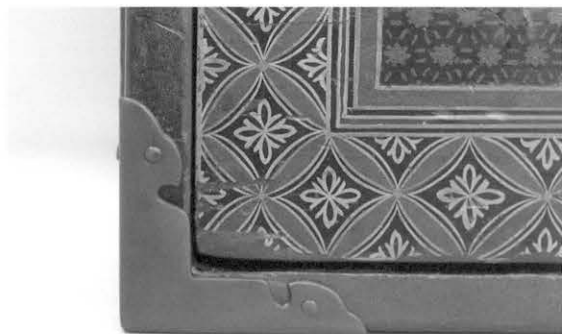
図 31 漆を焼付けて色調を合わせた復元隅金具と銅釘
Fig. 31 Corner metal fittings (reproduction) and nails whose tone of color was adjusted by baking urushi onto metal

図 32 復元隅金具

Three of the bottom corner metal fittings were missing and it was necessary to replace them in order to exhibit the Cabinet. Thus the one remaining bottom corner metal fitting that had been made in Europe and the original metal fittings on the top board were used as references to determine the shape of the corner metal fittings. Simple copper metal fittings with no decoration were made, reproducing only the shape. These were given an aged appearance by applying a very thin coating of urushi and baked. Copper nails were also made to attach the metal fittings. Manufacture of metal fittings was entrusted to Koshiro Izumi, a metal artist (Figs. 31, 32).

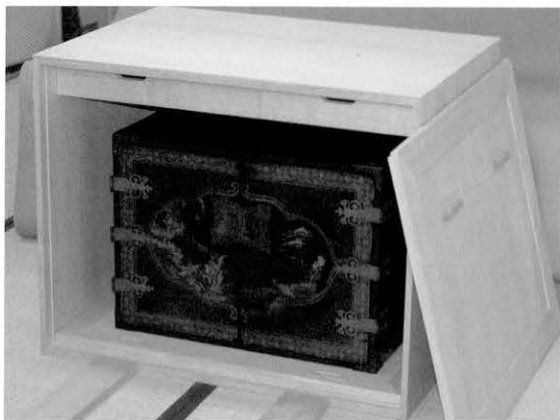
図 38 修復品の保存箱

Fig. 38 Storage box for the restored object

Since there is a risk of new damage occurring to the Cabinet depending on its new conservation environment, and since it is important to be able to preserve the Cabinet for future generations, a new storage box was made of paulownia wood. This paulownia box has a *kendon*-style door that sits in a rebate in the frame and can be removed by lifting it upwards into a recess which is slightly deeper than the one at the bottom and then pulling it outwards with the aid of a built-in handle. Manufacture of the box was entrusted to Takashi Otsuka, a wood craft maker of Aizu district (Fig. 38).
