花樹鳥獸蒔絵螺鈿洋櫃

平成 18 年度修復事業

資料名称：花樹鳥獸蒔絵螺鈿洋櫃
 所 蔵：ケルン東洋美術館（ドイツ）
 時 代：17世紀 江戸時代
 法 量：横 117.0cm 奥行 47.5cm 高さ 57.5cm
 修復者：松本達弥 北村 繁
 修復場所：ドイツ・ケルン東洋美術館 修復アトリエ内
 修復期間：1ヶ月

On the Restoration of
Ornamental Coffers with Flower and Bird Design in Makie and Raden Techniques
 in the Collection of Museum für Ostasiatische Kunst Köln

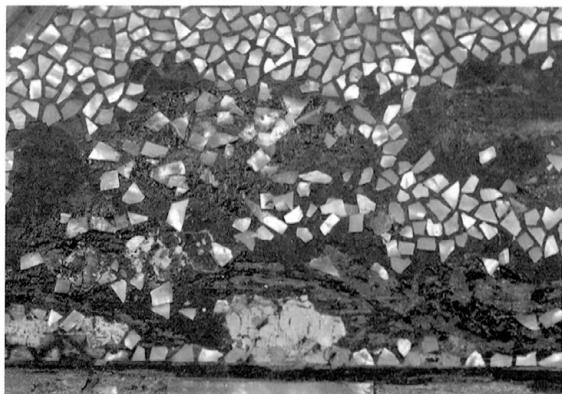
- ・蓋の正面中央のみじん貝は、剥離剥落が多く目立つ。一部後世に張り戻された部分があり、接着剤が溢れ貝も乱雑に置かれている為、非常に見苦しい状態である。(図9)
- ・蓋の正面、貝の剥落部分に、後補による白下地に銀色の塗料が塗られ、その塗料が劣化し断文が生じている。(図10)
- ・蓋の甲板部分、菱形枠内には後補で塗られた塗料の影響で、塗膜が黒ずんで蒔絵が見え難い状態である。(図11)
- ・蓋の正面左側の角金具周辺は、漆塗膜や貝の剥落が多くあり木地が露出している。(図12)

図9 正面 甲板 みじん貝損傷部分
Fig. 9 Front, top of the lid, damaged *mijingai*

- The minute shell pieces (*mijingai*) on the center front of the lid have become significantly lifted or lost. Some have been reattached in the past but the adhesive material has seeped out and the shells placed in a very disorderly way so that the overall impression is that of unsightliness (Fig. 9).

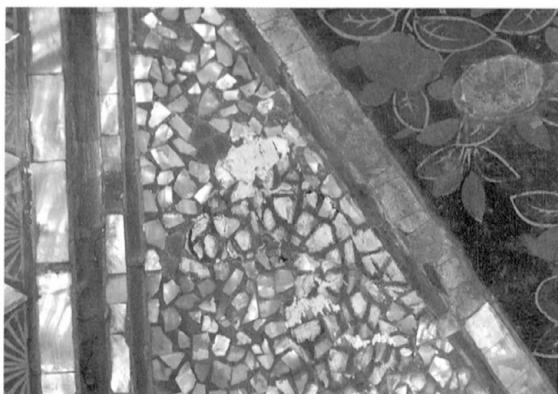
図10 正面 甲板 貝剥落部分の後補
Fig. 10 Front, top of the lid, later additions to area where the shell pieces had become detached

- Silver coating material is found over a white foundation applied in the past on the front face of the lid where the shells have fallen. There are microcracks on this coating material (Fig. 10).

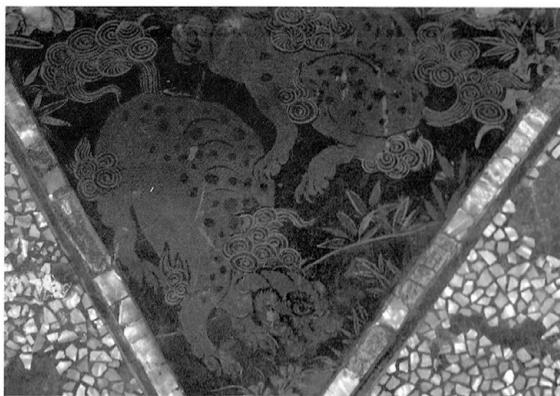
図11 正面 甲板 塗膜表面に塗布された後補塗料
Fig. 11 Front, top of the lid, coating material applied to the surface of the coating film in the past

- The *makie* inside the rhombus-shaped cartouche on the top of the lid is difficult to see because the coating film that had been applied in the past has become dark (Fig. 11).

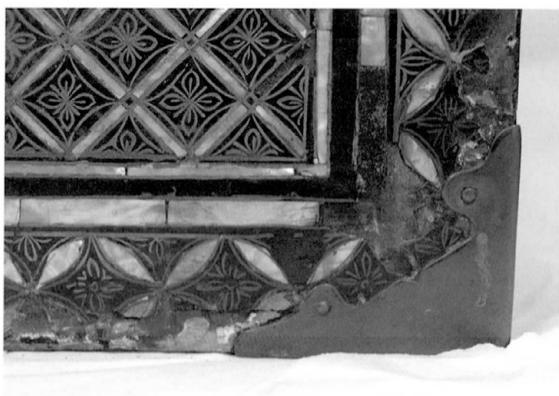
図12 角金具周辺の損傷部分
Fig. 12 Damaged area around the corner metal fitting

- The urushi coating film and the shell pieces around the metal fitting on the front left corner of the lid are missing, exposing the wooden substrate (Fig. 12).

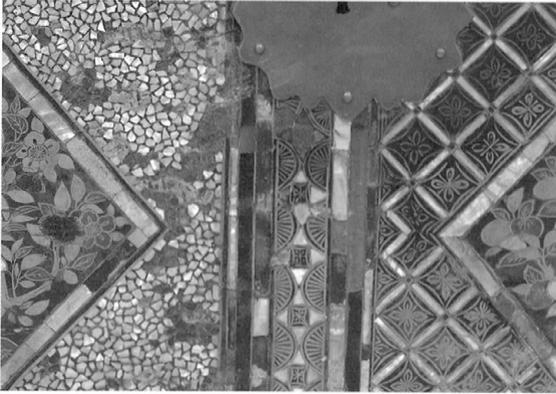
- ・身の正面、中央及び左側の表面塗膜は、後補で塗られた塗料の劣化により白濁化している。(図13)
- ・身の正面下の塗膜や貝は剥離剥落が多く、剥落した塗膜が下に落ちている。
- ・正面右下の角金具の銅釘が3本紛失している。

図13 正面中央 貝の剥離剥落及び後補塗料の白濁化
Fig. 13 Front center, places where the shell pieces had become lifted or detached and places where the coating material applied in the past had become opaque

- The coating film on the surface of the front center of the body and the left side have become opaque due to the deterioration of the coating material that was applied in the past (Fig. 13).

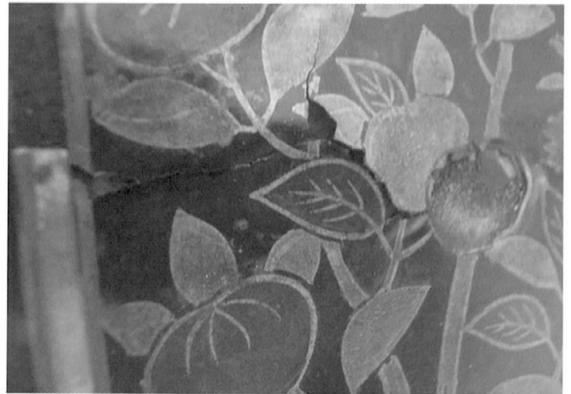
- ・表面塗膜は、何層も塗られた塗料の影響で蒔絵の金色が黒味を帯びている。
- ・塗膜及び貝は剥離剥落が多く目立ち、対面の右側面より状態が悪く、触れるだけで剥落しそうな危険な状態である。(図14)
- ・側面下の塗膜は殆ど剥離し、木地接合部には亀裂を生じている。

図14 右側面 漆塗膜の剥離
Fig. 14 Right side, lifting of the urushi coating film

- The gold color of the *makie* has become dark because several layers of coating film had been applied.
- There is much lifting and loss of the coating film and shell pieces. The condition on the left side is worse than that on the right so that even a slight touch might cause them to become detached (Fig. 14).
- The coating film on the lower portion of the left side has become lifted, and there are cracks on the joints of the wooden substrate.

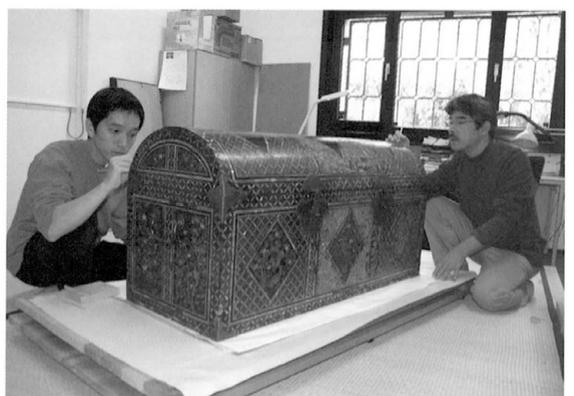
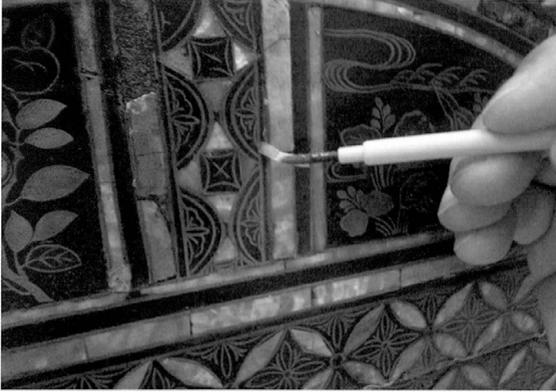
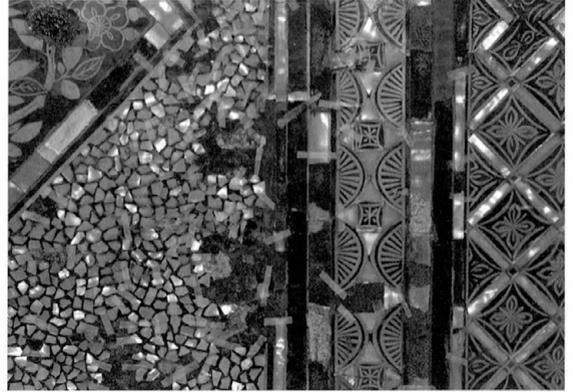
図18 仮止め養生作業
Fig. 18 Temporary facing

図 19 剥離した部分に雁皮を糊張り養生
Fig. 19 Facing the lifted parts by pasting strips of *gampi* paper

図 20 養生された貝や漆塗膜
Fig. 20 Shell pieces and urushi coating film that have been faced

It is believed that the Coffer had been placed for a long time in a dry place. For this reason, there was severe lifting and loss of the surface coating film and shell pieces and a risk of their becoming detached during restoration. In order to prevent this, small pieces of *gampi* paper were attached with

洋櫃は長年乾燥した場所に置かれていたと思われ、表面塗膜や貝は剥離剥落が激しく、作業中に剥落しそうな危険な状態であった。剥落防止として、細かく切った雁皮紙を糊張りし塗膜や貝の安定をはかった。(図 18~20)

paste (Figs. 18 – 20).

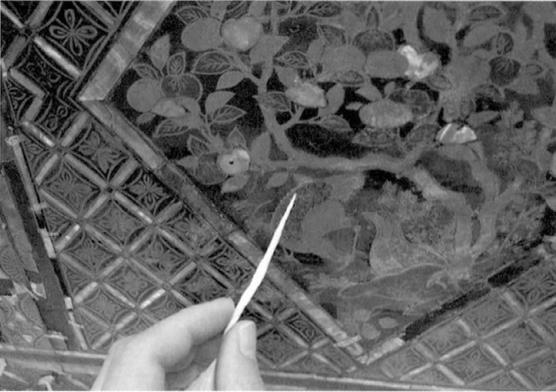
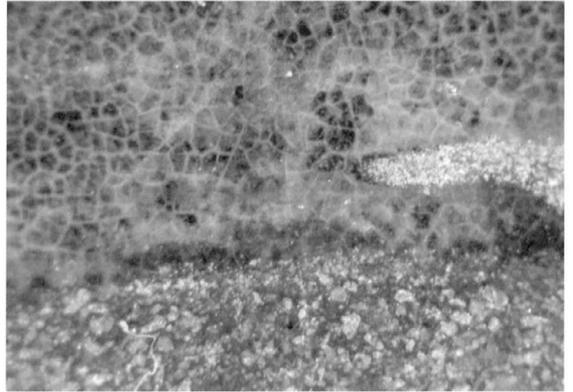
撮影した画像からは、表面塗膜に塗布された後補塗料が白濁化した様子、漆塗膜が劣化しクラックが入った様子など、肉眼では見えない状態が確認できた。(図 21. 22)

図 21 身正面 白濁化した後補塗料
Fig. 21 Body, front, coating material applied in the past that had become opaque

図 22 身正面 白濁化した後補塗料の拡大画像 (50 倍)
Fig. 22 Body, front, enlarged image of the coating material applied in the past that had become opaque (x50)

Photographs showed conditions that could not have been observed with the naked eye: the coating material applied to the surface coating film at a later date had become opaque and the urushi coating film had deteriorated, causing cracks to appear (Figs. 21, 22).

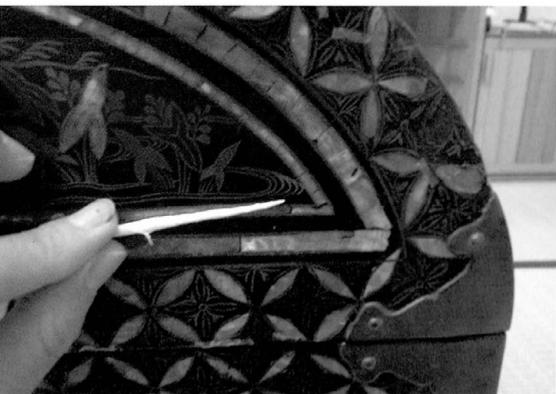
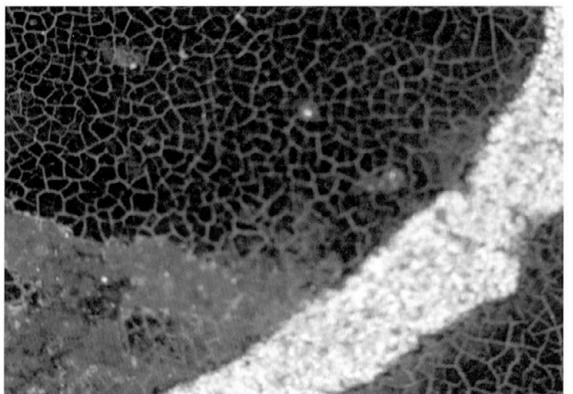
図 23 左側面 後補塗料の除去テスト部分
Fig. 23 Left side, part tested for the removal of the coating material applied in the past

図 24 左側面 後補塗料の除去テスト部分拡大画像 (50 倍) 後補塗料を除去した部分から劣化した漆塗膜が現れた
Fig. 24 Left side, enlarged image of the part tested for the removal of the coating material applied in the past (x50)
Deteriorated urushi coating film appeared from the part where the coating material applied in the past was removed.

The entire surface coating film of the Coffe was covered with a coating material that had been applied during restoration in Europe. Since the surface coating film had darkened and partially deteriorated, causing it to become opaque, it was necessary to remove this coating material. However, for this year the work of removing the coating film that had been applied in the past was limited to experimenting with solvents that could be used to remove the deteriorated coating film. The actual work of removal will be done during the next fiscal year.

塗料除去には蒸留水と弱い溶剤数種類を用いテストを行った。結果、劣化した漆塗膜や加飾の蒔絵部分などの影響を考慮し、先ず無水エタノールに50%の蒸留水を混合した溶剤を塗料に塗布し、塗料を軟化させてから無水エタノールで拭き取り除去する方法で行う事にした。(図 23. 24)

Several kinds of tests were made for possible removal of the coating material – from using distilled water only to using several kinds of weak solvents. As a result it was decided that absolute ethanol mixed with 50% distilled water will be applied to the coating material, taking into consideration the impact on the damaged urushi coating film and the *makie* decorations. Then after the coating material becomes soft, it will be wiped off with absolute ethanol (Figs. 23, 24).
