源氏九曜紋蒔絵箔箱 (フレンツ・ホップ東洋美術館)

Large Box for Writing Implements (Haku-bako)
(Ferenc Hopp Museum of Eastern Asiatic Arts)

フレンツ・ホップ東洋美術館所蔵
源氏九曜紋蒔絵箔箱

On the Restoration of *Large Box for Writing Implements (Haku-bako)*

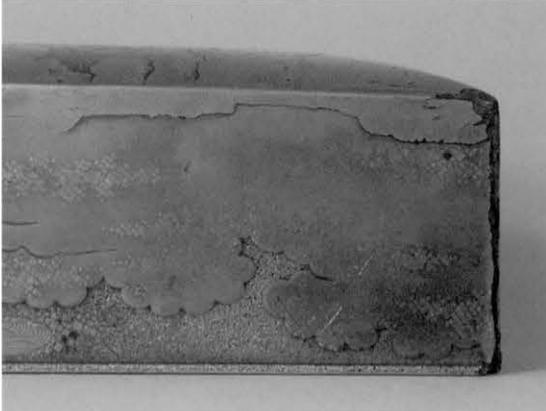
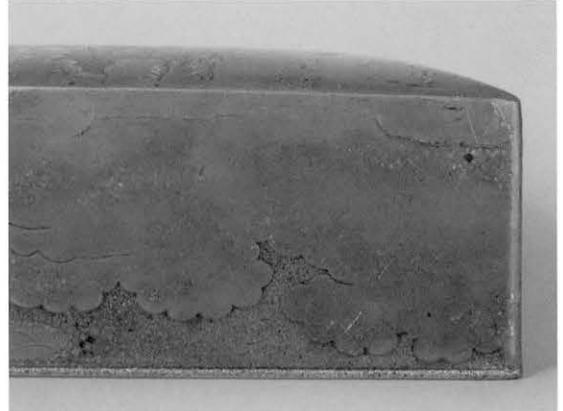
図7 右側面蓋壁の亀裂と塗膜欠損 修復前
Fig. 7 Cracks and missing coating film on the right side board of the lid, before restoration

図8 右側面蓋壁の亀裂と塗膜欠損 修復後
Fig. 8 Cracks and missing coating film on the right side board of the lid, after restoration

- There were cracks on the four corners of the lid and the substrate had completely become disjointed at two.
- There was a crack running horizontally 87 mm to the left and 65 mm to the right on the right side of the side board of the lid, and the substrate had become slightly distorted. This crack extended into the inside of the side board of the lid.

Since there were small cracks on the four corners of the lid in addition to cracks along the edges, the foundation and the coating film were reinforced before adhering the substrate. *Mugiurushi* diluted thinly with a solvent was used to reinforce the cracks.

The joints of the substrate of the side boards of the lid had become disjointed. In order to adhere them, *mugiurushi* diluted with a solvent was first impregnated. A bamboo spatula was used to insert *mugiurushi* into the gaps and excess urushi was wiped off with a solvent. In order to make sure that the lid and the very top part of the body would meet, the lid was placed on the body and stabilized by using a wooden frame, bamboo sticks and polyvinyl chloride sheet. These were removed temporarily before the urushi hardened and excess urushi was completely wiped off.

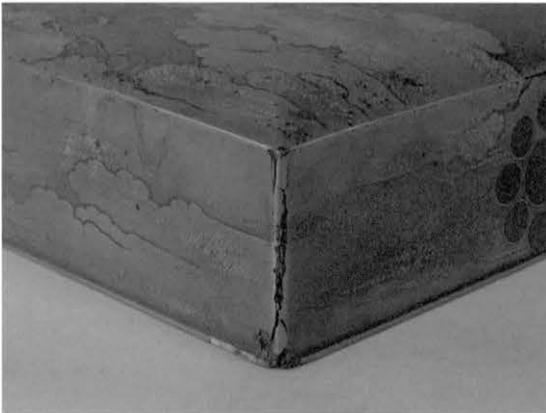
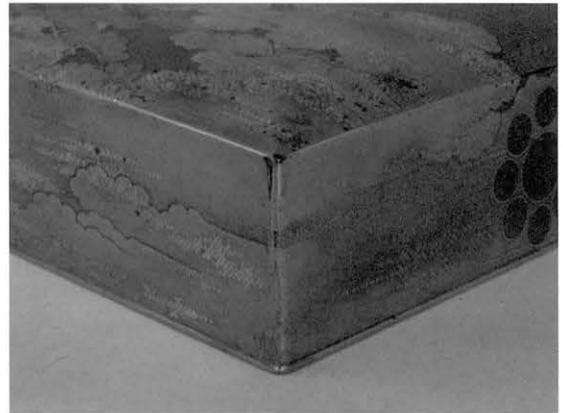
図9 蓋壁正面右隅の亀裂と塗膜欠損 修復前
Fig. 9 Cracks and missing coating film on the right corner of the front side board of the lid, before restoration

図10 蓋壁正面右隅の亀裂と塗膜欠損 修復後
Fig. 10 Cracks and missing coating film on the right corner of the front side board of the lid, after restoration

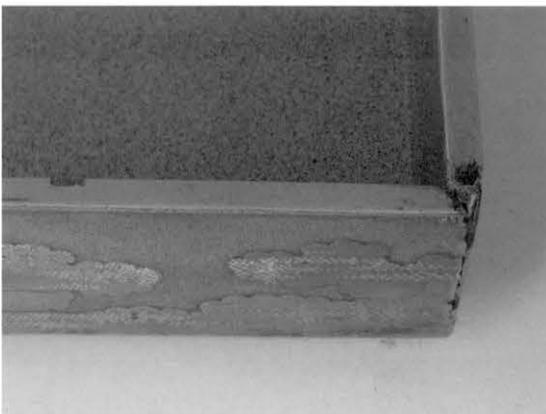
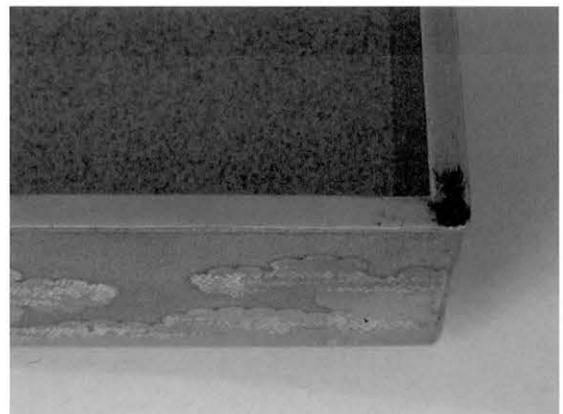
図11 蓋口縁部分の亀裂と塗膜欠損 修復前
Fig. 11 Cracks and missing coating film on the rim of the lid, before restoration

図12 蓋口縁部分の亀裂と塗膜欠損 修復後
Fig. 12 Cracks and missing coating film on the rim of the lid, after restoration

- At the right side of the inner side of the lid, there was a crack 110 mm long on the joint of the substrate of the side board and the top board.
- Lifting and detachment were observed at different places around the cracks. At some of the corners of the lid, especially, the coating film and the foundation had been lost and the substrate was exposed.

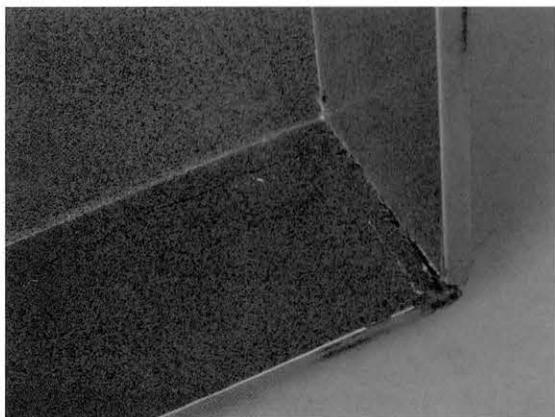
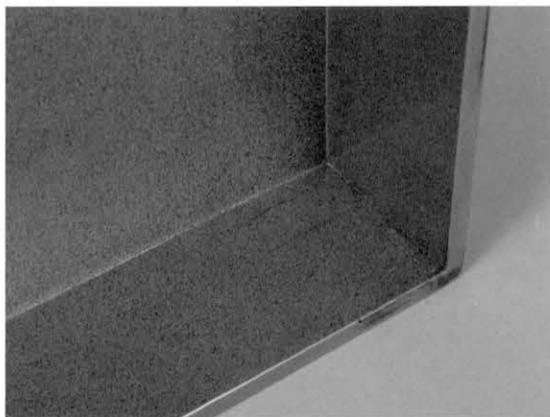
図13 蓋内側の亀裂と梨地の欠損 修復前

Fig. 13 Cracks and missing *nashiji* on the inner side of the lid, before restoration

図14 蓋内側の亀裂と梨地の欠損 修復後

Fig. 14 Cracks and missing *nashiji* on the inner side of the lid, after restoration

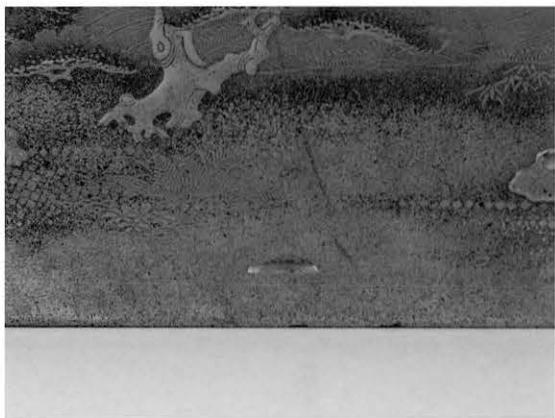
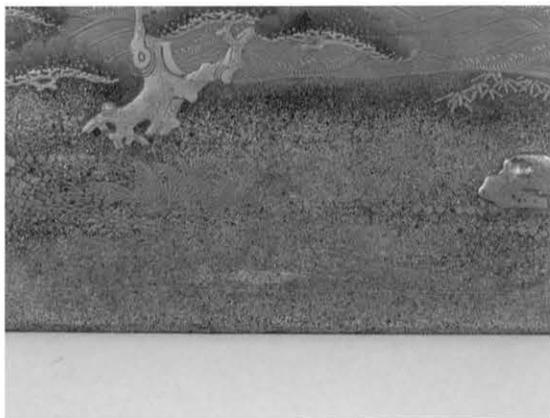
図15 身右側面下部の打損 修復前

Fig. 15 Dent on the lower part of the right side of the body, before restoration

図16 身右側面下部の打損 修復後

Fig. 16 Dent on the lower part of the right side of the body, after restoration

- There were many dents and the foundation and substrate were exposed. The substrate had become distorted especially on the lower right side, and there were two large dents of the same size on the lower middle portion. The coating film with *makie* on these dents was bent inward, and a part of the coating film had been lost.

Coating film around the cracks and dents had become lifted. Since some of the lifted coating film had become distorted, the shape was corrected as much as possible by preventing detachment. As the *makie* coating film on the dented portion at the center of the right side had been bent inward, it was treated to prevent loss. *Mugiurushi* diluted with a solvent was impregnated into the lifted coating film with a brush. A wooden frame, bamboo sticks and polyvinyl chloride sheet were used for press-stabilization. Excess urushi was wiped off completely with a solvent.

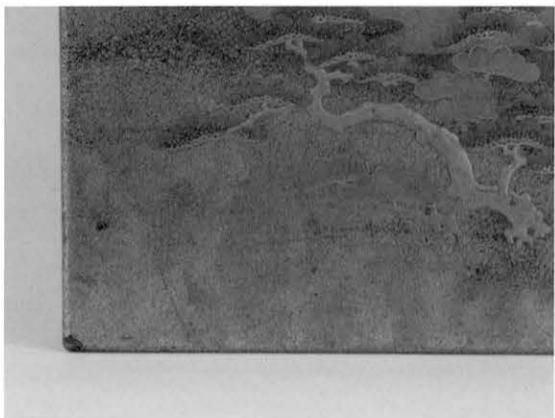
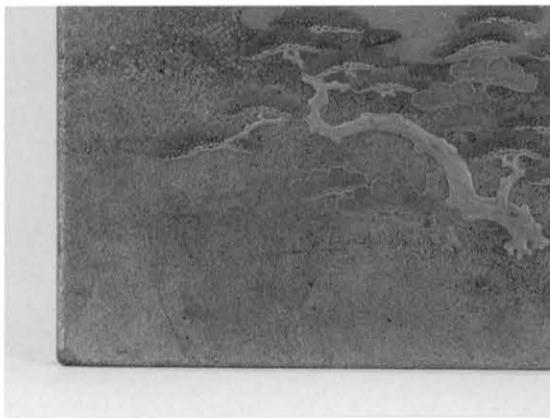
図17 身右側面下部の梨地斑 修復前

Fig. 17 Spots on the *nashiji* on the lower part of the right side of the body, before restoration

図18 身右側面下部の梨地斑 修復後

Fig. 18 Spots on the *nashiji* on the lower part of the right side of the body, after restoration

- A trace of a streak of water was found on the lower portion of the left side. Water had caused considerable spotting on the deteriorated *nashiji*.
- Spots of black coating material were found on the side boards and top board of the lid.

Spotting on the *nashiji* and the *nashiji* powder that had become exposed by abrasion were protected and the color was adjusted. A mixture of *nashiji* urushi and translucent urushi was diluted with a solvent and rubbed in thinly to the damaged parts with a brush. Color adjustment was done in several steps.

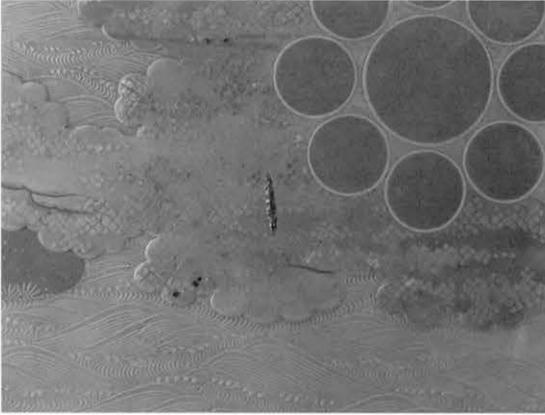
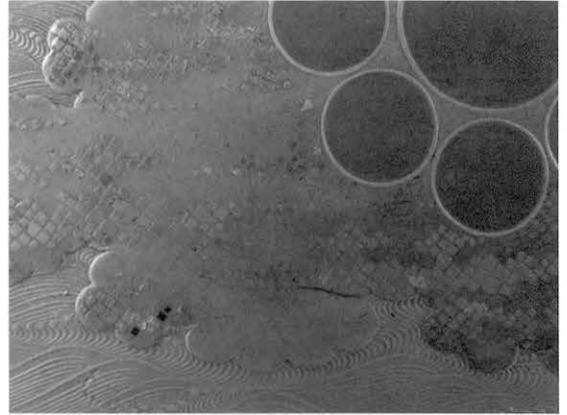
図19 身正面の付着物 修復前

Fig. 19 Coating material on the front of the lid, before restoration

図20 身正面の付着物 修復後

Fig. 20 Coating material on the front of the lid, after restoration

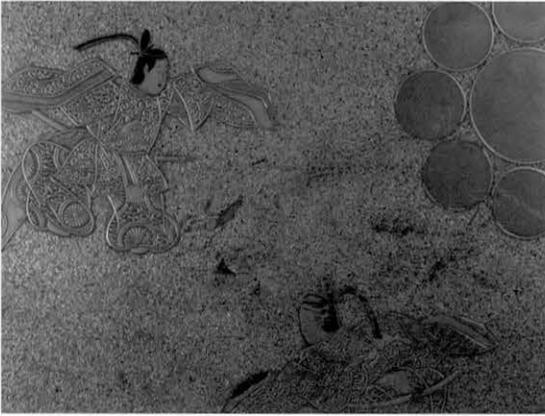
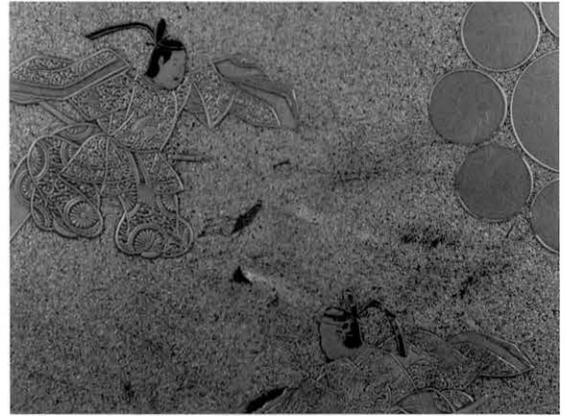
図21 蓋甲板人物周辺の損傷 修復前

Fig. 21 Damage around the figure on the top board of the lid, before restoration

図22 蓋甲板人物周辺の損傷 修復後

Fig. 22 Damage around the figure on the top board of the lid, after restoration

- There was much abrasion on all the sides of the box. There was much particularly around the figure on the right of the lid top. This caused a loss of the expression on the figure's face, and the black coating film and the foundation were exposed.

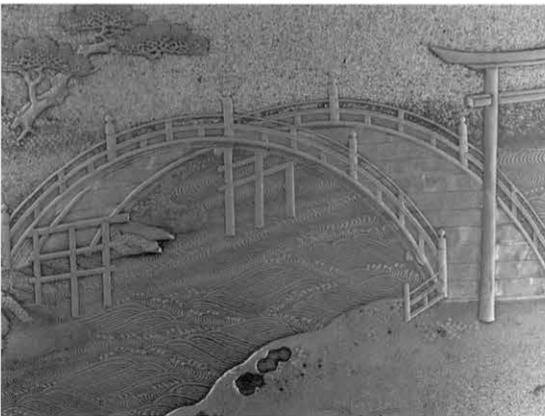
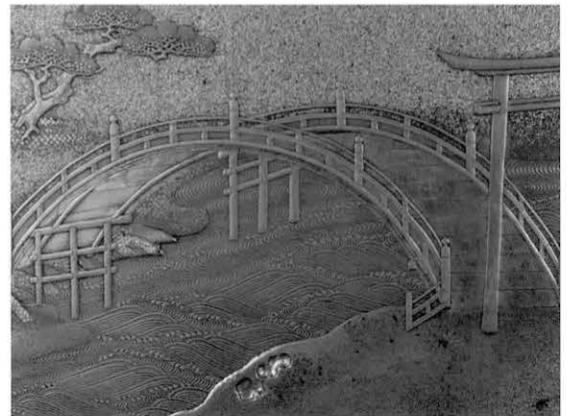
図23 蓋甲板金具の剥離 修復前

Fig. 23 Lifted *kanagai* on the top board of the lid, before restoration

図24 蓋甲板金具の剥離 修復後

Fig. 24 Lifted *kanagai* on the top board of the lid, after restoration

- Much gold and silver *kirikane* applied on the *takamakie* had become lifted and detached.
- *Kanagai* on the bridge had become lifted at several places due to the shrinkage of the substrate of the top board of the lid. Because the lifting of *kanagai* had happened below the *takamakie*, there was a gap below the *kanagai*.

Kirikane and *kanagai* that had become lifted protruded from the *makie* surface and there was a possibility of its becoming detached and lost with a simple contact. So the first step in the restoration was to treat the *kirikane* and *kanagai* so that they would not be lost. The shape of the lifted *kirikane* was corrected with a spatula made of tortoise shell. Then a small amount of animal glue solution, pellet type animal glue diluted to 17–20%, was used to adhere the *kirikane* and *kanagai*. Excess animal glue was completely wiped off. The number of *kirikane* thus treated totaled 31 on the lid and 23 on the body.

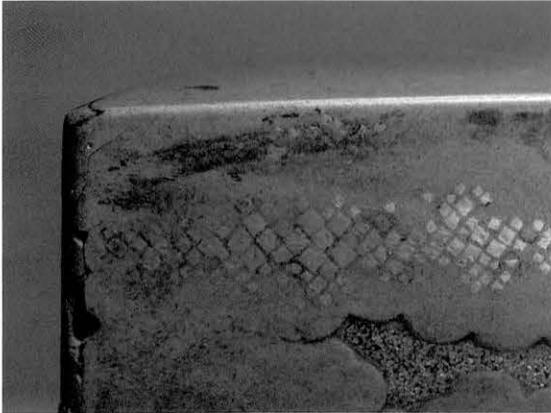
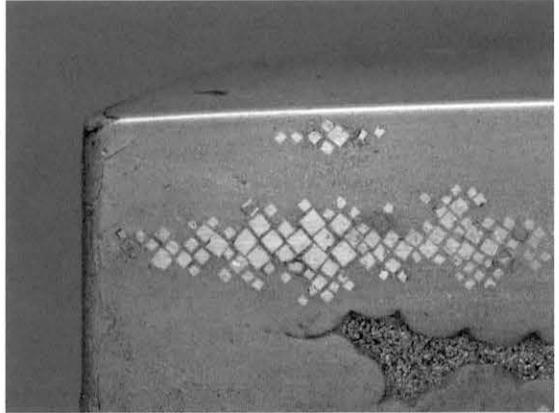
図 25 黒色塗料の付着 修復前
Fig. 25 Black coating material, before restoration

図 26 黒色塗料の付着 修復後
Fig. 26 Black coating material, after restoration

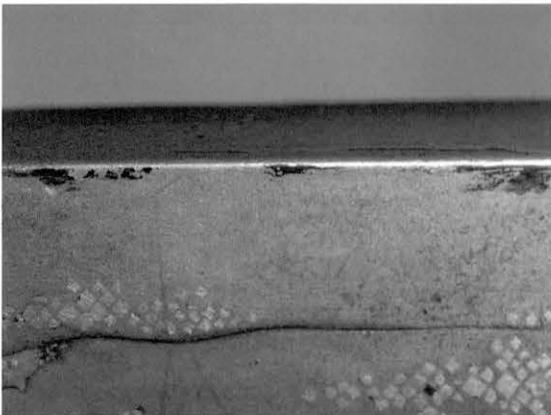
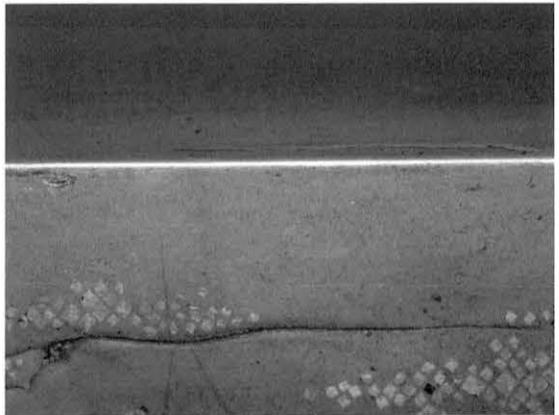
図 27 背面蓋板の汚れと塗膜欠損 修復前
Fig. 27 Stains and missing coating material on the back side board of the lid, before restoration

図 28 背面蓋板の汚れと塗膜欠損 修復後
Fig. 28 Stains and missing coating material on the back side board of the lid, after restoration

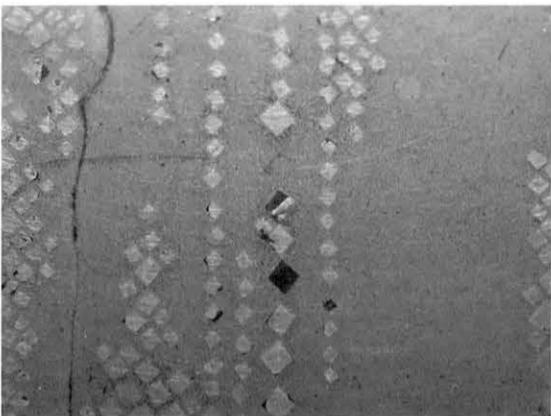
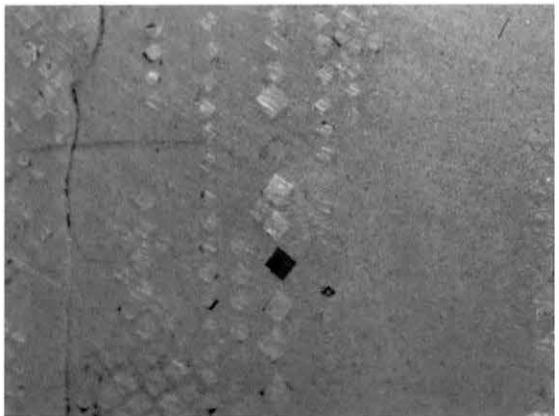
図 29 切金の剥離 修復前
Fig. 29 Lifted kirikane, before restoration

図 30 切金の剥離 修復後
Fig. 30 Lifted kirikane, after restoration

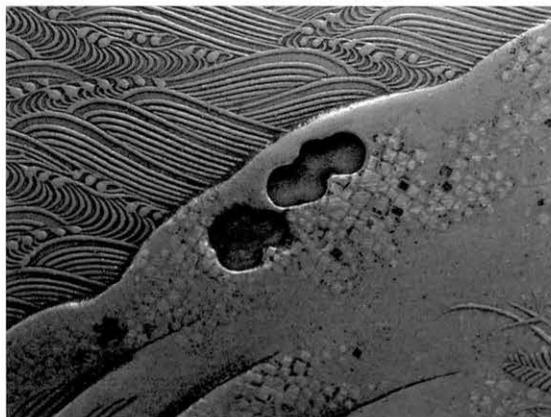
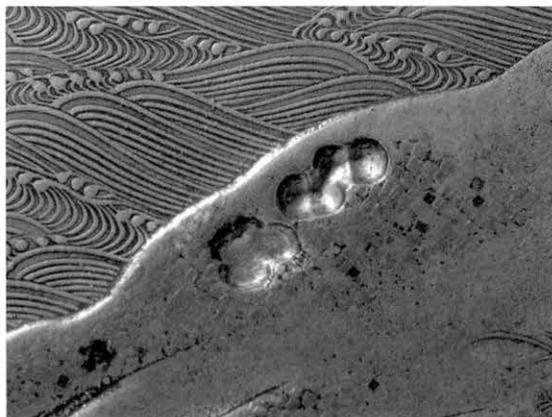
図 31 極込みの埃と汚れ 修復前
Fig. 31 Dust and stains on *kimekomi*, before restoration

図 32 極込みの埃と汚れ 修復後
Fig. 32 Dust and stains on *kimekomi*, after restoration

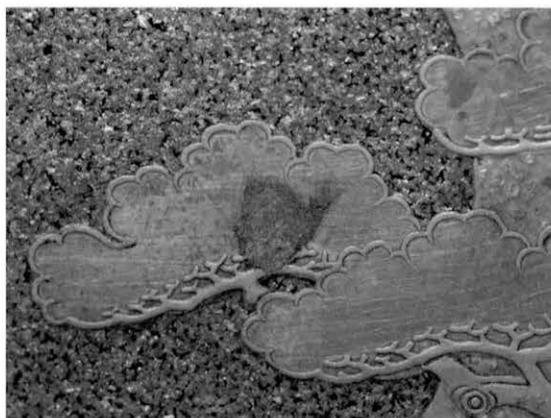
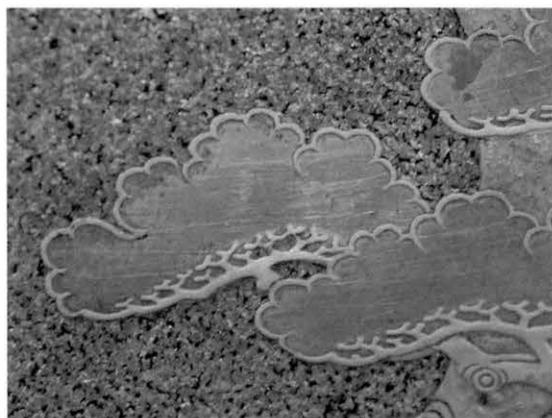
図 33 下地の付着 修復前
Fig. 33 Foundation on the *kanagai*, before restoration

図 34 下地の付着 修復後
Fig. 34 Foundation on the *kanagai*, after restoration

- The coating film and the surface of *makie* decoration had deteriorated and there were many microcracks.
- The color of *nashiji* had changed and the color tone of each side was slightly different. The *nashiji* on the top board of the lid had been damaged and restored in the past so that it was brighter than the rest.
- Dust and dirt had collected on the edges of the *takamakie*, making it dark.
- There were three brownish substances on the back of the body; foundation material was also found on

the metal fitting at the front.
