楼閣山水螺鈿筆筒

平成 18・19 年度修復事業

所蔵：キョッソーネ東洋美術館

勝又智志

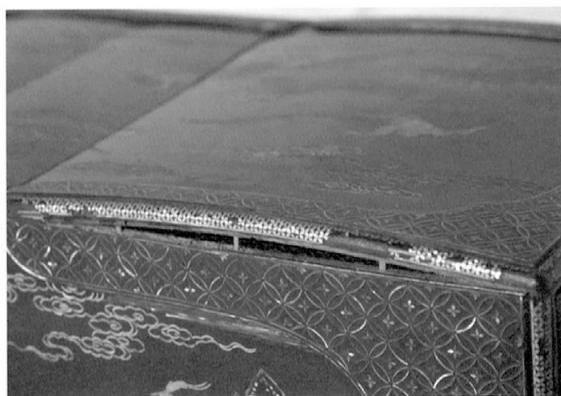
1. 長期に渡る乾燥のため構造材である木地が収縮し、各所に亀裂、変形を生じさせている。天板は中央と右中程の2カ所で大きく縦方向に亀裂が入り左右の2カ所で変形が見られる。特に左半分は最大5mmほどの木地の反りが大きく生じ、側面から木地の木口が完全に確認できる状態である。（図6. 7）天板に接する銀杏面は中央から上下に分離し表面の薄貝螺鈿の装飾が崩れ落ちている。又正面及び背面の楼閣山水図を囲む花菱輪違文で飾られた窓枠部は、本体構造材に貼り付ける形式のため構造材の収縮に追従できず、中央部で上下ともに木地から亀裂を生じ、山形に盛り上がるように折れ曲がった状態である。（図8. 9）特に正面下部の亀裂部分は部材のはみ出しが大きく、これを保存するためと思われる黄褐色の接着材が充填されているが十分な配慮がなされていないため周囲を汚損している。（図10）六段ある引き出しは格段ともに内部側板の上部に打損が見られる。又底部には使用に伴う擦れが生じ下地が露出している。（図11）
2. 本体底部四隅に円形二段型の足が付く、4本のうち背面左は二段ともに欠失しており半円球状の後補材が白木のまま添えられている。又背面右は下段の材が新補されているが形状が異なり不自然な状態にある。（図12）本作には印籠を納めるための区割り用の黒塗りの木枠が2個、引き出しの飛び出しを防止する目的と考えられる底裏に紐通しの溝が刳られた板が一枚、真田紐一本が付随するが引き出し底部分に見られる内容品の形跡が木枠の物と一致せず、形状及び漆塗りの品質から判断しても制作当初からのものではないことから、後世、印籠箆筒として使用するために付随したものと考えられる。
3. ほぼ全面を飾る薄貝螺鈿は、亀裂と木地収縮のため各所で剥離、剥落が進行しており危険な状態

图6 背面 天板
Fig. 6 Back, top board

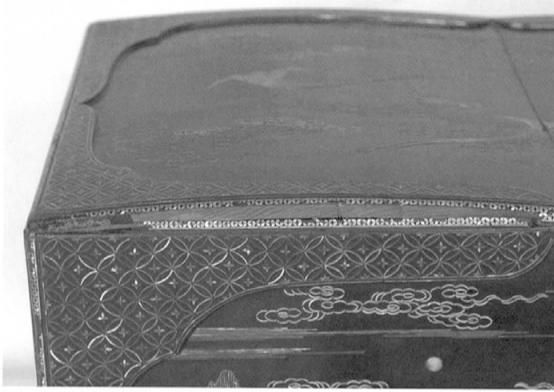
図7 正面 天板
Fig. 7 Front, top board

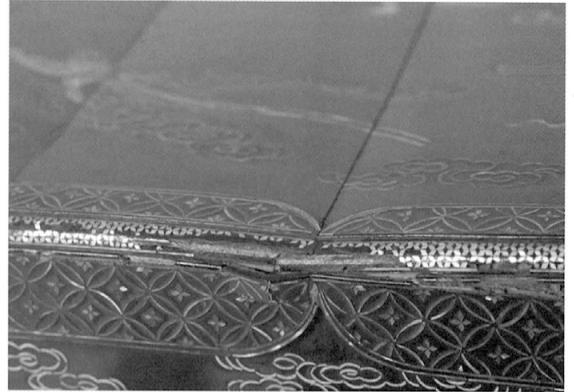
図8 背面 銀杏面
Fig. 8 Back, planed off edge

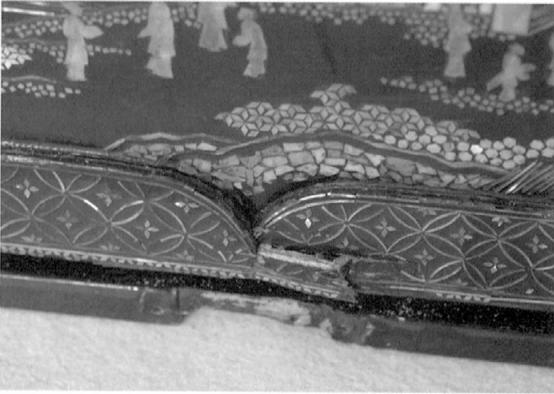
図9 正面 下部
Fig. 9 Front, lower edge

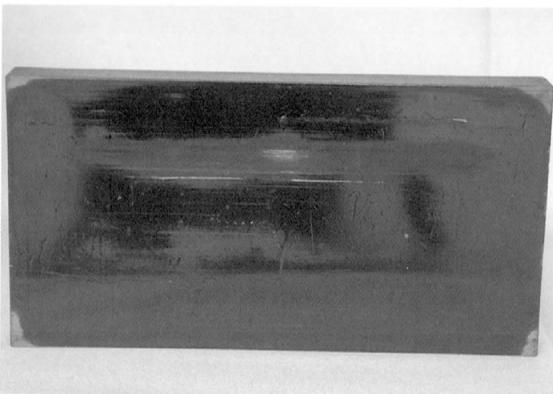
図11 引き出し底裏
Fig. 11 Bottom of a drawer

abraded due to use and the foundation is exposed (Fig. 11).

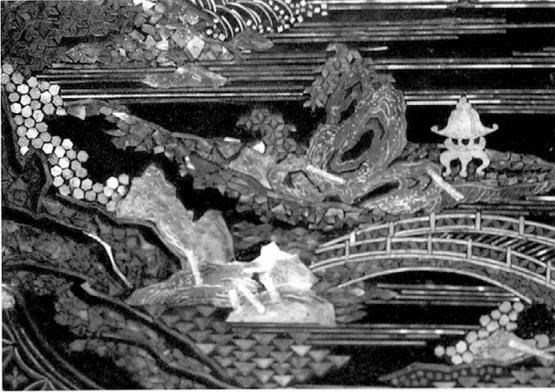
图13 背面 螺鈿剝離部
Fig. 13 Back, lifted raden

1. 修復前に現状を詳細に写真撮影した。記録媒体はデジタル保存とした。
2. 破損の状態を記録するとともに材料や構造について調査を行い、作業手順を整理した。
3. 剥落の危険がある箇所は、雁皮紙を正麩糊を用いて仮止めした。(図 13)
4. 表面に固着した汚れは精製水を含ませた綿布及び綿棒を用いて除去した。破損した周囲には接着材と思われる光沢のある皮膜が残留していたが、エタノールと酢酸エチルを使用しこれを取り除いた。また、内部に発生した黴については消毒用アルコールを用いて拭きとり今後の発生を抑えた。(図 14)

3. Places where there was risk of the *raden* pieces and coating film becoming detached were faced with *gampi* paper and wheat starch paste (Fig. 13).

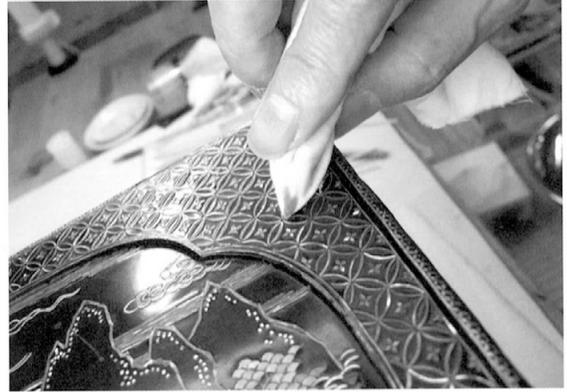
图14 掃除
Fig. 14 Cleaning

4. Cotton cloth and cotton swabs moistened with purified water were used to clean the surface. A glossy film thought to have been that of an adhesive was found around the damaged areas. This was removed by using ethanol and ethyl acetate. Molds that had grown on the inside were wiped off with sterilizing alcohol to prevent future growth (Fig. 14).

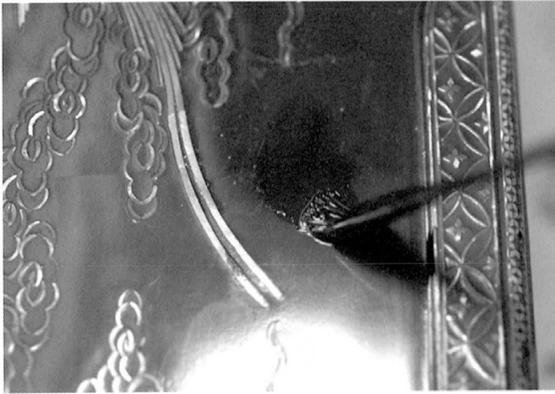
图15 漆固め
Fig. 15 Consolidation

5. In order to reinforce the coating film that had deteriorated because of molds and ultraviolet ray, raw urushi diluted with a solvent was applied with a brush. Excess urushi was wiped off with paper (Fig. 15).

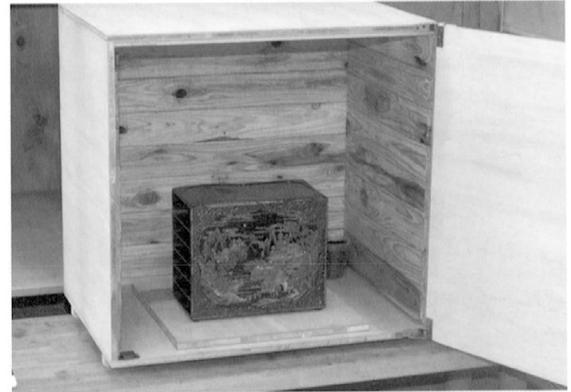
图16 加湿用箱
Fig. 16 Humidifying box

5. 黴や紫外線などの影響により劣化した塗膜は、溶剤で希釈した生漆を筆を用いて浸み込ませ余分な漆を紙で拭き上げ、塗膜の補強を行った。(図 15)
6. 本体天板部に生じた木地乾燥による変形を修正するために、内部に杉材を張り巡らせた合板製の外箱を制作した。(図 16) 器物抽斗の最上段に水分を含ませたスポンジを挿入し、箱内部の湿度を 60% から徐々に 90% 前後の高湿度の環境に移行させ、乾燥し硬化した木地に柔軟性をあたえた。(図 17) 更に上部より芯張りにて圧力を加える事で胴張状に膨らんだ天板を可能な限り平面の状態とする矯正作業を繰り返した。(図 18)

6. In order to correct the distortion that had occurred on the top board due to the drying of the wooden substrate, an outer box whose interior was covered with plywood of Japanese cedar was made (Fig. 16). A moistened sponge was inserted into the uppermost drawer to gradually raise the humidity inside from 60% to about 90%. This gave the substrate, which had become hard because of drying, resiliency (Fig. 17). Moreover, by applying pressure from above by using the *shimbari* technique, the swelling of the top board was corrected. This process was repeated several times to make the surface of the top board as flat as possible (Fig. 18).

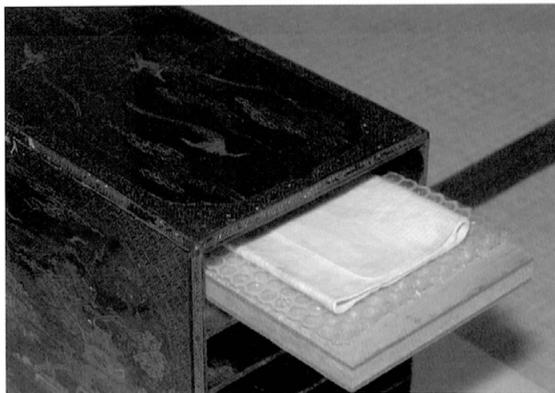
图17 内部 加湿
Fig. 17 Applying humidity from the inside of a drawer

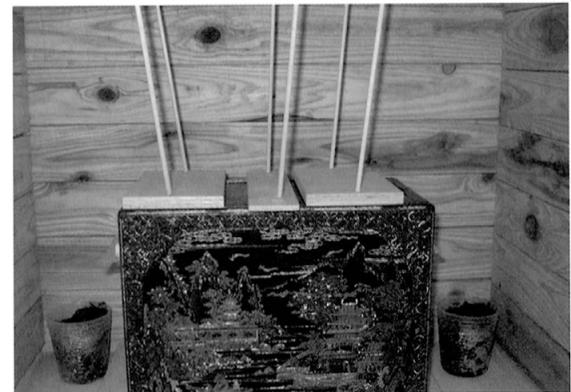
图18 形状修正
Fig. 18 Using shimbari sticks to flatten the surface

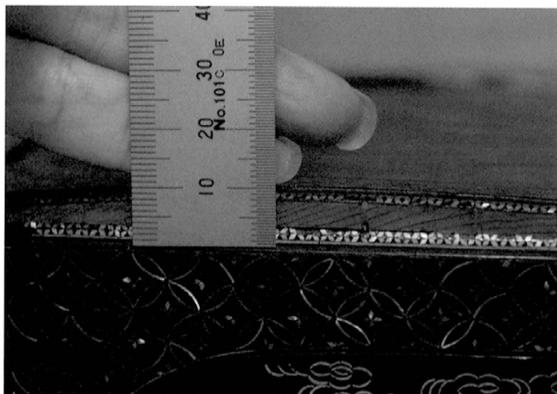
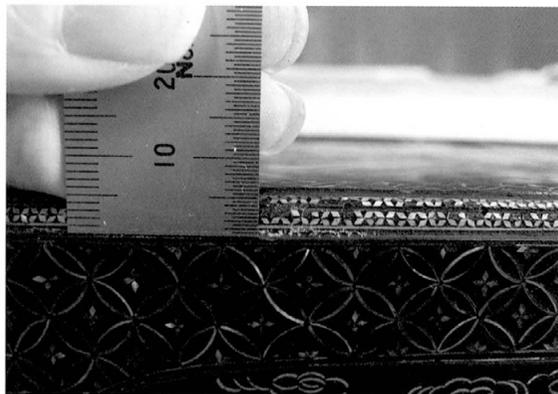
图19 天板 加湿前

图20 天板 加湿後

7. 前年度の木地矯正により天板に生じた変形部が、作業環境である湿度 50 ~ 60% の状況においても 1mm ほどの浮き上がりに収まった事を確認し、接着作業に取りかかった。(図 19. 20) 天板の接着作業は正面及び背面側板中央上部に生じた破損部に直接接する箇所であり、同時に接着することが望ましいことから、この破損部を切開し形状を整える作業を先行した。当該箇所は薄貝の装飾を伴った状態で逆 V 字型に 3mm 程隆起しているため、塗膜及び薄貝の修復中の剥離を予防するため雁皮紙による仮止めを厳重に行った。次に浮き上がっている木地の隙間に極薄の鋸を差し込み、元の形状に収まるまで余分な木部を徐々に削り落とす作業を繰り返し、加湿をしながら圧を加えることで表面の塗膜及び薄貝の損傷を最小限にとどめながら器物の面に安定させることができた。(図 21. 22) 天板と側板に生じた亀裂から小麦グルテンと生漆を調合した麦漆を溶剤で希釈し、スポイトを用いて数回に分けて流し込んだ。余分な麦漆を溶剤で拭き取り、加湿用の箱に 3 時間程度入れることで、麦漆の硬化を促進した。麦漆の粘調が最も高まった頃合をはかり、芯張りとはタガネを用いて上方と両側面の 3 方行より適度な圧を加え接着作業を完了した。(図 23. 24) 翌日、圧力によって浸み出した麦漆を取り除き、更に 2 週間芯張りによる圧力を継続した。また、正面及び背面中央下部に生じた亀裂は、正面側の内部に充填された接着剤を刀で削り落とした後、それぞれ上部破損と同様の形状修正を行い、接着した。天板部については形状が安定した段階で上下を反転し、天板裏に生じた亀裂から再度麦漆を充填させ、芯張りによる圧を加え続けた。

7. Confirming that, in the working environment of 50–60% humidity, the lifting at the distorted portions of the top board which had been corrected the previous year had settled at about 1mm, the work of adhering was started (Figs. 19, 20). Since this would involve working directly on the damaged portions found at the front and on the upper central portion of the back board, it was desirable to work on these two places at the same time. So the damaged portions were cut open to adjust the shape. Since the portions in question had risen approximately 3 mm in an up-side-down V-shape together with the thin

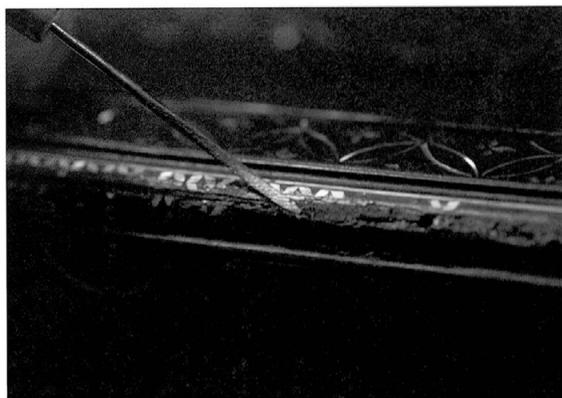
图25 刻亭充填
Fig. 25 Filling with kokuso

8. 破損部の接着が安定した後、亀裂部及び木地と下地の欠損部に麦漆に 60 メッシュで篩を掛けた木粉と麻の繊維を混ぜ合わせた刻苧を充填した。乾燥後ヤスリと刀で形状を修正した後再度 80 メッシュで篩い掛けした木粉と麦漆で充填を行った。(図 25)
9. 薄貝の剥離は比較的大きな貝が使用された正面及び背面に多く発生していた。本作は黒漆塗りの上に膠と思われる透明度のある薄い接着材料が使用されている事から、膠による修復を行った。また、欠失した箇所については現状のままとした。膠は粒膠の接着強度の強い種類を使用し、10% 前後の濃度で使用した。筆を用いて含浸した後、余分な膠をぬるま湯で拭き取る作業を数回

8. When the damaged parts had been adhered and stabilized, the cracks and the missing areas of the substrate and foundation were filled with *kokuso*, which was made by adding to *mugiurushi* saw dust that had been sifted through a 60-mesh sieve and hemp fibers. Once this had hardened, the shape was adjusted by using a file and a knife. This was followed by filling a mixture of sawdust, this time sifted through an 80-mesh sieve, and *mugiurushi* (Fig. 25).

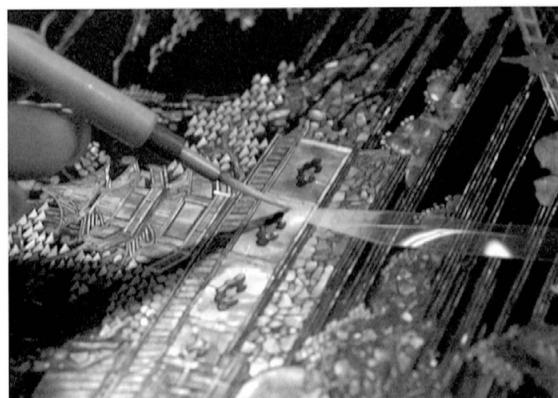
图26 膠含浸
Fig. 26 Impregnating animal glue

繰り返し、貝裏に十分な膠が充填されたのを確認した後、芯張りにて圧力を与えた。(図 26) 貝が安定した事を確認した後、更に麦漆を剥離した貝の周囲にある塗膜の亀裂に含浸させ、同様に芯張りにて接着を施した。(図 27. 28)

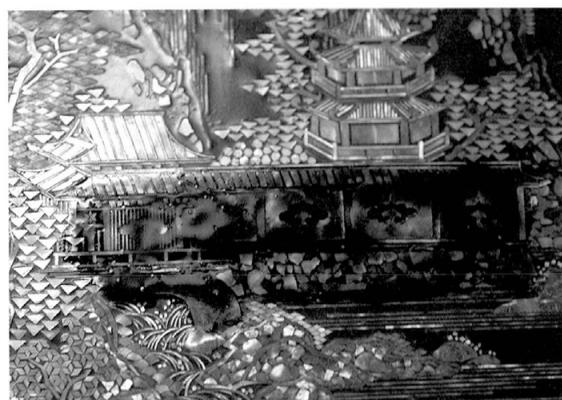
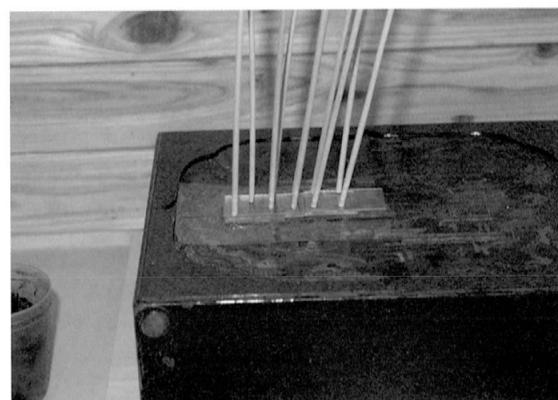
图27 麦漆含浸
Fig. 27 Impregnating mugiurushi

图28 芯張
Fig. 28 Shimbari

9. Detachment of thin shell pieces was found especially on the front and back where comparatively large pieces had been used. Since a highly translucent, thin adhesive like animal glue had been used on top of the black urushi coating, animal glue was also used for restoration. It was decided not to restore the parts where the shell pieces were missing. Pellet-type animal glue with strong adhesive power was used at about 10% concentration. After impregnating it with a brush, excess animal glue was wiped off with lukewarm water. This was repeated several times. Once enough animal glue had been applied to the reverse side of the shell pieces, pressure was applied by using the *shimbari* technique (Fig. 26). When the shell pieces had been stabilized, *mugiurushi* was impregnated into the cracks of the coating film around the parts where the shell pieces had fallen. These parts were similarly adhered by using the *shimbari* technique (Figs. 27, 28).

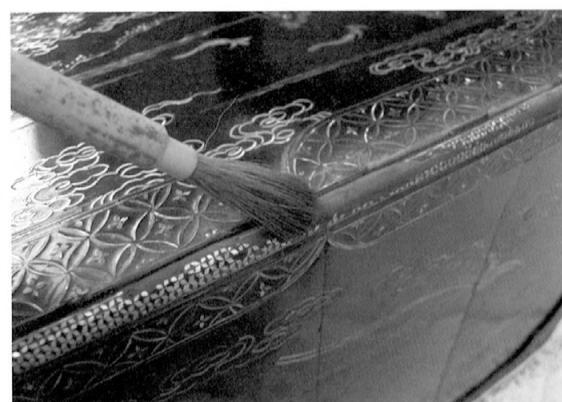
图29 蒔地
Fig. 29 Makiji

10. In order to adjust the surface of *kokuso* that had been applied to the cracks and the missing areas of the substrate and foundation, urushi foundation to which soot had been mixed was applied and then the surface was polished. This was followed by a thin application of raw urushi using a *makie* brush and a sprinkling of the finest *Wajima jinoko*. When this had hardened, *rose urushi*, a mixture of black urushi and raw urushi, was used to consolidate the *jinoko* that had been applied and to make the surface as close in luster and color as possible with the surrounding coating film (Fig. 29).

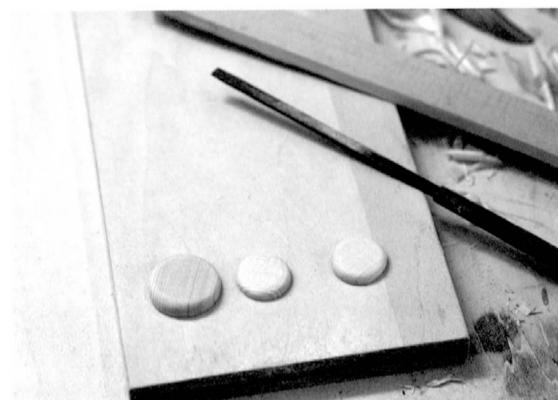
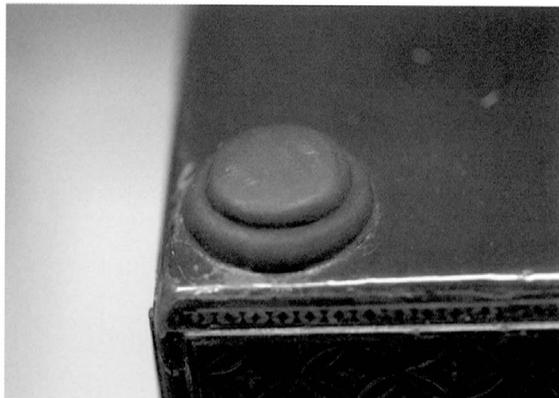
图30 脚部成形
Fig. 30 Shaping parts of a leg

图31 脚部接着
Fig. 31 Attaching a leg

10. 亀裂及び木地と下地の欠損部に施した刻苧表面を整えるため、カーボンを混入した漆下地を施した後、更に研ぎを行い、生漆を蒔絵筆で薄塗りし、珪藻土の微粉を蒔いた。乾燥後黒漆に生漆を合わせた呂瀬漆で珪藻土粉を固め、現状塗膜に近い艶と色を与えた。(図 27)
11. 本体底部の円形二段型の脚部の内、欠失した 2 カ所については檜材で削りだし、形状を整え生漆で摺漆した後、麦漆で接着し破損箇所と同様に蒔地仕上げとした。(図 30. 31)
12. 引き出しの内外に生じた傷や塗膜の破損は、深く大きな箇所には刻苧を行い、浅い傷と判断される箇所については漆下地で形状を整えた。
13. 塗膜及び貝の際にカーボンを混入した漆下地を篋付けし溶剤でふき取る作業を行い、剥落防止処理とした。(図 32)
14. 全体を再度クリーニングし修復後の確認を行った。
15. 修復後の写真を撮影し全ての修復作業を完了した。

11. For the missing leg, cypress wood was carved and the shape adjusted. After rubbing in raw urushi (*suri urushi*) it was adhered with *mugiurushi* and sprinkled with gold powder (Figs. 30, 31).

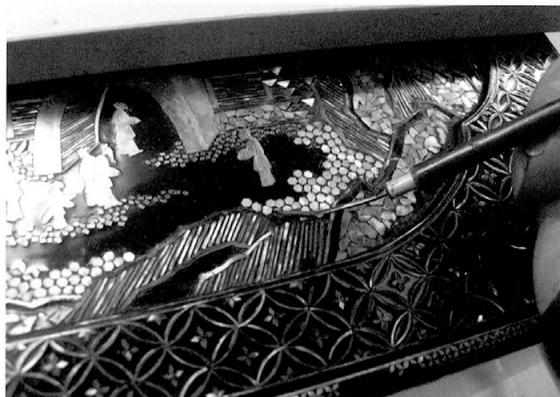
图32 際錆
Fig. 32 Kiyasabi

13. In order to prevent detachment, urushi foundation into which soot had been mixed was applied with a spatula to the edges of the coating film and shell pieces. After that, excess urushi was wiped off with a solvent (Fig. 32).
14. The entire cabinet was cleaned again and the restoration work was inspected.
15. Photographs were taken after restoration.
