花卉螺鈿ライティングビューロー

平成 18・19 年度修復事業

株式会社 小西美術工藝社
岩本 元・表 美幸・共田鈴香

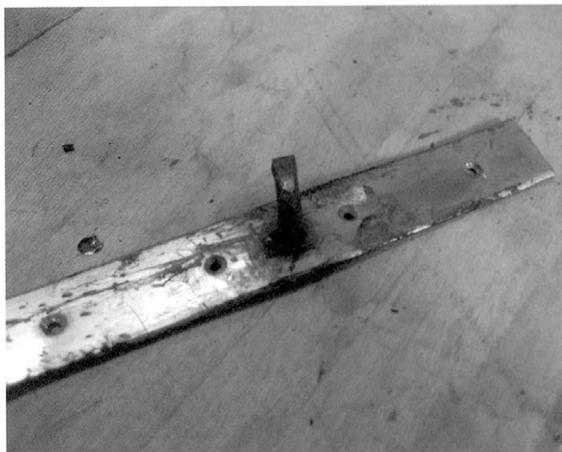
図1
Fig. 1

扉取り付け金具一対の内 1 本が欠失し、開け閉めが不十分な状態であった。また、その取り付け基部の金具は、軸を曲げ釘で代用した極めて簡便なものが取り付けられていた。（図 1. 2）

One of the pair of metal hinges for the door had been lost, making it difficult to close and open the door. Moreover, a very simple device using a bended nail was used to replace that metal fitting. (Figs.1, 2)

扉板の本体との取り付け金具は一对の内1本が欠失していたので、当初材同様に復元したものを取り付けた。その際使用した木ねじは時代性を考慮し、マイナス皿木ねじを製作のうえ使用した。

なお、復元金具は回転機能に十分耐えうる強度を持たせた。(図16、17)

Since one of the pair of metal fittings that was used to attach the door panel was missing, a similar one was reproduced. Period fastenings were used instead of flat head wood screws.

The reproduced metal fittings were made so that they would bear opening and closing movements. (Figs.16, 17)

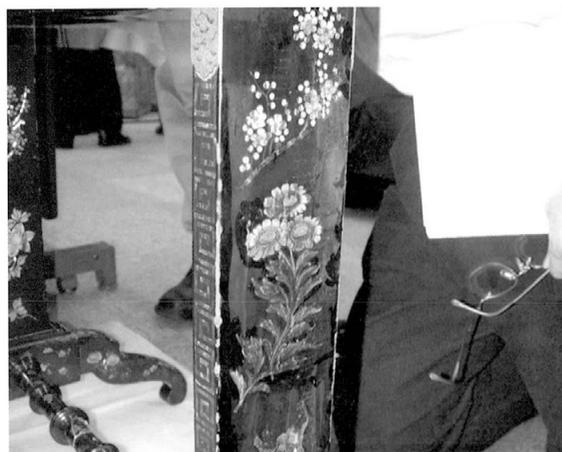
図3
Fig. 3

- ・総体に汚れ・後世の修復・ニス状塗布物の変色により色調が低下し、著しく美観を損なっていた。（図 3. 4）
- ・塗膜随所に浮きが見られ、一部に剥落が認められた。（図 5. 6. 7. 8）
- ・螺鈿随所に浮きが見られ、一部に剥落が認められた。（図 9. 10）
- ・木地接合部は目立った緩みは見られず、輸送・展示活用には支障無しと判断した。

- The overall appearance of the writing bureau had been significantly lost because of staining, past restorations and the loss in the quality of color that had deteriorated due to the change in color of the varnish. (Figs.3, 4)
- The coating film had become lifted at many places and some had been lost. (Figs.5, 6, 7, 8)
- Lifting of *raden* pieces was observed and some had become detached. (Figs.9, 10)
- The joints of the substrate had not become loose, so it was decided that there would be no problem in transporting or exhibiting the writing bureau.

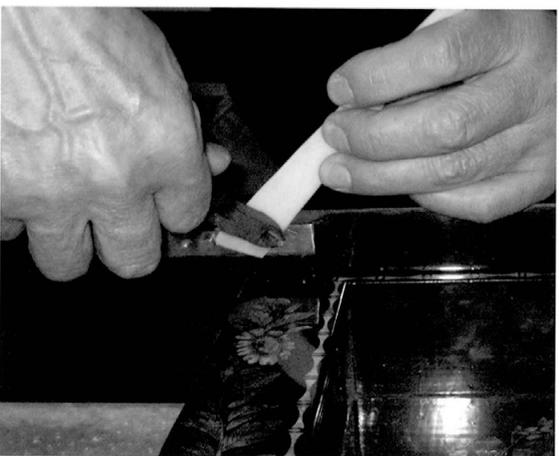
图 11
Fig. 11

錠前金具の受け座は、当初性が高いと思われるので温存した。（図 11）

The metal fitting of the lock was preserved since the possibility of its being the original was considered to be great. (Fig.11)

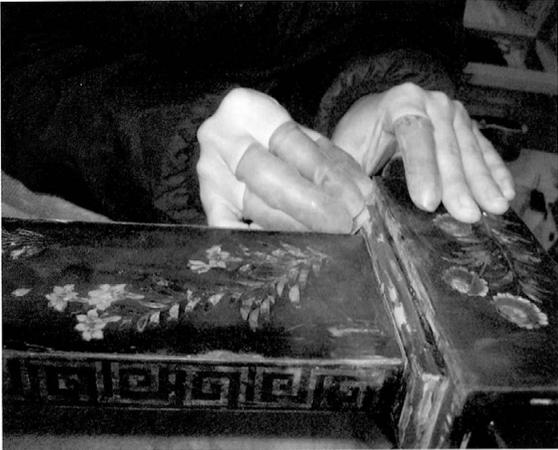
図 13
Fig. 13

本件にはヨーロッパに於いて施されたと思われる下地欠損部へのプラスター状物質による充填が見られたが、素材の整合性を優先し、漆下地による修復に置き換えた。(図13)

Plaster-like substance that had been used in Europe to fill missing areas was removed and urushi foundation was used for restoration. (Fig.13)

下地が露出した欠損部は、漆による吸い込み止めを十分に行った後、コクソ・錆漆による充填・整形を施した。

整形に際しては既存の塗膜を損なわぬ様、実体顕微鏡下の精密切削整形を行った。
