# 花樹鳥獸蒔絵螺鈿洋櫃

平成 18・19 年度修復事業  
(3 年計画の 2 年目)

所蔵：ケルン東洋美術館

松本達弥

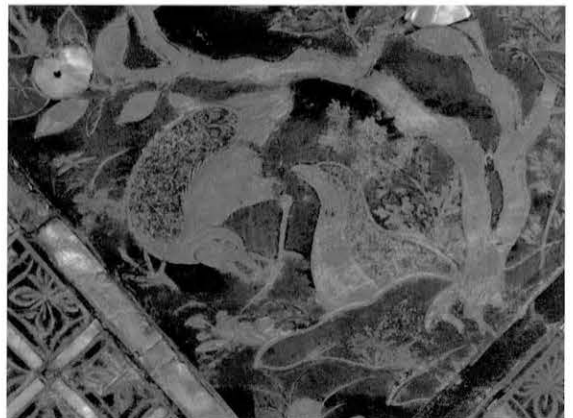
- ・蓋の正面左側の角金具周辺は、漆塗膜や貝の剥落が多くあり木地が露出している(図7)。
- ・身の正面、中央及び左側の表面塗膜は、後補で塗られた塗料の劣化により白濁化している(図6)。
- ・身の正面下の塗膜や貝は剥離剥落が多く、剥落した塗膜が下に落ちている。
- ・正面右下の角金具の銅釘が3本紛失している。

図6 修復前(正面) 後補塗料の劣化  
Fig. 6 Before restoration (front), deteriorated coating material from a past restoration

- The surface coating film that had been applied in the past on the front of the body has become opaque at the center and to the left due to deterioration (Fig.6).

なお、今年度は3人の方にそれぞれ5日間、後補塗料の除去（クリーニング）を手伝っていただいた。塗料除去に使用した溶剤は、先ず、無水エタノールに蒸留水を50%ほど混ぜた溶剤を面棒に含ませて塗料面に塗布し後補塗料を膨潤させた後、無水エタノールにて拭き取る方法でクリーニングを行った（図9. 10. 11. 12）。

- This year, 3 people were asked to help for 5 days each in removing (cleaning) the coating material from the past.
- The first solvent used to remove the coating material was a mixture of 50% absolute ethanol in distilled water. A cotton swab was immersed in this solvent and used to soften the coating surface. Then, absolute ethanol was used to wipe off the coating material (Figs. 9, 10, 11, 12).

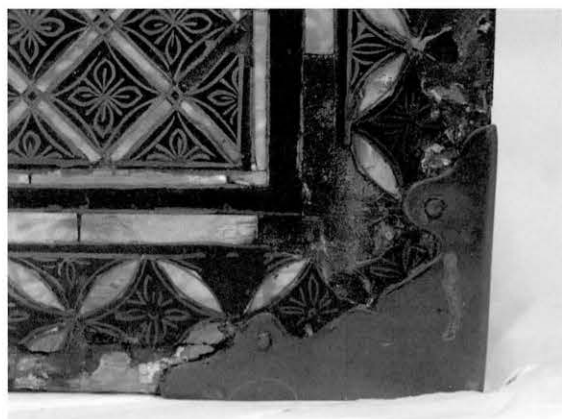
図7 修復前 角金具周辺 損傷部分

Fig. 7 Before restoration, damaged area around a corner metal fitting

- The urushi coating film and the shell pieces on the area around metal fitting on the front left corner of the lid have become detached and the substrate exposed (Fig.7).

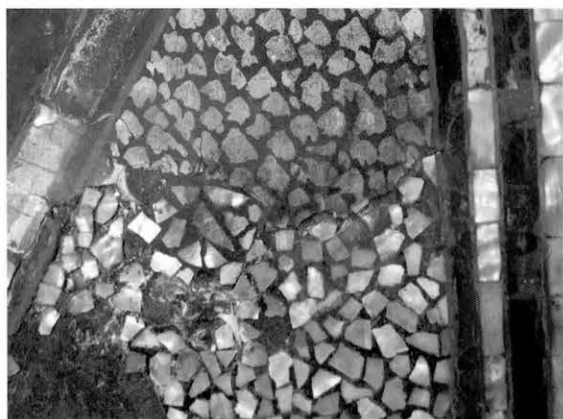
- ・蓋の正面中央のみじん置きされた貝は、剥離剥落が多く目立つ。一部後世に張り戻された部分があり、接着剤が溢れ貝も乱雑に置かれている為、非常に見苦しい状態である。
- ・蓋の正面、貝の剥落部分に、白い下地に銀色の塗料が塗られ、その塗料に断文がある（図8）。
- ・蓋の甲板部分、菱形枠内には後補で塗られた塗料の影響で、塗膜が黒ずんで蒔絵が見え難い状態である。

図8 修復前 後世修復部分

Fig. 8 Before restoration, a part restored in the past

- Silver coating material was used to coat the white foundation found on the front of the lid where the shell pieces had been lost, and there are microcracks on this coating (Fig.8).

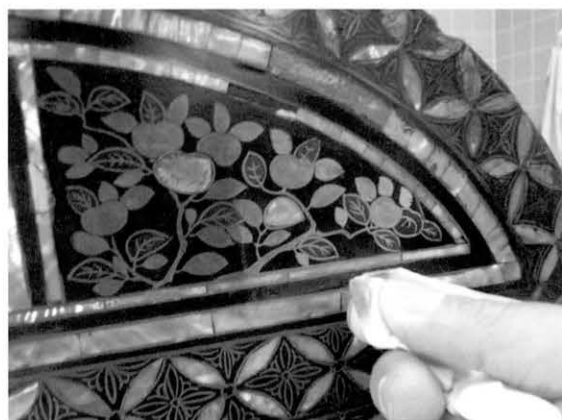
図9 後補塗料 除去作業中

Fig. 9 Removing coating film applied in the past

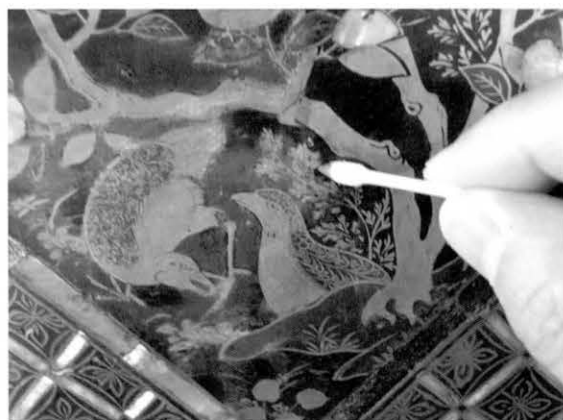
図10 後補塗料 除去作業中

Fig. 10 Removing coating film applied in the past

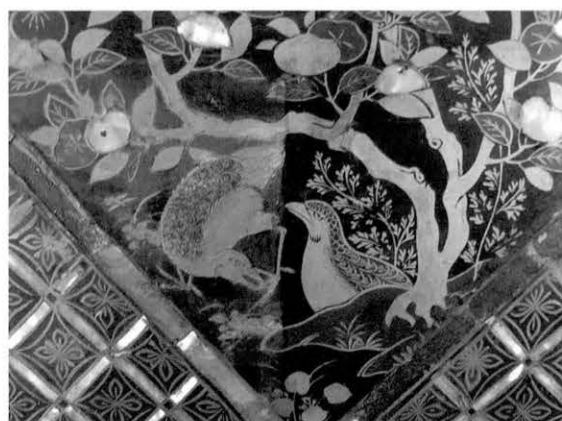
図11 後補塗料除去 (左 除去前、右 除去後)

Fig. 11 Removing coating film applied in the past (left: before removal, right: after removal)

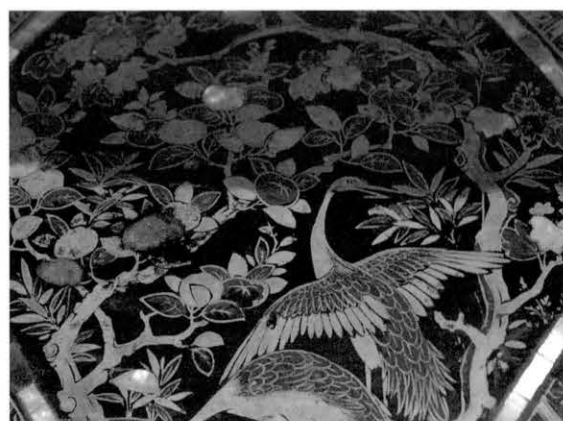
図12 後補塗料の除去 (上 除去前、下 除去後)

Fig. 12 Removing coating film applied in the past (top: before removal, bottom: after removal)

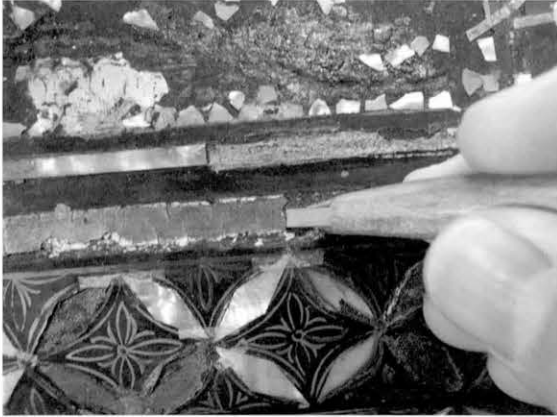
- ・側面の表面塗膜には、塗られた塗料の影響で全体に黒ずみ、特に提環周辺の塗膜は状態が悪い。
- ・蓋の角部分の塗膜及び貝は剥離剥落が多く、貝の剥落した部分には銀色の塗料で塗られている(図13)。
- ・身の側面下には木地の接合部に亀裂があり、その周辺塗膜は剥離剥落が多くある。

図13 後補材の除去  
Fig. 13 Removing material from a past restoration

- The surface coating film has become dark and its condition is bad especially around the handle.
- There is much lifting and detachment of the coating film and the shells on the corner of the lid. Parts where the shell pieces have fallen are coated with a silver coating material (Fig.13).
- There are cracks on the joint of the substrate on the lower side face of the body. The coating film around the crack have become lifted or detached.

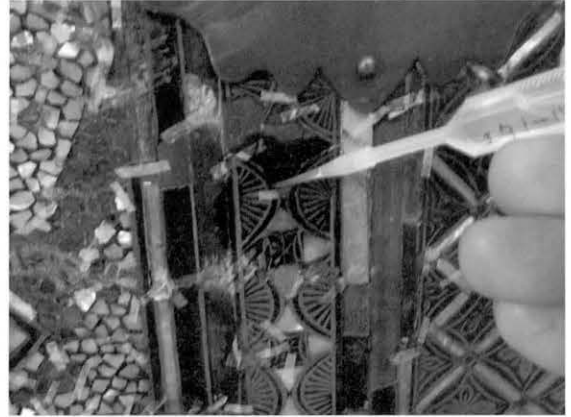
図14 剥離部分にエタノール含浸  
Fig. 14 Impregnating ethanol into a lifted area

圧着作業は洋櫃を木枠内に設置し、竹ひごの弾力を利用した芯張りによる圧着とした。先ず、剥離した塗膜下や貝下にエタノールを含浸し膠の透りを良くしてから、筆に含ませた膠を含浸した。なお、膠にも少量のエタノールを加え浸透力を良くして剥離部分に含浸し接着を行った（図14. 15. 16. 17. 18）。

- For press-stabilizing, the coffer was placed in a wooden frame and the resiliency of thin bamboo sticks were used (shimbari technique). First, ethanol was impregnated under the detached coating film and shell pieces to make it easy for animal glue to permeate. Then animal glue was impregnated with a brush. A small amount of ethanol was also added to animal glue to increase permeation (Figs. 14, 15, 16, 17, 18).
- This year, the left and right sides and the back of the body were press-stabilized.

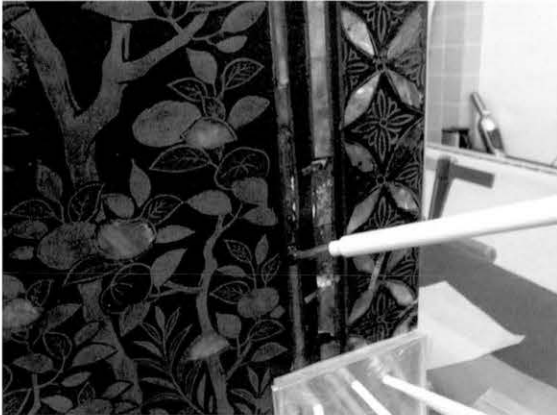
図15 膠含浸  
Fig. 15 Impregnating animal glue

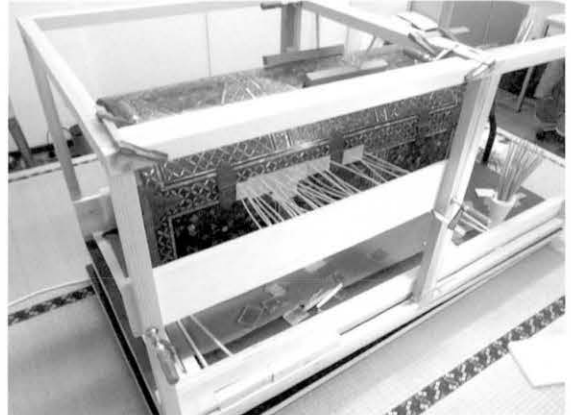
図16 木枠内での芯張り圧着  
Fig.16 Press-stabilizing in a wooden *shimbari* frame

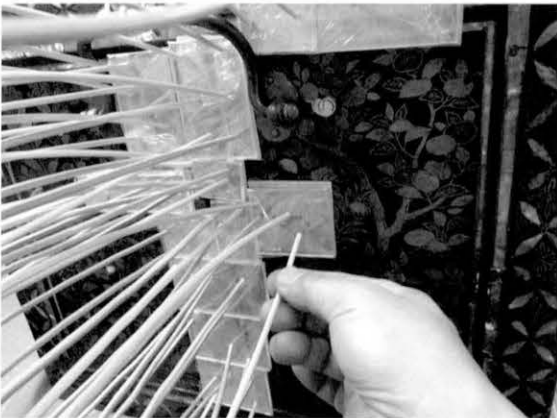
図17 芯張り圧着  
Fig. 17 Press-stabilizing with *shimbari* sticks

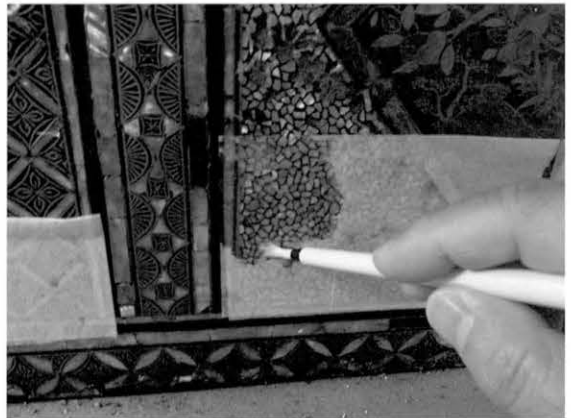
図18 圧着後の膠除去  
Fig. 18 Removing animal glue after press-stabilizing
