松に孔雀図屏風

平成20年度修復事業

修復報告

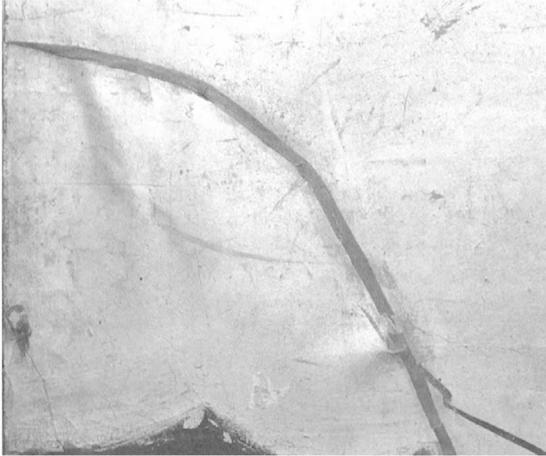
図1 修復前 テープで補修された亀裂箇所
Fig. 1 Before treatment Cracked areas mended with tape

- Areas of large tears were treated with synthetic glue injected through the tears onto the inside of the wooden core structure and covered by attaching adhesive tape to the front surface. (Fig. 1,3,5)

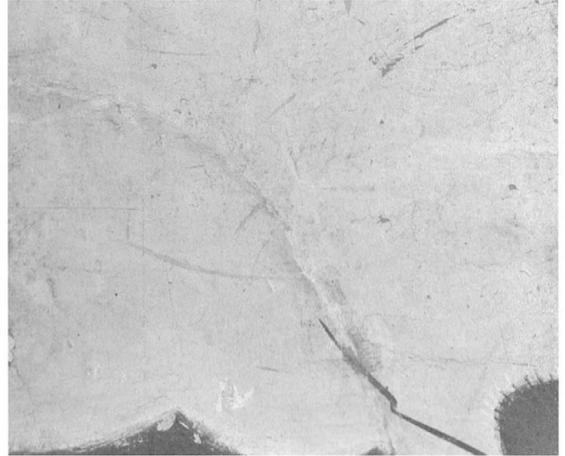
図2 修復後
Fig. 2 After treatment

12. 亀裂の補修 (図2、4)

- ・亀裂部分は、絵がきれいに繋がるよう細心の注意を払った。裏面から細い美濃紙の帯を当てて補強し、肌裏打ち後、もう1枚美濃紙の帯を当てた。

12. Mending of cracks (Fig. 2,4)
 - To mend the cracked areas of the painting, great care was taken to make sure the images were perfectly aligned. Narrow strips of Mino paper were applied from the reverse side to fortify the cracked areas. After the application of the first lining, another round of Mino paper strips were attached to the same areas.

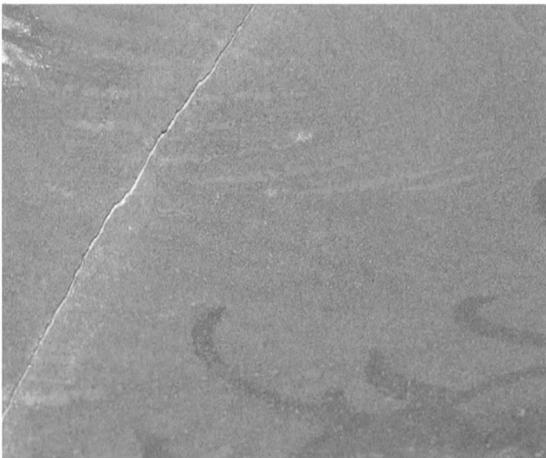
図3 修復前 本紙の亀裂
Fig. 3 Before treatment Cracks in the painting

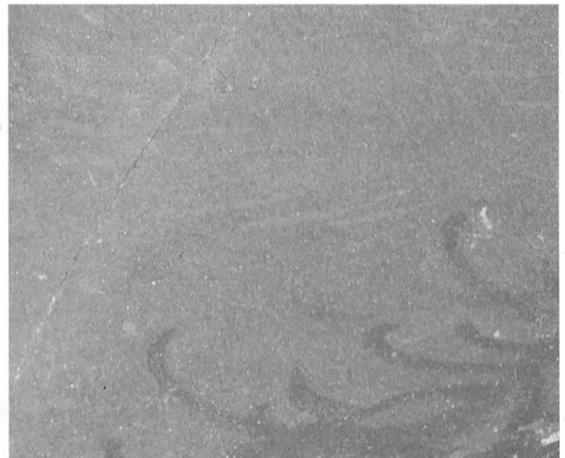
図4 修復後
Fig. 4 After treatment

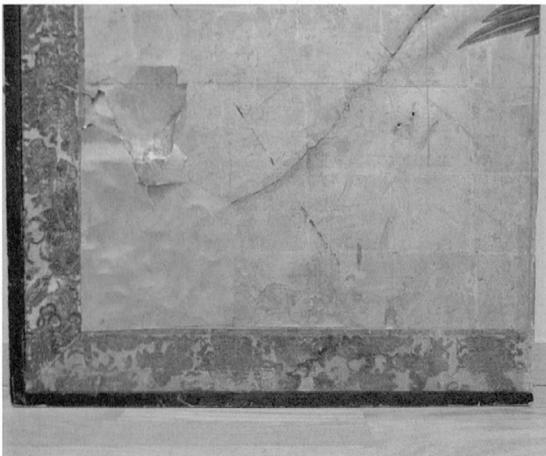
図5 修復前 大きな補修紙が当てられた箇所
Fig. 5 Before treatment Area in which a large piece of mending paper had been applied

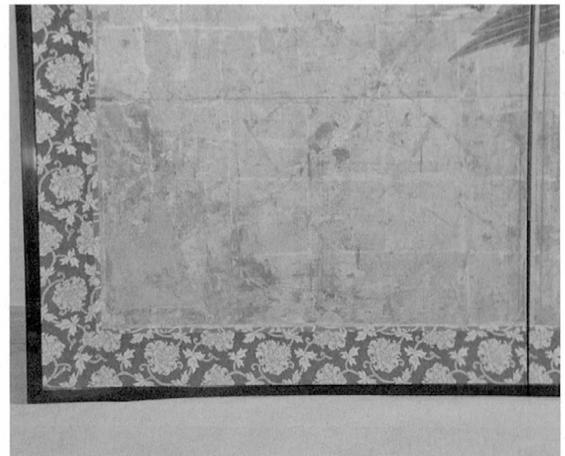
図6 修復後
Fig. 6 After treatment

11. 補紙 (図6)

- ・本紙の繊維分析を行って、組成を特定した。
- ・繊維分析の結果に基づき、補修紙として矢車で染めて水洗いした雁皮紙を用意した。
- ・本紙の欠損箇所と同型に補修紙を整形し、重なり部分を必要最小限になるようにして、本紙裏面から新糊（小麦粉澱粉糊、水：澱粉 = 1 : 1、PH 6 ~ 7）で添付した。

11. Mending paper (Fig. 6)
 - The fiber of the support paper of the painting was analyzed to determine its material.
 - Based on the findings of the analysis, *gampi* paper dyed in *yasha* and rinsed in water was prepared to be used as mending paper.

- The mending paper was cut to match the shapes of the missing areas in the painting with as little amount of overlap as possible. These pieces were pasted on from the reverse side of the painting using a wheat starch paste (water/starch ratio: 1:1, pH 6-7).

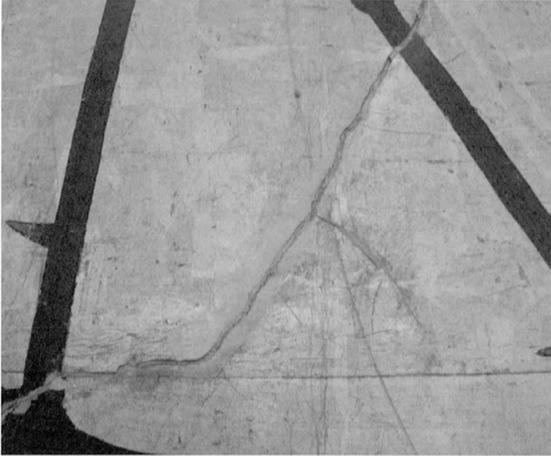
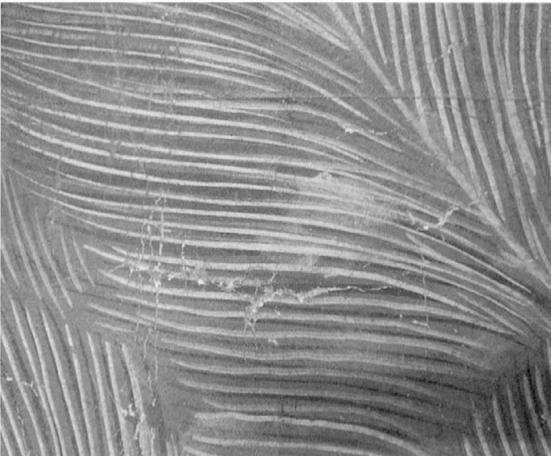
2. 裏面の接着剤の除去 (図7~10)

- ・大きく破れた部分の裏側には、接着剤が厚く塗り込められていた。
- ・観察からは、表から、亀裂の内側に向かって接着剤を注入したと思われる。
- ・かなりの広範囲に接着剤は及んでいた。
- ・テストの結果、有機溶剤で接着力を緩めると、その湿りによって本紙にしみができることがわかったため、小刀にて除去する方法をとることにした。
- ・また、テストの結果、水分が加わることによっても、接着剤の周囲で汚れが溶け出し、染みを作ることがわかったため、まず、すべての接着剤を除去してから、全体の煤だしなどのクリーニングを行なうこととした。

図7 修復前
Fig. 7 Before treatment

図9 修復前
Fig. 9 Before treatment

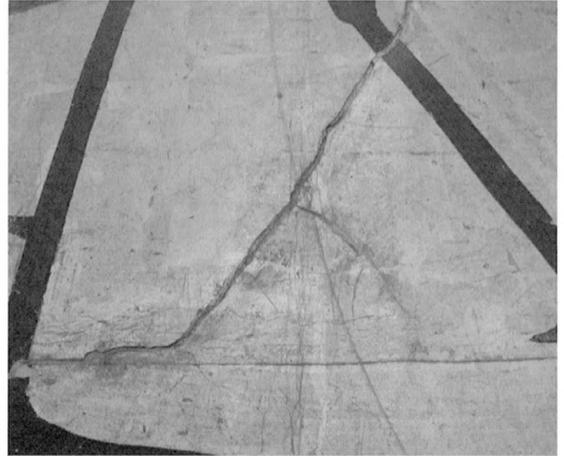
図8 修復後 (エタノールで樹脂類を除去)
Fig. 8 After treatment (Resins were removed with ethanol)

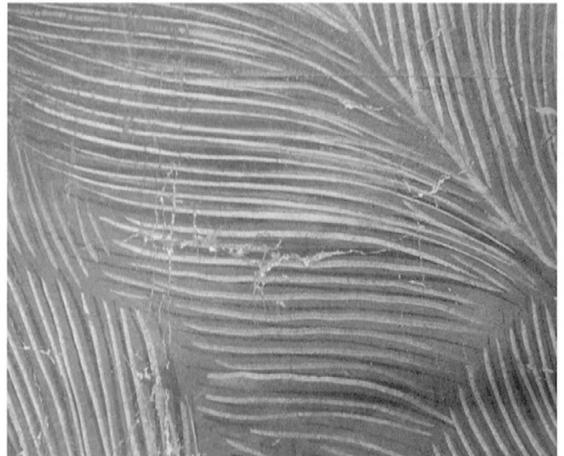
図10 修復後 (DMFで樹脂類を除去)
Fig. 10 After treatment (Resins were removed with DMF)

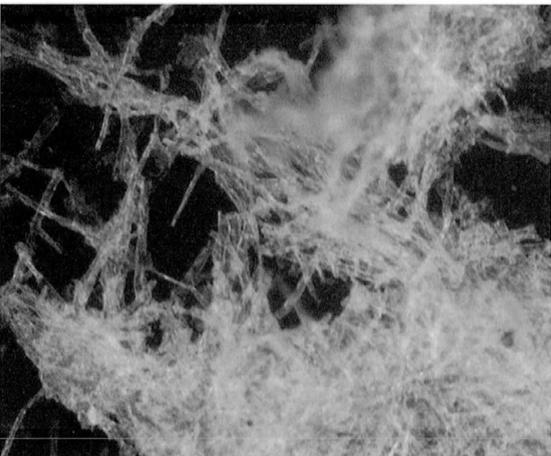
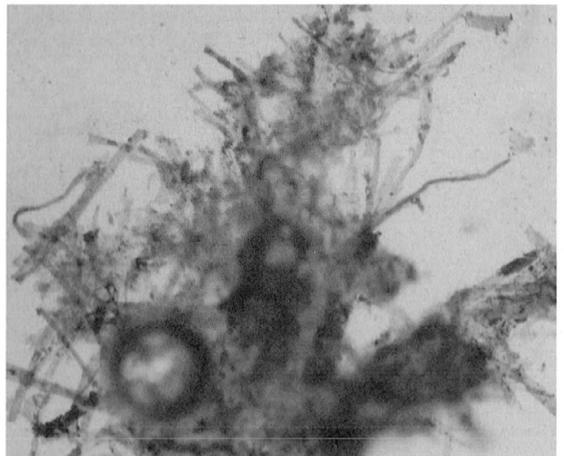
3. 繊維分析 (宍倉ペーパーラボ、図11、12)

- ・水の吸収は遅い。繊維が短く細く、繊維膠着が強いので完全分散は困難。
- ・強く酸化劣化した雁皮が使われ、全て繊維が0.2ミリ以下に劣化短小し、塗布したと思われるドーサが酸で膠着しているので、単繊維化が特に難しい。
- ・C染色液写真で黄色の細かい異物は米粉の変色した物と思われる、紫色の雁皮特有の非繊維細胞も見られる。

図11 本紙繊維 顕微鏡写真
Fig. 11 Fiber of the painting photomicrograph

図12 本紙繊維 (C染色液染め) 顕微鏡写真
Fig. 12 Fiber of the painting (dyed with C-stain solution)
photomicrograph

- Water absorption is slow. Because the fiber is short, thin, and bound to each other very tightly, complete fiber dispersion would be difficult.
- The paper being used is a severely oxidized *gampi*. All of the fiber has deteriorated and shortened to under 0.2 mm. The *dosa* (alum/animal gelatin sizing), presumably applied in the past, has agglutinated due to the acid. For these reasons, it would be particularly difficult to defibrate.
- The small extraneous yellow particles found in a C-stain solution photograph is presumed to be discolored rice powder. Violet colored non-fibrous cells characteristic of *gampi* paper were also found.

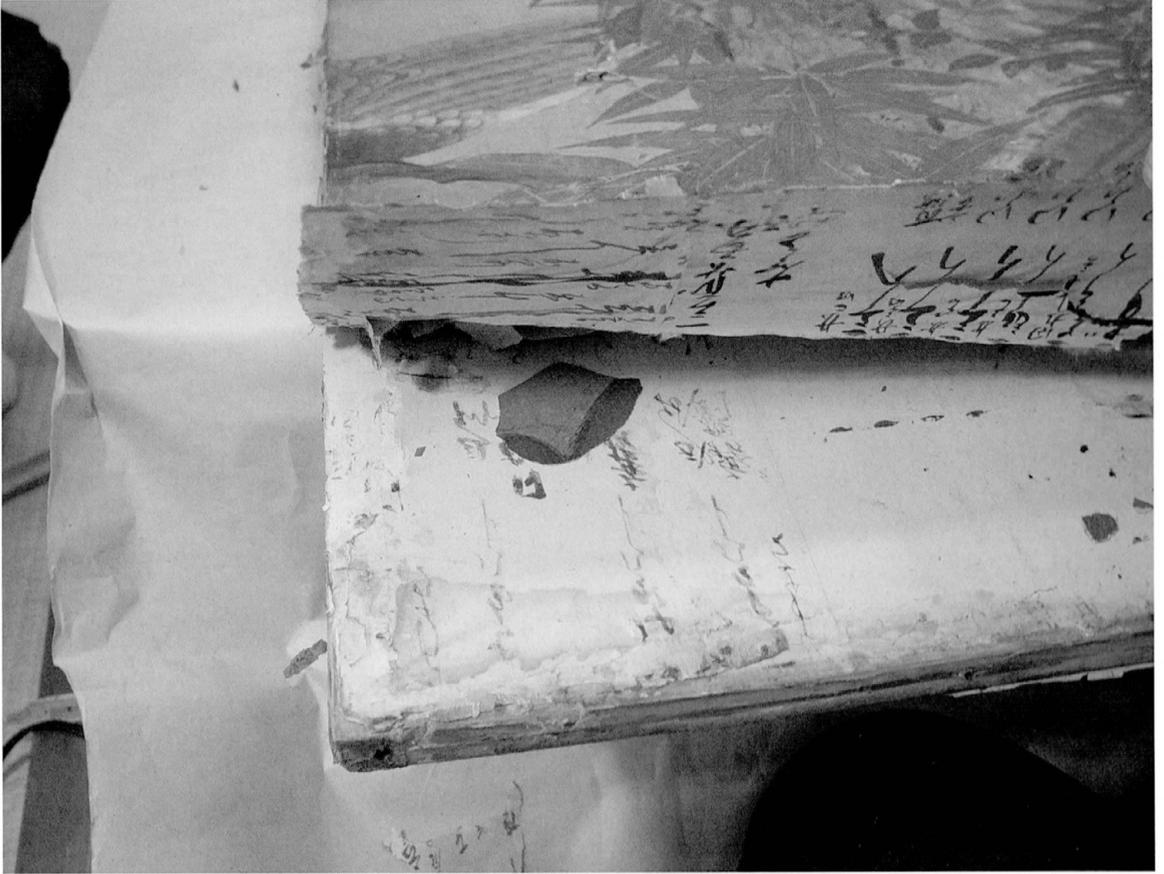
4. 破片の発見 (図13~15)

- ・下地から本紙を取り外す際に、本紙と下地の間から、いくつかの破片が見つかった。傷跡や絵具

の様子などから、破片が元あった場所を特定し、その位置に戻した。

図13 解体時に見つかった本紙片

Fig. 13 Fragments of the painting found during disassembly

- When removing the painting from the wooden core structure, several fragments of the painting were found in between the painting and the core structure. The original locations of the fragments were determined based on traces on the painting and characteristics of the pigments, and the found fragments were returned to these locations.

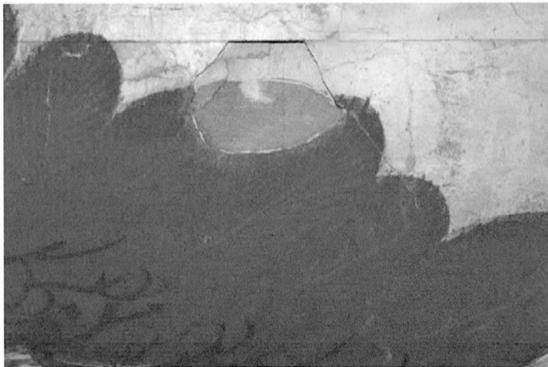
図14 修復前 本紙が欠落し、裏打紙に直接補彩がなされていた
Fig. 14 Before treatment An area which a piece of the painting was missing. Inpainting had been applied directly onto the lining paper.

4. Discovery of broken fragments (Fig. 13-15)

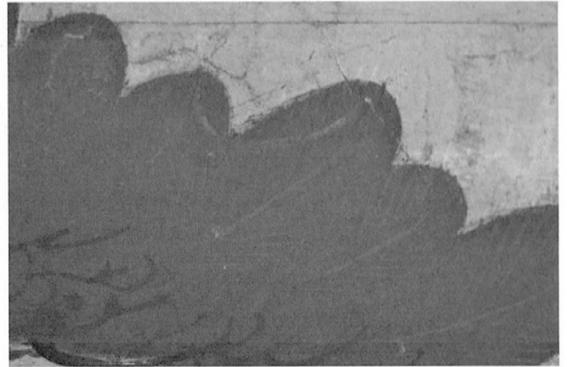
図15 修復後 紙片を本来の位置に戻した
Fig. 15 After treatment The missing fragment was returned to its original location

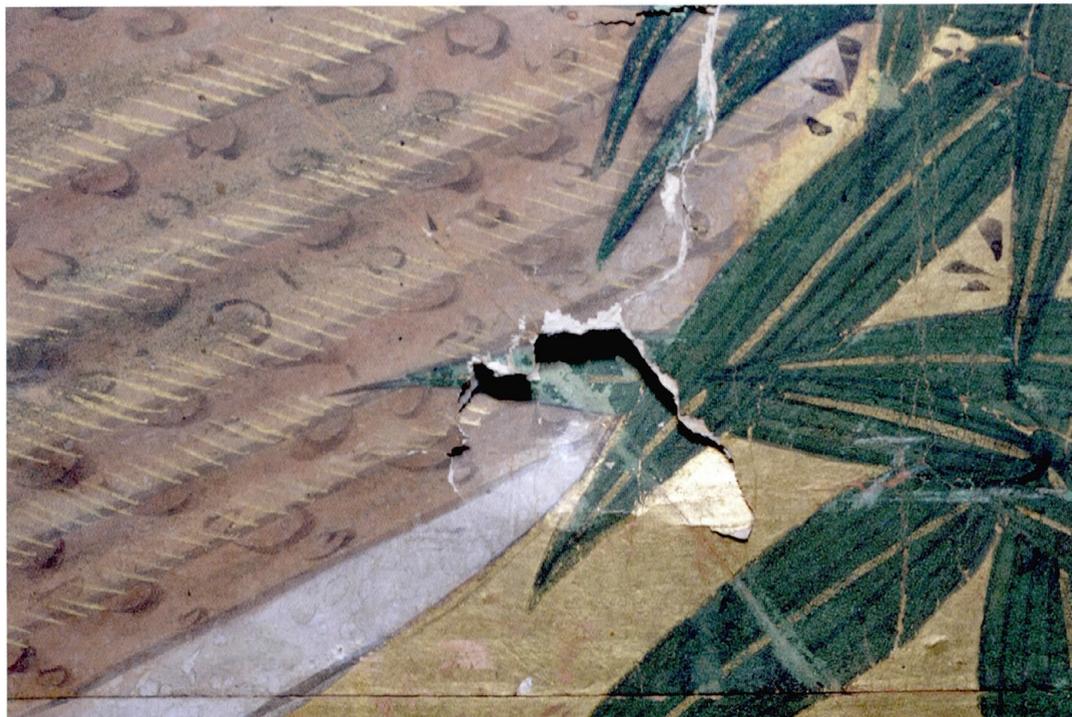
(2)-1 修復前 (部分) 突き傷
Before treatment (Detail) : A puncture
