楼閣山水蒔絵箱

平成19・20年度修復事業

所蔵：オーストリー応用美術館

山下 好彦

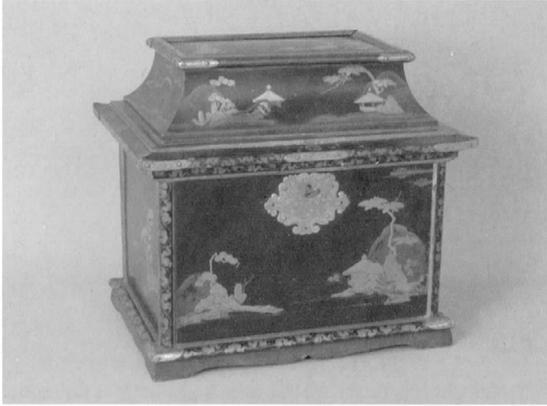
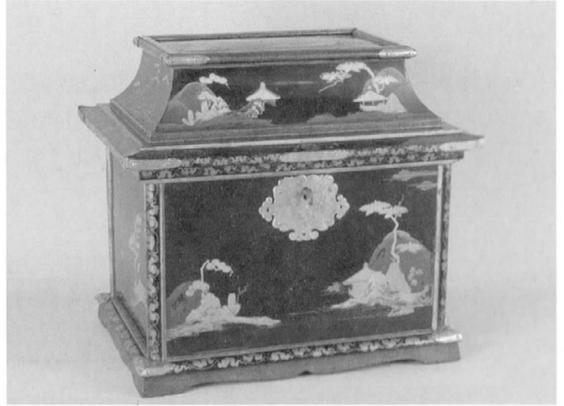
修復前
Before restoration

修復後
After restoration

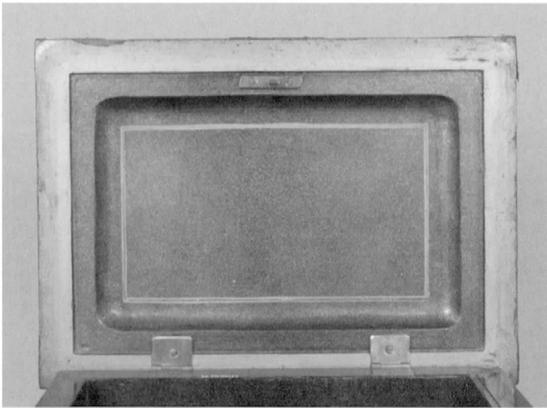
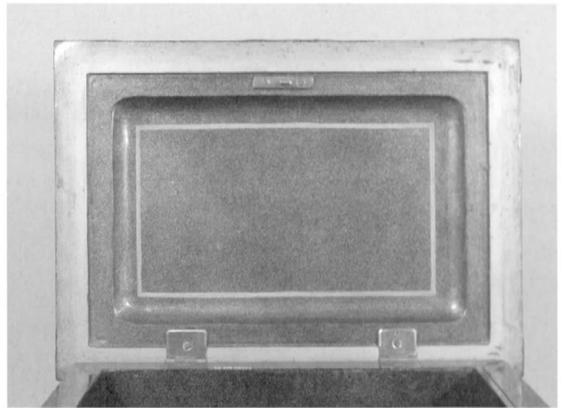
蓋裏 修復前
Inside of the lid, before restoration

蓋裏 修復後
Inside of the lid, after restoration

形状復元部分の色合せを行った。蓋内部は錫粉と金粉を用い、他は真鍮粉と漆を練り合わせて筆塗りした。茶色味を調節するためその上から本地呂漆を薄く塗り込んだ。

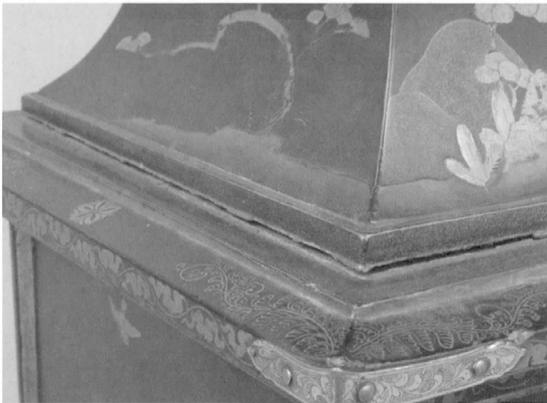
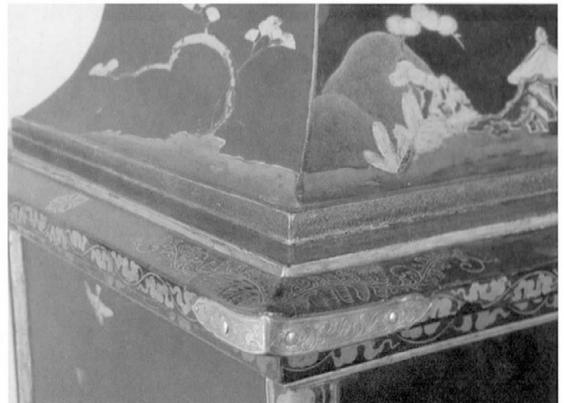
素地の接合部のほぼ全てに亀裂が入っていた。特に、蓋の側板と蓋下部材の接合部は素地が完全に離れ、不安定な状態になっていた。底板はほぼ中央で割れ、素地接合部分に亀裂があった。塗膜に剥離が認められ、すでに多くの塗膜と下地が剥落していた。また、擦傷や打損があり、蒔絵粉の銹化や

蓋の亀裂 修復前
Crack on the lid, before restoration

蓋の亀裂 修復後
Crack on the lid, after restoration

外れた蓋の側板と蓋下部材の素地の歪みを直すため、蓋を湿度調節した箱に入れ、素地に柔軟性が戻ってから木枠とヒゴ、クランプを用いて徐々に力を加えて固定した。その後、素地部分に溶剤で希釈した麦漆を含浸し、蓋の側板と蓋下部材の素地を接着した。余分な漆は完全に拭き取り、数週間固定したまま乾燥させた。蓋の押さえを取り外した後、亀裂が入り段差が出来た蓋裏板を出来る限り修正して麦漆で接着した。

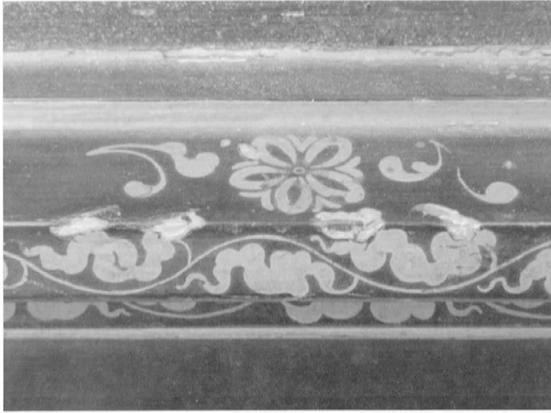
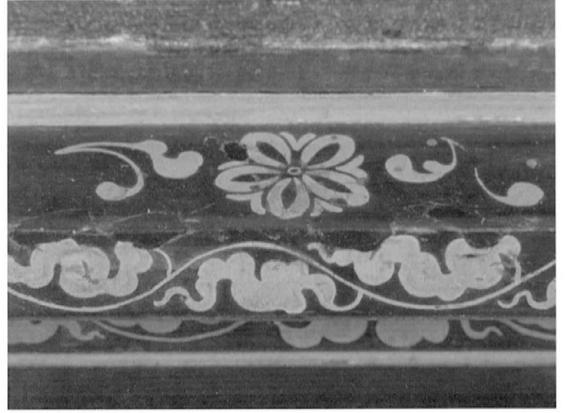
蓋周囲の塗膜と下地の欠損 修復前
Coating film around the lid and the missing foundation, before restoration

蓋周囲の塗膜と下地の欠損 修復後
Coating film around the lid and the missing foundation, after restoration

打損部や下地が欠損した部分は刻苧を充填した後、錆下地を行って形状を整えた。次に、黒漆を数回塗り表面を整えた。亀裂も同時に下地を行い、必要に応じて漆塗りを行った。

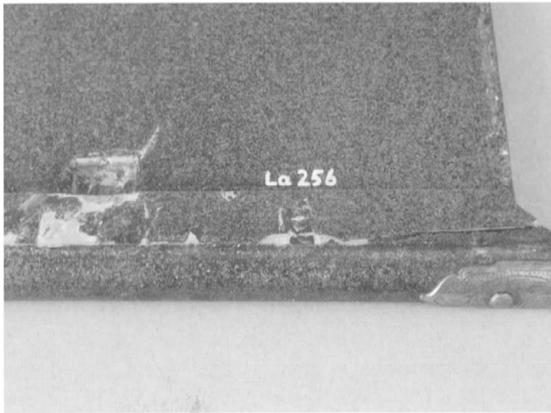
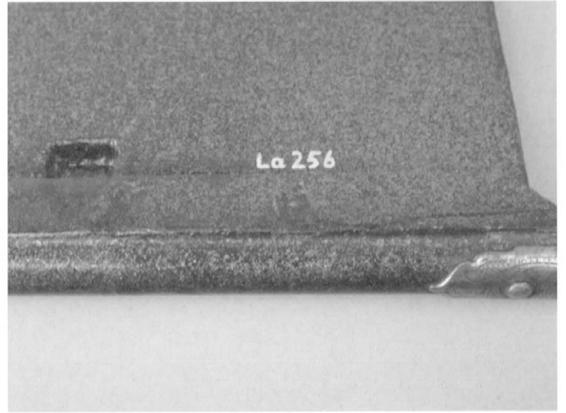
損傷が著しく進行していた。鍵金具や隅金具の釘が緩み下部の隅金具に緑青が付着していた。また、鍵金具の金属棒が一部突出し、蓋の引板裏側に傷が入っていた。

蓋天板裏側の亀裂と剥落 修復前
Crack and detached coating film on the reverse side of the top board of the lid, before restoration

蓋天板裏側の亀裂と剥落 修復後
Crack and detached coating film on the reverse side of the top board of the lid, after restoration

蓋甲板や身の口縁部の塗膜剥離箇所を溶剤で希釈した麦漆を含浸し、木杵とヒゴ、クランプを用いて圧着した。

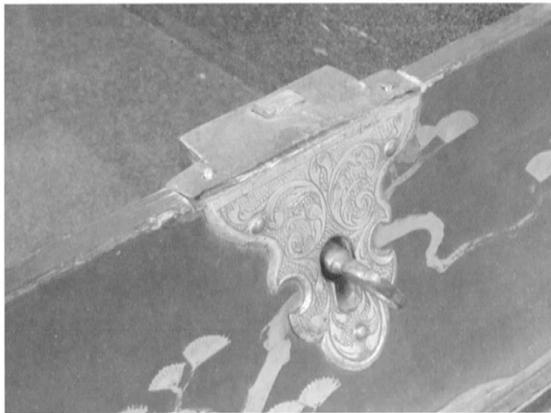
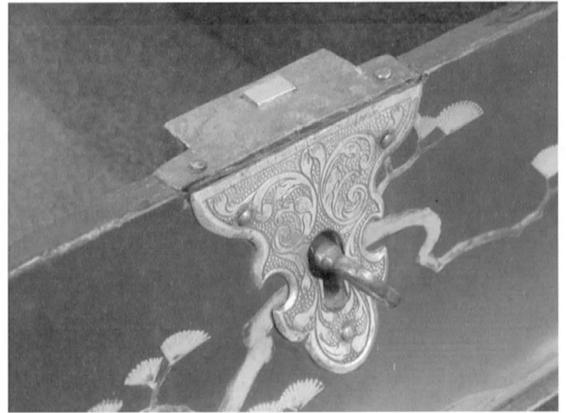
蓋の鍵金具 修復前
Metal lock on the lid, before restoration

蓋の鍵金具 修復後
Metal lock on the lid, after restoration

蓋の鍵金具に打たれていた後世修理の緩んだ鉄釘2本を交換するため、オリジナルの形状に合わせて真鍮釘を作製した。釘の色を合わせるため、油煙を少量混ぜた本地呂漆を釘に筆塗りし、火で焼き付けた。突出していた鍵金具部分を鉄鑿で形状を整えた。釘穴は釘がしっかり止まるように釘穴を適度に刻苧で充填した。

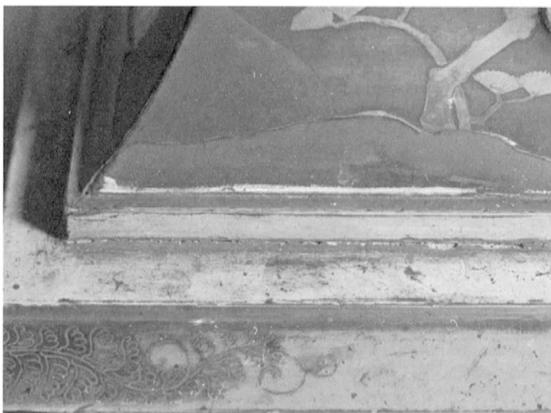
本資料はヨーロッパにおける後世修理が各所に入っていた。蓋の天板外面、側板外面、身の正面と左右面のみがオリジナルであり、他はオリジナルの上から黒色の西洋塗料を塗り込み、その上に梨地や蒔絵に模して加飾がされていた。蓋や身の鍵金具周辺では下地欠損部分を白色の下地で充填、隅金具の釘の周囲にも後世修理の充填材が認められた。正面右の柱部分は2本の釘で柱を止め直し、蓋には他の資料の隅金具を打ちなおしていた。蓋の内側鍵金具部分に後補の鉄釘が打たれていた。蝶番も後補と考えられ、マイナスの鉄製目ネジを使用していた。

後世修理箇所（紫外線写真）修復中
Part restored in the past (UV photograph), during restoration

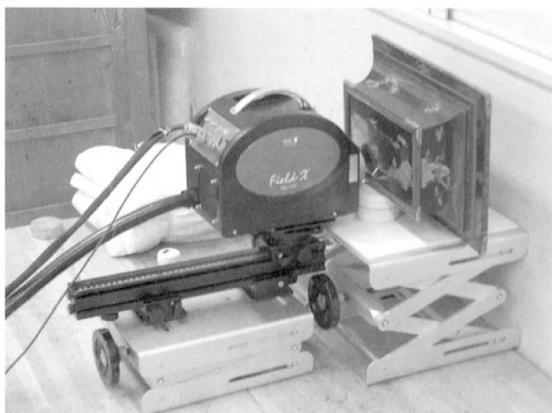
本資料は紫外線による調査の結果、広い面積にヨーロッパにおける修復の手が入っていることが判明したため、数種類の科学分析を行った。素地や蒔絵についてはX線透過撮影を行い、内部の構造を確認した。その結果、身の差し蓋上部に素地割れを修理したと考えられる素地の新補部分があり、身の底板周囲は小さな素地を繋ぎ合わせていることが判った。塗膜材料については赤外線吸収スペクトルによる分析を行った。その結果、多くの部分にシェラックが被っていることが分かった。加飾材料についてはポータブル蛍光X線分析を行った。その結果、オリジナルの蒔絵は金96-97%（残りはCu）、復元には真鍮（Cu90%-Zn10%）を使用していることが判明した。

蛍光X線分析 修復中
X-ray fluorescence analysis, during restoration

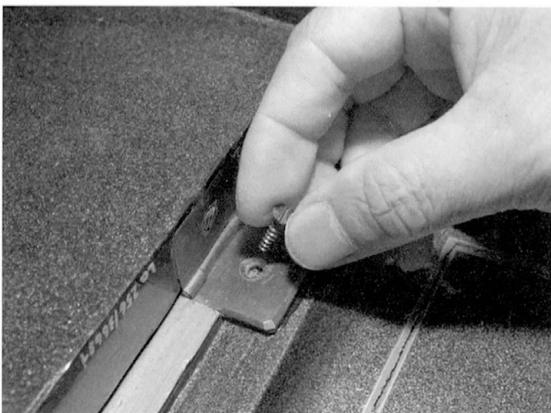
蝶番の取り外し 修復中
Removing a hinge, during restoration

蓋の亀裂接着作業を進めるにあたって、所蔵館に蝶番を取り外す許可を得、蓋を身から取り外した。蝶番の木ねじは別保管した。

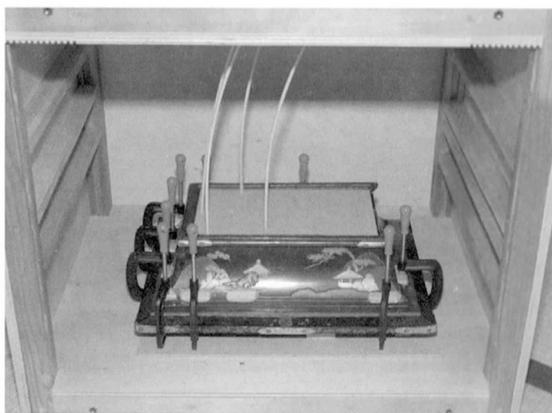
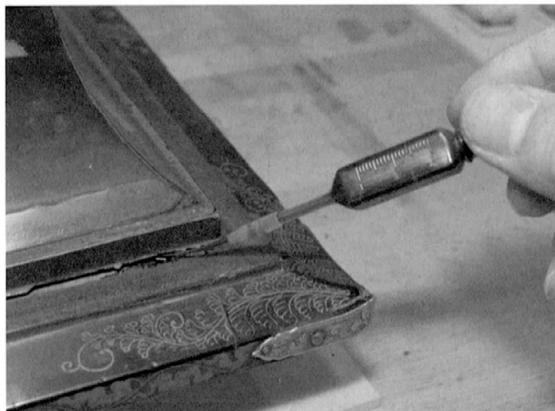
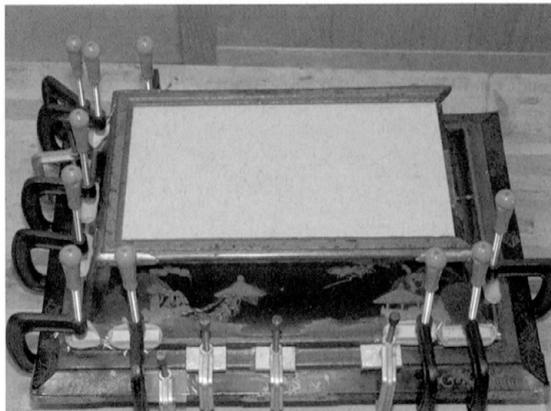
蓋亀裂の形状調整 修復中
Adjusting cracks on the lid, during restoration

蓋亀裂の接着（麦漆含浸） 修復中
Adhering a crack (impregnating *mugi-urushi*), during restoration

クランプによる蓋亀裂の接着 修復中
Adhering cracks on the lid using clamps, during restoration

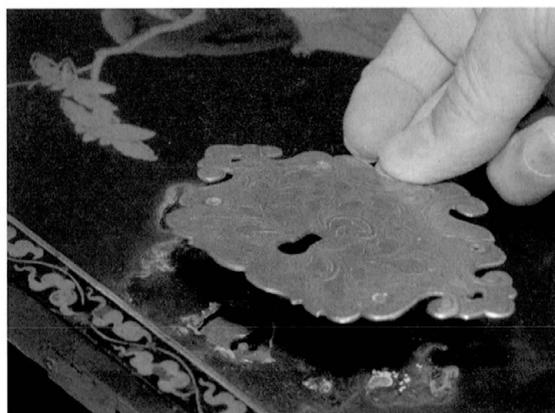
鍵金具の取り外し 修復中
Removing the metal lock, during restoration

クリーニングに先立って、身正面と蓋内側の鍵金具を取り外した。釘の取り外しにはプラスティ

クシートと鉄製の篋を用いて塗膜に傷を付けないように丁寧に行った。取り外した金具と釘は別保管した。

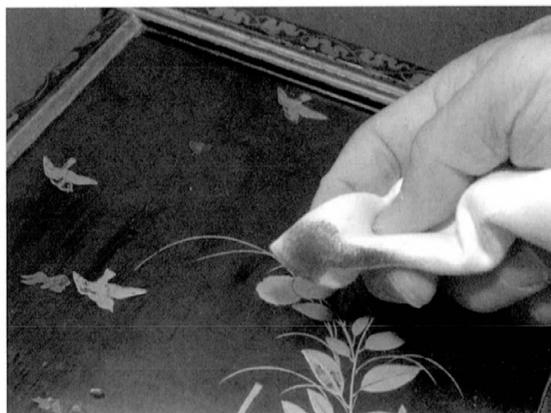
DMSOによるクリーニング 修復中
Cleaning with DMSO, during restoration

西洋塗料の除去をするため、有機溶剤によるクリーニングテストを行った。クリーニングは初めに塗膜に付着した埃と汚れを水で除去した。次に、全体にキシレン、トルエン、DMSOを用いて付着物を除去した。蒔絵部分は、表面のみに有機溶剤 (DMSO) を筆塗りし、後世修理の塗料を溶かしてから慎重に紙で押し拭きをした。塗膜や蒔絵のクリーニングは、仕上げに消毒用エタノールを用いて拭き上げた。

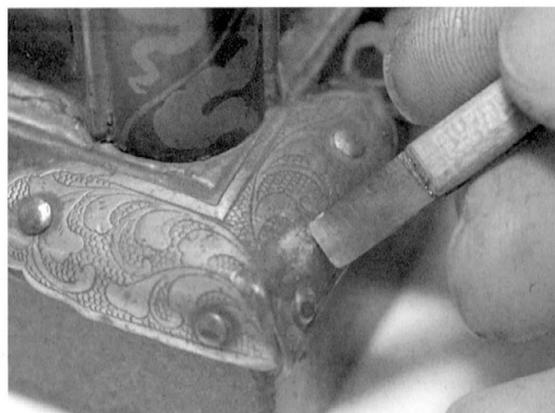
隅金具のクリーニング 修復中
Cleaning a corner metal fitting, during restoration

金具はエタノールと鼈甲の篋を用いて緑青や後世修理の塗料を除去した。

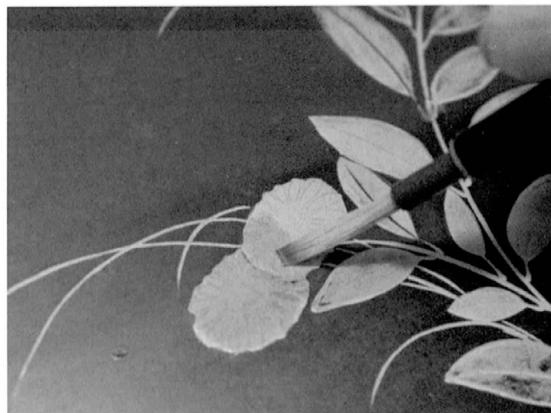
蒔絵の補強 修復中
Reinforcing *makie*, during restoration

蒔絵部分にクリーンソルGで4～5倍に希釈した本地呂漆を筆で含ませ、乾燥しないうちにリグロインで軽く拭き取った。蒔絵の補強は2度行った。また、塗膜にもクリーンソルGで4～5倍に希釈した生正味漆を含ませ、乾燥しないうちにリグロインで拭き取った。

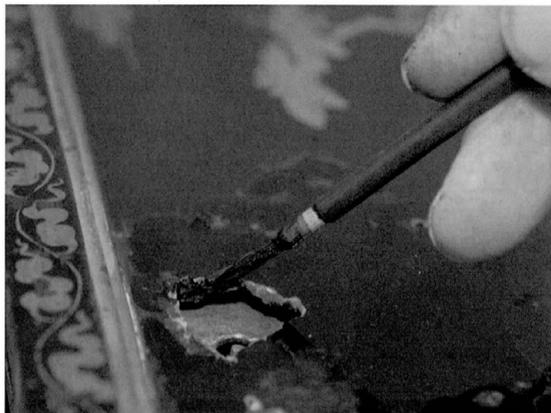
塗膜の剥落止め 修復中
Preventing detachment of the coating film, during restoration

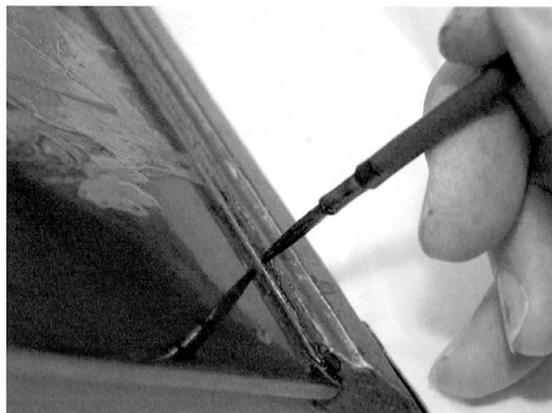
亀裂の補強と接着 修復中
Reinforcing and adhering a crack, during restoration

素地構造部のほぼ全てに及ぶ亀裂部分にリグロインで希釈した麦漆を含浸して補強した。余分な麦漆はリグロインで完全に拭き取った。

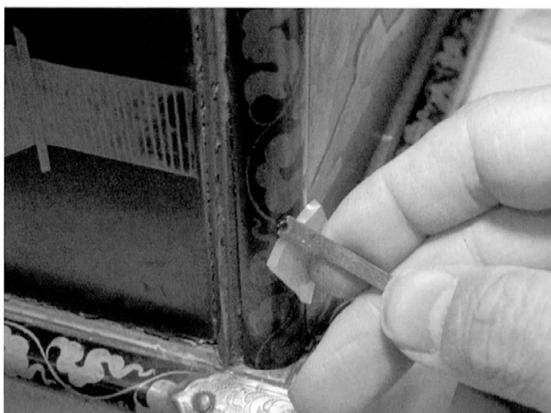
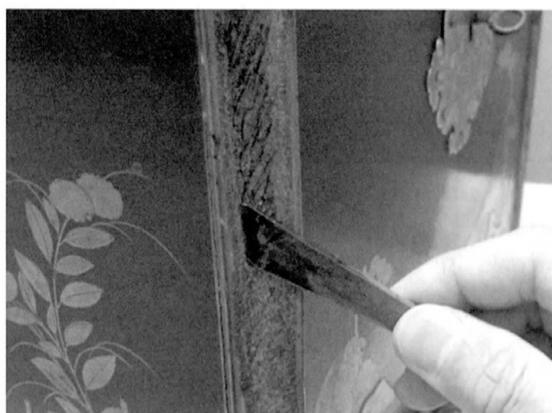
釘の取り外し 修復中
Removing a nail, during restoration

パラロイドB44Nによる柱の接着 修復中
Adhering *hashira* with Paraloid B44N, during restoration

正面右の柱部分に打たれた後世修理の2本の釘をプラスチックシートと鉄篋で丁寧に取り外した。次に、パラロイドB44Nキシレン35%溶液で元の位置に再接着した。

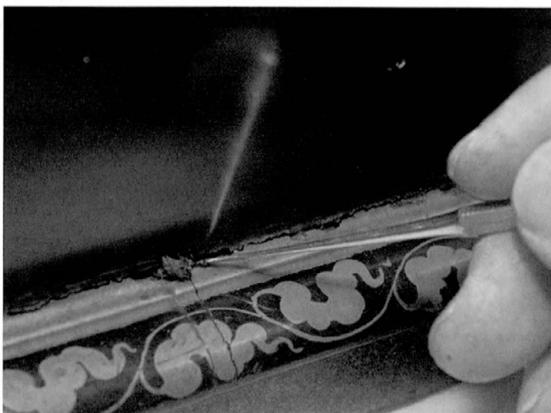
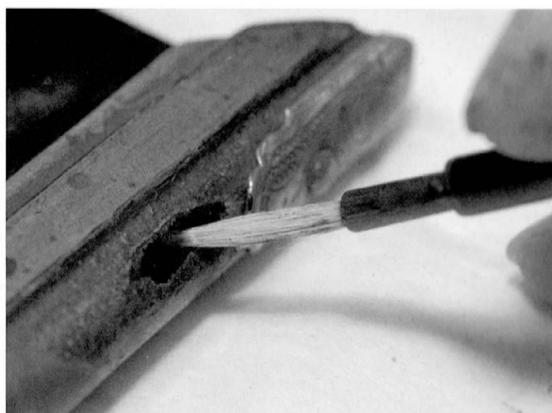
刻苧による欠損部の充填 修復中
Filling a missing area with *kokuso*, during restoration

漆による欠損部の成形 修復中
Re-shaping a missing area with *urushi*, during restoration

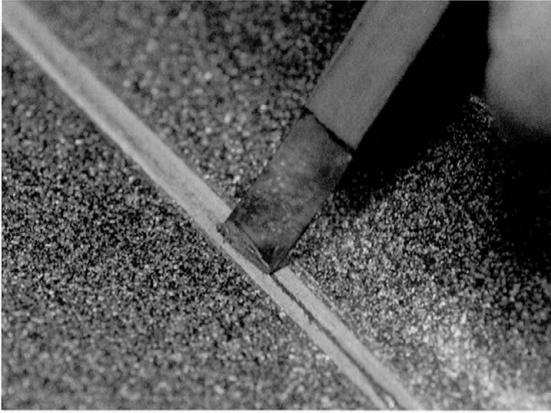
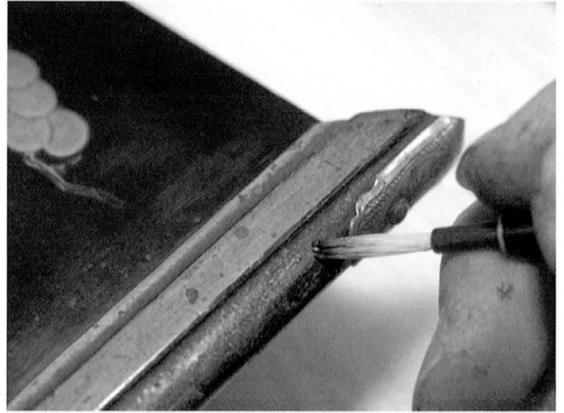
蓋裏の色合せ 修復中
Adjusting colors on the back of the lid, during restoration

梨地部分の色合せ 修復中
Adjusting colors on the *nashiji* portion, during restoration

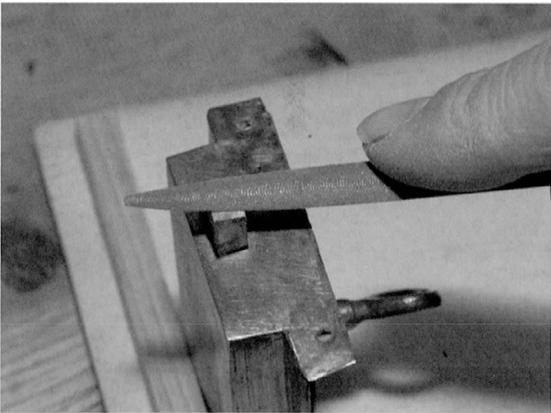
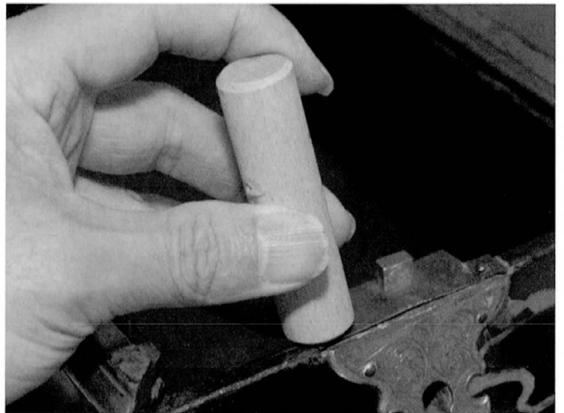
鍵金具の形状修正 修復中
Re-shaping the metal lock, during restoration

鍵金具の取り付け 修復中
Attaching the metal lock, during restoration

蓋と身の鍵金具を元の位置に取り付けた。蓋内側鍵金具には新補の釘2本を使用した。

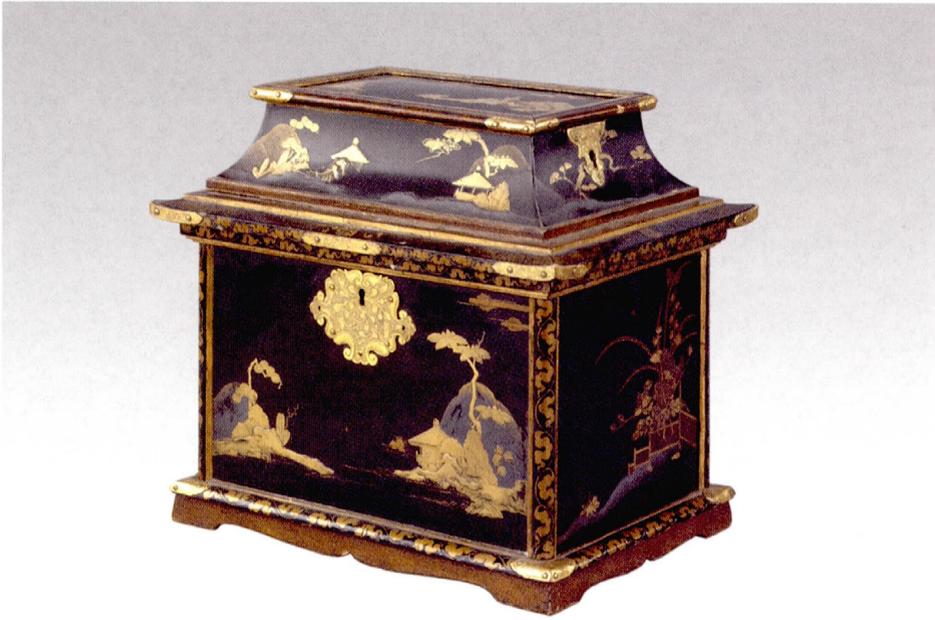
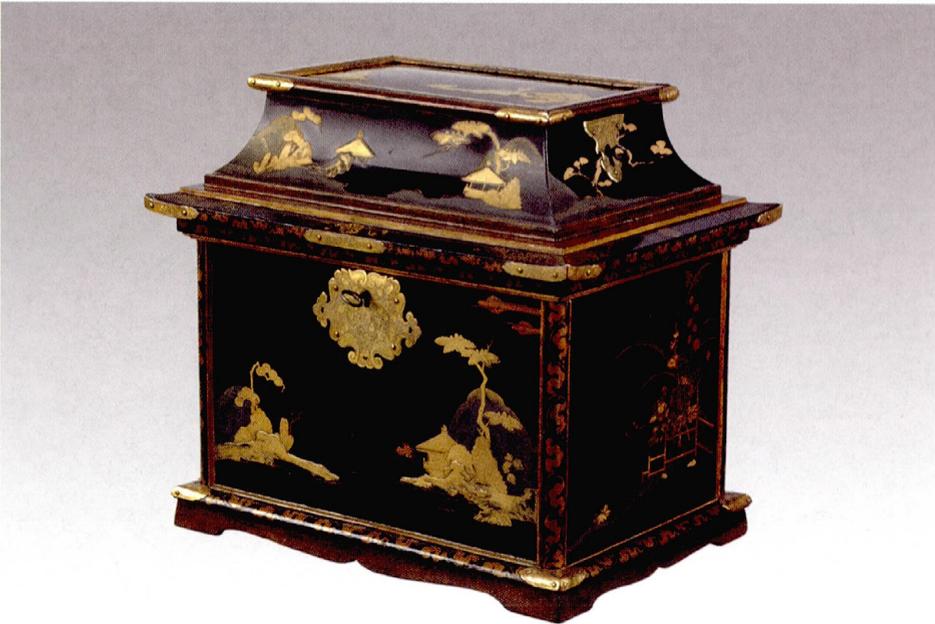
修復前 前姿
Before restoration, front view

修復後 前姿
After restoration, front view

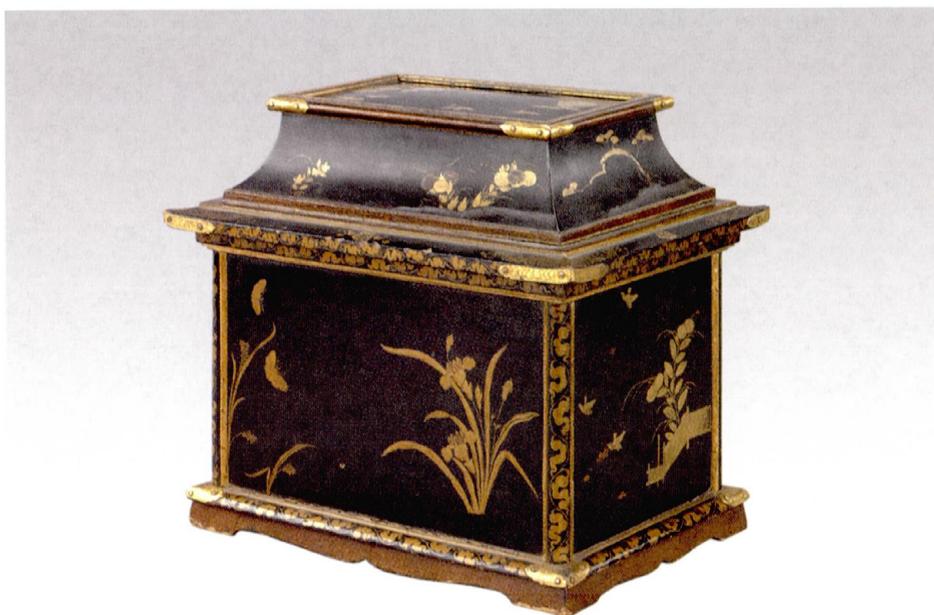
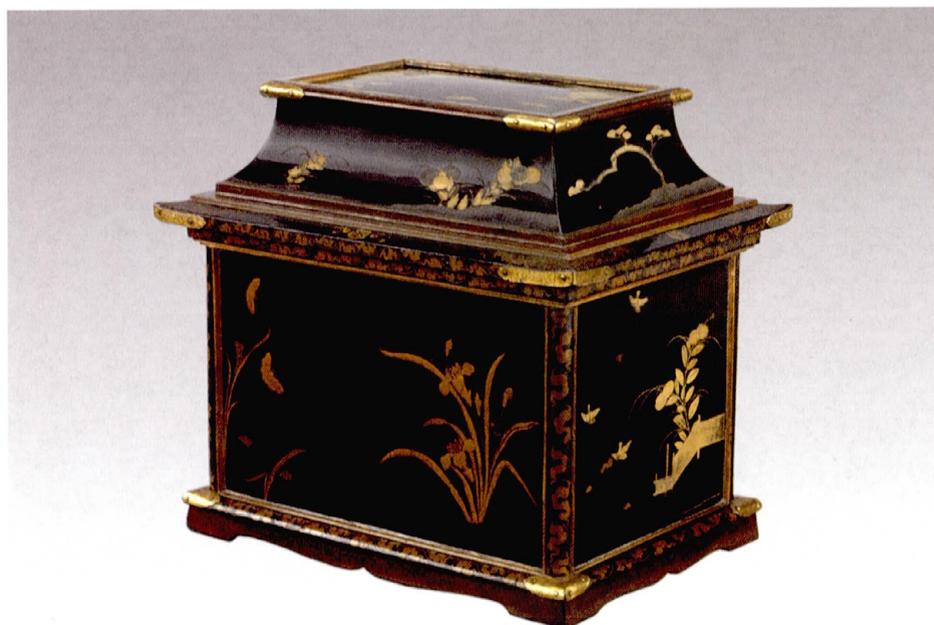
修復前 後姿
Before restoration, back view

修復後 後姿
After restoration, back view
