住吉蒔絵文台

平成19・20年度修復事業

所蔵：ヴィクトリア・アンド・アルバート美術館（イギリス）

修復品名	住吉蒔絵文台
所蔵美術館	ヴィクトリア・アンド・アルバート美術館（イギリス）
制作年代	17世紀 江戸時代
修復品寸法	35.5cm×59.5cm 高さ9.8cm
修復期間	平成20年6月～平成21年3月（10ヶ月間）
修復場所	東京文化財研究所 漆修復アトリエ

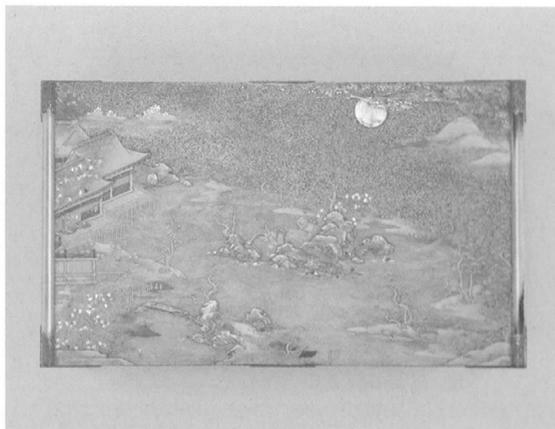
- ・文台の甲板面は、紫外線や経年劣化により蒔絵部分の艶が無く、蒔絵粉が剥き出しの状態であった。
- ・文台の表裏の塗膜は、後世修理の際に塗られた塗料が劣化し、塗膜面に滲みや斑文があり、蒔絵部分は黒ずんで見えた。
- ・文台の甲板右下、松の木周辺にある亀裂は、素地に節のある材が使われていたと思われ、裏面にも同じような亀裂を生じていた。
- ・甲板裏面に素地の狂いを止めるための端喰が2本使われているが、素地の収縮の違いが原因となり亀裂や塗膜の剥離を生じていた。
- ・脚部には素地からの亀裂が入り、一部の脚は甲板との接合部にも亀裂や剥離を生じ、後補されていた。
- ・蒔絵部分に使われた金具は殆どが剥離状態であり、一部捲れ上がった部分があった。

图2 修復前 (甲板表面)
Fig. 2 Before restoration (top board)

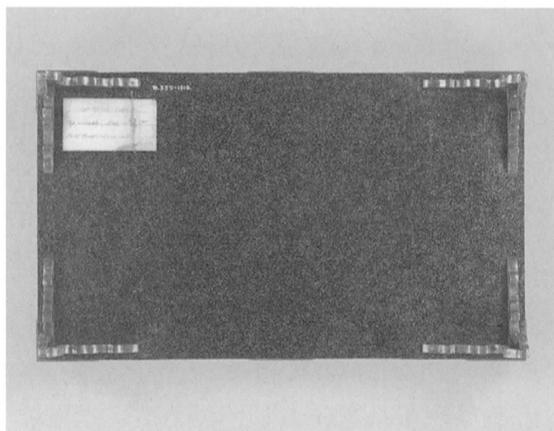
图3 修復前 (甲板裏面)
Fig. 3 Before restoration (underside of the top board)

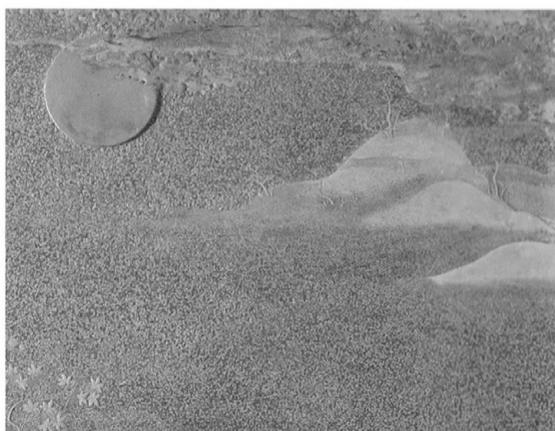
图6 修復前 表面 梨子地部分
Fig. 6 Before restoration (top board, nashiji portion)

甲板の梨子地部分の漆固めは、梨子地漆+木地呂漆+生正味漆を7:2:1の割合の漆に石油系溶剤のペトロロールで4倍~6倍に希釈し漆固めとした。漆の拭き取りは劣化した塗膜に浸み込ませ、表面の蒔絵や高蒔絵の際に残らないよう丁寧に拭き取った。

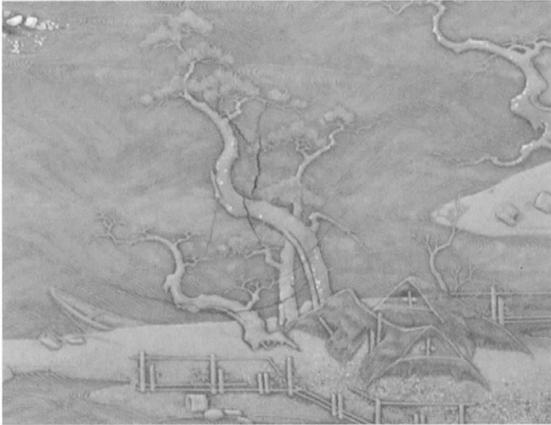
図7 修復前 塗膜 亀裂部分
Fig. 7 Before restoration, coating film, cracked portion

甲板裏の亀裂は、亀裂部分から希釈した麦漆を含浸し、竹ヒゴを用いた芯張り方法で圧着を行った。また、周辺塗膜も同時に圧着を行った。

亀裂部分の戻しきれない隙間や塗膜の欠損部分には、麦漆に木粉や麻の繊維を混入した刻苧を充填し形態を復元した。刻苧の充填は必要に応じて荒さを変えて数回に分けて行った。

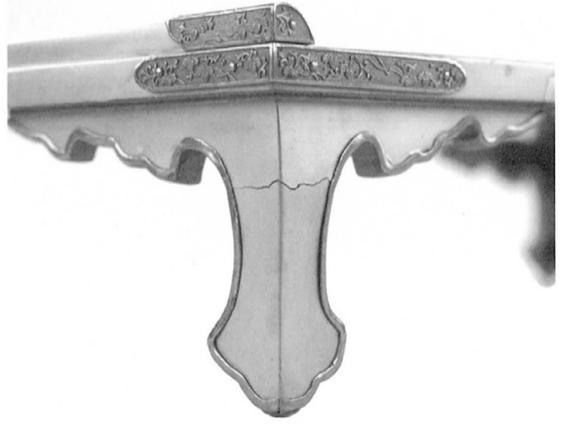
文台の甲板面の蒔絵部分は紫外線や経年変化により劣化し、塗膜表面が黒ずんで見える事により、後世修理で塗料が塗られた形跡が窺えた。また、甲板の反りを防ぐための端喰部分や脚部分に亀裂を生じていた。脚部分の亀裂は、素地構造の問題や覆輪をつけた際に打たれた釘の影響で亀裂を生じたものと考えられた。尚、修復前の損傷部分の詳細は下記に記す。

図8 修復前 脚 亀裂部分
Fig. 8 Before restoration, leg, cracked portion

圧着の前に覆輪を取外し、本資料の設置台や押さえ治具の準備を行い作業に取り掛かった。亀裂部分の接着は、接着力を強くするためグルテンの量を多くした麦漆を使用した。

左前の脚の覆輪を取り外したところ、脚はグラグラの状態で4本の釘で補強されていた。この部分は何度か修理されていて、接合部分は荒れた状態であった。よって、接着は、麦漆に少量の木粉と麻布の繊維を混ぜ合わせた、透間の充填を兼ねた接着剤を使った。尚、圧着は数種類のクランプを用いて安定させた。

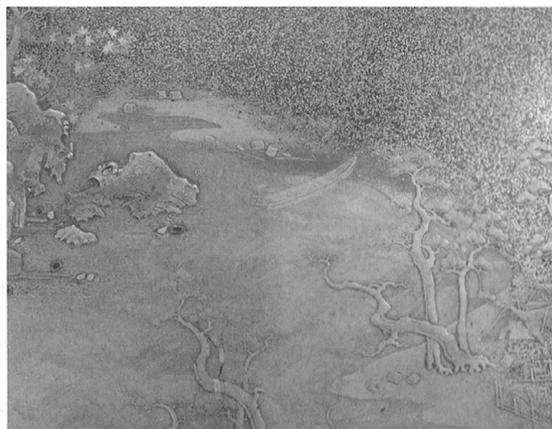
本資料は、ヨーロッパでの修復の際に塗料が塗られ、紫外線や経年変化により塗料の塗膜が劣化していた。また、漆塗膜も劣化し大変脆くなっている為、塗料除去は細心の注意を払った。

図14 塗料除去 (左 除去前、右、除去後)
Fig. 14 Removing the coating material (left: before removal; right: after removal)

塗料除去は、無水エタノールに50%ほどの蒸留水を混合し、綿棒や柔らかい布に含ませて、除去を行った。波部分の汚れは特殊な綿棒を使用し、付描に沿って丁寧に塗料や汚れを除去した。

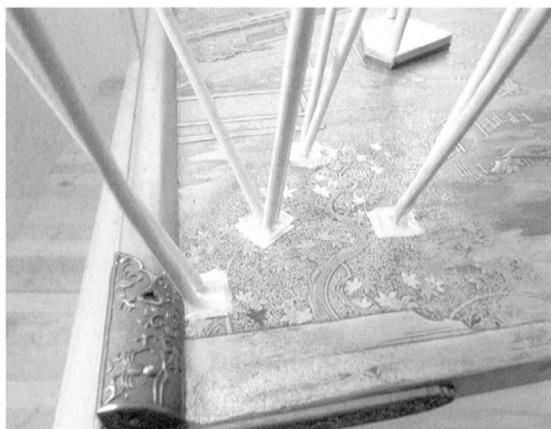
図15 剥離金具の圧着
Fig. 15 Press-stabilizing the lifted *kanagai*

塗料除去作業の前に剥離した金具の接着を行った。蒔絵部分にある金具は殆ど剥離状態にあり、捲れ上がった部分もあった。捲れ上がった金具や剥離した金具は丁寧に戻し、膠を含浸し接着した。金具の圧着は、竹ヒゴの弾力を利用した芯張り方法で安定させた。

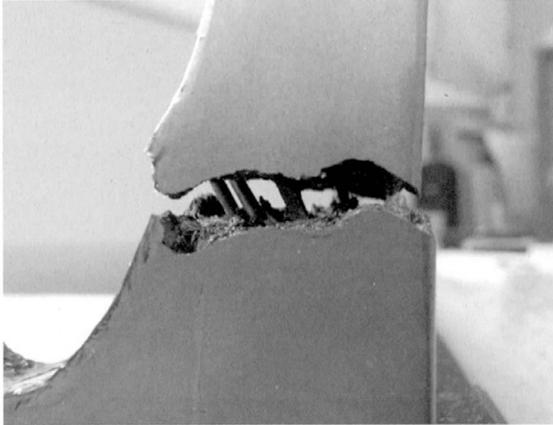
図19 脚 損傷部分
Fig. 19 Leg, damaged portion

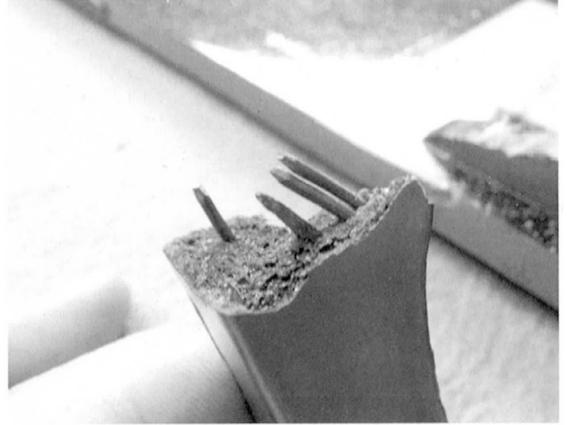
図20 脚 後補の釘
Fig. 20 Leg, nails from a previous restoration

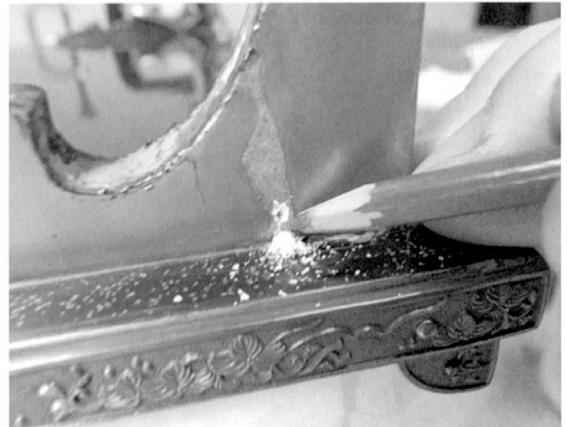
図24 後補材の除去
Fig. 24 Removing western restoration material from a previous restoration

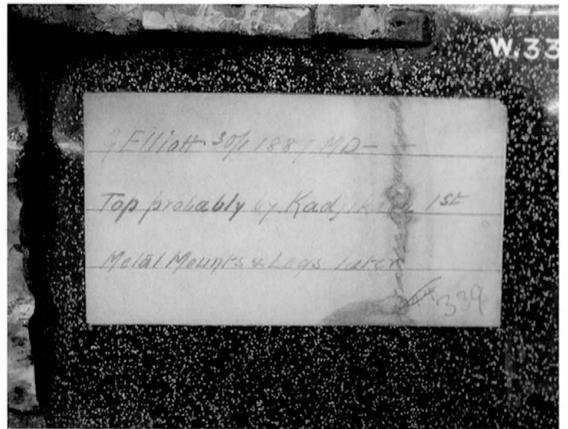
甲板裏面にある紙片は、本資料の購入時の事を書いてあり資料として貴重なものである。しかし、紙片の下には、亀裂があり修復作業を進めていくうえで取り除く必要があった。所蔵美術館の担当者と当研究所の担当者と協議した結果、取り剥がし別保存することになった。また、白書きされた所蔵番号は除去し、修復終了時に同じ場所、同じ字体で書くことに決まった。

図28 作品購入時のラベル
Fig. 28 Label with information about the purchase of the object

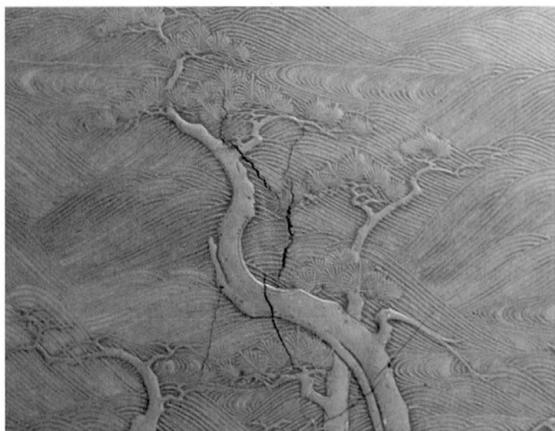
图45 修復前 (龟裂部分)
Fig. 45 Before restoration (cracked portion)

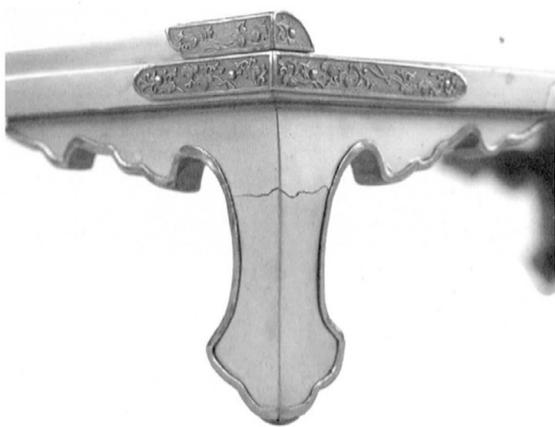
图47 修復前 (脚龟裂部分)
Fig. 47 Before restoration (cracked portion of the leg)
