花鳥紋章蒔絵楯

平成19・20年度修復事業

修復品名	花鳥紋章蒔絵楯
所蔵	アシュモリアン美術館（イギリス）
修復品年代	17世紀
修復品寸法	53.5cm×54.0cm 高さ6.5cm
修復期間	平成20年6月～平成21年3月（10ヶ月間）
修復場所	東京文化財研究所 漆修復アトリエ

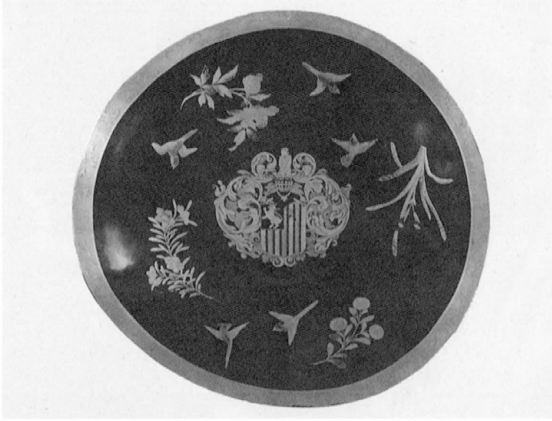
楯の素地に使われた皮の収縮により、形は大きく変形し、漆下地や漆塗膜にダメージを生じていた。また、漆塗膜には経年劣化や紫外線による損傷があり、塗膜表面はヨーロッパにおいて塗料が塗布されていた。尚、修復前の損傷部分の詳細は下記に記す。

图1 修復前 (表面)
Fig. 1 Before restoration (outer side)

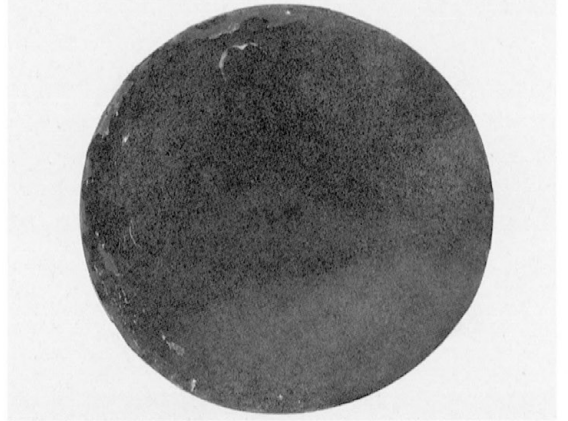
图2 修復前 (裏面)
Fig. 2 Before restoration (reverse side)

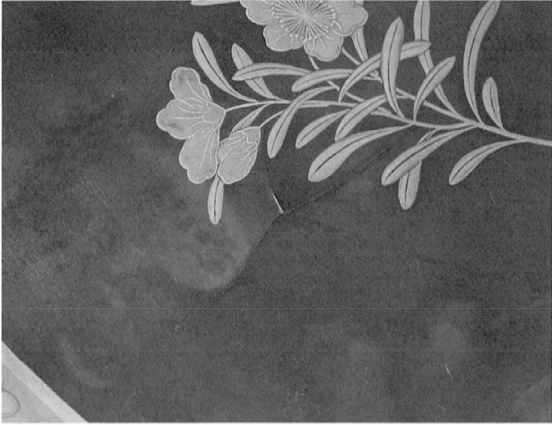
- ・楯の表面塗膜は、紫外線や経年劣化により塗膜表面の艶に斑を生じていた。
- ・楯の表裏の塗膜には、後世修理の際に塗られた塗料が劣化し、塗膜面には滲みや斑文があり、蒔絵部分は黒ずんで見えた。
- ・楯の表裏の縁部分には、素地の収縮や打損による漆塗膜の欠損が多く見られた。
- ・塗膜の欠損部分の周辺塗膜は剥離し、触るだけで剥落しそうな状態であった。
- ・表面左側の塗膜に4cmほどの亀裂があり、その周りの塗膜は剥離していた。
- ・裏面の塗膜面には、素地の収縮が原因と思われるひび割れを生じていた。
- ・裏面には塗膜が大きく剥離し、数回付けた膠下地が確認できた。
- ・裏面の梨子地塗に使われた銀粉が錆化していた。

图3 修復前 (表面) 塗膜龟裂部分
Fig. 3 Before restoration (outer side), part of the coating film with a crack

塗膜の欠損部分や亀裂部分の戻しきれない隙間には、麦漆に木粉や麻の繊維を混ぜ合わせ、珪藻土を焼いた地の粉を加えた刻苧を充填し形態を復元した。刻苧での形態復元はオリジナルの漆塗膜面よりやや低めとし、充分乾燥した後、砥石で刻苧肌を研いで整えた。

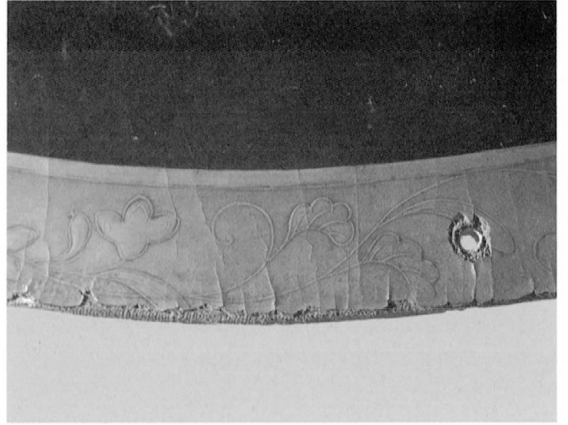
图4 修復前 (表面縁)
Fig. 4 Before restoration (rim on the outer side)

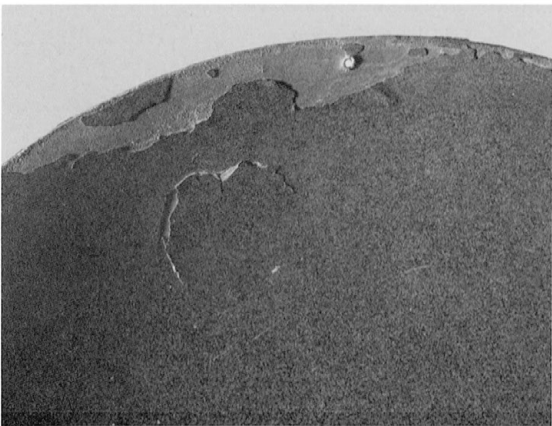
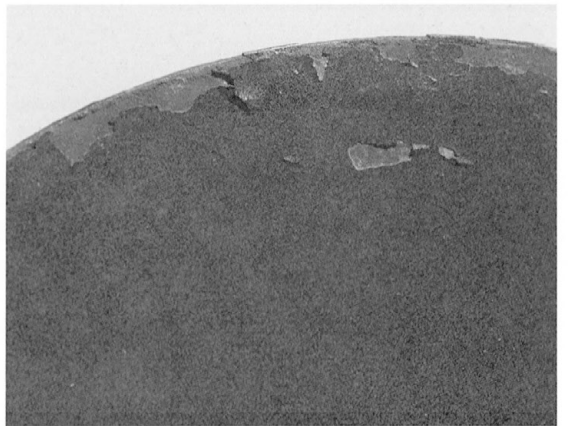
裏面の大きく剥離した部分には、膠下地が層になって剥がれていた。この様な制作当初の下地の様子が確認できるのは貴重な資料になる為、所蔵美術館の担当者や当研究所の担当者と協議した上で、一部分を今後の資料として現状保存する事にした。

图5 修復前 (裏面) 塗膜 剝離剝落部分
Fig. 5 Before restoration (reverse side), part with lifted and missing coating film

图6 修復前 (裏面) 塗膜 剝離剝落部分
Fig. 6 Before restoration (reverse side), part with lifted and missing coating film

尚、裏面の今後の資料として現状保存する箇所の塗膜圧着には、制作時の下地に使われた膠で接着を行った。

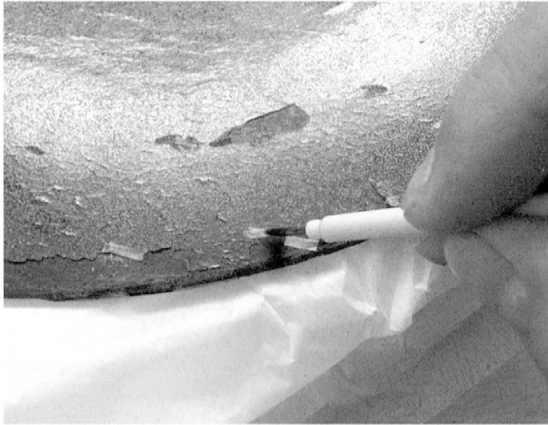
図7 養生
Fig. 7 Facing

本資料の欠損部分や亀裂部分の塗膜周辺は、作業中剥落しそうな危険な状態にあるため、細かく切った雁皮紙を糊貼りし塗膜の剥落防止を行った。

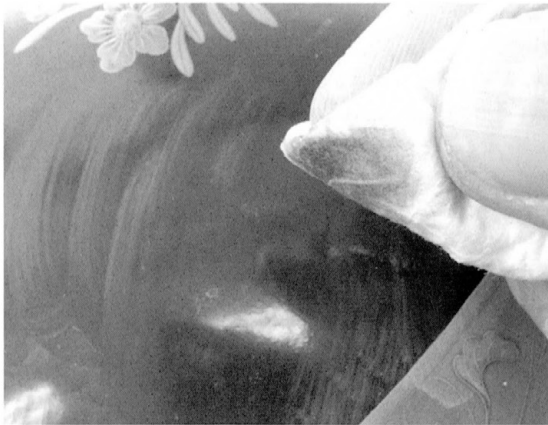
図9 後補塗料 除去作業中
Fig. 9 Removing coating material from previous restorations

本資料は、ヨーロッパでの修復の際に塗料が塗られ、紫外線や経年変化により塗料塗膜が劣化していた。また、塗料下の漆塗膜も劣化し大変脆くなっていて、加飾部分にある塗料の除去は細心の注意を払った。塗料除去に使用する溶剤は、劣化した漆塗膜に影響を与えない溶剤を選択した。

塗料除去は、無水エタノールに30%~50%の蒸留水を調合し、綿棒や柔らかい布に含ませて丁寧に除去した。

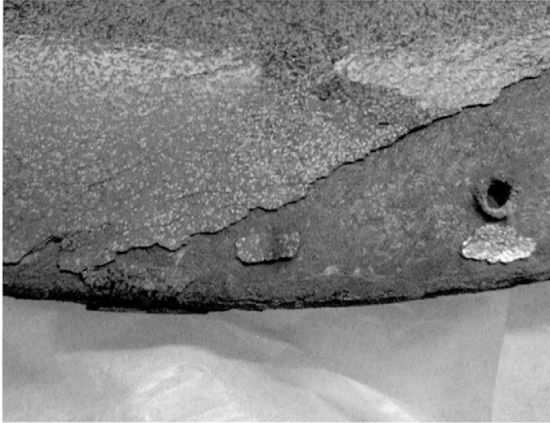
図13 裏面縁 損傷部分
Fig. 13 Rim on the reverse side, damaged portion

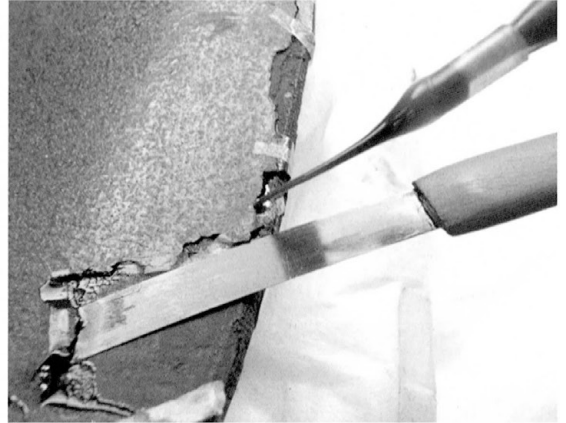
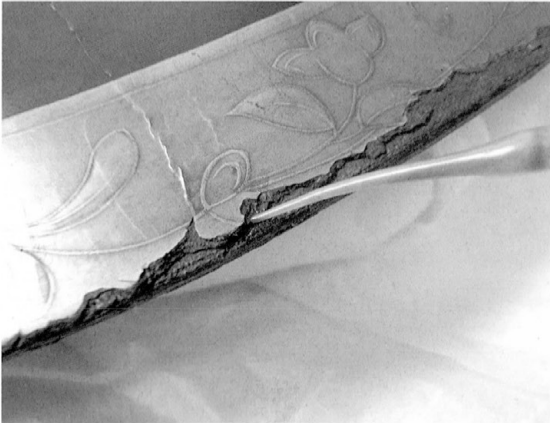
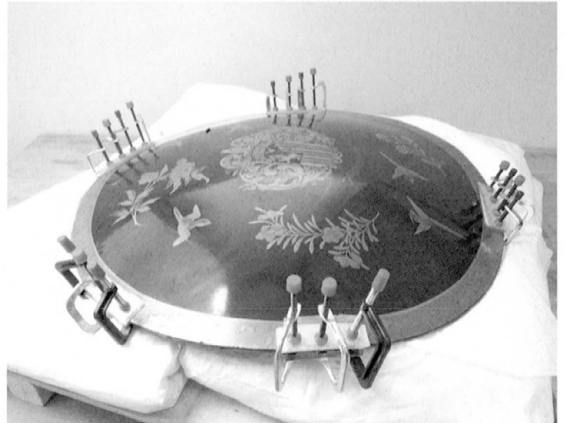
図14 剥離部分に麦漆含浸
Fig. 14 Impregnating *mugi-urushi* to a part with lifted coating film

図15 剥離部分に麦漆含浸
Fig. 15 Impregnating *mugi-urushi* to a part with lifted coating film

図16 麦漆含浸後 クランプ圧着
Fig. 16 After impregnating *mugi-urushi*, press-stabilizing with clamps

亀裂部分や欠損部分の周辺塗膜は剥離状態で、安全に作業を行う上で裏面の剥離塗膜から圧着する必要があった。剥離部分の接着は、接着力を強くするためグルテンの量を多くした麦漆を使用した。

先ず、麦漆をリグロインで希釈しスポイトにて剥離塗膜下へ含浸し、リグロインの揮発を待って再度希釈濃度を変えた麦漆を含ませた。圧着作業は、形状の異なった数種類のクランプを使い分けて剥離塗膜の安定を計った。

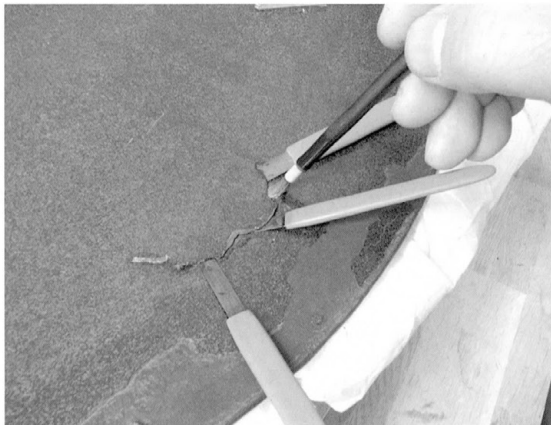
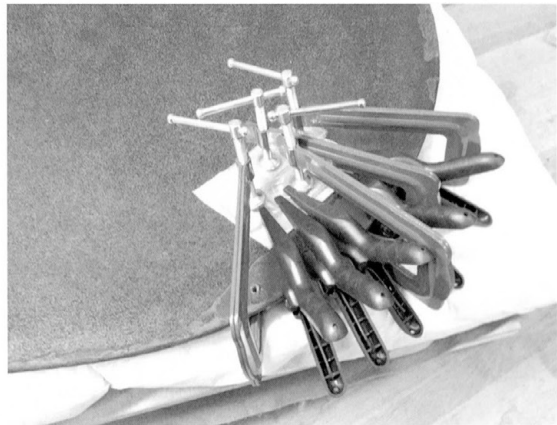
図19 膠含浸(裏面)
Fig. 19 Impregnating animal glue (reverse side)

図20 膠含浸後 クランプ圧着
Fig. 20 After impregnating animal glue, press-stabilizing with clamps

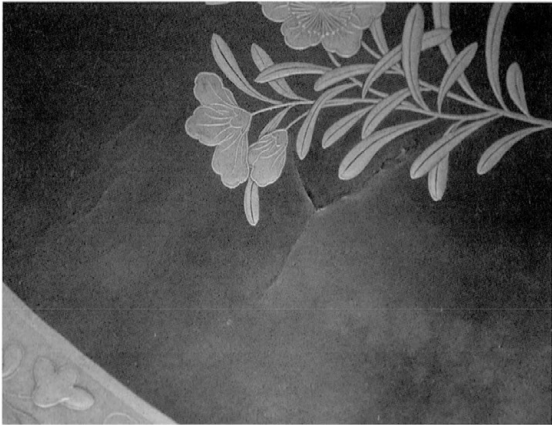
図39 修復後 亀裂部分
Fig. 39 After restoration, part of the coating film with a crack

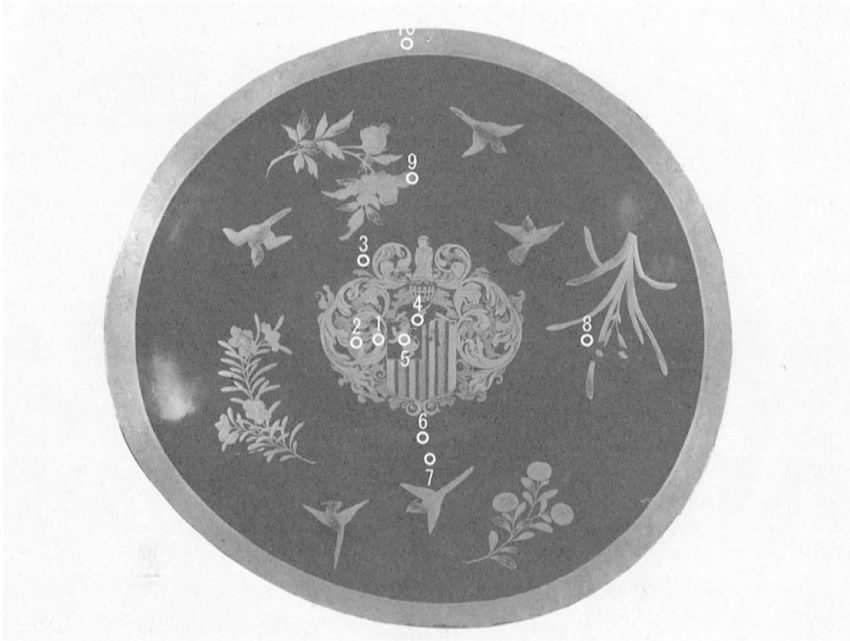
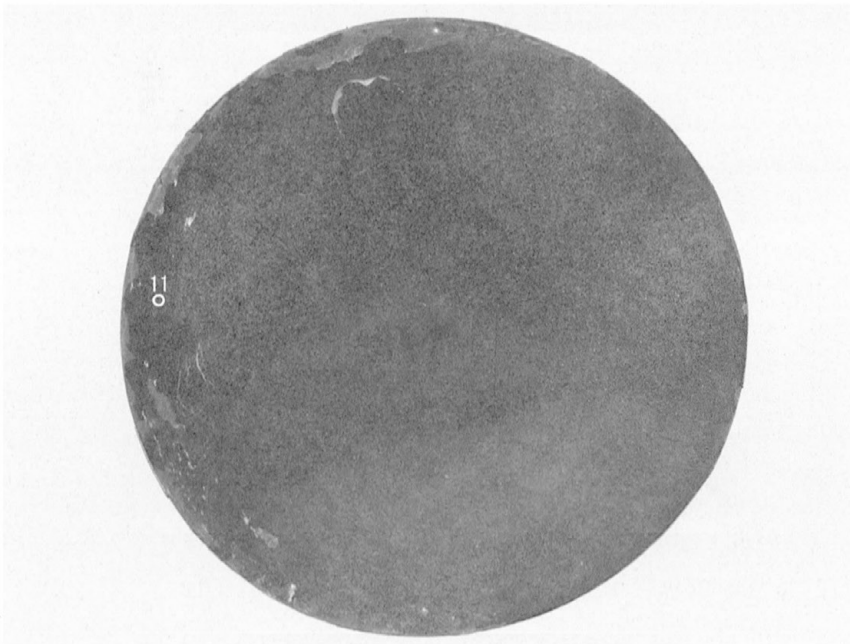
花鳥紋章蒔絵楯 蛍光X線分析位置
Points for X-ray fluorescence analysis

- ・金色部分 (1, 5, 10) の材料はAu97-Ag1-Cu2 wt.%とほぼ同じ化学組成である。
- ・茶色部分 (3, 4, 8) からはFeとHgが比較的多く検出されており、Fe系材料とHg系材料が併用されていると考えられる。
