花樹鳥獸蒔絵螺鈿洋櫃 (ケルン東洋美術館)

*Ornamental Coffin*

Museum für Ostasiatische Kunst, Köln

平成18・19・20年度（3年計画の3年目）修復事業

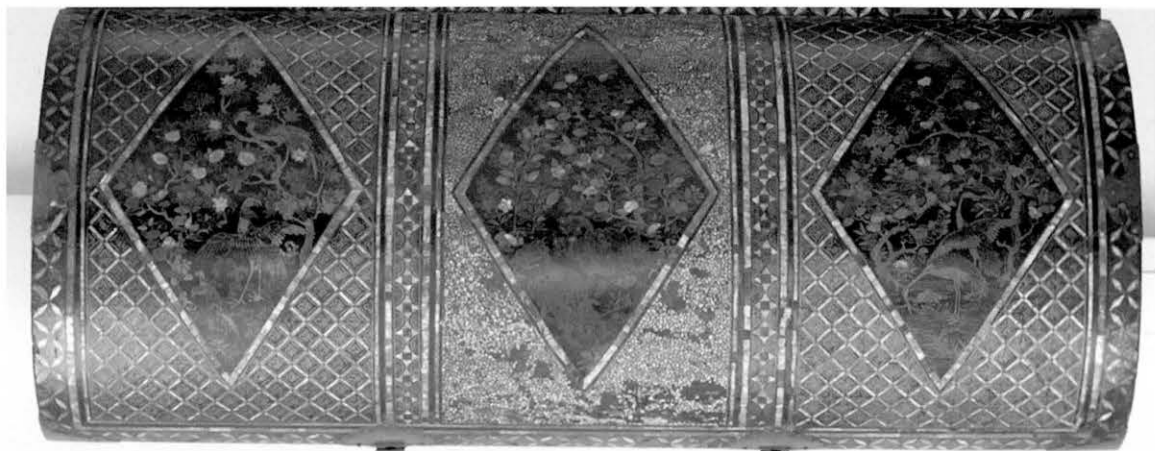
蓋甲板 修復前  
Top board of the lid before restoration, 2006

- On the top board of the lid, the coating film inside the rhombus-shaped cartouche had become dark due to the coating film that had been applied in the past, making it difficult to see the *makie* decoration.

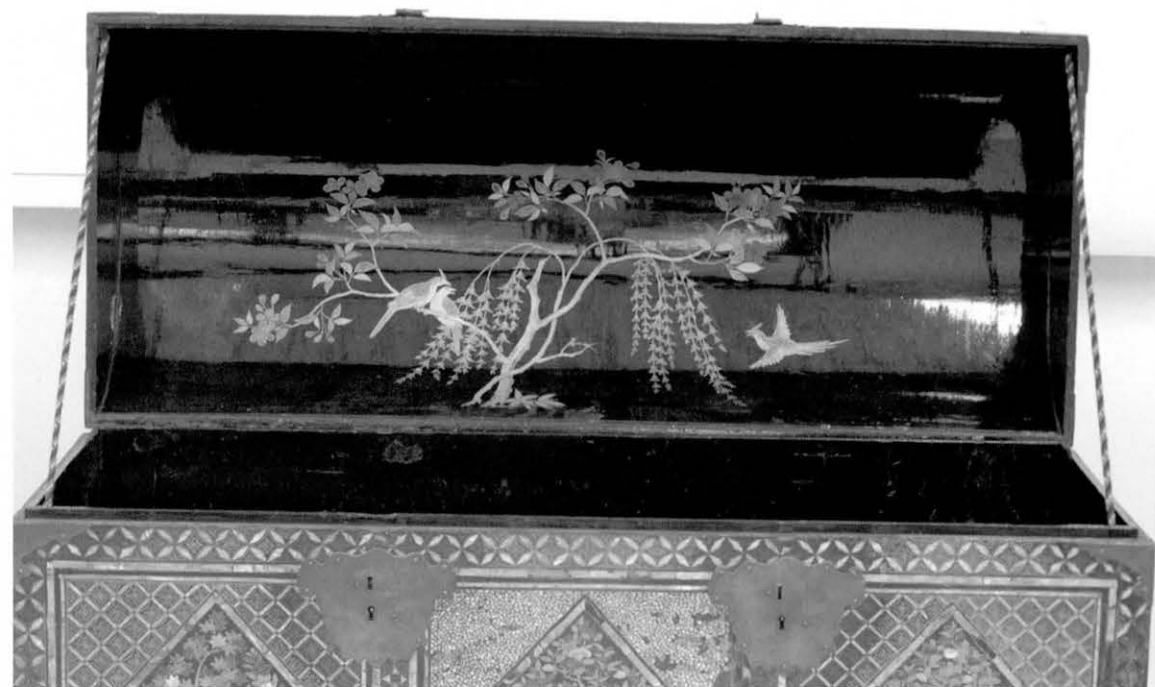
- ・内側には、木地の接合部と思われる箇所に2本の亀裂を生じている。
- ・左右側面に打損による塗膜の損傷がある。
- ・蓋表の錠金具の付け替え時に生じた、釘による塗膜の損傷がある。
- ・内角の表面塗膜にカビによるとと思われる汚れがある。

蓋内側  
Inside of the lid, 2006

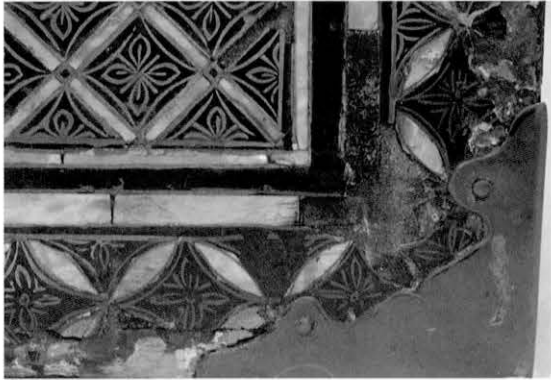
- ・蓋の正面中央のみじん置きされた貝は、剥離剥落が多く目立つ。一部後世に張り戻された部分があり、接着剤が溢れ、貝も乱雑に置かれている為、非常に見苦しい状態である。
- ・蓋の正面、螺鈿の剥落部分に、白い下地に銀色の塗料が塗られ、その塗料に断文がある。
- ・蓋の甲板部分、菱形枠内には後補で塗られた塗料の影響で、塗膜が黒ずんで蒔絵が見え難い状態である。
- ・蓋の正面左側の角金具周辺は、漆塗膜や螺鈿の剥落が多くあり木地が露出している。

金具周辺部分の損傷  
Damage around a metal fitting, 2006

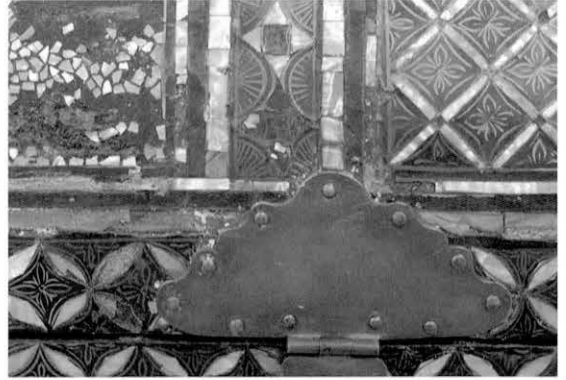
金具周辺部分の損傷  
Damage around a metal fitting, 2006

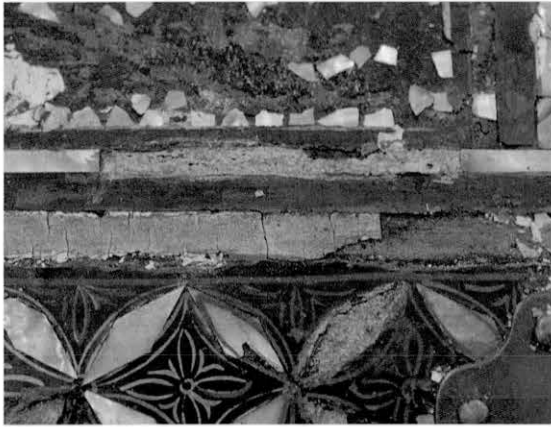
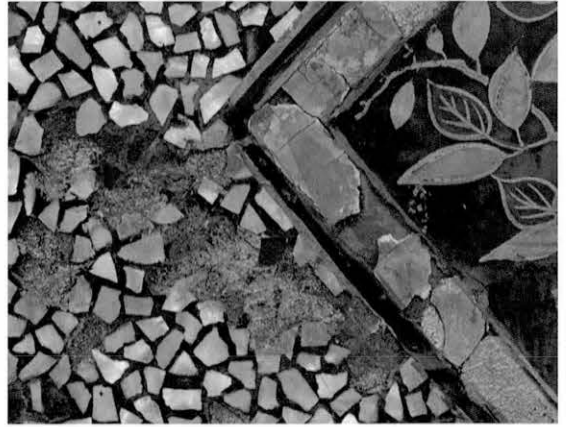
後補材料の剥落  
Loss of restoration material from past restorations, 2006

螺鈿の欠損部に充填されていた後補の充填部のうち、粗雑であったり色調が合わなかったりしたものは、慎重に刃物などを使用して除去した。除去した後補充填材の一部はサンプルとして保管した。

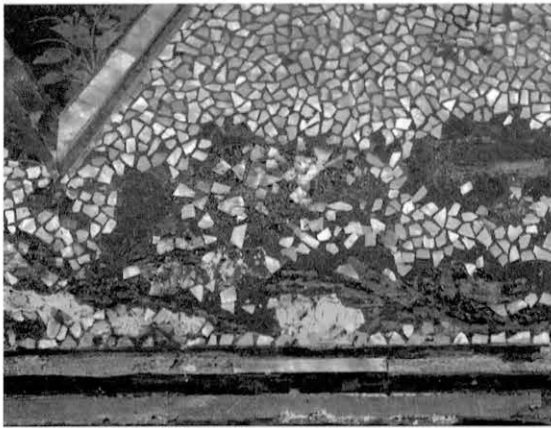
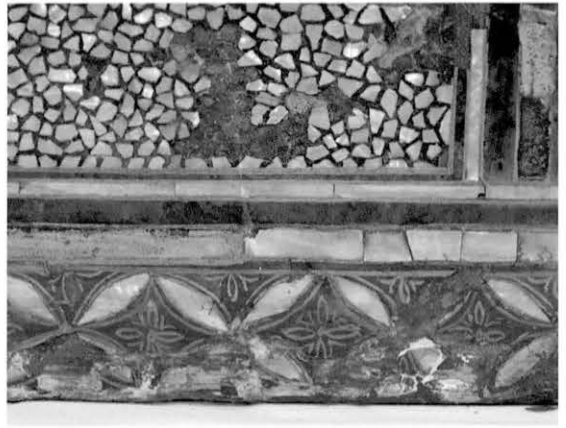
螺鈿の剥落  
Missing raden shell pieces, 2006

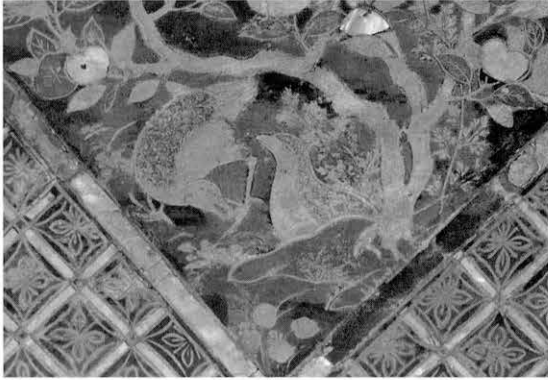
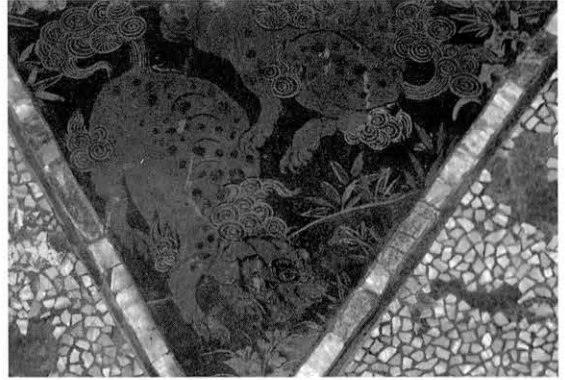
- ・洋櫃の表面塗膜は全体に艶が無く、後補によるヨーロッパ製の塗料が塗られ全体に黒ずんで見える。また、塗られた塗料が劣化し白濁化している。
- ・錠金具、提環、角金具及び銅釘は、全てヨーロッパでの作り替えである。

後補塗料  
Coating material from past restorations, 2006

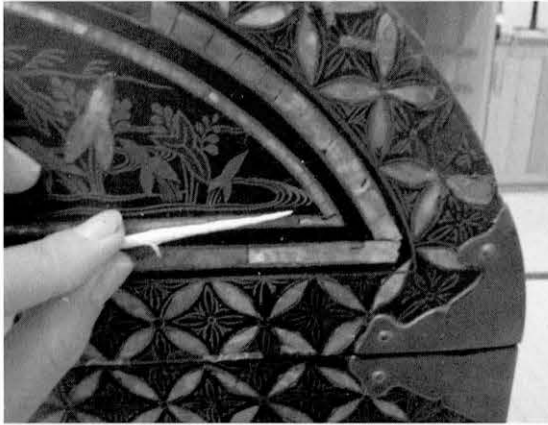
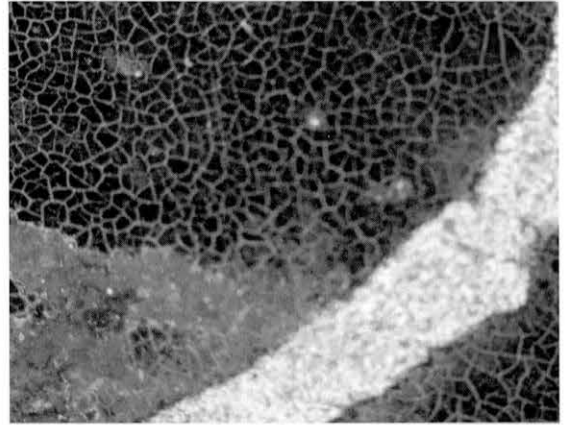
漆塗膜の劣化 後補塗料の劣化  
Deterioration of ursuhi coating film, deterioration of coating material  
from past restorations, 2006

漆塗膜の劣化 後補塗料の劣化×50  
Deterioration of ursuhi coating film, deterioration of coating material  
from past restorations × 50, 2006

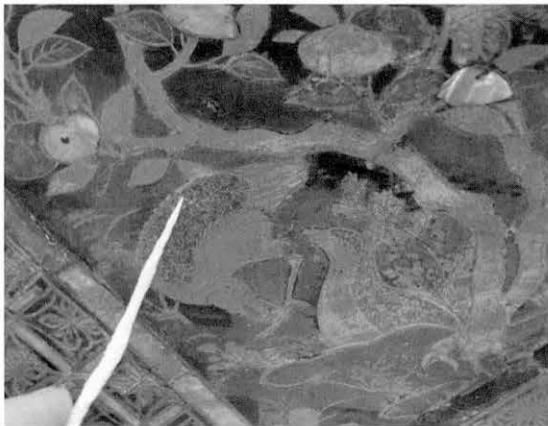
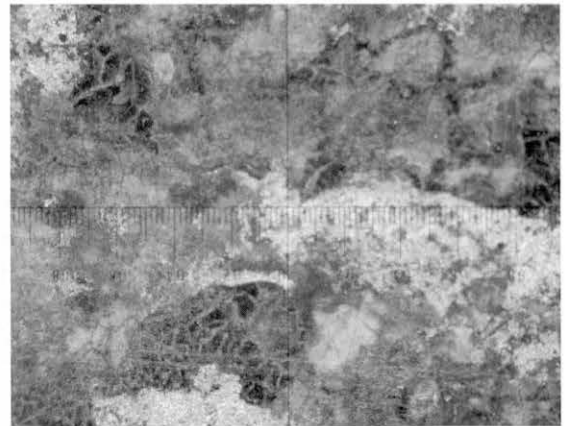
後補塗料の劣化  
Deterioration of coating material from past restorations, 2006

後補塗料の劣化×50  
Deterioration of coating material from past restorations × 50, 2006

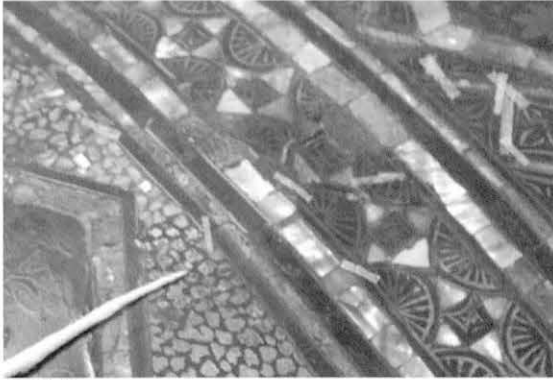
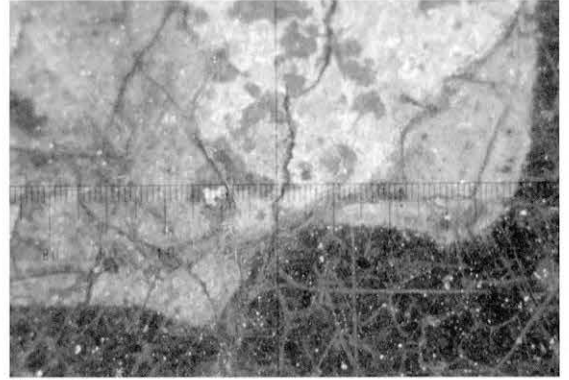
後補塗料  
Coating material from past restorations, 2006

後補塗料×50  
Coating material from past restorations × 50, 2006

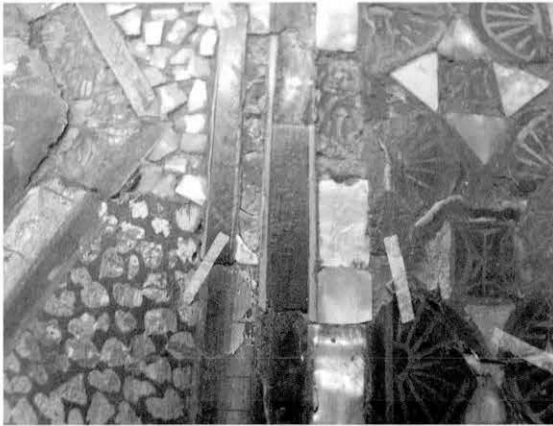
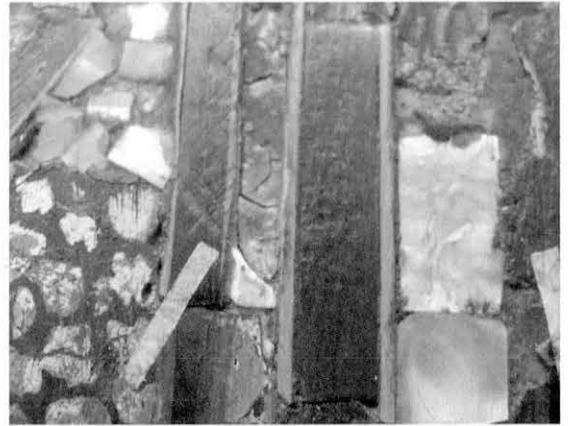
木象嵌による修復  
Restoration in Europe by inlaying wood, 2006

木象嵌による修復 拡大  
Restoration in Europe by inlaying wood, enlarged, 2006

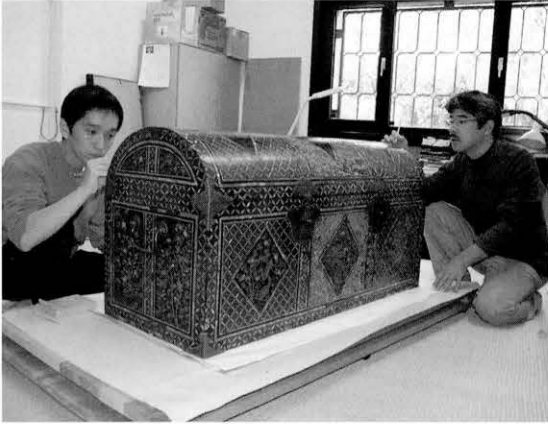
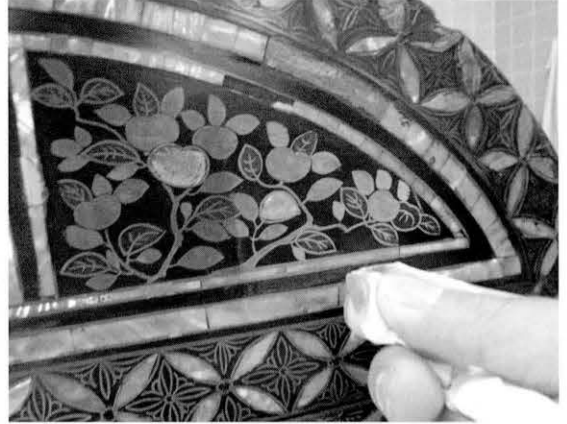
クリーニング後補塗料の除去  
Cleaning, removing coating material from past restorations, 2006

塗料除去に使用した溶剤は、先ず、無水エタノールに蒸留水を50%ほど混ぜた溶剤を綿棒に含ませて塗料面に塗布して後補塗料を膨潤させた後、無水エタノールで拭き取る方法でクリーニングを行った。

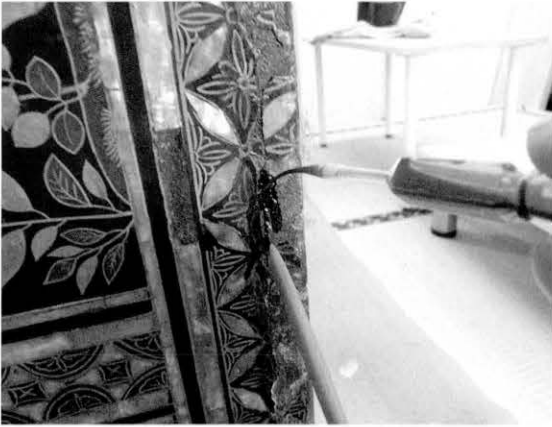
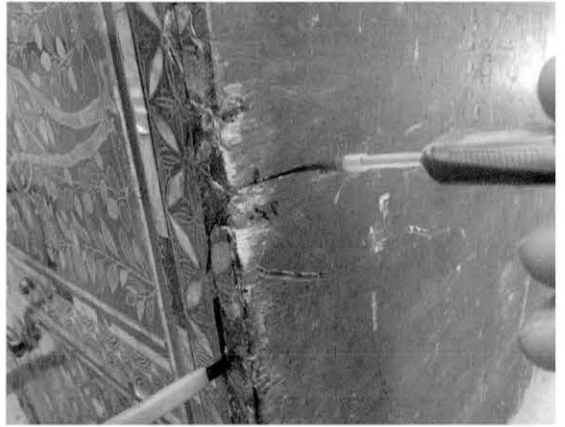
亀裂部分に麦漆の含浸  
Impregnating *mugi-urushi* into a crack

蓋甲板の中央付近、両端側面の木地接合部、底板との接合部に生じた木地の亀裂部分に溶剤で希釈した麦漆を含浸した。なお、溶剤はドイツ国内で購入した石油系溶剤を用いた。

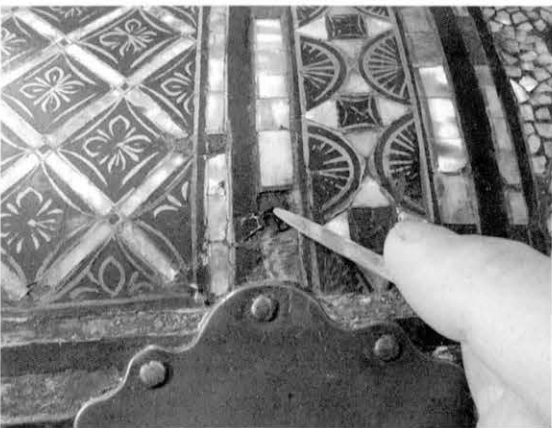
刻字の充填  
Filling *kokuso*

麦漆に炭化させた松の木粉（惣身粉そうみこ）と珪藻土を炭化させた地の粉（輪島地の粉三辺地）を混合して作った刻苧を塗膜欠損部や素地の露出部分に充填した。
