近江八景蒔絵香棚 (市立ヴェルケ・メディジチ博物館)

Pair of Shelves for Incense
(Museum Velké Meziříčí)

近江八景蒔絵香棚

平成 20・21 年度修復事業

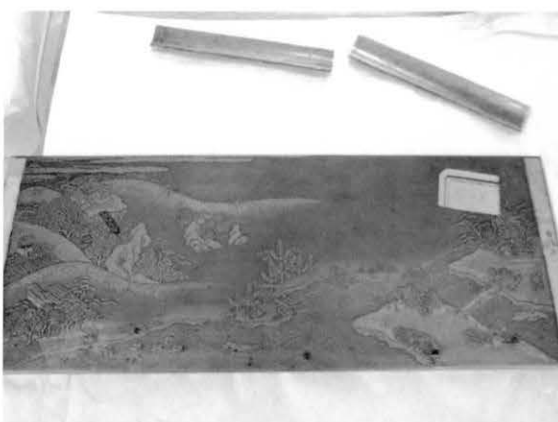
図4 修復前 天板部分
Fig. 4 Before restoration, top board

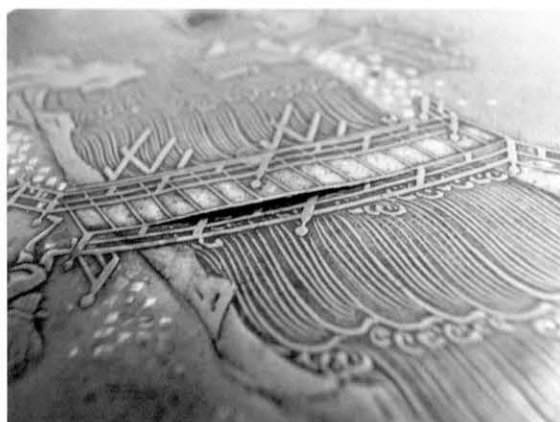
- ・ 棚の本地接合部の殆どが分解状態であった。
- ・ 棚板の1枚、数箇所の引出しが紛失していた。
- ・ 各部材の表裏の塗膜には、後世修復の際に塗られた塗料が劣化し、塗膜面にはしみや斑文があった。
- ・ 漆塗膜は、紫外線や経年変化による劣化で黒ずんで、銀梨子地粉が錆化していた。
- ・ 各部材の接合部には、制作当初や後補の接着剤が付着していた。
- ・ 部材の一部は接合状態であったが、外れそうな危険な状態であった。
- ・ 棧や脚の角や接合部には塗膜の欠損が多くあった。
- ・ 天板の蒔絵部分には紙片が付けられていた。
- ・ 蒔絵部分に貼られた金具の一部は剥離状態であった。

図10 金貝 剥離部分
Fig. 10 Kanagai, lifted part

蒔絵部分にある金貝や切金は剥離状態にあり、一部捲れた部分もあった。捲れた金貝は丁寧に戻し、膠を含浸し接着した。圧着には、竹ひごの弾力を利用した芯張り圧着法とクランプを使い安定させた。

Kanagai and *kirikane* on the *makie* decoration had become lifted and part were turned back. These were carefully placed back and adhered by impregnating animal glue. *Shimbari* method using the resilience of bamboo sticks and clamps was used for press-stabilization.

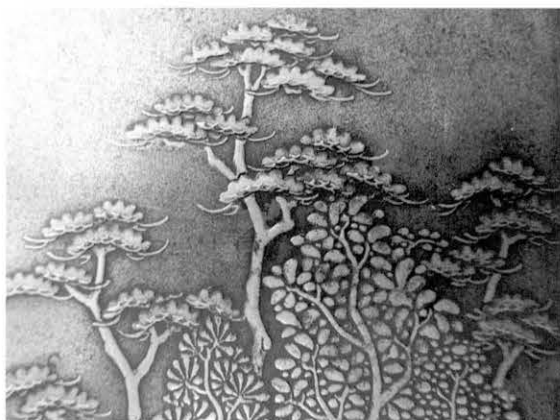
本資料は、ヨーロッパでの修復の際に塗料が塗られ、紫外線や経年変化により塗料が劣化していた。また、塗られた塗料が高蒔絵などの際に溜まり、黒ずんでいた。塗料の除去に使用する溶剤は充分テストを行い適切な溶剤を選択した。結果、エタノールに蒸留水を混合した溶剤で塗料除去を行った。

図11 後補塗料の溜まり
Fig. 11 Coating material of a past restoration that has accumulated

Coating material had been applied in Europe in past restorations, but it had become deteriorated due to UV ray and passage of years. In addition, some of the coating material on the edges of *takamakie* had become very dark. Solvent used to remove the coating material was tested sufficiently and the most appropriate one was selected. A mixture of ethanol and distilled water was used to remove the coating material.

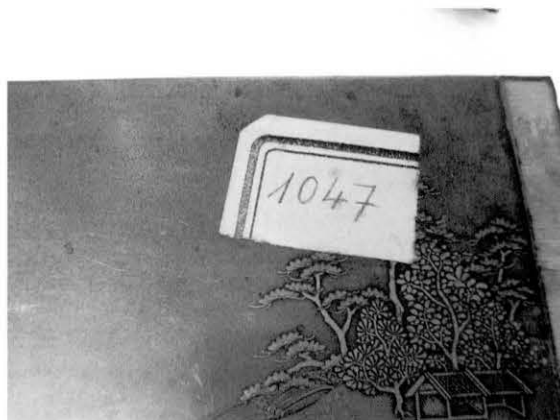
図12 天板に貼られたラベル
Fig. 12 Label attached to the top board

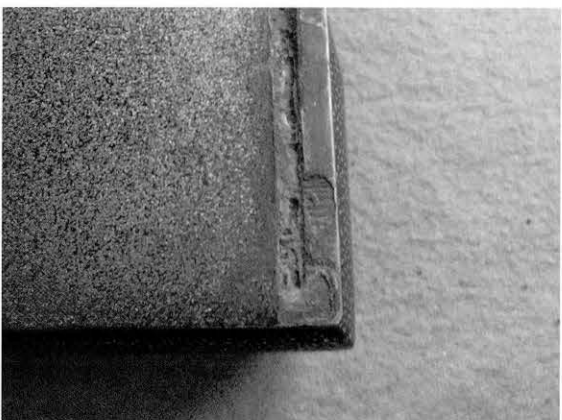
また、各部材の接合部の接着剤は膠が使われていたため、水分を含ませ膨潤させて竹の篋や刃物で丁寧に除去した。

図17 接合部 後補接着剤
Fig. 17 Joint; note the adhesive used in a past restoration

Since animal glue had been used as an adhesive to join the elements, it was swollen by applying moisture and carefully removed with a bamboo spatula and knife.

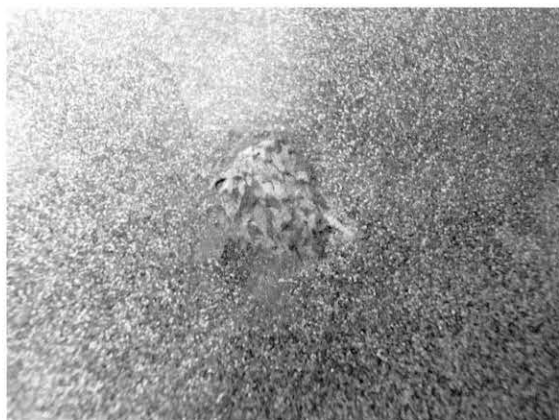
図19 後補

Fig. 19 Trace of a past restoration

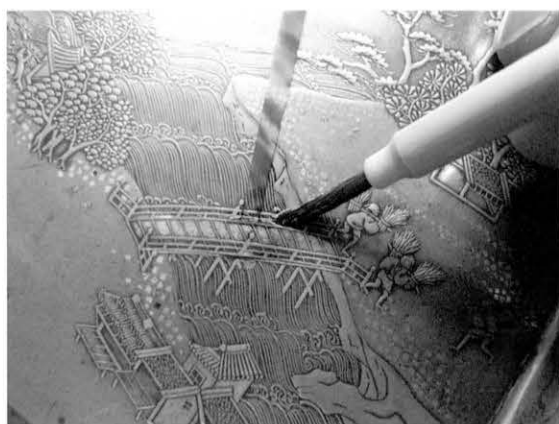
図21 剥離金具部分 膠含浸

Fig. 21 Lifted *kanagai* part, impregnating urushi

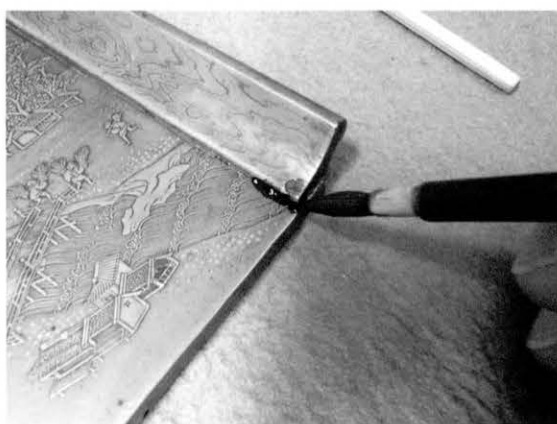
図22 亀裂部分 希釈した麦漆含浸

Fig. 22 Cracked portion, impregnating diluted *mugi-usurhi*

圧着の前に本資料の設置台や押さえ治具の準備を行い作業に取り掛かった。部材接合部や亀裂部分の透間から希釈した麦漆を含浸し、端金やクランプで圧着を行った。また、剥離した塗膜も同時に圧着を行った。圧着に使用した接着剤は、接着力を強くするためグルテンの量を多くした麦漆を用いた。

Before press-stabilization, a stand for parts to undergo restoration and tools were prepared. Diluted *mugi-urushi* was impregnated into the joints and spaces in the cracked portion before press-stabilizing with bar clamps. Lifted coating film was also press-stabilized. Since strong adhesion was needed, *mugi-urushi* containing more gluten was used for press-stabilization.

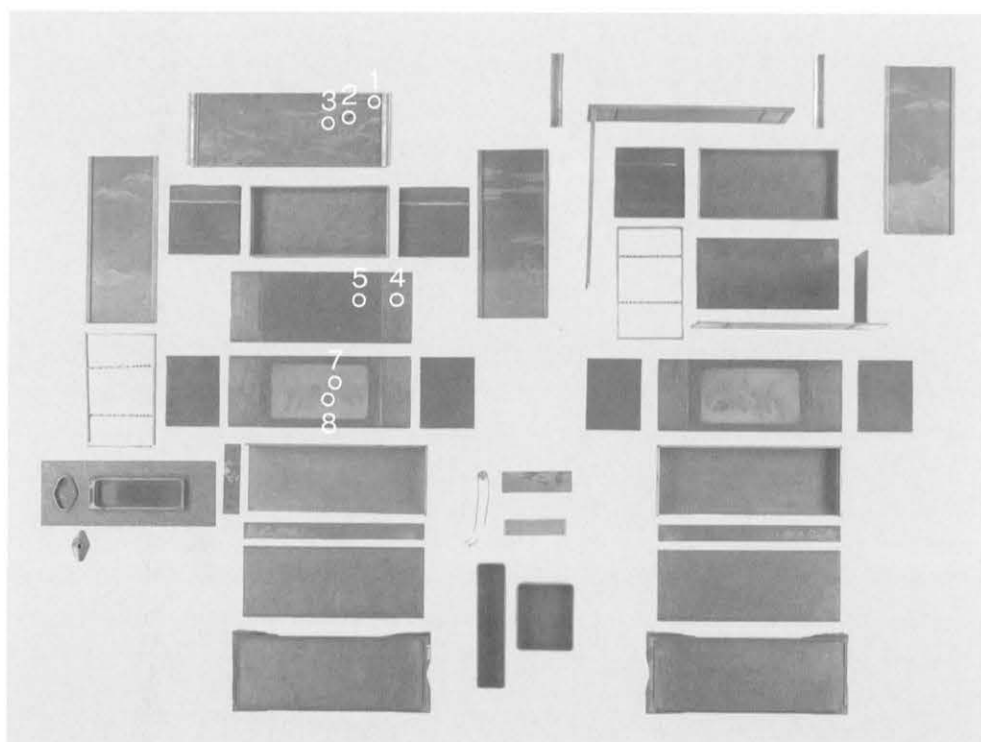
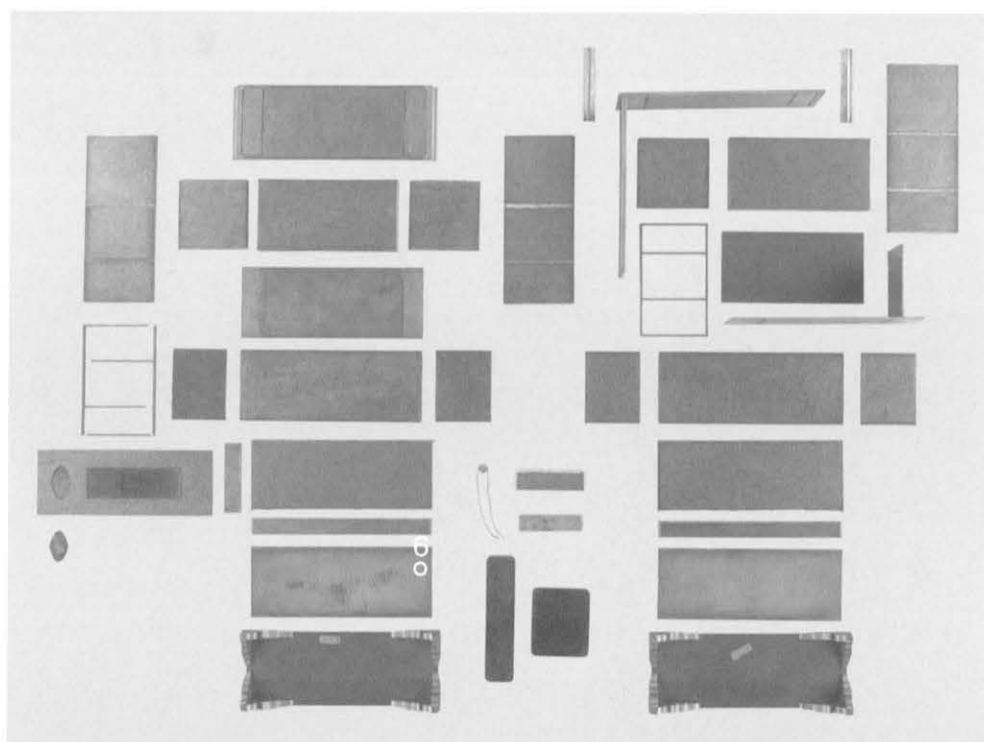
ヴェルケ・メデイチ博物館 近江八景蒔絵香棚 蛍光X線分析位置
Measuring points for X-ray fluorescence analysis

- ・本作品では多くの箇所で金粉と銀粉が併用されていると考えられ、それらの箇所については両材料の化学組成を正確に求めることは困難であり、上記表中では空欄にした。
- ・No.2は、粉ではなく単一材料の板(箔)状であり、Ag>99%以上の材料である。
- ・No.1からはHgが大量に検出された。他の箇所からは検出されない。その由来は不明である。

- (1) It is thought that gold powder and silver powder are used together at many places of this object and that it is difficult to obtain accurate chemical composition of both materials. For this reason, the chemical compositions are not filled in on the above table.
- (2) No. 2 is not in powder form. It is a foil of single material with Ag>99%.
- (3) A great amount of Hg was detected in No. 1 while it was not detected at other points. The reason, however, is not clear.
