蕪蒔絵大鼓胴 (ベルリン国立アジア美術館)

Drum Body with Turnip Design

On the Restoration of
Drum Body with Turnip Design

Tatsuya Matsumoto

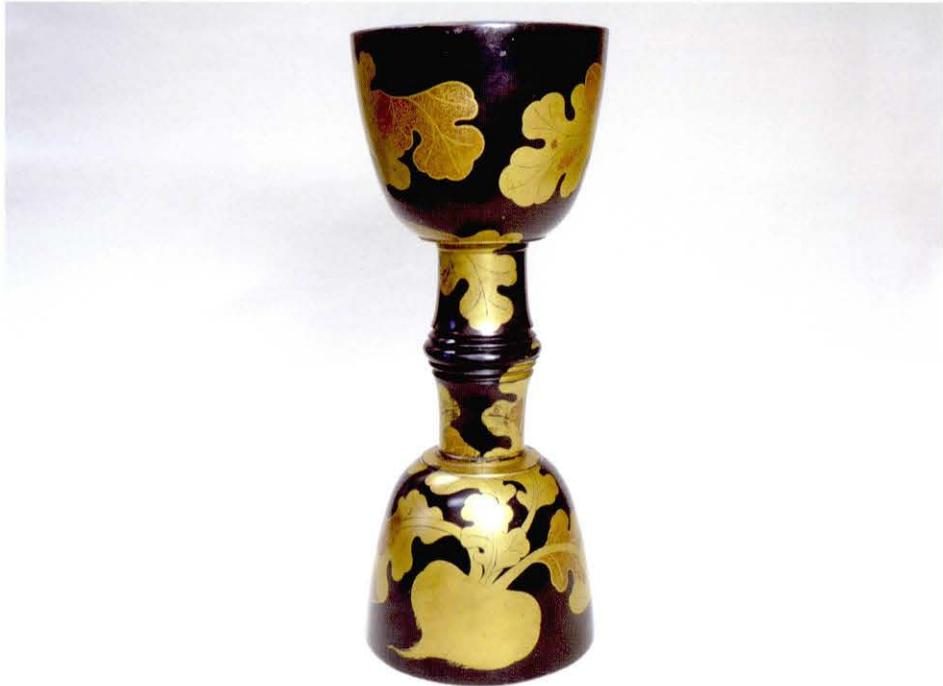
修復前 全景

Before restoration, overall view

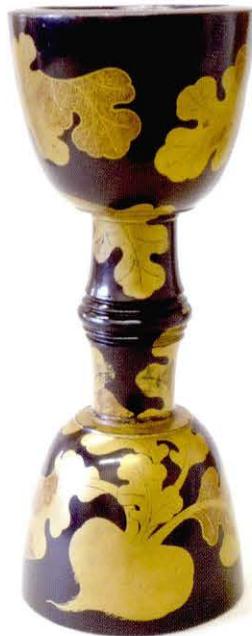
修復後 全景

After restoration, overall view

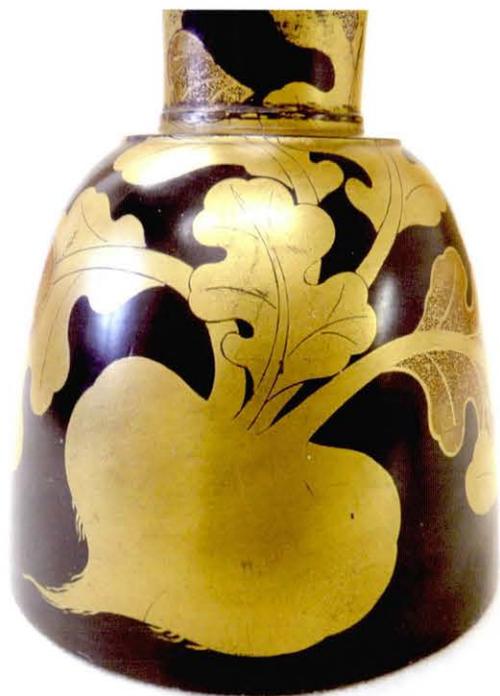
修復前 乳袋
Before restoration, bowl-shaped part

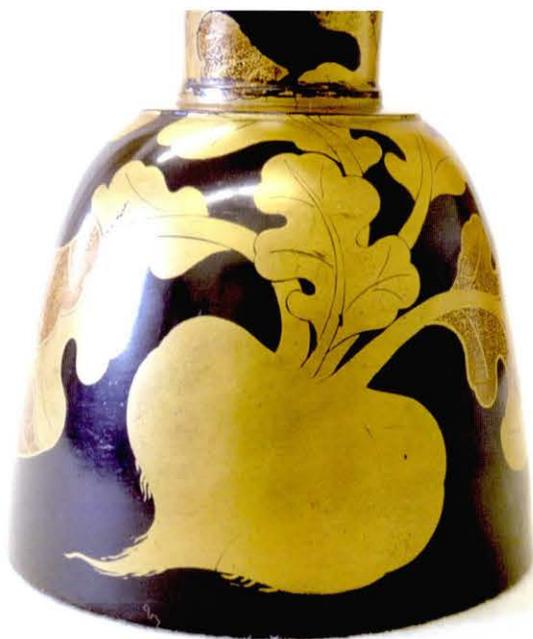
修復後 乳袋
After restoration, bowl-shaped part

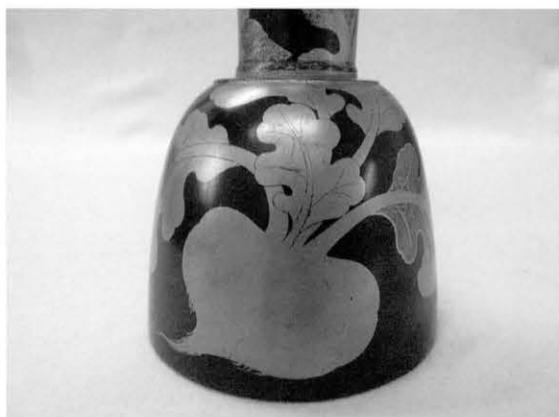
- ・ 漆塗膜や蒔絵は、経年変化や紫外線の影響で劣化し、艶の無い状態であった。また、塗膜表面には気泡が弾けたような塗膜剥離が無数見られた。
- ・ 棹の節部分の塗膜の殆どが剥離状態にあり、それらの塗膜も剥落しそうな危険な状態であった。また、棹部分の一部と思われる塗膜片が保管されていた。
- ・ 棹や乳袋に、擦り傷が多く見られた。
- ・ 乳袋の木口には、数箇所亀裂を生じていた。

圖4 修復前 乳袋

Fig. 4 Before restoration, bowl-shaped part

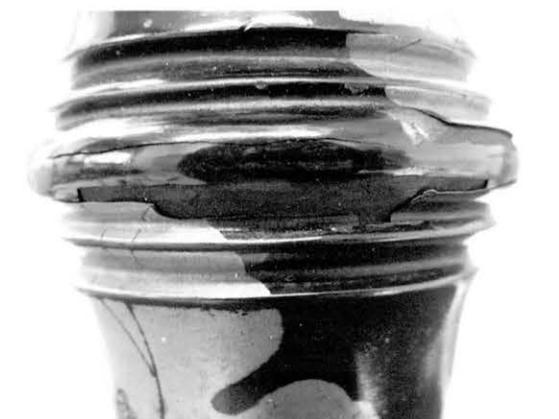
圖5 修復前 塗膜剝落部分

Fig. 5 Before restoration, part where the coating film has become lifted and/or detached

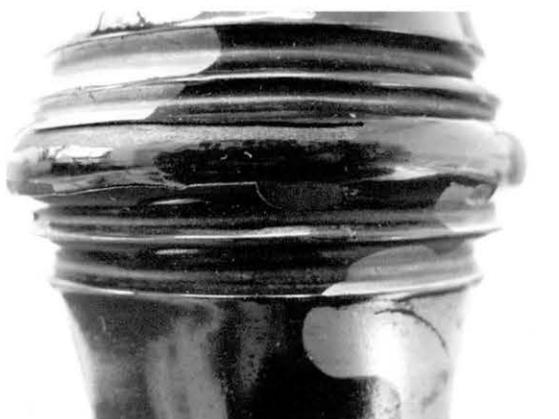
圖6 修復前 塗膜剝落部分

Fig. 6 Before restoration, part where the coating film has become lifted and/or detached

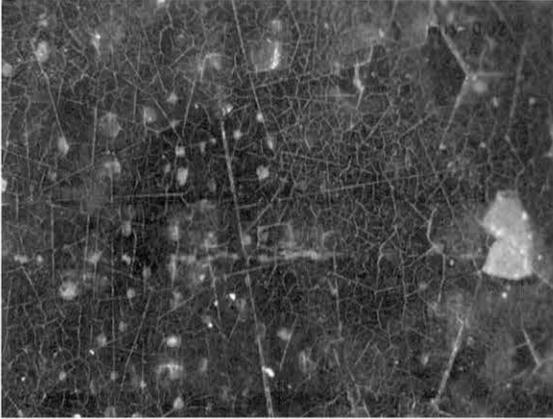
图7 塗膜劣化 (x 20)
Fig. 7 Deteriorated coating film (x 20)

- The urushi coating film and *makie* had deteriorated due to the passage of time and UV ray so that there was no gloss characteristic of urushi. There was a countless number of bubble-like spots on the surface of the coating film where the coating film had become lifted.
- Almost all of the coating film on the constricted parts of the waist had not only become lifted but were also ready to fall. Fragments of the coating film from a part of the waist were saved separately.
- There were many abrasion marks on the waist and the bowl-shaped part of the drum (*tsuzumi*).
- There were several cracks on the cut-end of the bowl-shaped parts.

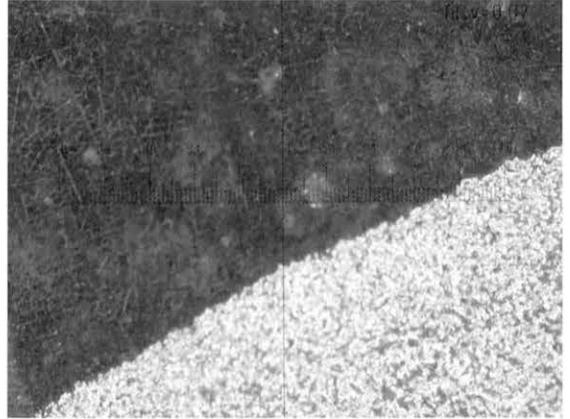
图8 塗膜劣化、蒔絵部分 (x 20)
Fig. 8 Deteriorated coating film, makie (x 20)

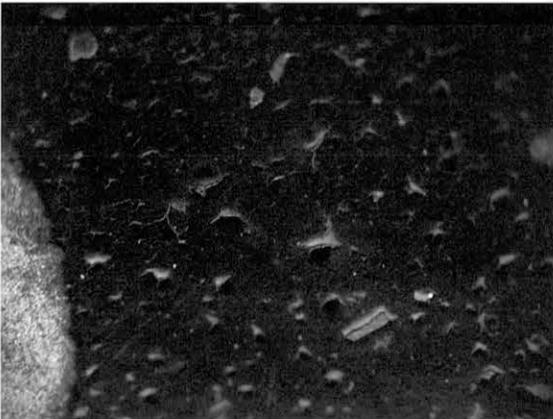
图9 塗膜剝離
Fig. 9 Lifted coating film

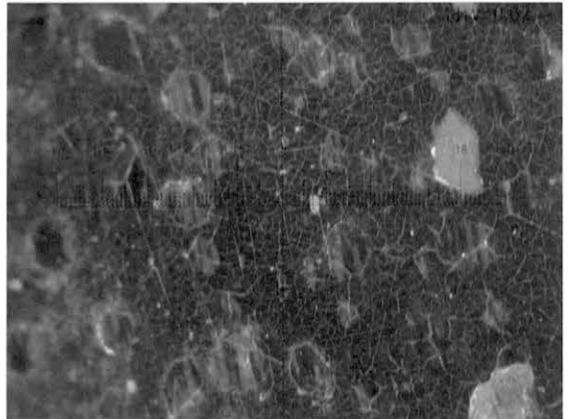
图10 塗膜剝落
Fig. 10 Lifted coating film

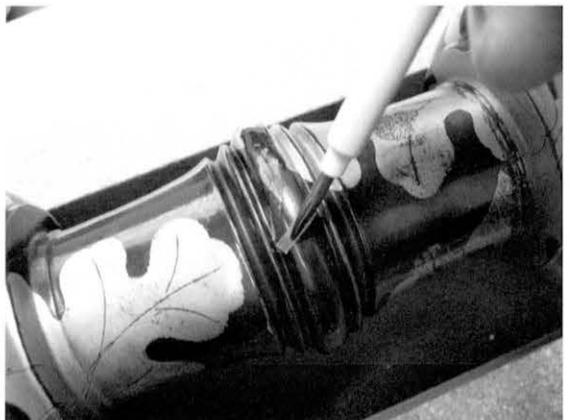
图12 養生
Fig. 12 Facing

The coating film around the missing areas and cracks on the object were in such a state that they might become completely detached. In order to prevent this, narrowly-cut strips of *gampi* paper and paste were used to hold the coating film down. The proper position of fragments of coating film that had been saved separately was confirmed.

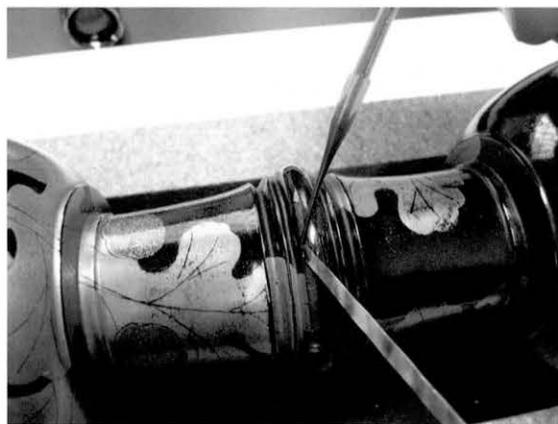
図 15 希釈した麦漆含浸
Fig. 15 Impregnating diluted *mugi-urushi*

To adhere the lifted coating film, *mugi-urushi* was used. In order to obtain stronger adhesion, flour that contains more gluten was kneaded in water and mixed with *kijomi urushi*.

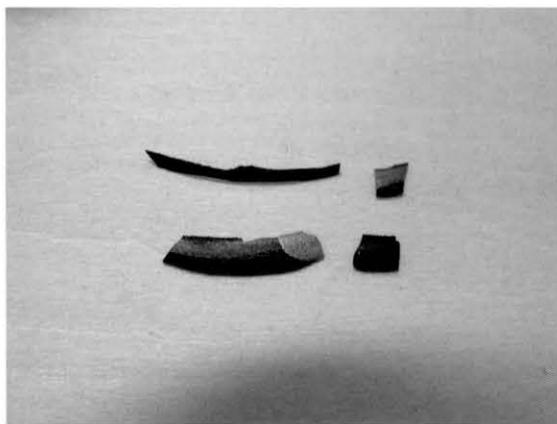
図 16 剥落した塗膜片
Fig. 16 Fragment of detached coating film

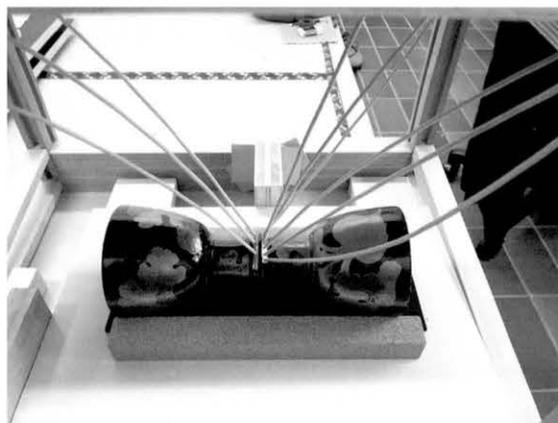
図 17 剝離塗膜の芯張り圧着
Fig. 17 Press-stabilizing lifted coating film with *shimbari* sticks

Preparations were done to make a stand and clamps for press-stabilization. The object was placed in a wooden frame so that it might be restored safely. Bamboo sticks were used in a technique known as the *shimbari* method.

Since the coating film on the waist was almost completely detached, it was stabilized by applying pressure several times.

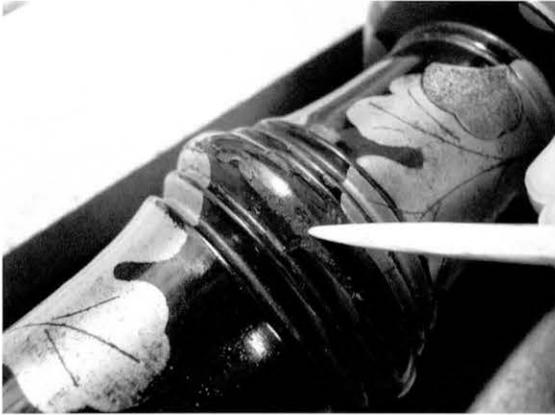
図 19 刻字充填
Fig. 19 Filling with kokuso

Gaps of the cracks that could not be easily closed and missing coating film were filled with *kokuso*, a mixture of *mugi-urushi*, sawdust and hemp fibers, and the shape was reproduced. *Kokuso* of different coarseness was used as required; it was applied several times. The surface of the area filled with *kokuso* was made one level lower than that of the original coating film.

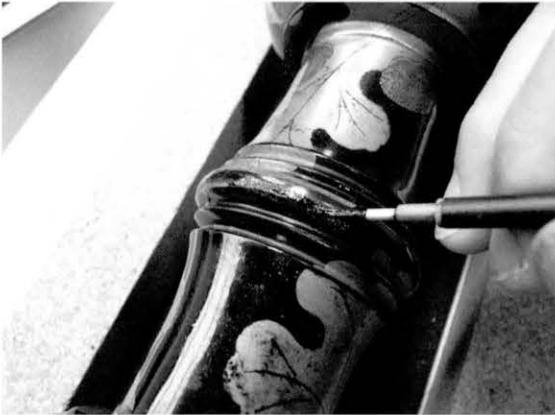
図 21 際錆
Fig. 21 Kiyasabi

Sabi-urushi made by mixing powdered diatomaceous earth to *mugi-urushi* was applied to the edges of the coating film that had been adhered and of the part filled with *kokuso* in order to prevent the coating film from becoming lifted again.

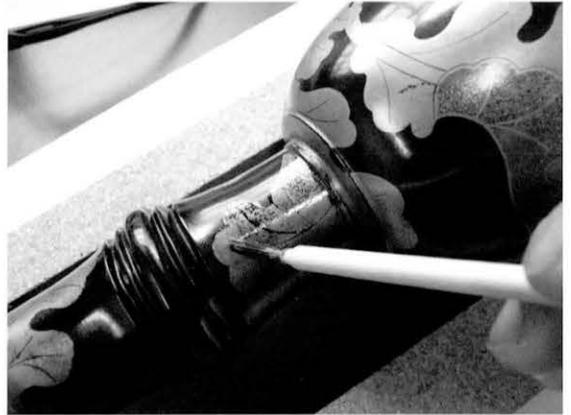
図 22 蒔絵部分の漆固め
Fig. 22 Urushigatame of makie

In order to reinforce the coating film and to give back gloss, a mixture of *kijiro urushi*, *nashiji urushi*

and *kijomi urushi* was diluted to about 4 times for *urushigatame*. Urushi was made to permeate into the damaged coating film. Urushi remaining on the surface was wiped off with a solvent.

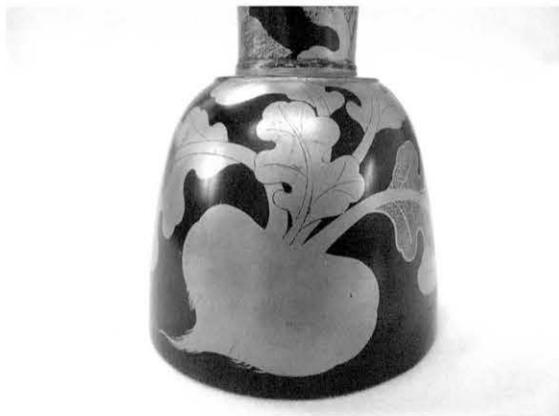
图 27 修復前 乳袋
Fig. 27 Before restoration (bowl-shaped part)

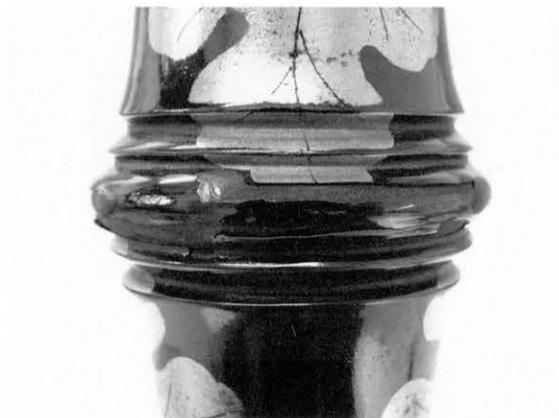
图 29 修復前 棹部分
Fig. 29 Before restoration (waist)

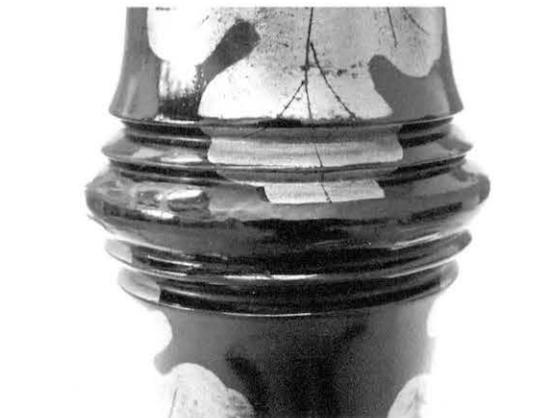
图 30 修復後 棹部分
Fig. 30 After restoration (waist)
