# 秋草虫籠蒔絵茶葉入

平成 21 年度修復事業

所蔵:国立ナールステク博物館 (チェコ)

松本達弥

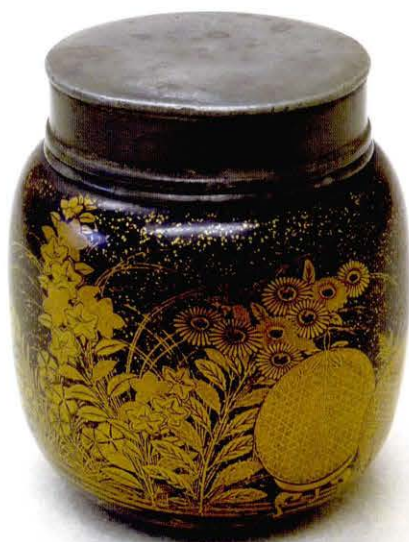
修復前 正面

Before restoration, front

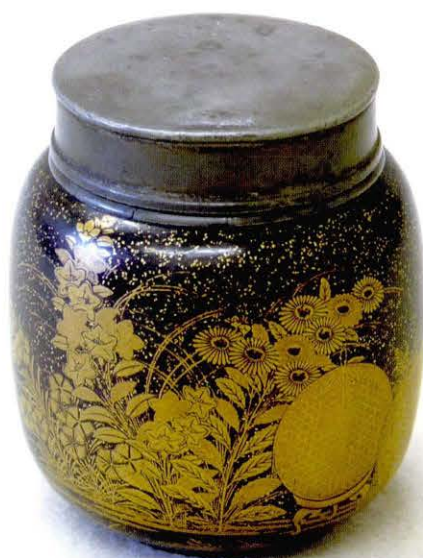
修復後 正面

After restoration, front

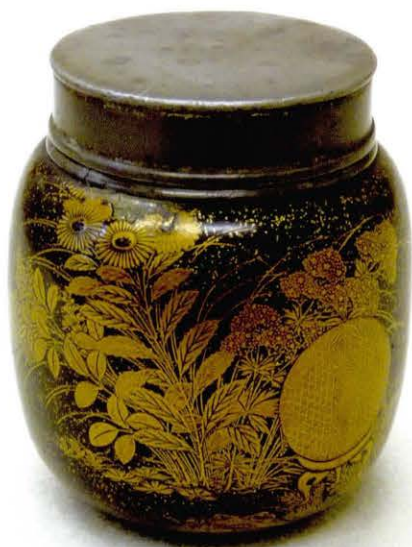
修復前 背面  
Before restoration, back

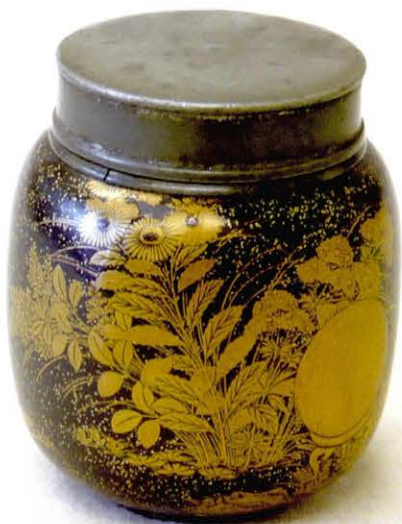
修復後 背面  
After restoration, back

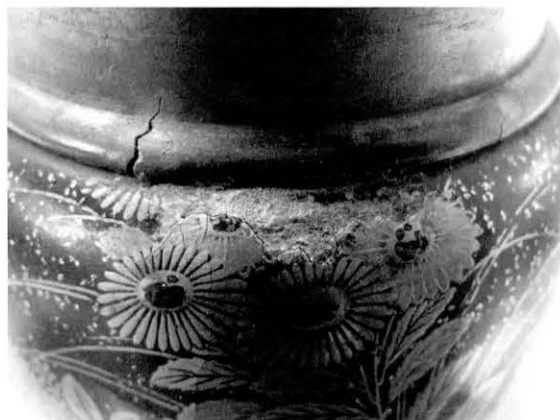
図4 修復前 損傷部分  
Fig. 4 Before restoration, damaged area

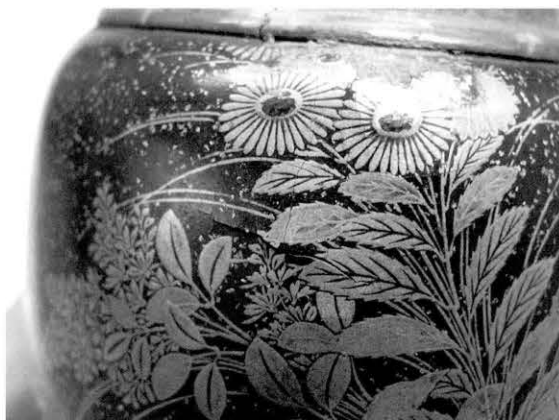
図5 修復前 塗膜亀裂部分  
Fig. 5 Before restoration, cracked coating film

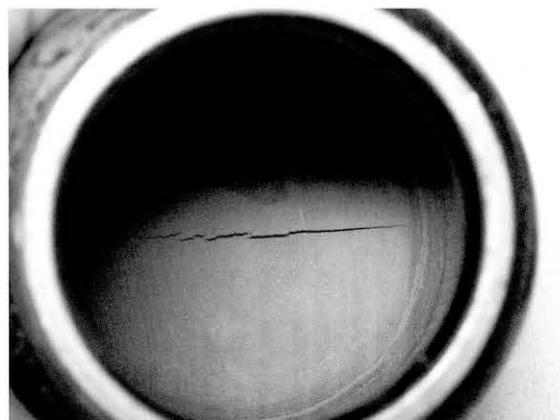
図6 内側 見込部分の亀裂  
Fig. 6 Crack on the inner side

- ・茶葉入に損傷を与えることなく安全に作業を遂行できるよう、凹型の設置台を制作し修復を行った。
- ・作業中に塗膜剥落を防ぐために、小片に切った雁皮紙を貼り養生した。
- ・塗膜除去に使用した溶剤は、劣化し脆くなった漆塗膜や蒔絵部分に影響を与えない適切な溶剤を選択した。
- ・剥離した塗膜の圧着は、麦漆で接着した。圧着治具に関しては、竹ヒゴの弾力を利用した芯張り法で圧着した。
- ・内側底の見込部分の亀裂は、今回の修復ではさわらなかった。

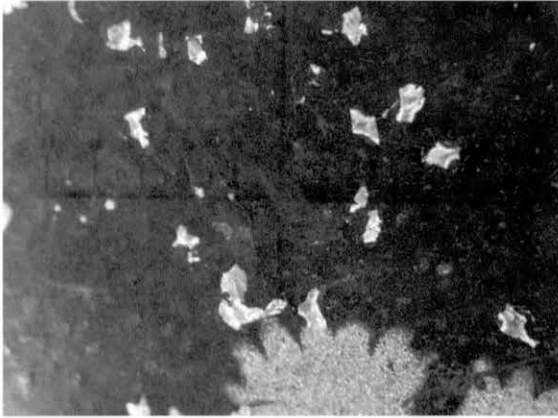
図7 塗膜劣化 (× 20)  
Fig. 7 Deteriorated coating film (x 20)

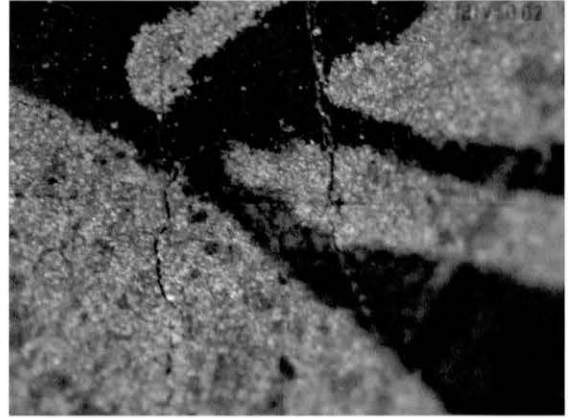
図8 塗膜劣化、亀裂 (× 20)  
Fig. 8 Deteriorated coating film, crack (x 20)

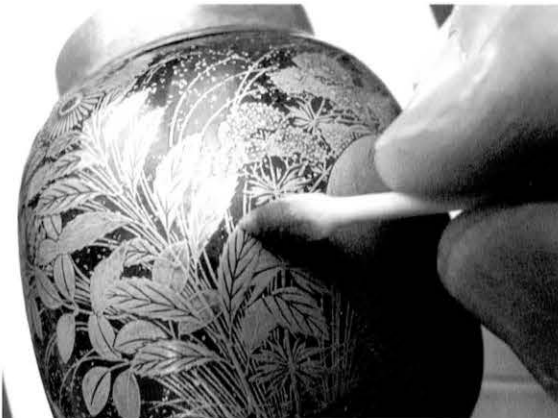
図11 塗料除去  
Fig. 11 Removing coating material

本資料は、ヨーロッパでの修復の際に塗料が塗られていた。また、塗料下の漆塗膜も劣化し大変脆くなっていたため、特に蒔絵部分の塗料除去は細心の注意を払った。塗料の除去に使用した溶剤は充分テストを行った結果、無水エタノールに純水を混合し、塗料除去を行った。

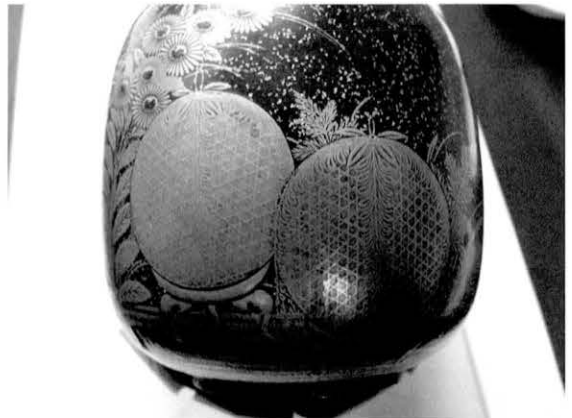
図12 塗料除去中  
Fig. 12 Removal of the coating material (left, not yet removed; right removed)

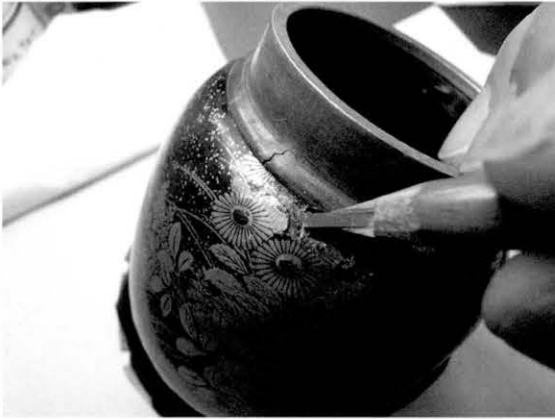
図 13 後補材の除去  
Fig. 13 Removing infilled material from a past restoration

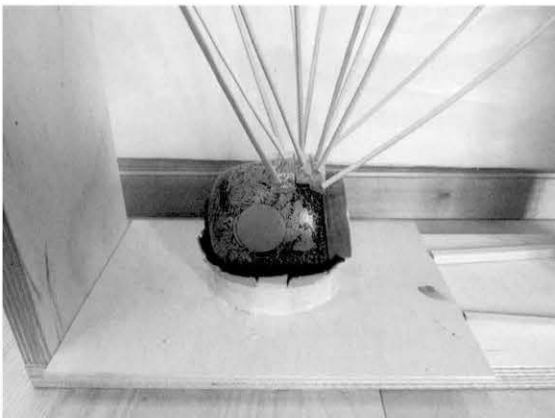
図 17 剥離塗膜の芯張り圧着  
Fig. 17 Press-stabilizing lifted coating film with *shimbari* sticks

圧着の際に使用する本資料の設置台や押さえ治具の準備を行い作業に取り掛かった。剝離塗膜や亀裂の接着は、接着力を強くするためグルテンの量を多くした強力小麦粉と漆を混ぜた麦漆を使用した。圧着作業は、本資料を安全に作業が行えるよう木枠に設置し、竹ヒゴの弾力を利用した芯張り法で圧着した。

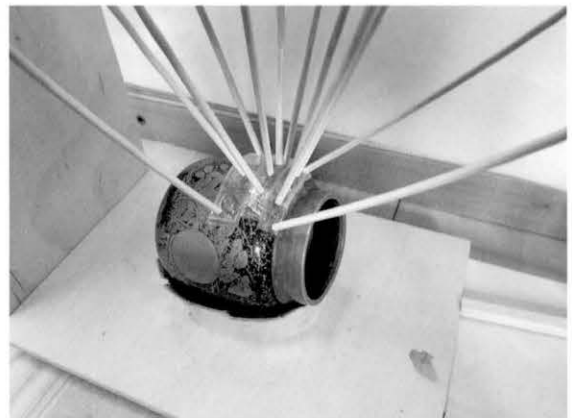
図 18 芯張り圧着  
Fig. 18 Press-stabilizing by *shimbari* method

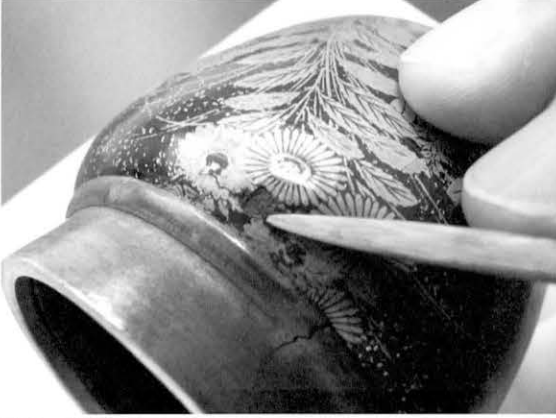
図19 刻蒔充填  
Fig. 19 Filling with kokuso

亀裂部分の戻しきれない隙間や塗膜の欠損部分には、麦漆に木粉や麻の繊維を混入した刻苧を充填し形態を復元した。刻苧の充填は必要に応じて数回に分けて行き塗膜の一段下がりの高さで仕上げた。

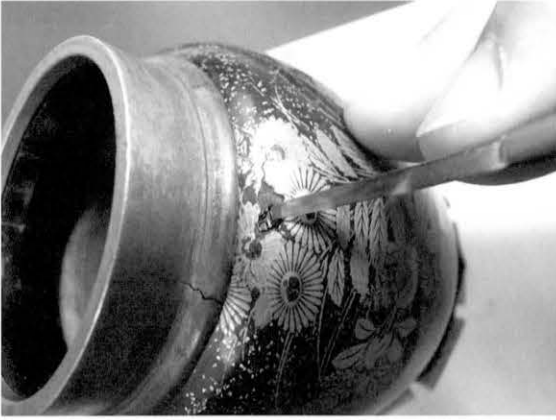
図21 際錆  
Fig. 21 *Kiwasaki*

剝離した塗膜際や刻苧で充填した部分に、麦漆に珪藻土を焼いた微粒子の粉末を混ぜた漆錆を、再剥落の防止や刻苧肌の固めとして施した。

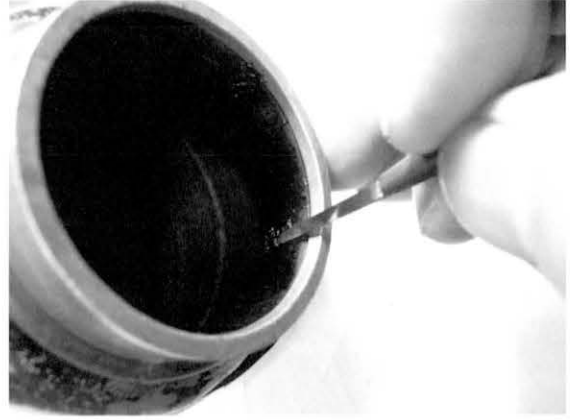
図22 亀裂部分に際錆  
Fig. 22 Applying *kiwasabi* around a crack

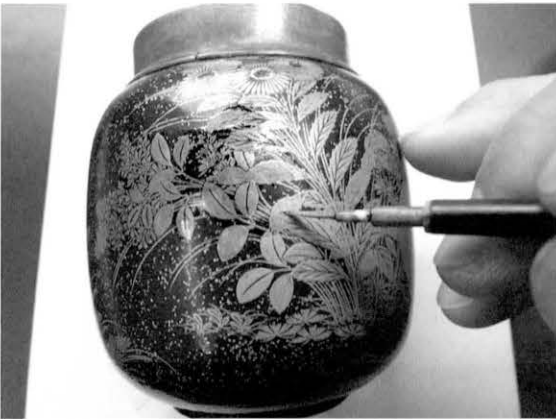
図23 蒔絵部分の漆固め  
Fig. 23 *Urushigatame* of *makie*

漆塗膜面の強化と艶を取り戻すために、溶剤で希釈した漆を数回吸わせ漆固めを行った。漆固めに使用した漆は、木地呂漆、梨子地漆、生正味漆を夫々目的や場所に合わせた配合で漆を調合し使用した。また、際錆を行った部分にも漆を数回吸わせて固めとした。

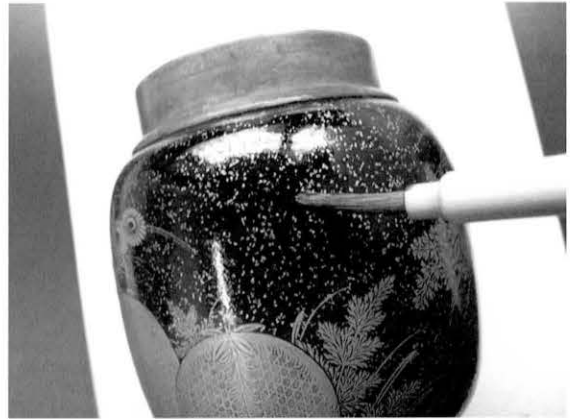
図24 梨子地塗膜部分の漆固め  
Fig. 24 *Urushigatame* of *nashiji* coating film

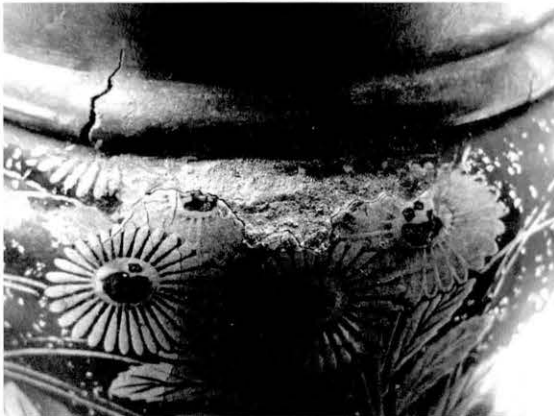
図 29 修復前 損傷部分  
Fig. 29 Before restoration (damaged area)

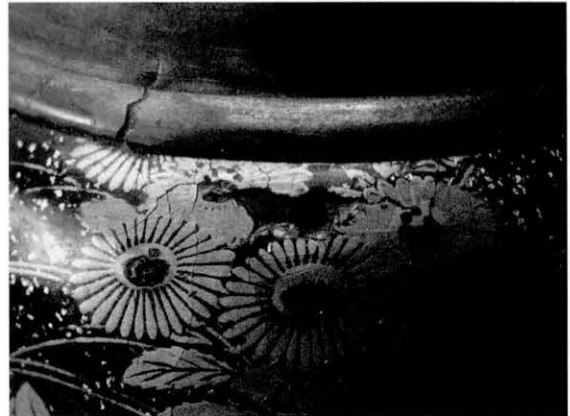
図 30 修復後 損傷部分  
Fig. 30 After restoration (damaged area)
