## 5. 菱繫文螺鈿箆笥

### 5. *Cabinet with Lozenge Design*

国立ナープルステク博物館（チェコ共和国）所蔵  
Náprestek Museum, National Museum, Prague (Czech Republic)

## 5.1. Restoration Report

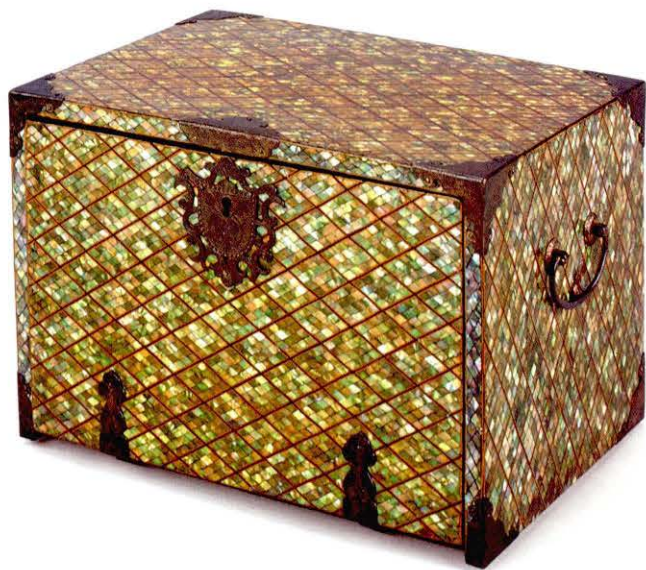
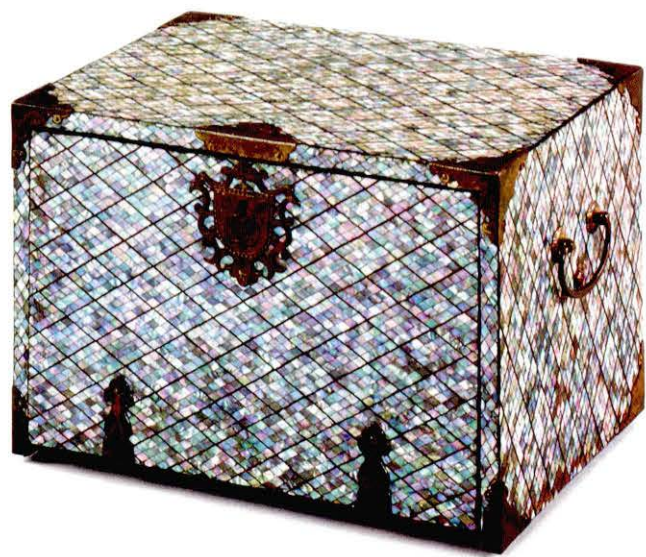
C5.1 菱絜文螺鈿箱筒  
*Cabinet with Lozenge Design*

a 修復前  
Before restoration

b 修復後  
After restoration

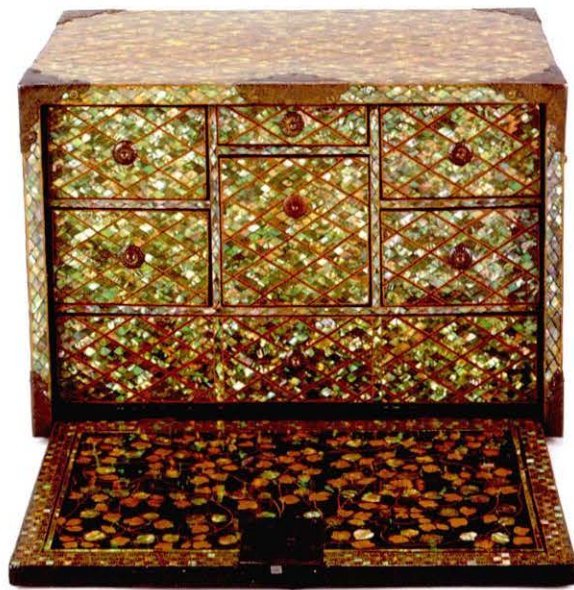
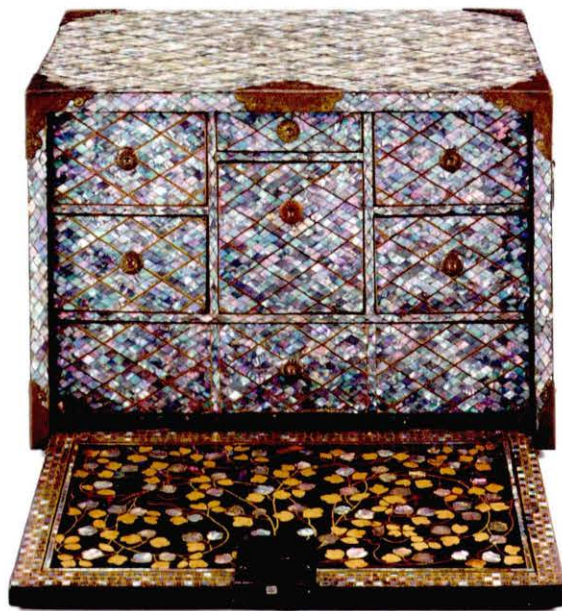
C5.2 菱繫文螺鈿單笥 —引出—  
*Cabinet with Lozenge Design, drawer*

a 修復前  
Before restoration

b 修復後  
After restoration

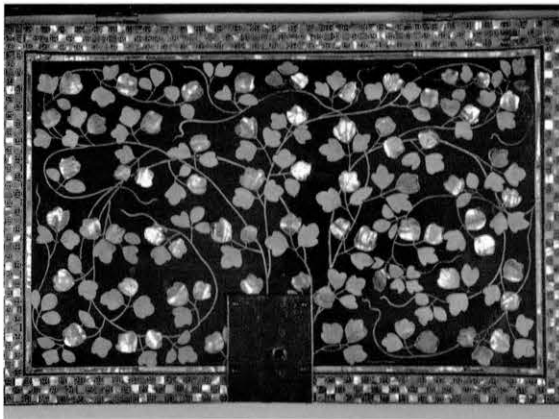
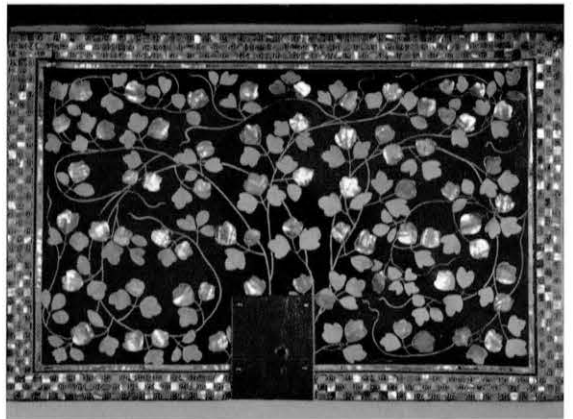
- Some dust and soiling were observed over the entire surface of the cabinet.
- There were traces of adhesive tape near the top of the cabinet.
- There were shallow cracks on the joints of the substrate. They were progressing especially on the left and right ends inside the lid.

- The urushi coating film around the cracks had become lifted.
- There was a thick coating of yellow material on the outer surface of the cabinet, except at the back, and on the inner side of the fall front and the surface of the drawers.

Fig. 5.3 蓋裏 Inner side of the lid

Cracks on the joints of the substrate were reinforced by impregnating *mugi-urushi* that had been adjusted.

*Mugi-urushi* was impregnated into the lifted coating film which was then press-stabilized with a wooden frame and bamboo sticks.

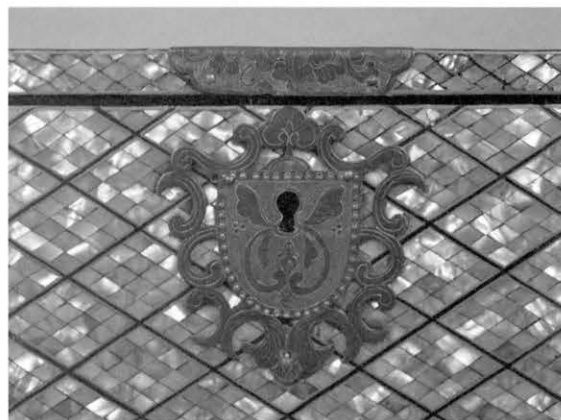
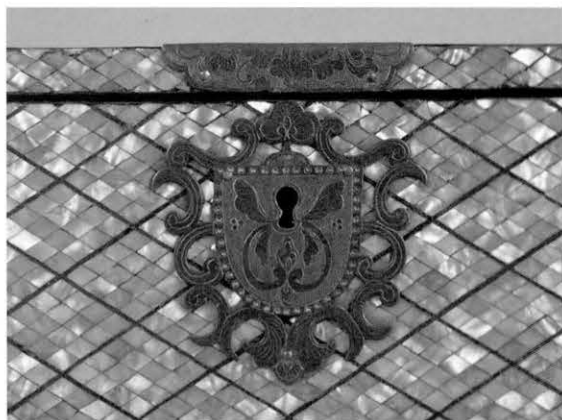
- Gilding executed on the metal lock plates and the corner metal fittings had already been lost.
- The metal lock plate in the front had become loose, and the head of one of the nails was missing.

Fig. 5.4 鍵金具と釘の損傷 Metal lock plate and damaged nail

(17) Reproduction of the nails

old finish by using copper sulfate, vinegar and salt. The nails were reproduced by Akira Kusano of the Tokyo University of the Arts.

Warping of the metal fittings was simply corrected and the metal lock plate, corner metal fittings and the hinges were returned to their original positions. Nail holes that were loose were filled with *kokuso* and the metal fittings were nailed down. Since the right hinge was warped severely, causing a problem opening and closing the fall front, adjustment was made by removing the foundation under the hinge.

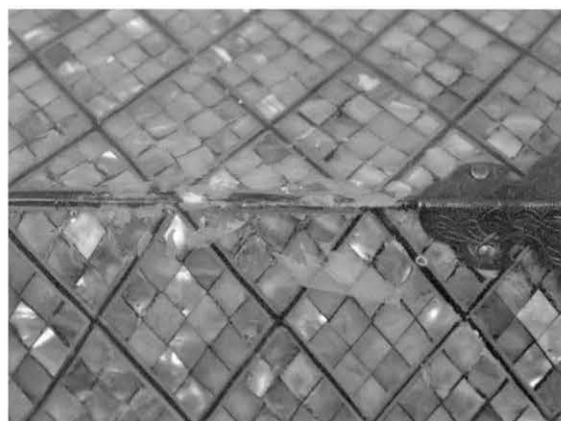
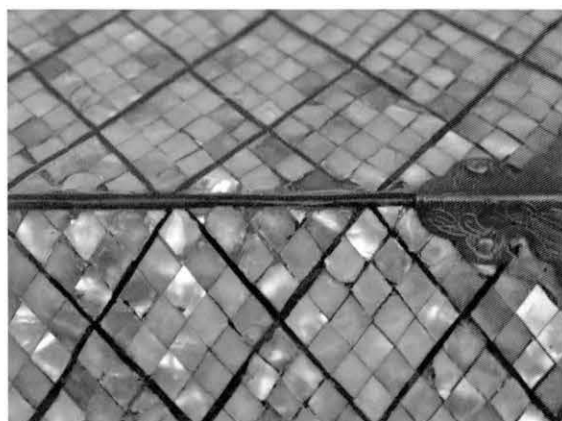
Fig. 5.5 テープ接着材の付着 Trace of adhesive tape

Traces of adhesive tape on the top board and the right side of the cabinet were removed with acetone.

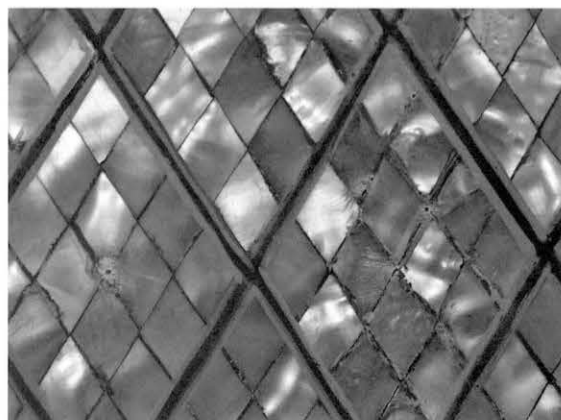
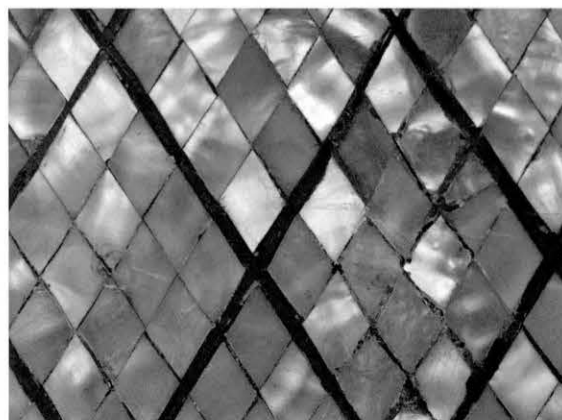
- Traces of past restorations could be seen over a large area of the *raden*; the shell pieces had been re-adhered.
- There were new *raden* pieces at various places of the cabinet; thin abalone shell pieces and medium thick pearl oyster had been used.

Fig. 5.6 螺鈿の修理箇所 Raden restored in the past

To adjust the color of *raden*, Pearl Powder (mica powder) and Paraloid B72 were diluted with xylene and applied to produce the color of the shell; acrylic paint was used to subdue the chroma.

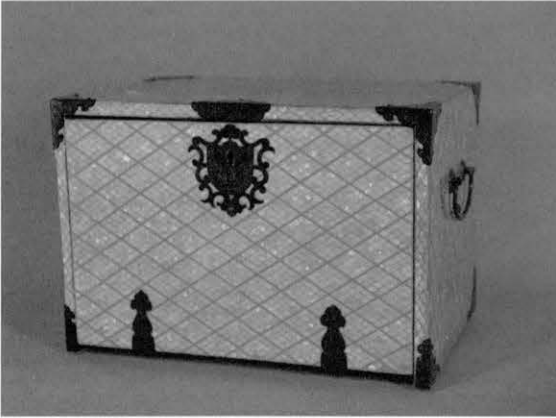
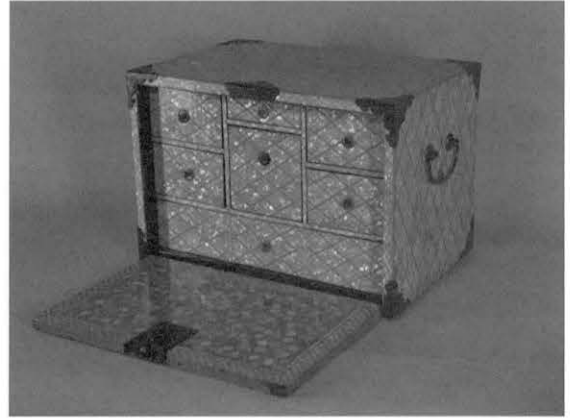
First, investigation using a UV lamp was done. As a result, the yellow coating material applied on the surface fluoresced to unclear yellow, but the black coating material on the back surface the inside and bottom of the cabinet did not fluoresce. From this, it was thought that the yellow coating material is shellac, which is used in Europe as a restoration material, or some other resin.

Fig. 5.7 紫外線光による蛍光 修復前  
Fluorescence under UV light, before restoration

Fig. 5.8 紫外線光による蛍光 修復前  
Fluorescence under UV light, before restoration

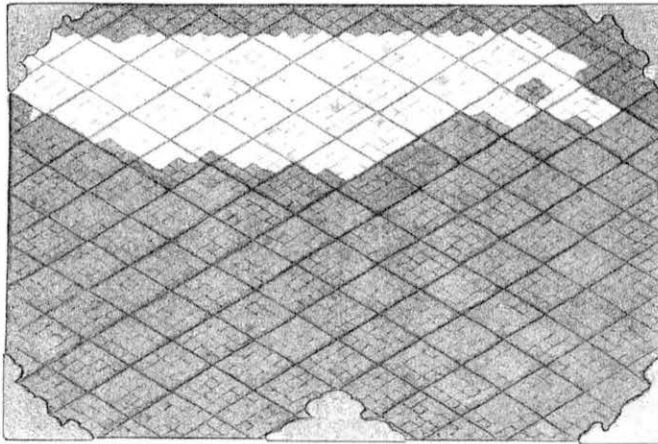
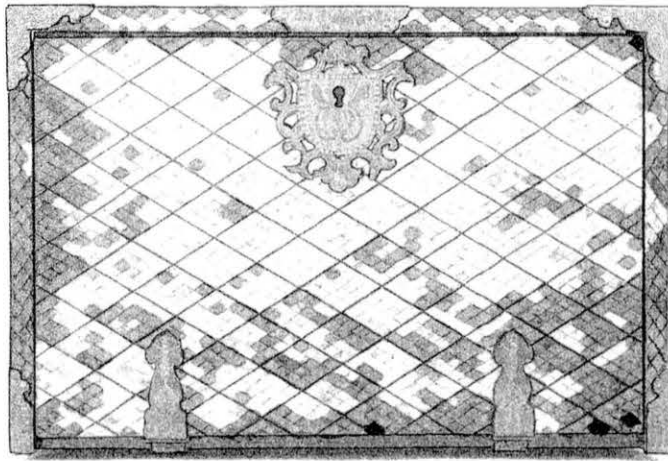
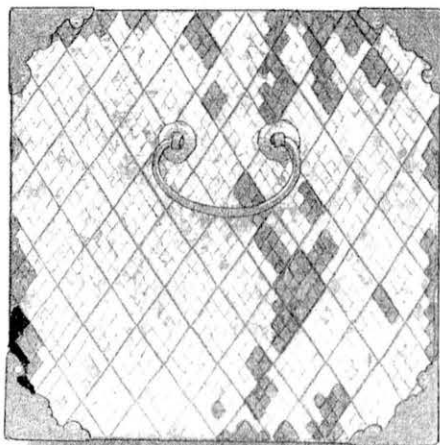
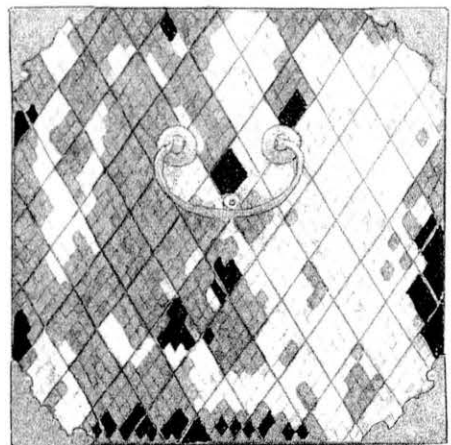
Fig. 5.22 菱繫文螺鈿箆筒 螺鈿後世修復箇所  
Parts treated in past restorations of *Cabinet with Lozenge Design*

貼直し  
Reattached during  
past restorations

後補  
Added during past  
restorations

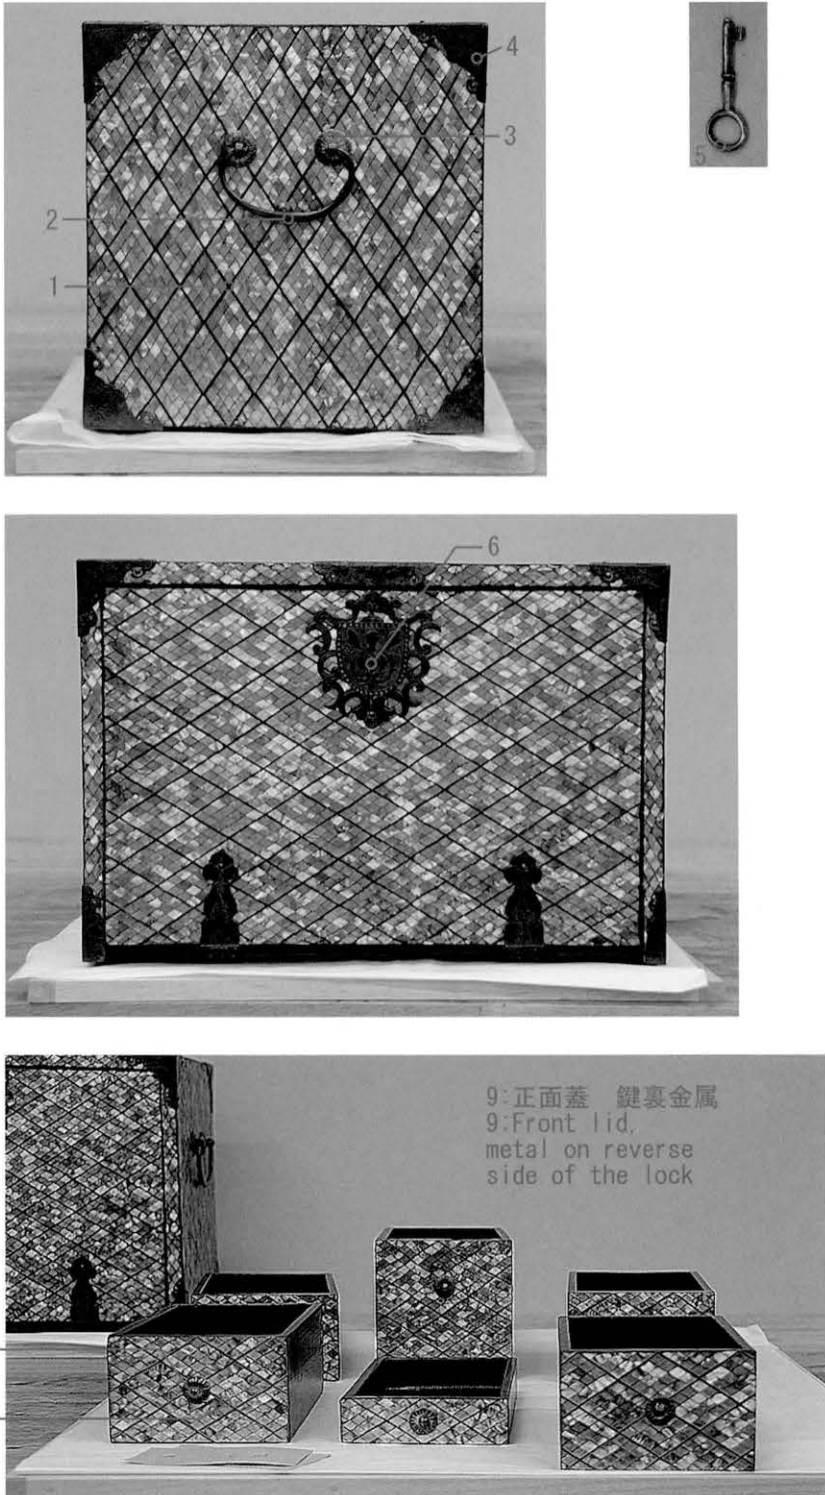
Fig. 5.23 螢光 X 線分析位置  
Measuring points for X-ray fluorescence analysis

- At measuring points Nos. 1 and 7, Hg was detected in addition to Au. It is possible that there is red material (vermilion) underneath the gold line.
- At measuring points Nos. 2, 3, 4, 6 and 8 gilding is done on copper base.

- The color at measuring point No. 5 remains whitish silver. Iron gilded with chromium is used.
- The metal used at measuring point No. 9 is iron, but chromium was not detected here.

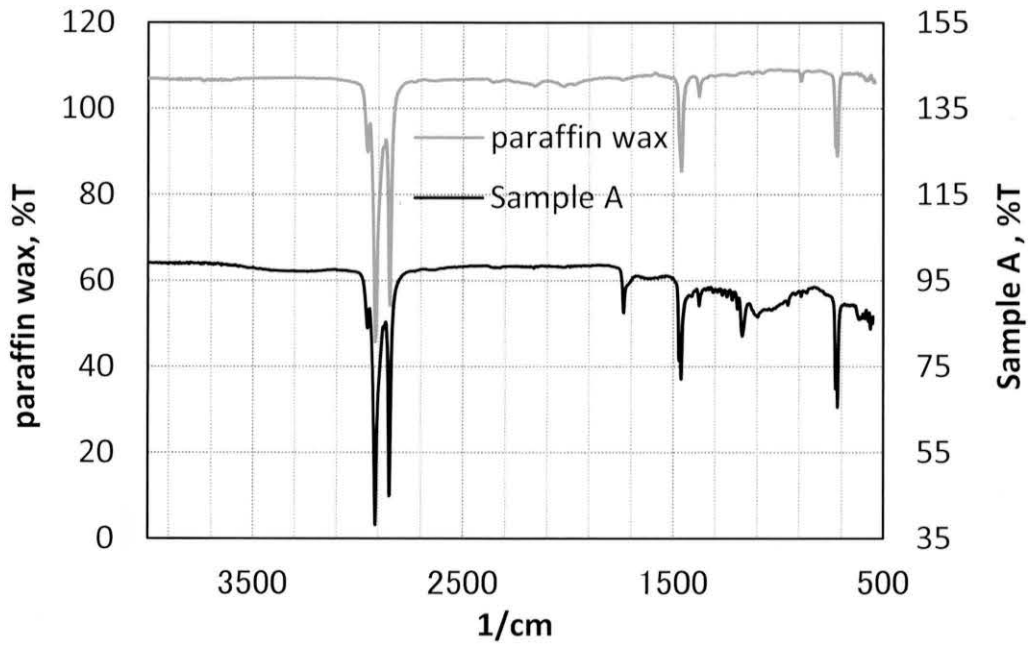
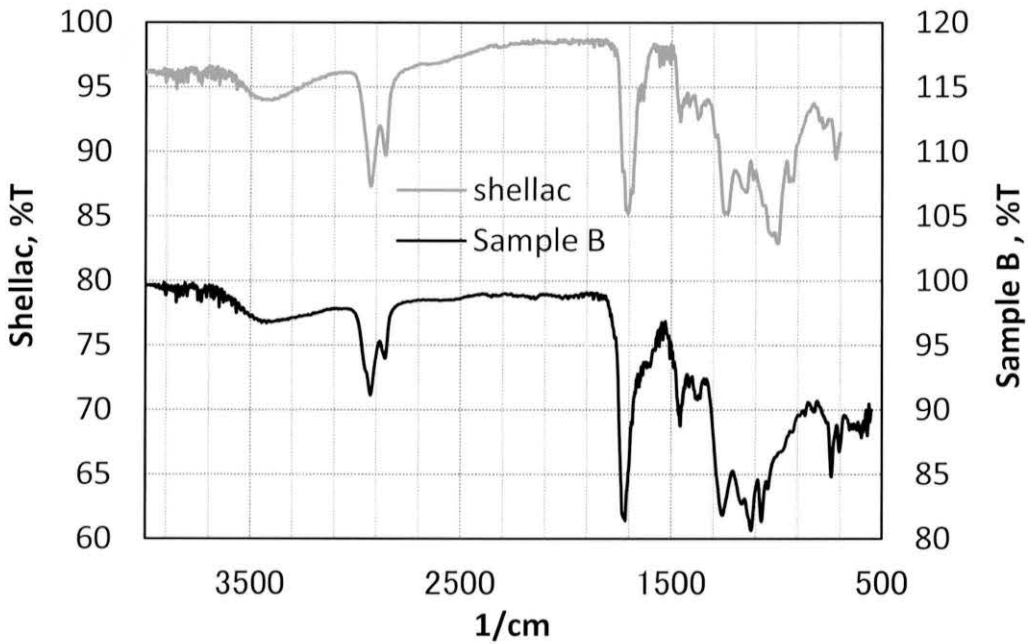
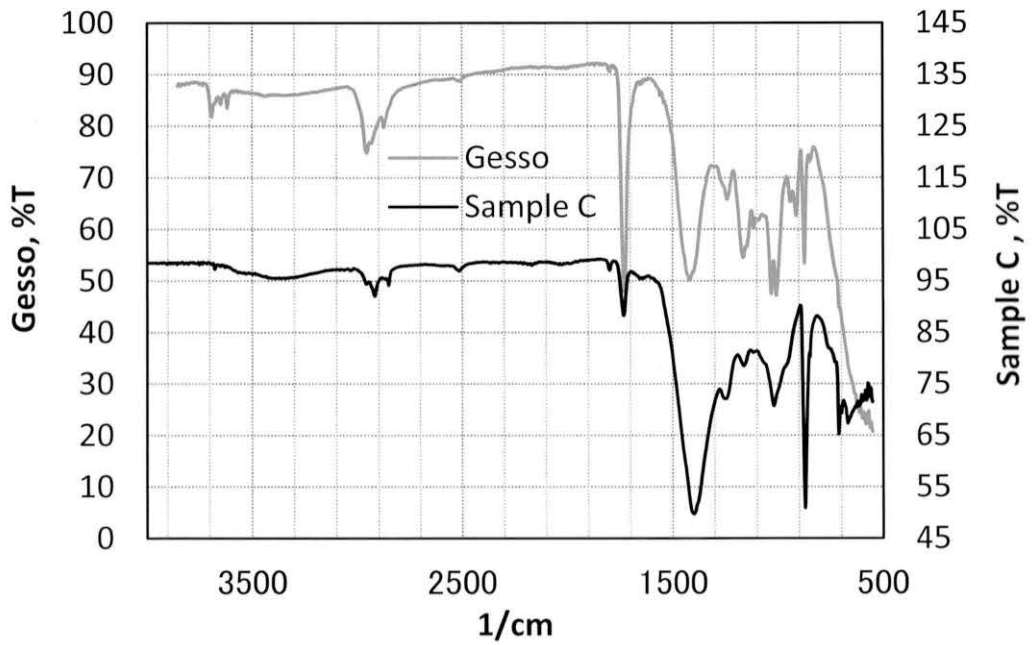
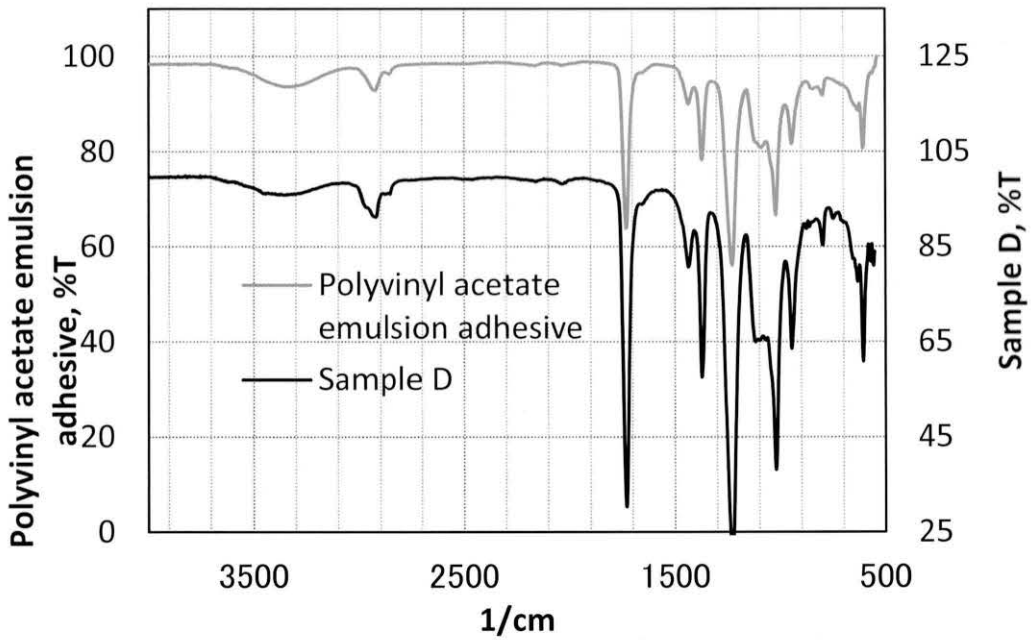
Samples were taken from the foundation materials, both white and black, that had been filled into the spaces of the *raden* and from the adhesive agent used to adhere the pieces in past restorations. These were analyzed by FT-IR. As a result, it was found that the white foundation from the upper portion was calcium carbonate, while the black material from the lower portion was paraffin and the adhesive was vinyl acetate.

Fig. 5.24 赤外線スペクトル分析 試料 A  
Fourier transform infrared spectroscopy, Sample A

Fig. 5.25 赤外線スペクトル分析 試料 B  
Fourier transform infrared spectroscopy, Sample B

Fig. 5.26 赤外線スペクトル分析 試料 C  
Fourier transform infrared spectroscopy, Sample C

Fig. 5.27 赤外線スペクトル分析 試料 D  
Fourier transform infrared spectroscopy, Sample D
