6. 花樹鳥蒔絵螺鈿箆笥

6. *Cabinet with Floral Design*

アシュモリアン博物館（英国）所蔵

6.1. 修復報告

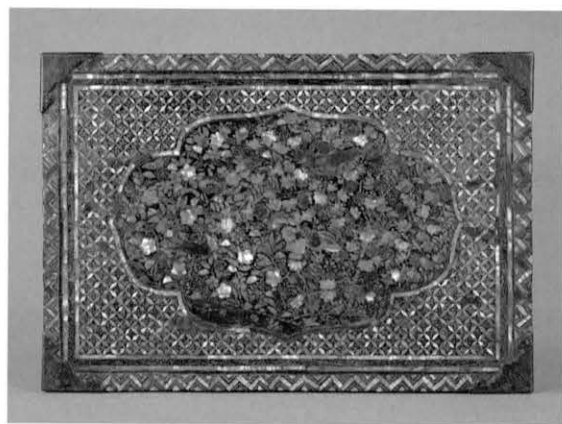
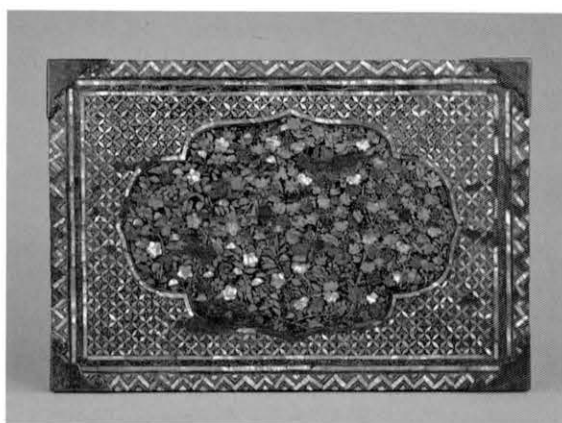
Fig. 6.2 天板部分 Top board

- There was significant lifting of the coating film and *raden*. Lifting was found over a large area in the cartouche on the top board.
- Some of the urushi coating film and *raden* had fallen from the cabinet, exposing the foundation.

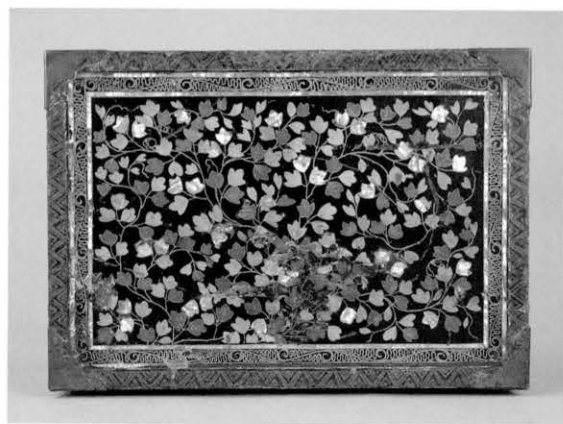
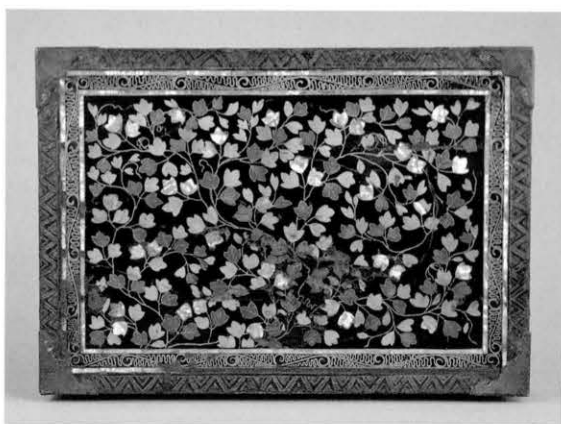
Fig. 6.3 背面部 Back

Cracks caused by shrinkage of the substrate were found around the joints of the substrate. A gap of approximately 1 mm was found on the back and the upper portion of the sides because the direction of the grain on the board for the back and that of the boards for both sides of the cabinet differ.

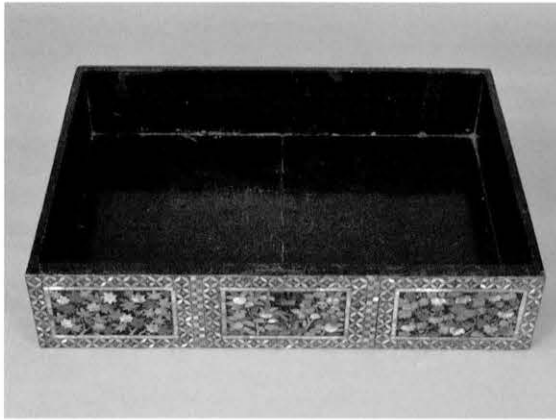
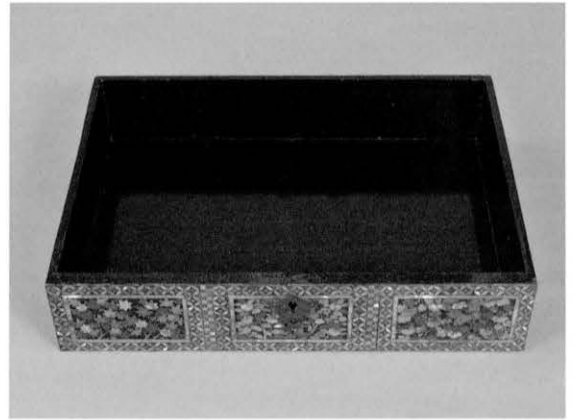
Fig. 6.4 上段引き出し部分 Upper drawer

- The entire surface of the cabinet was covered with dust and soiling.
- Cracks were observed on various parts of the joints of the substrate.
- The substrate of the bottom board of the upper drawer was cracked in the middle from the front to the back.

Adjusted *mugi-urushi* was impregnated into cracks around the joints of the substrate for reinforcement. The crack on the upper drawer was further reinforced by using filling material composed of *mugi-urushi* to which a small amount of sawdust and *jinoko* were added for greater adhesive force.

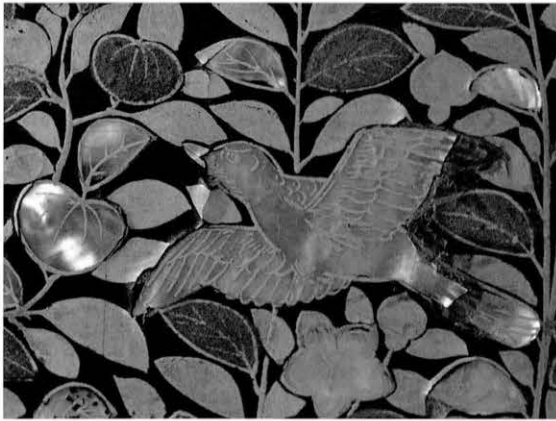
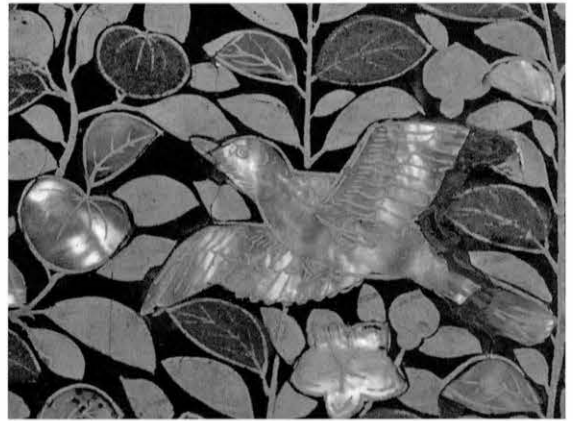
Fig. 6.5 漆塗膜の剥離と後世修復材料の付着 左側面
Lifted urushi coating film and traces of past restorations

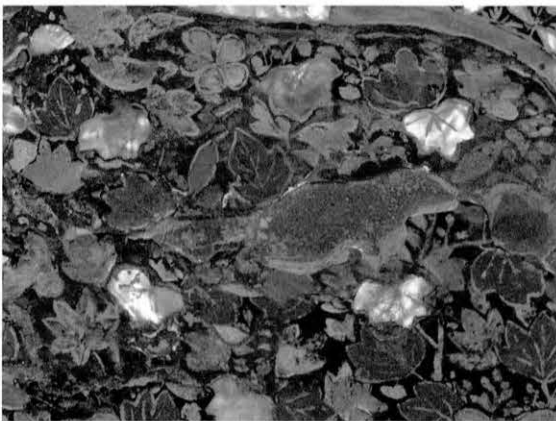
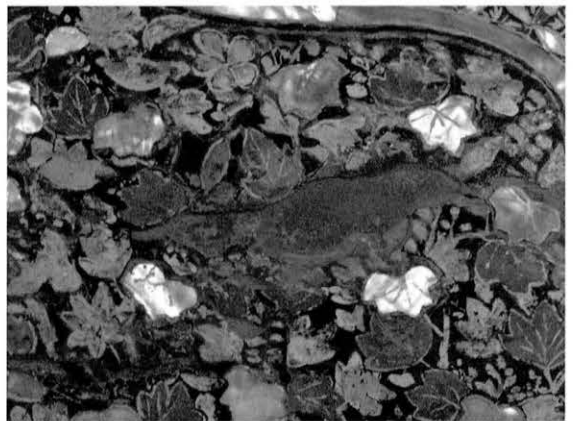
Fig. 6.6 螺鈿の剥落と西洋塗料による文様の書き込み
Parts where raden has fallen and designs have been drawn with Western coating materials

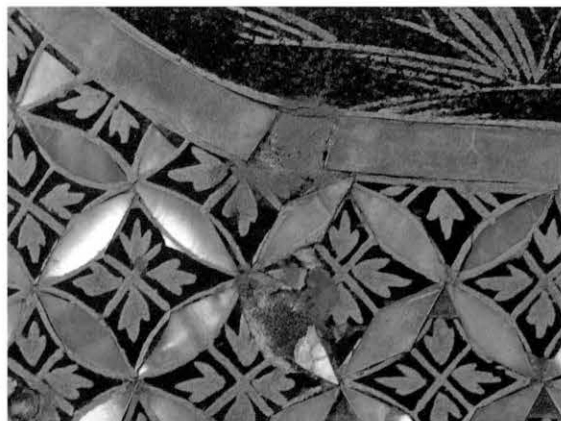
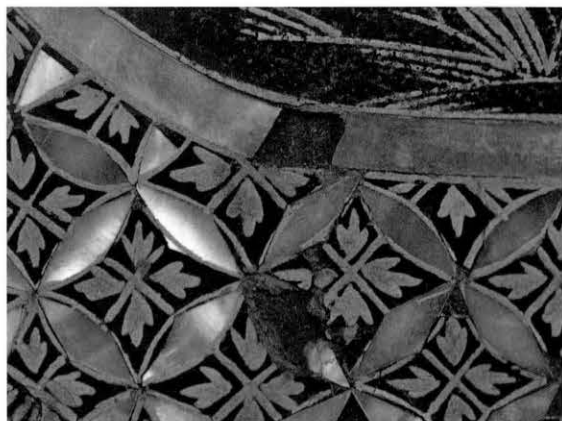
Fig. 6.7 剥落部分に使用された後世修復材料 右側面下部
Restoration material from the past used on a lost area, lower portion on the right side

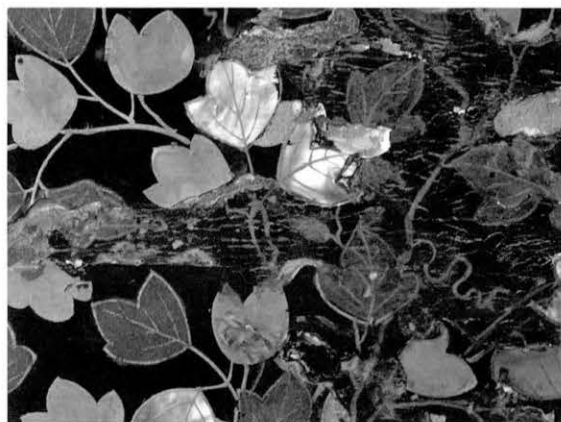
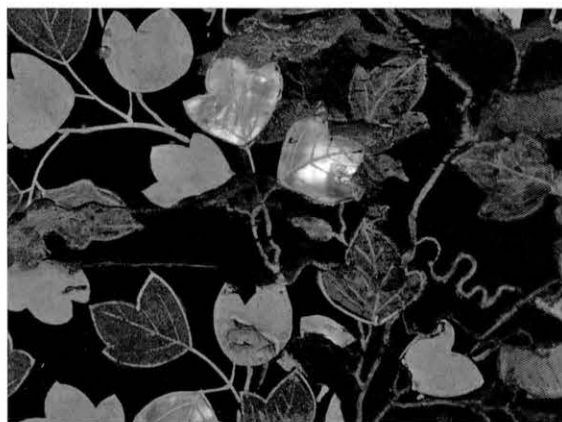
Fig. 6.8 後世修復による文様の書き込みと西洋修復材料 背面部分
Drawing of a design using Western restoration materials during past restorations, back

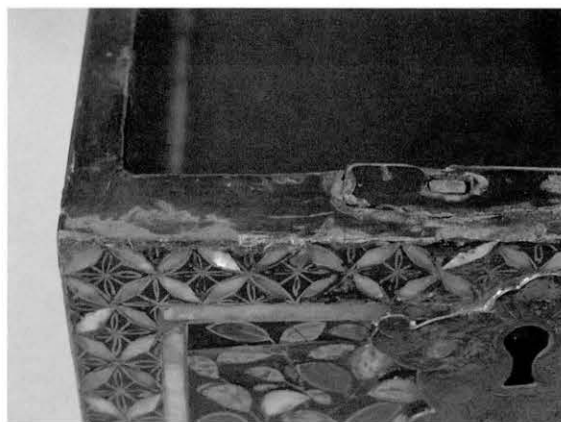
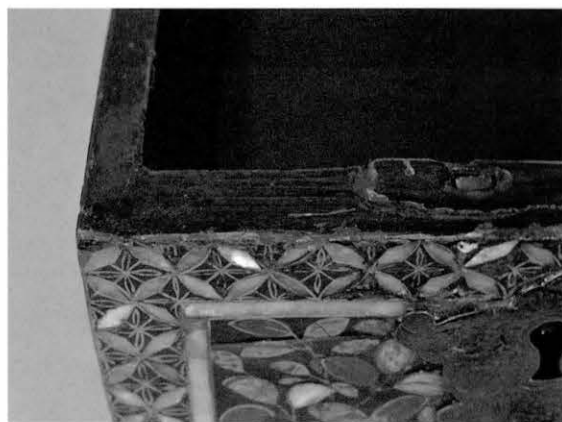
Fig. 6.9 金色材料の付着 引き出し上部
Gold coloring material on the upper part of a drawer

Methanol and cotton swabs were used to remove the Western coating materials that had become attached to the coating film surface. This was done carefully so as not to damage the parts with designs. Gold coloring material used during past restorations that had become attached to parts other than the designs were removed with THF and cotton swabs.

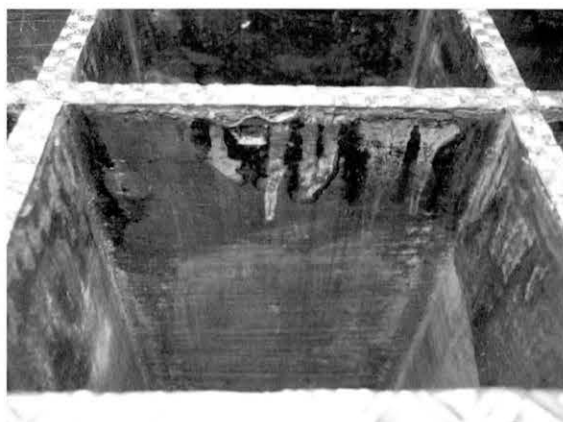
Fig. 6.10 埃と西洋塗料の付着 箆筒内部 修復前
Dust and Western coating materials that have accumulated, inside the cabinet, before restoration

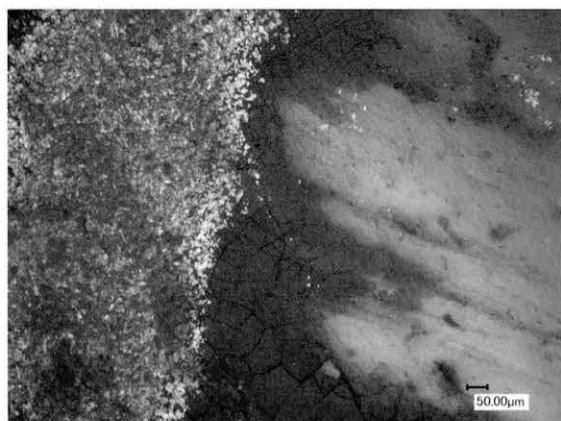
Fig. 6.26 上塗り漆と蒔絵・螺鈿加飾の拡大観察
Observation of the top coating of urushi and makie and raden decorations, enlarged

- (1) As a result of observation of the details of decoration on the object, it was found that the particles of *makie* powder were uneven, including coarse ones and very fine ones (Fig. 6.26).

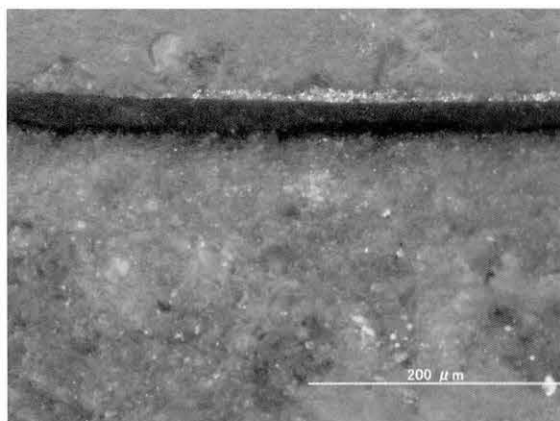
Fig. 6.27 蒔絵塗膜断面の拡大観察
Observation of the cross-section of makie coating film, enlarged

- (3) As a result of the observation of the cross-section of the sampled coating film fragment, it was found that there is a great possibility of brownish doro foundation consisting of fine clay or diatomaceous earth mixed with paste or animal glue having been used for the foundation. Nevertheless, since the sample for analysis was very small, scientific discriminative analysis was not conducted for the animal glue, paste or raw urushi assumed to have been mixed into the foundation. For this reason, the foundation is referred to as "*sabi shitaji*," which is the generic term for foundation using clay minerals rather than "*sumiko shitaji*," which is the generic term for foundation using charcoal powder.

- (4) *Hiramakie* decoration was made in the following way: 1) *Sabi shitaji* was applied to the wooden substrate. 2) A layer of thin black charcoal was applied on top of this *sabi shitaji* to produce black color. 3) One layer of reddish-brown urushi was applied over this foundation to produce the black urushi ground. 4) Red urushi was applied over this black urushi ground to serve as an adhesive and the draft drawing. 5) *Makie* powder was sprinkled for *hiramakie* decoration (Fig. 6.27).
