7. Container in the Shape of Crane

アムステルダム国立博物館（オランダ王国）所蔵
Rijksmuseum Amsterdam (Kingdam of the Netherlands)

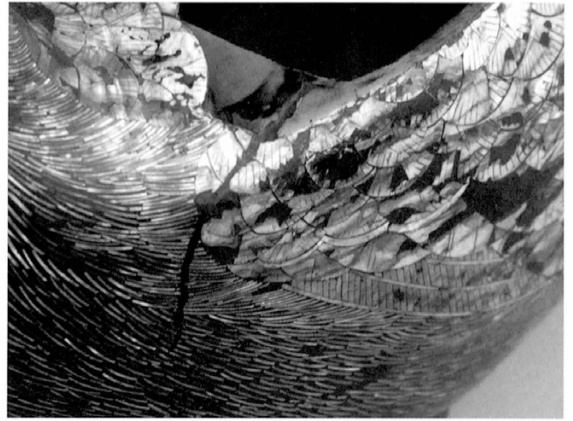
b 修復後 After restoration

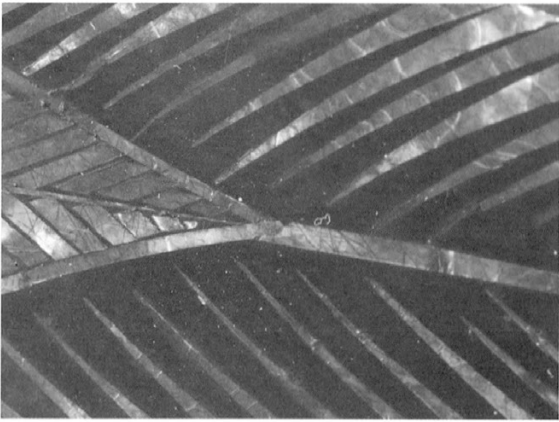
a 修復前 Before restoration

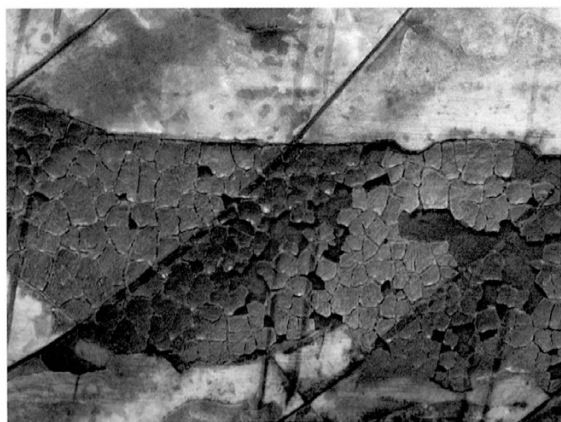
Fig. 7.8 貝欠損部 後世修復 塗料の劣化
Part with missing shell pieces, deteriorated coating material from a past restoration

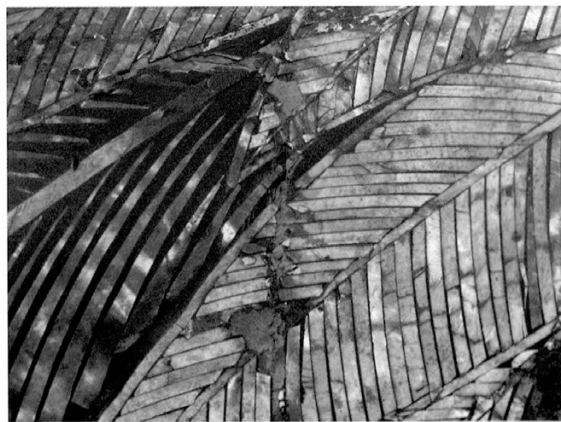
Fig. 7.9 亀裂及び貝、塗膜の剥落
Crack and parts where the shell pieces and coating film have been lost

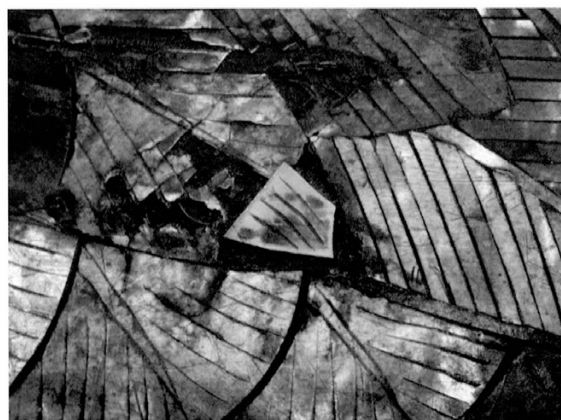
Fig. 7.10 貝欠損部 後補の貝
Part with missing shell pieces and a shell piece applied in a past restoration

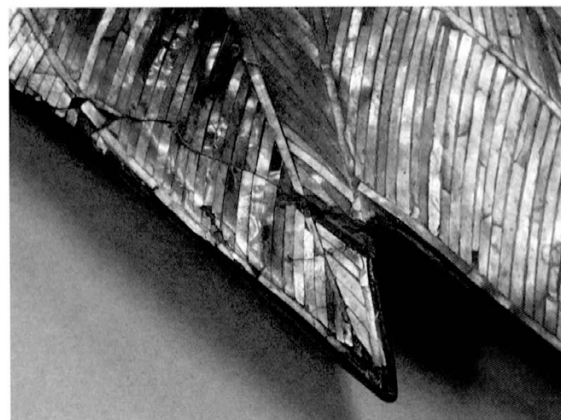
Fig. 7.11 蓋 尾羽部分の亀裂
Lid, cracks on the tail feather

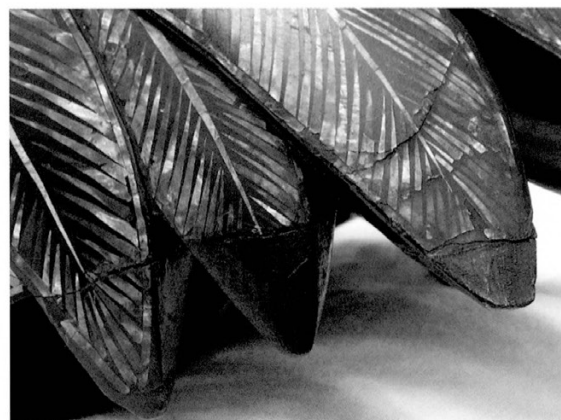
Fig. 7.12 尾羽 亀裂及び後補部分
Tail feathers, cracks and parts added later

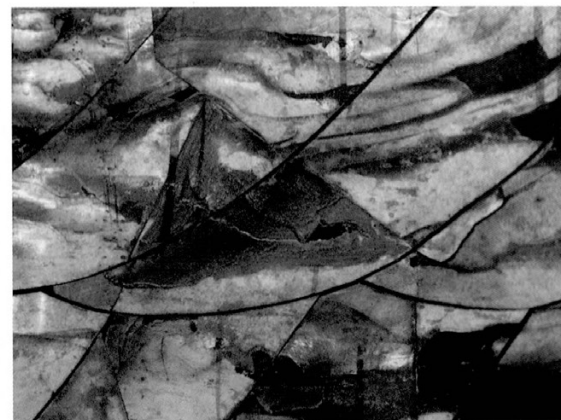
Fig. 7.13 貝欠損部 後世修復
Part with missing shell pieces, restored in the past

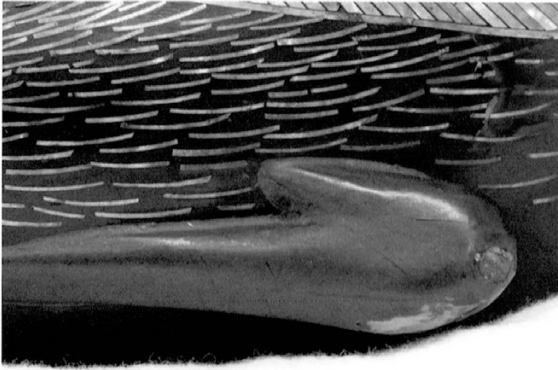
Fig. 7.14 後足部分 漆塗膜の損傷
Hind leg, damage to the urushi coating film

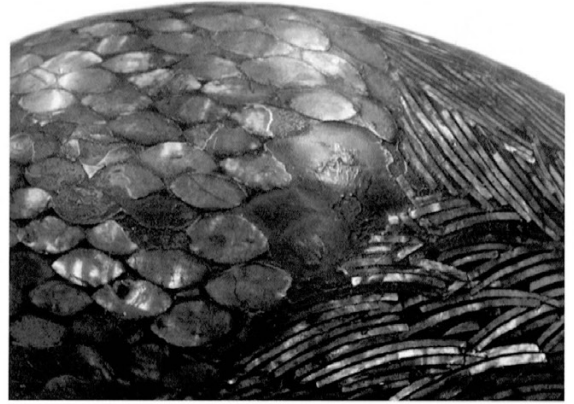
Fig. 7.15 頭部 伏彩色した貝の欠損
Head, missing shell pieces with *fusezaishiki*

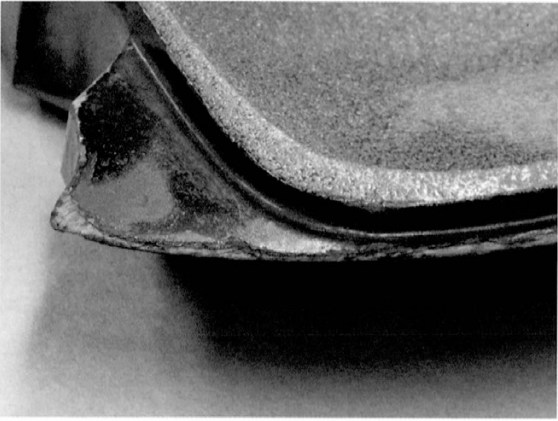
Fig. 7.16 蓋裏 縁部分の損傷
Backside of the lid, damage along the edge

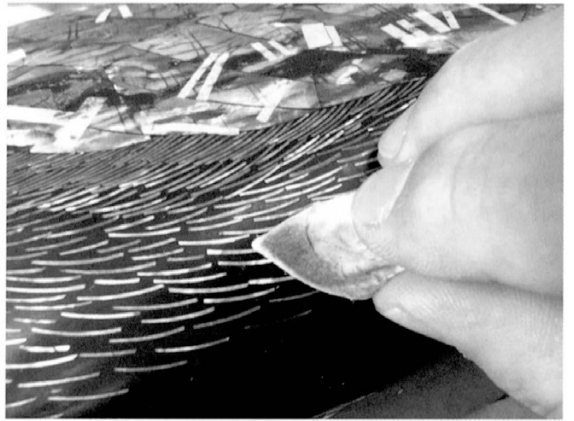
Fig. 7.17 クリーニング
Cleaning

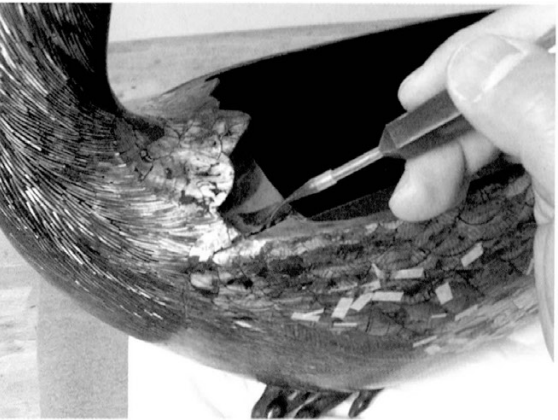
Fig. 7.18 亀裂部分 希釈した麦漆含浸
Impregnating diluted *mugi-urushi* into the cracked portion

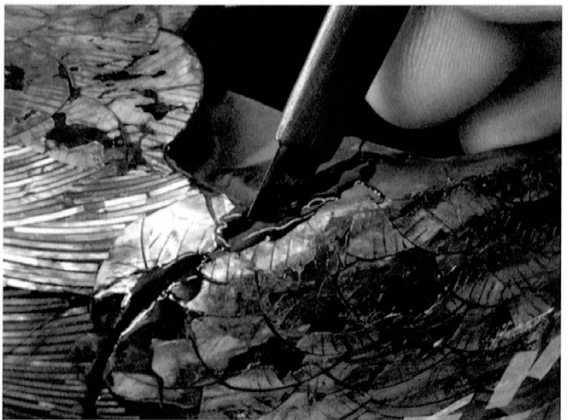
Fig. 7.19 亀裂部分 麦漆含浸
Impregnating *mugi-urushi* into the cracked portion

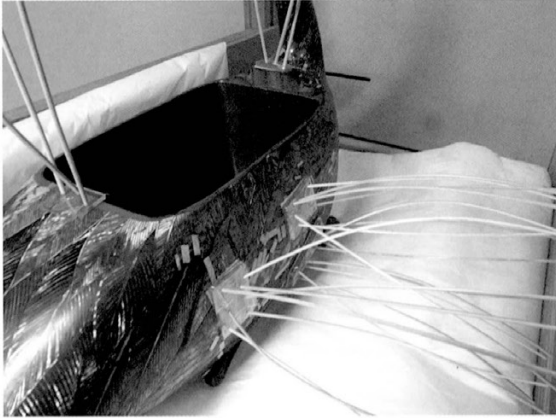
Fig. 7.20 亀裂部分 芯張り圧着
Press-stabilizing the cracked portion

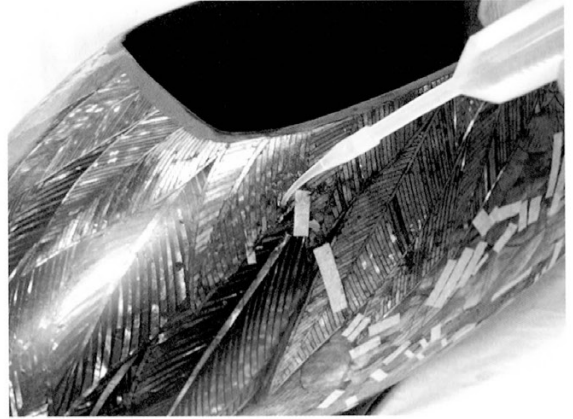
Fig. 7.21 エタノール含浸
Impregnating ethanol

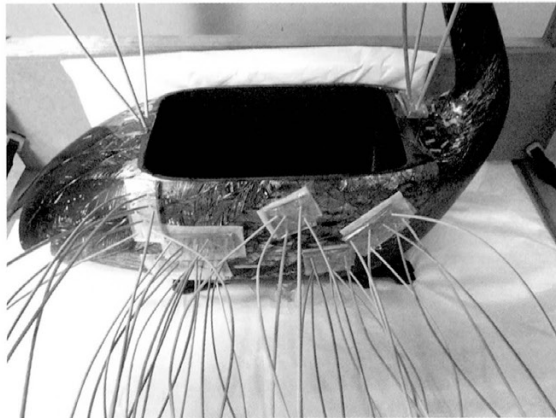
Fig. 7.24 貝の剥離 側面部分の圧着
Pres-stabilizing the shells on the side that have become lifted

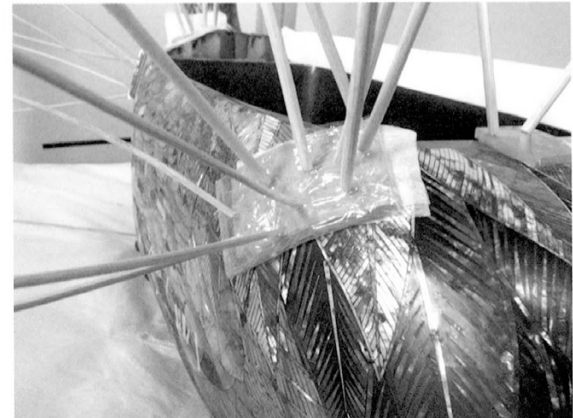
Fig. 7.25 貝の剥離 曲面部分の圧着
Pres-stabilizing the shells on the curved surface that have become lifted

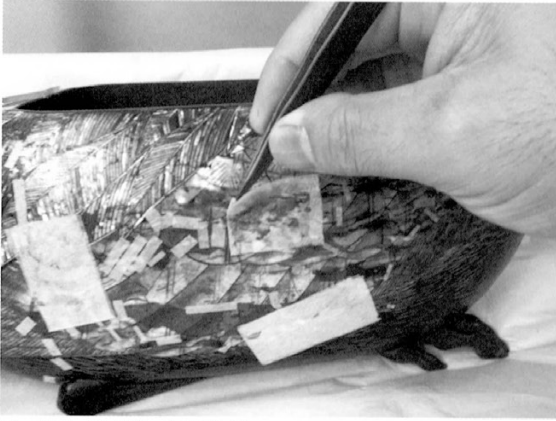
Fig. 7.26 圧着後 和紙剥がし
Removing Japanese paper after press-stabilizing

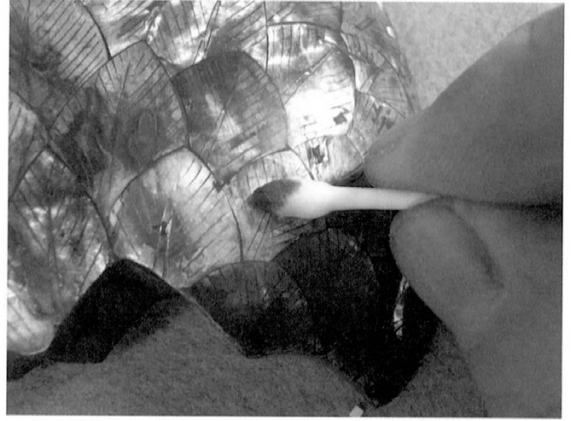
Fig. 7.27 塗料除去 貝部分
Removing the coating material from the surface of shell pieces

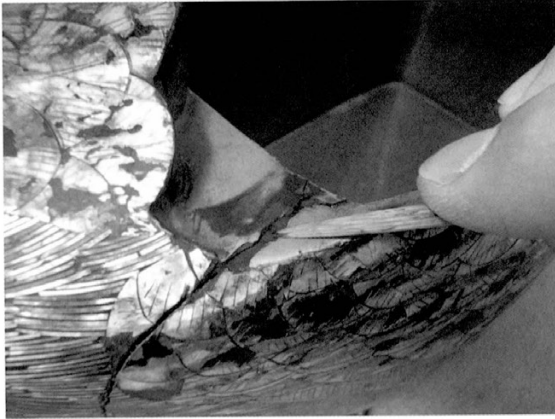
Fig. 7.32 亀裂部分 刻苧充填
Filling a crack with *kokuso*

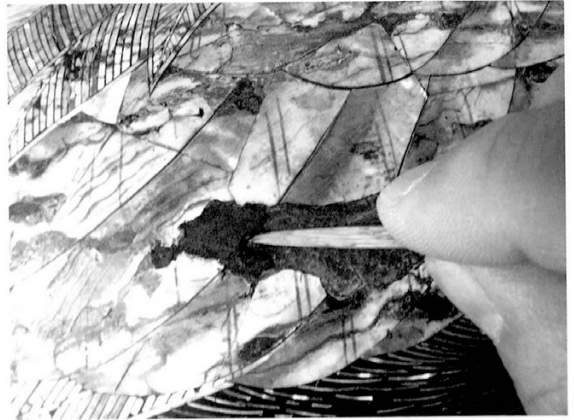
Fig. 7.33 刻苧付け
Applying *kokuso*
