Project for Investigation of Damage Situation of Cultural Heritage in Nepal

Structural Survey of Historic Buildings

October 2016

Tokyo National Research Institute for Cultural Properties

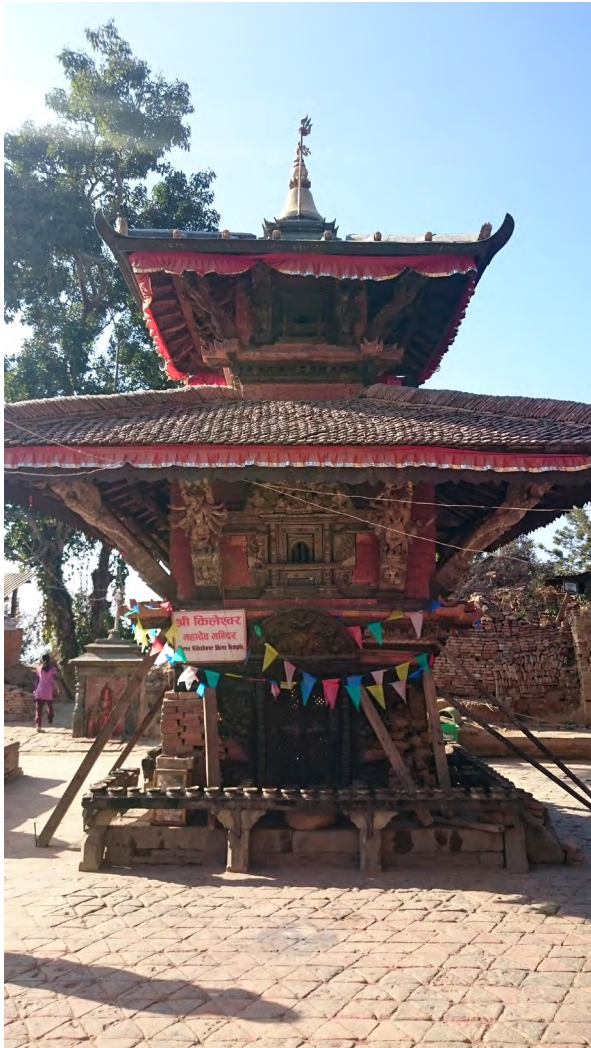
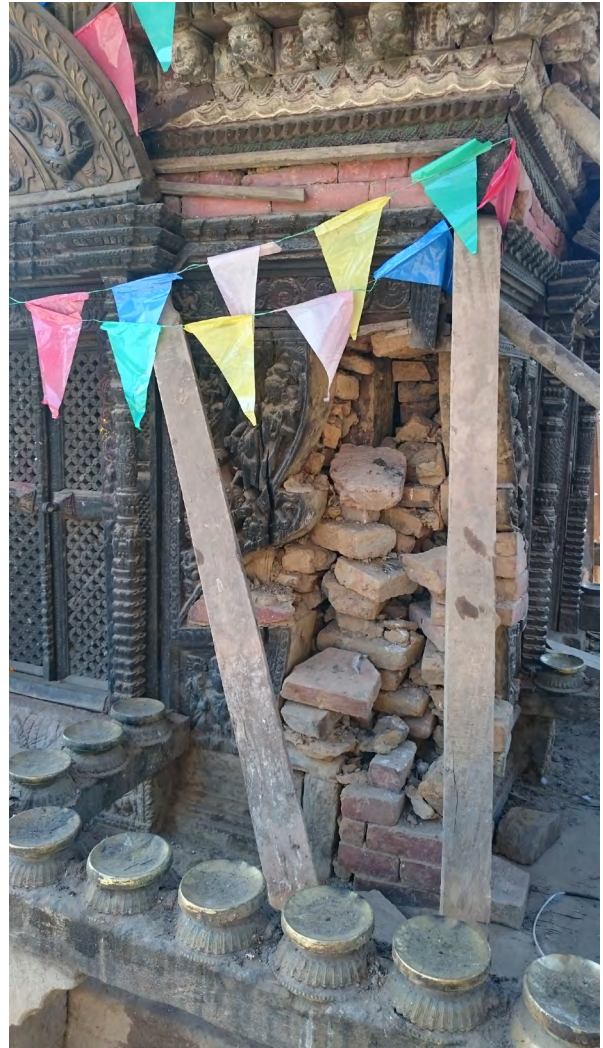
Pic.3-1-1 Changu Narayan Temple structure saved from collapse by the timber columns inside of the brick wall

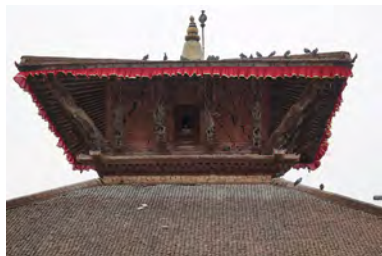
As shown in Pic. 3-2-1 damage to the Jagannath Temple following the Gorkha Earthquake was concentrated in the third (top) storey of the building. The shear failure of the brick walls appeared at the cut-out for the roof beam. The shear failure was concentrated in the joint between bricks; failure of the brick itself was not observed.

Third (top) storey: Brick wall damage

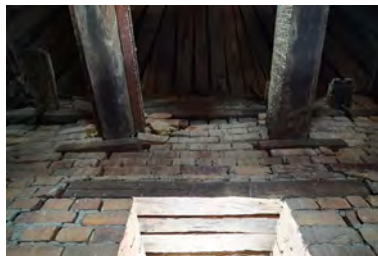
Third (top) storey: Crack from the cut-out for the beam (1)

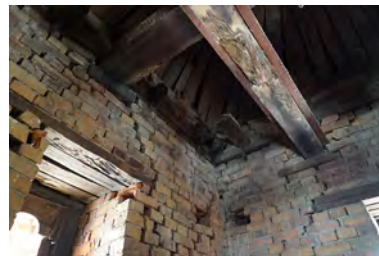
Third (top) storey: Crack from the cut-out for the beam (2)

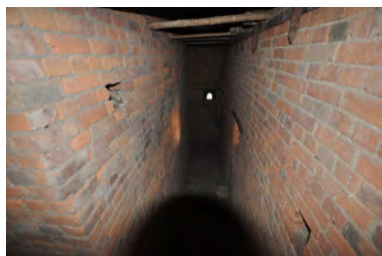
Second storey: Slight damage to inside and outside wall

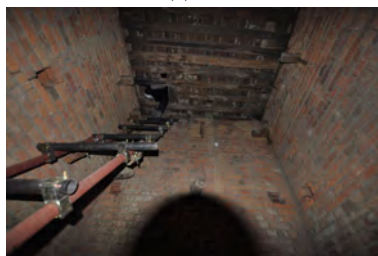
Second storey: Slight damage to inside wall

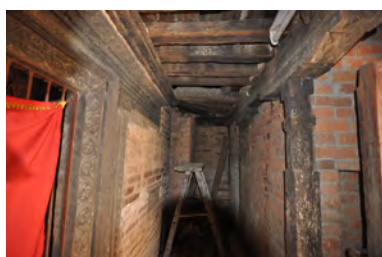
First storey: Slight damage

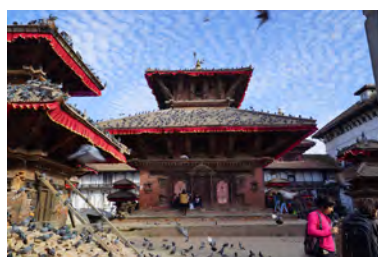
First storey: Slight damage

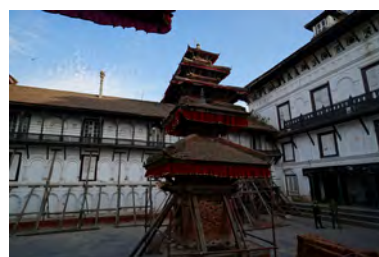
Annex towers: Heavy damage

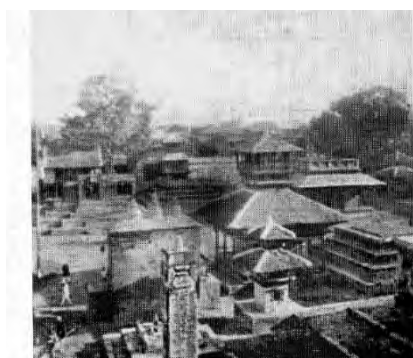
Jagannath Temple was collapsed by Nepal-Bihar earthquake in 1934 and rebuilt.

Pic.3-2-2 The Hanuman Dhoka Palace after 1934 Nepal-Bihar earthquake (the temple at rear-right side is Jagannath Temple)

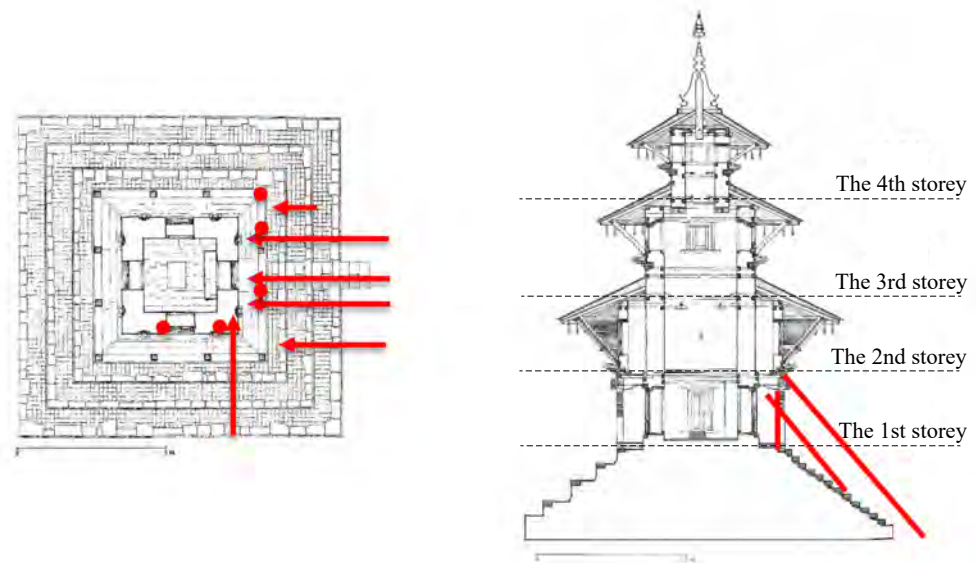
As shown in Fig. 3-3-1, the Gopinath Temple was supported with a temporary column and knee brace as an emergency measure against the earthquake damage. The knee brace provided additional support at the east and south sides of the structure; residual deformation to the east or southeast direction was likely. As shown in Pic. 3-3-1, structural damage to the Gopinath Temple was concentrated in the first storey. Primary structural damage included collapsed brick wall joints, peeled inner wall plaster, and fallen timber beams at the periphery. Conversely, wall damage in the second and third storey was not observed.

Fig3-3-1 The supports as an emergency measure implemented to Gopinath Temple

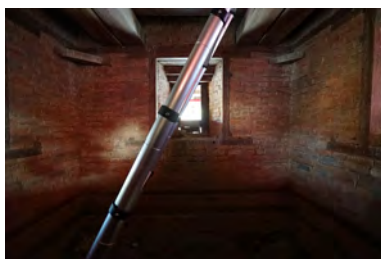
Third storey: Slight outer wall damage

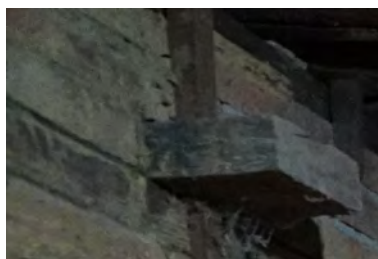
Second storey: Slight inner wall damage

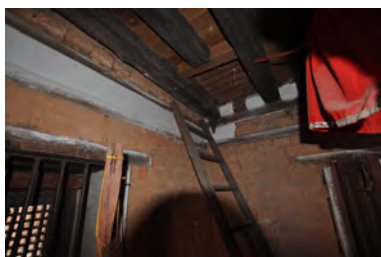
First storey: Peeling plaster from inner wall and damage at the masonry joint

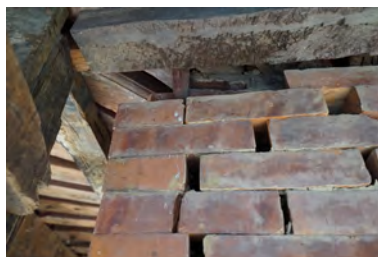
First storey: Damage at the masonry joint at outer wall

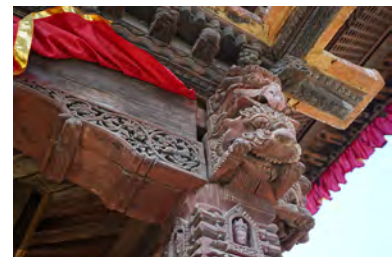
Timber beam coming out from the column
