2015 Project for International Contribution to Cultural Heritage Protection

Project for Investigation of Damage Situation of Cultural Heritage in Nepal

Survey of Historic Settlement

National Research Institute for Cultural Properties, Tokyo

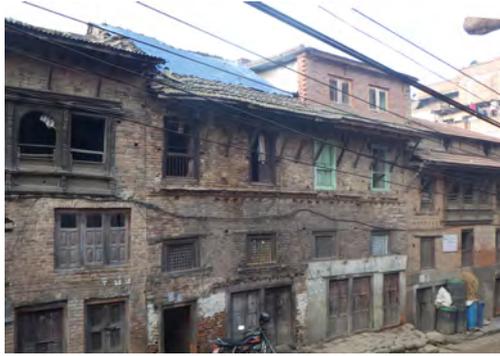
One of four traditional houses which escaped the collapses caused by the earthquake is situated on Nyala Dan Street (S10 and S11). Like other houses, this house has suffered significant transformation; however, the stones piled up before 1934 remain in the foundations, carved timbers remain inside, and the original courtyards are kept in good condition. There is also the altar inside which an image of a Goddess was previously placed. This house is thus the public space of the residents. As it is very important for the history of Khokana, it is advisable to investigate it more profoundly, with the perspective of conservation and restoration.

Fig. 2-6-56 House which has remained from before 1934 (partially extended)

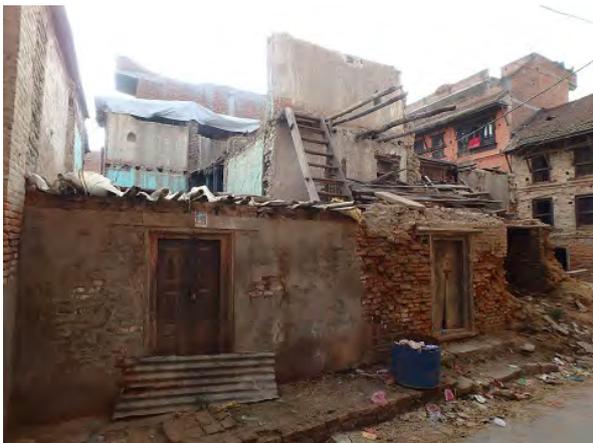
Pict. 3-2-1 Heavy damage of the building Type AB

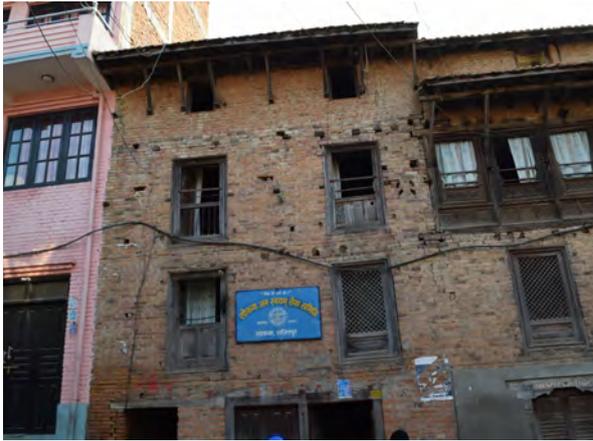
Fig. 3-4-1 House extended on the 3rd floor (S16). Roof and struts are relocated to one floor higher up. The trace of the past supporting beams is left on the façade.

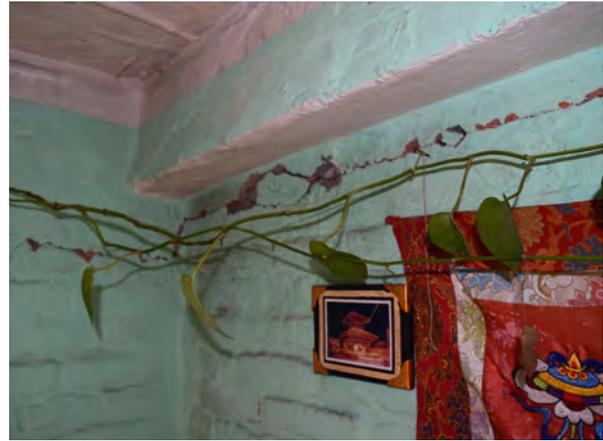
Fig. 3-4-2 Cracks over the wall under the beam of the extended floor.

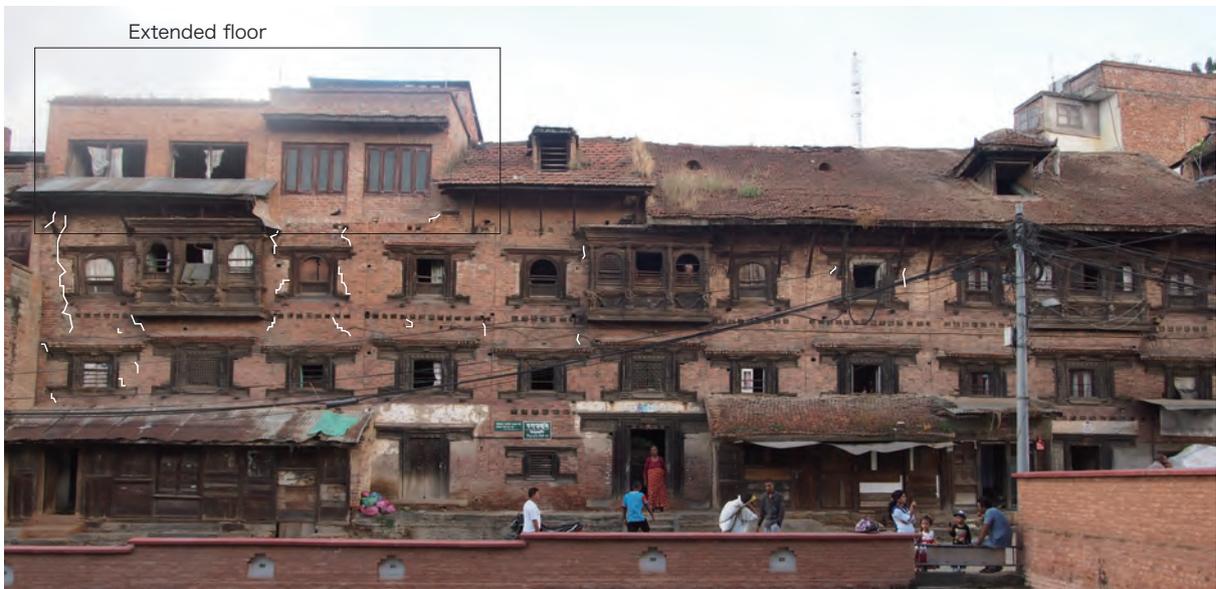
Fig. 3-4-3 Cracks are seen on the left side, under the extended floor more than right side where traditional roof style remains (Kirtipur), taken by author on 18th Sep. 2015

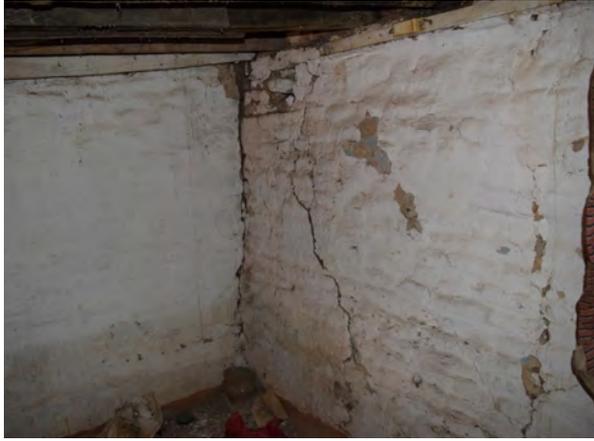
Fig. 3-4-6 Cracks over the corner of the wall (S13)

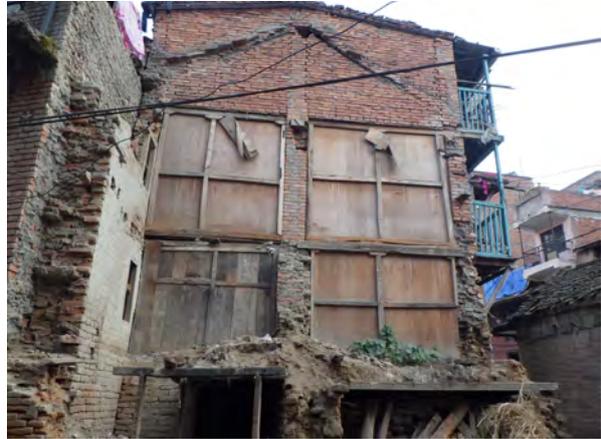
Fig. 3-4-9 Example of damaged houses (N00) neighboring the one with blue balcony (N01)

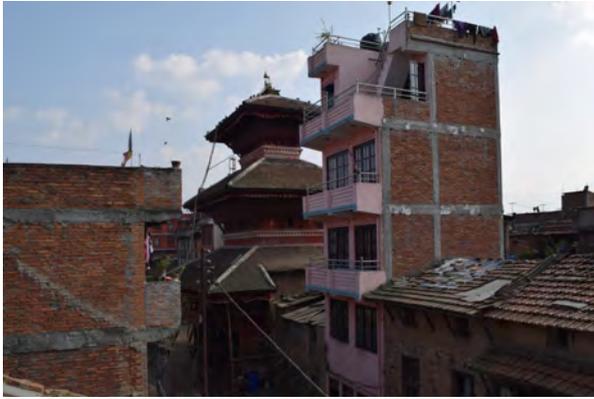
Fig. 3-4-17 High-rise house where water storage tank was placed (S17) and damaged low-rise house by the fall of the tank (S18)

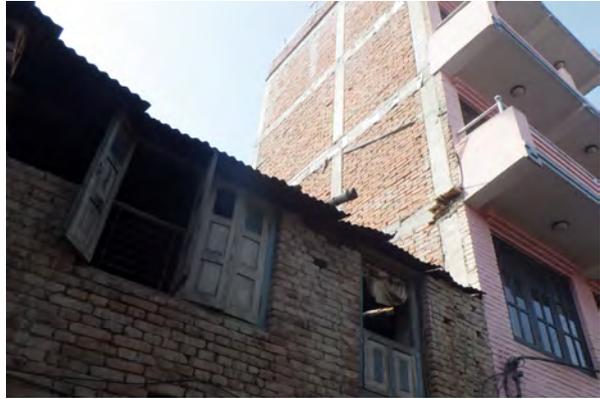
Fig. 3-4-18 Damage spot by the fall of water storage tank (S18)

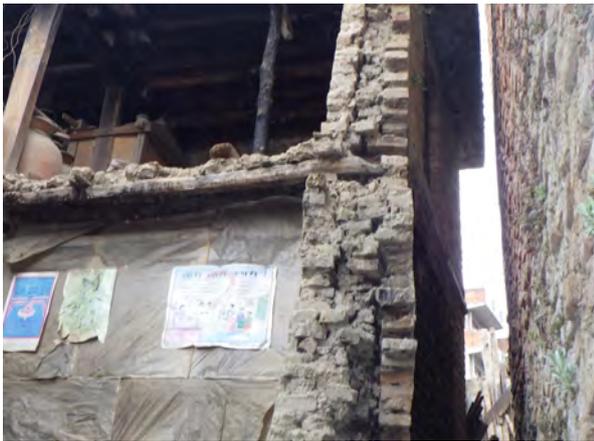
Fig. 3-4-19 The inside of brickwall is made and not unified with the outside made of burning brick.

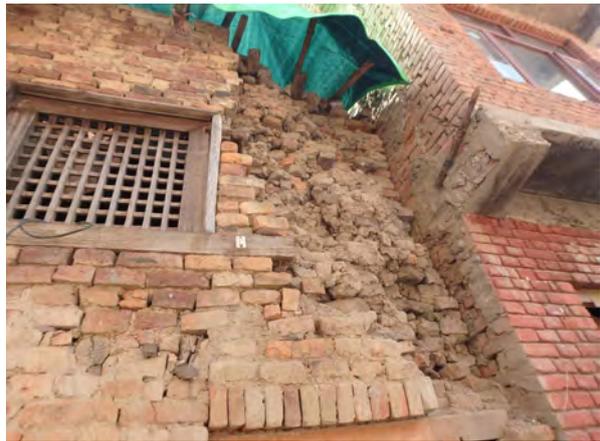
Fig. 3-4-20 Damage of a brick wall after the disaster, with peeling off of surface brick
