VERNACULAR HOUSES **in Bhutan**

Western Central Area
Thimphu, Punakha, Paro, Haa

Royal Government of Bhutan
Ministry of Home and Cultural Affairs
Department of Culture

Published in February 2022

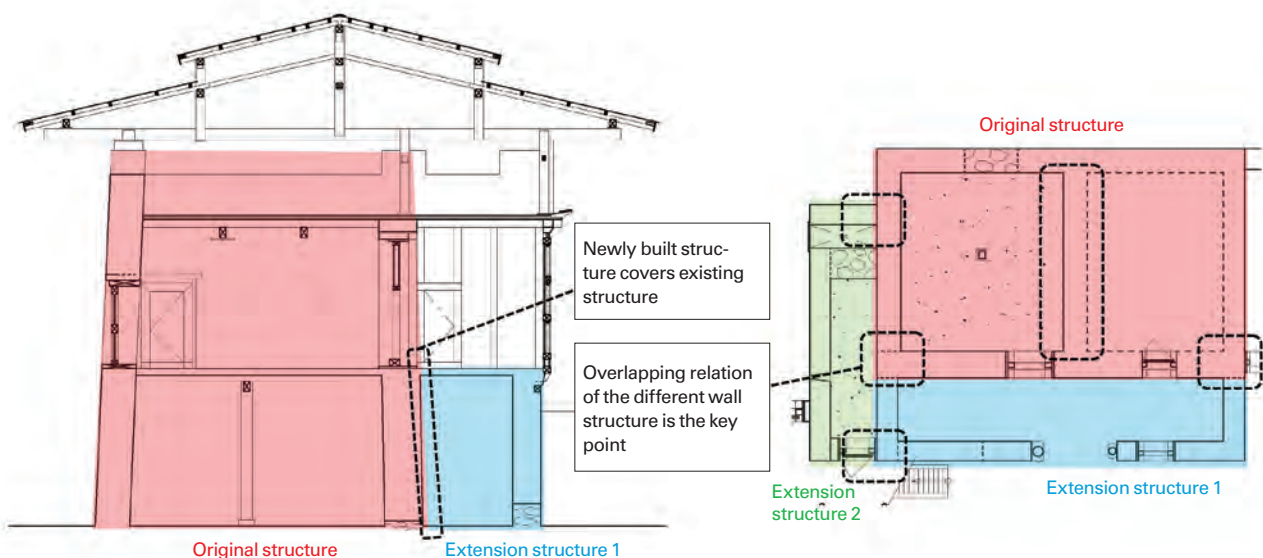
Additions of rammed earth walls

due to additions made over the rammed earth walls. Besides the difference in layers between the part of the wall with rammed earth added to the top and the old wall, the wall is thinner on the inside, and is easily distinguishable from the old wall by the difference in thickness.

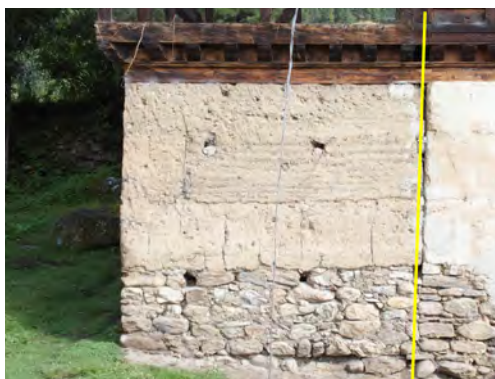
The third pattern relates to the difference in the structure of foundations; even if the structure is the same stone masonry, if the stones are of different sizes or shapes, or if the height of structure itself is different, it can be inferred that a foundation was constructed at a different time compared to another foundation. If the foundations differ—despite being connected to the rammed earth wall above—it is possible that the wall was modified by adding a foundation and rebuilding it.

Difference of foundation structure

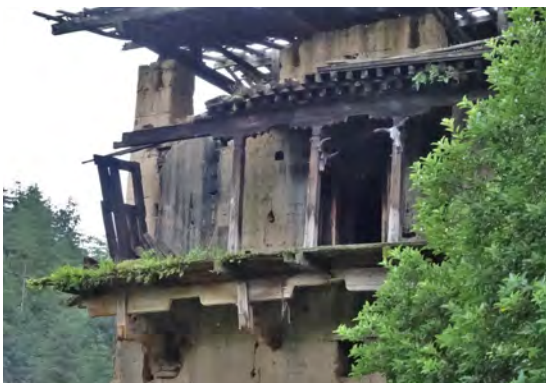
Lham Pelzom House, Details of the west façade in June 2013

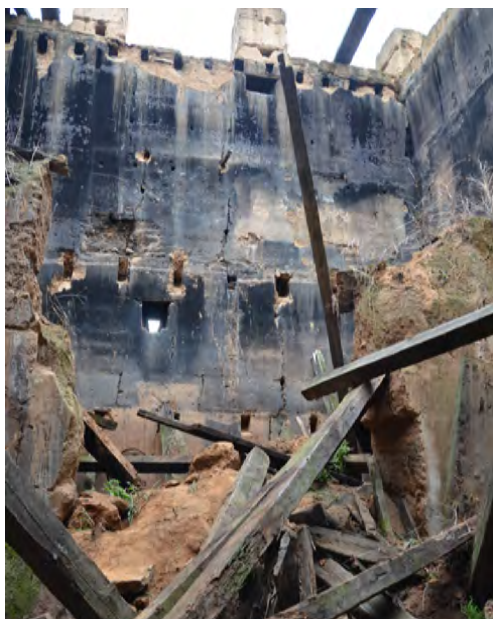
Inside view from the west showing the collapsed central section of the partition rammed earth wall

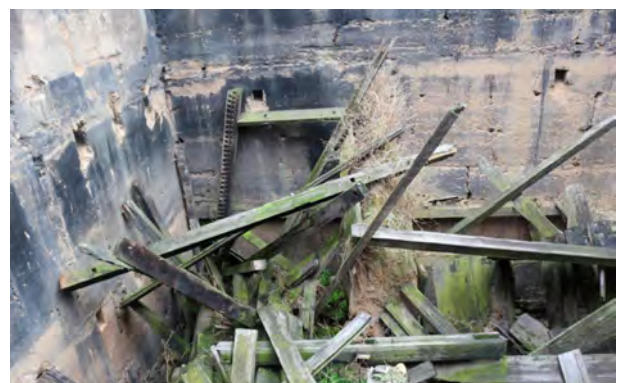
Inside view from the north showing as-found condition of collapsed wooden members

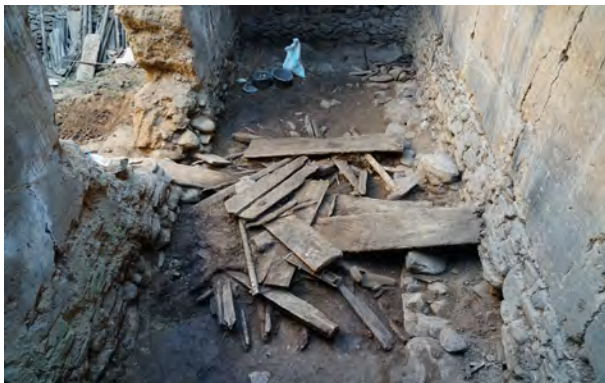
Buried wooden members found in the east side of the building

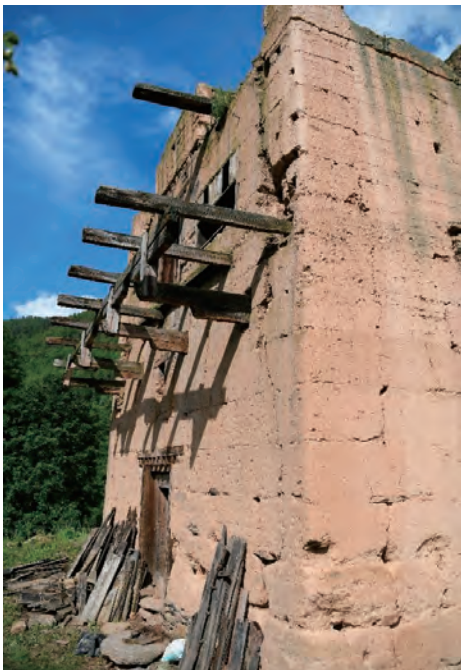
The rammed earth walls are believed to have been constructed approximately 300 years ago; they are approximately 1m thick at the foundation, and 0.7m thick at the top. Viewed from the outside, the outer walls slant inward. There is very little slant from the inner walls towards the outer walls. There appear to be wooden crosspieces built into the wall to connect the corners. The front and back walls constitute the full span of the width, with the side walls inserted between the front and back walls. Most of the openings are concentrated on the front face of the building, with an entrance on the ground floor, a small window on the first floor, and an entrance leading to and from the open balcony that projects out from the second floor. The building has very few openings overall, which likely contributes both to maintaining the strength of the rammed earth

Condition of the rammed earth walls (front corner section)

In areas where additional strength is needed, iron plates will be concealed inside and secured in place with bolts. Coarse linen will be pasted to the wall mud and covered with additional layers of wall mud. Sheathing boards will be used for the portions of the rammed earth wall that have been lost, thus reproducing the traditional construction method. In temple construction
