Conservation and Restoration of Concrete Structures

Foreword

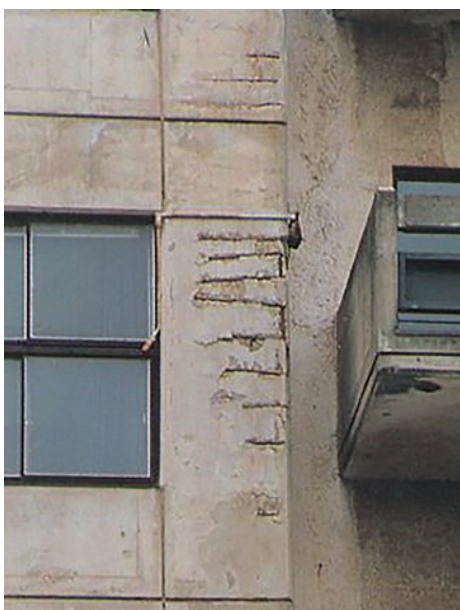
photo 3 Example of carbonation³

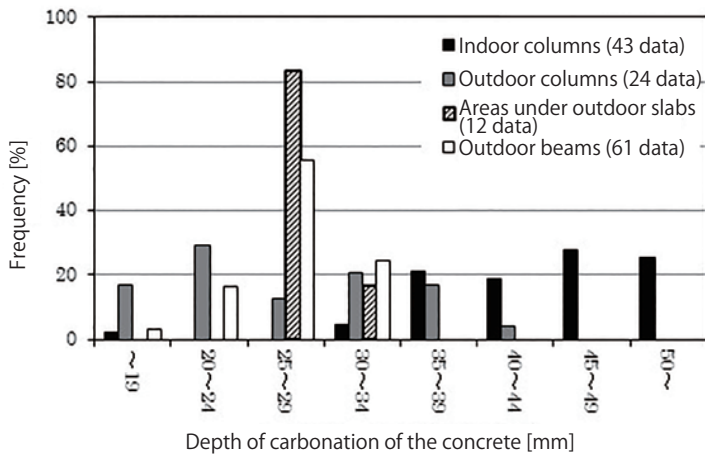
figure 19 Distribution of the depth of carbonation of the concrete

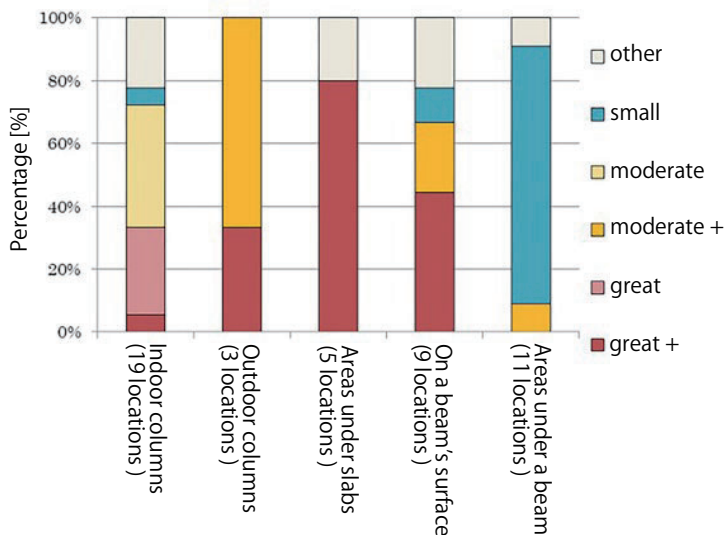
figure 20 Classification of the degree of risk that the rebar at various locations will corrode

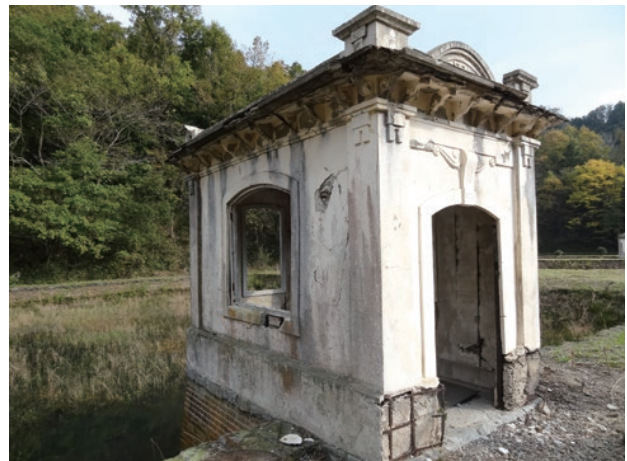
photo 2 Water control shed No. 2 before restoration. This was the most severely damaged of all wells.

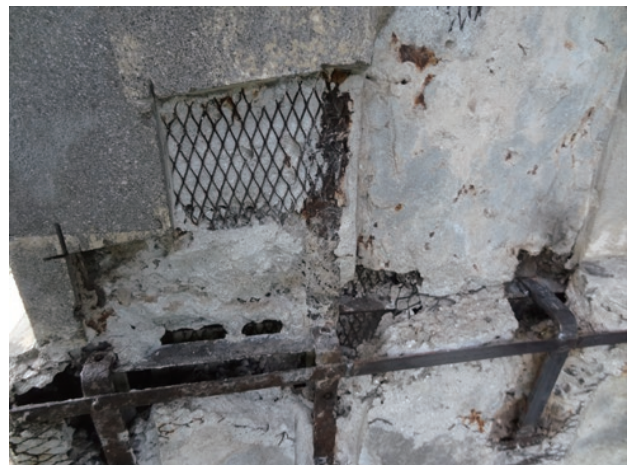
photo 3 The original diamond-shaped metal lath and steel frame members, after removal of damaged mortar finish

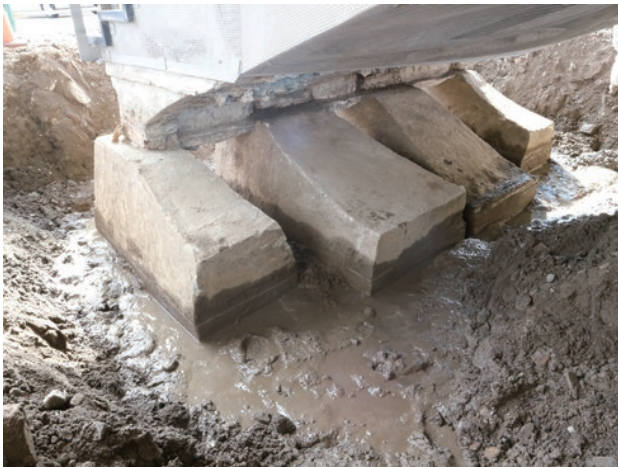
photo 19 Independent foundations underneath the staircase were removed following permission for alteration of the present state.

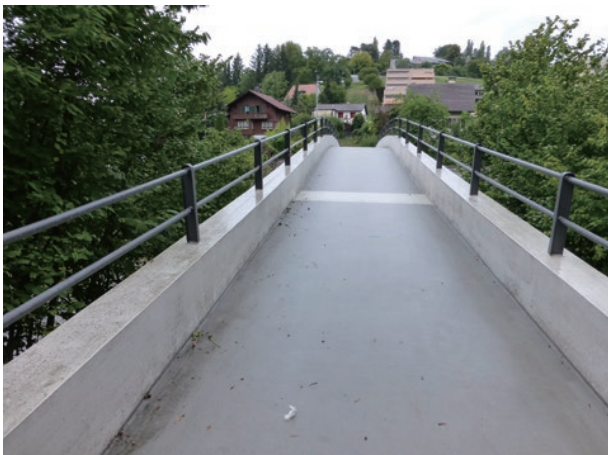
photo 29 Condition of the bridge's surface

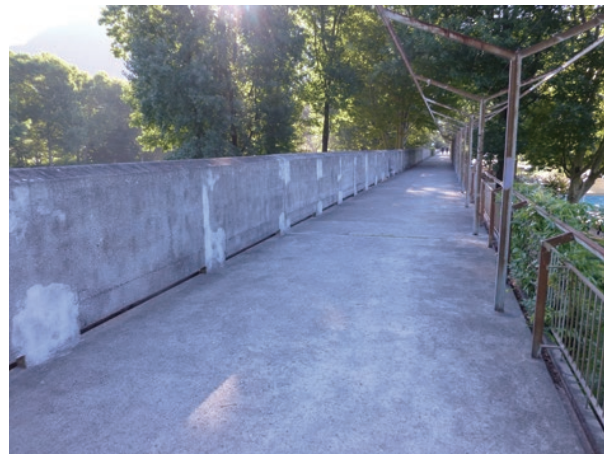
photo 62 Repaired concrete balustrade wall (the color of the concrete repair is conspicuously lighter)

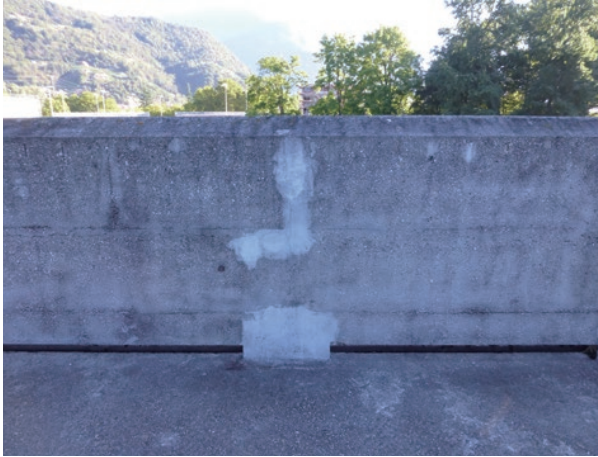
photo 63 Repaired concrete balustrade wall (the color of the concrete repair is conspicuously lighter)

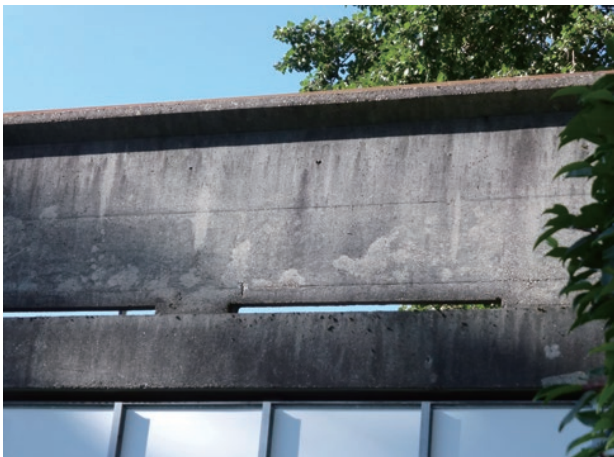
photo 65 The color of the repaired areas is close to the color of the original structure, making them look more natural.)

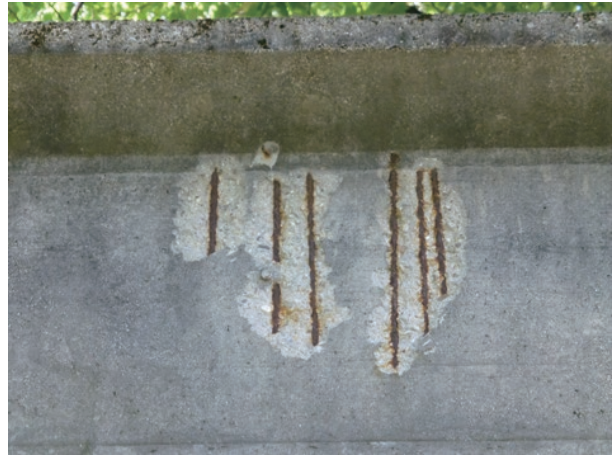
photo 66 Corroded steel bars (1)

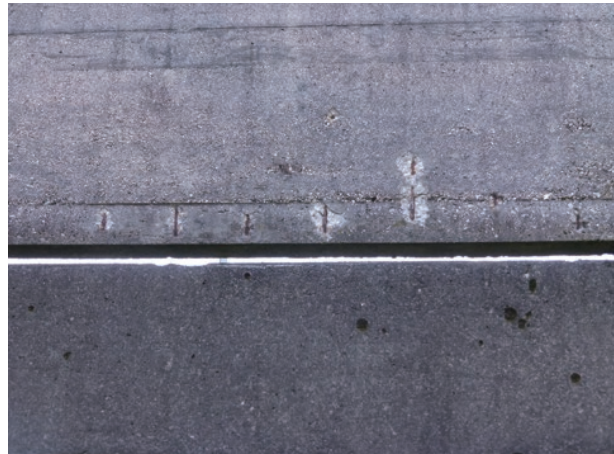
photo 67 Corroded steel bars (2)

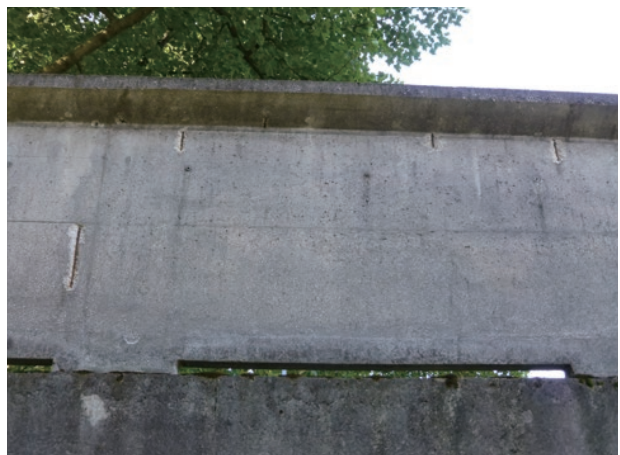
photo 68 Corroded steel bars (3)

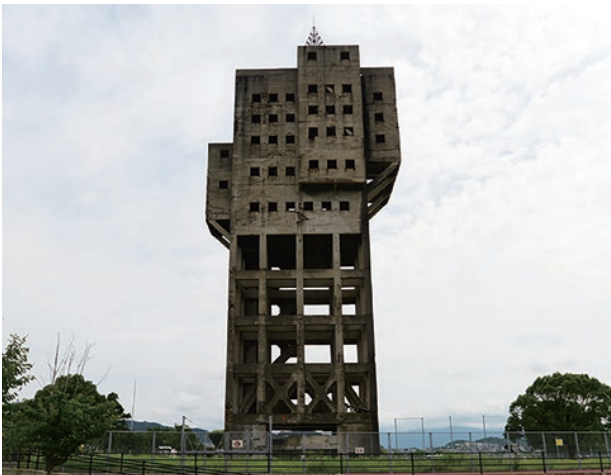
Igawa: The repair of the Former Shime Coal Mine Shaft Tower (hereinafter referred to as the Shime Shaft Tower) started last year. Presently, there is almost no covering thickness of the concrete, so the reinforcing bars are corroded and exploded. Though it will likely be restored to a sound condition, how the finish of the cover part should be treated, etc., has become a problem.

Hasegawa: The investigation work was performed at the Shime Shaft Tower until two years ago. Apart from the cover problem, the reinforcement had already exploded, the concrete had peeled off, and the reinforcing bars were exposed. It was found that the original covering surface was not sufficiently rehabilitated because the covering thickness was thin even after the original covering surface had been restored. Therefore, it is necessary to further add 6 cm of coverage thickness. As to whether this practice is good for the conservation and restoration work of a cultural property is controversial, to preserve the Shime Shaft Tower, an additional 6 cm covering thickness must be added, otherwise the same deterioration will recur.

photo 2-1: Exterior view of the Former Shime Coal Mine Shaft Tower before restoration

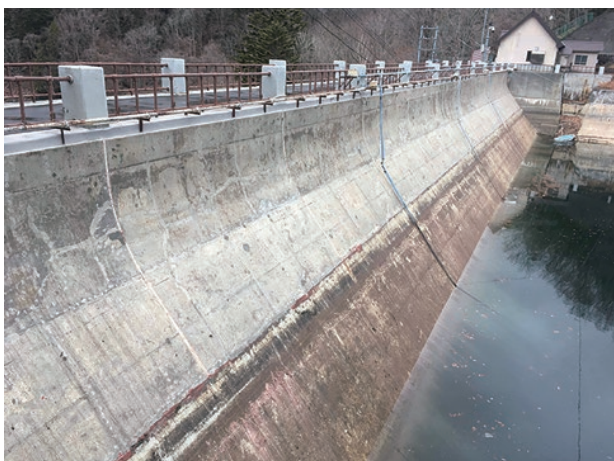
photo 3-7 : buttress frost damaged (photo provided by : Tokyo Electric Power Company Holdings, Incorporated)

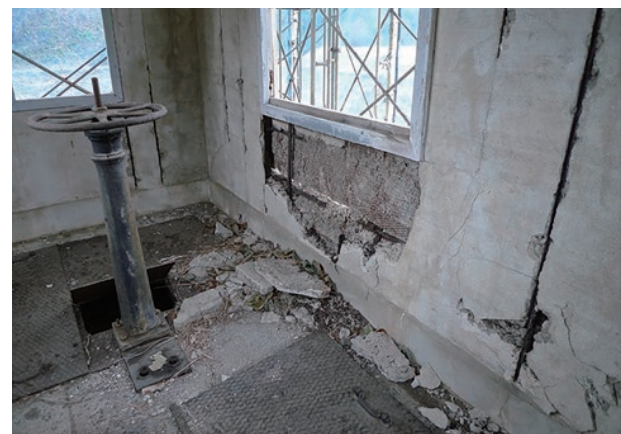
photo 4-3: Deteriorated and damaged internal walls of No.2 intake water control gate shed (reference : 『重要文化財 旧美敷水源地下水道施設 保存修理工事報告書』、p.95)
