Conservation and Restoration of Internal Features

Tokyo National Research Institute for Cultural Properties
Center for Conservation Science, Restoration Techniques Section

Foreward	Saito Takamasa	3
Introduction	Nakayama Shunsuke	5
Chapter1 Conservation and restoration of internal features in the Bank of Iwate (Former Morioka Bank) Main Office Main Building	Tsumura Yasunori	9
Chapter2 Restoration lighting historic house	Fukuda Kazuya	33
Chapter3 Painting repair of graining in Meiji-mura - Case study of restoration of No.25, Nagasaki Foreign Settlement -	Matsushita Michio	75
Chapter4 Case study of conservation and restoration of internal features	Nakayama Shunsuke	89

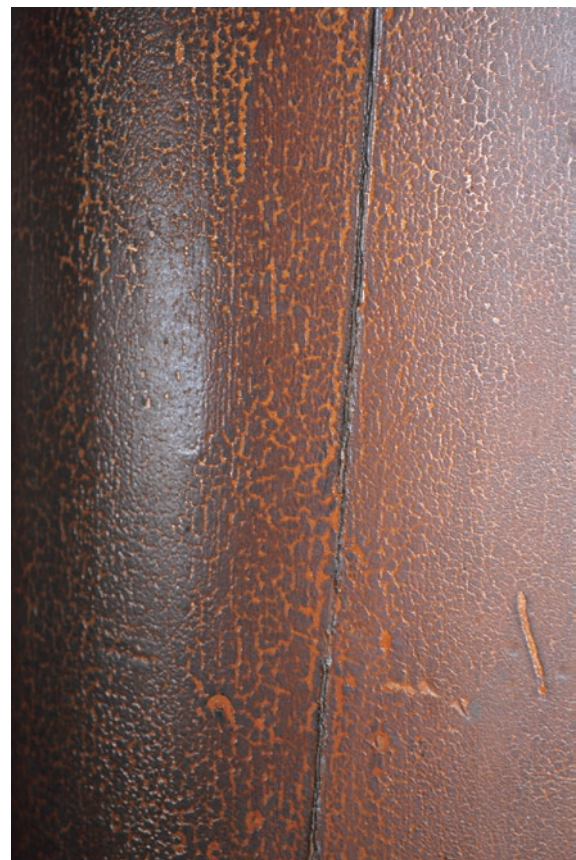
photo 14 Scale-like cracks in wooden parts of the wall

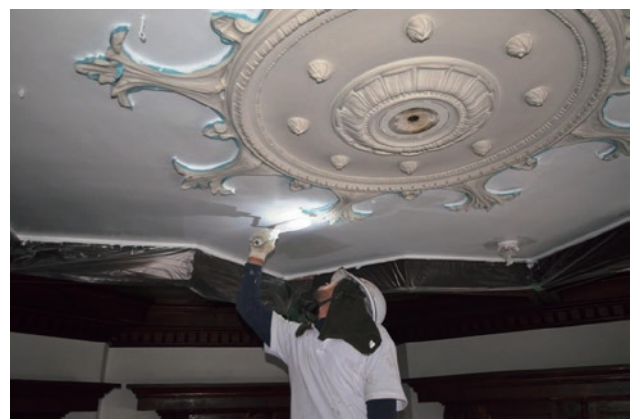
The ceiling of each room was decorated with water-based paint on the original wooden plaster base, and the floating, peeling, cracking, water leakage, and age-related stains of the coating film were observed in various places (**photo 15**). There were cracks that reached not only the paint film but also the plaster, but many of them remained around the central deco-

photo 15 Southeastern public space ceiling

ration. As they were all hair cracks, none of them were considerably serious. Cracks of 0.1 mm or more were putty-treated and painted (white synthetic resin emulsion paint). After removing the deteriorated part of the existing coating film (EP) on the surface with a leather

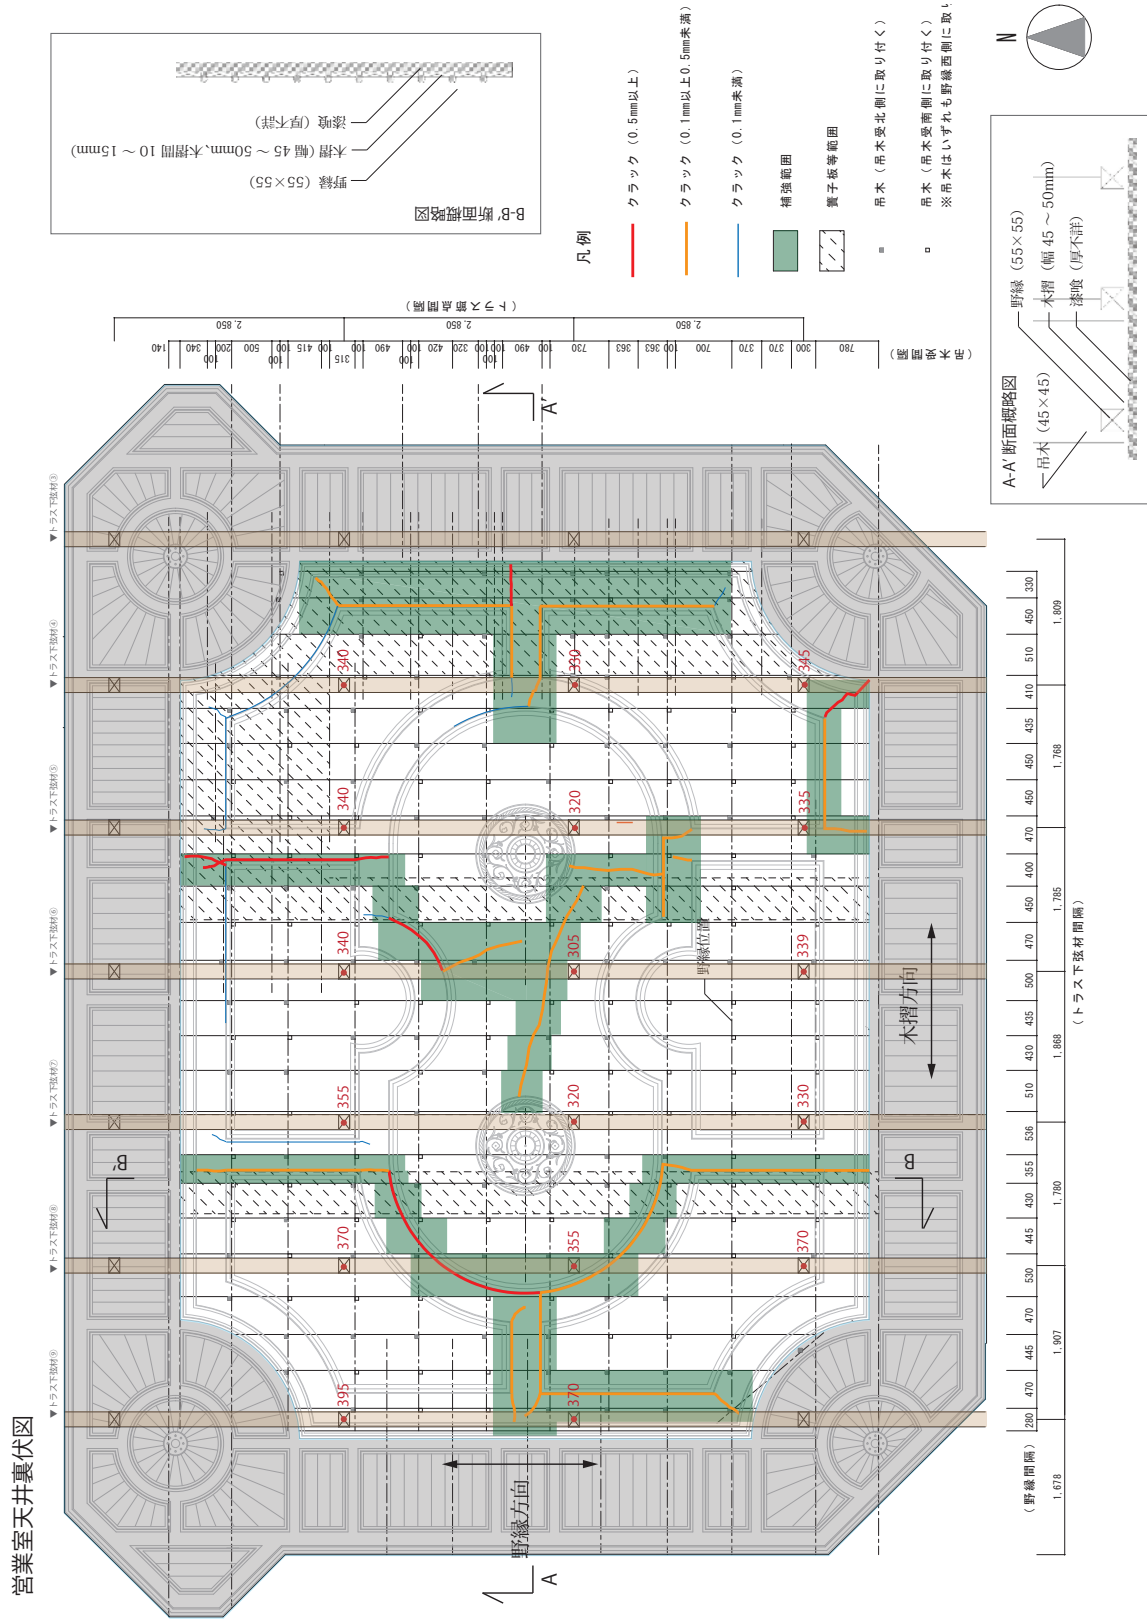
figure 6 Cracks in the woodem plaster ceiling of the business office

The ceiling of the business office was large, and its cracks were not limited to hair cracks alone. It also had bigger cracks of 0.5 mm or more (**figure 6**). The ceiling of the business office is approximately 9 meters high. To prevent human casualties from a large area of plaster potentially falling during an earthquake, while the room might be used by numerous visitors, only the existing cracks at the back of the building were reinforced, and plastering was done. The positions of the cracks were recorded from the business office side, and the plaster layer thickness, the thickness of the wood slide, etc., were measured. The locations and depth of the perforation were examined, the worn areas were marked in accordance with their locations, perforation was performed using a drill (powder was removed after perforation), and reinforcing acrylic resin was injected with a syringe for follow-up. After repeating the resin injection once more, the viscous acrylic resin finishing was injected into the perforated part, and a hemp string was inserted.

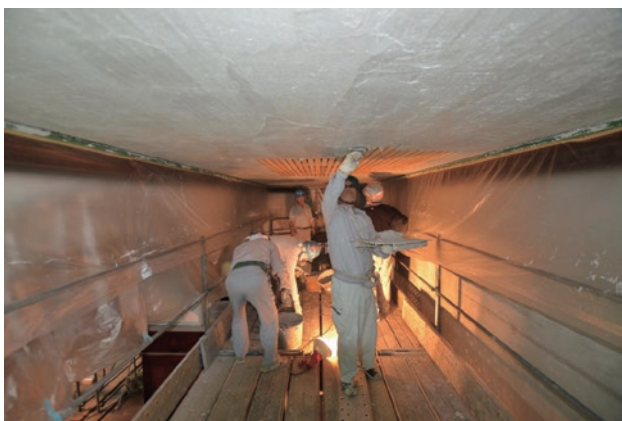
photo 16 West side public space ceiling

The civic gallery and the west side public space were remodeled in a later period; therefore, they were dismantled during the investigation. To apply a new plaster ceiling, the height of the old ceiling was checked, and after installing the base materials such as wood railings, the ceiling was finished smoothly with plaster (**photo 16**).

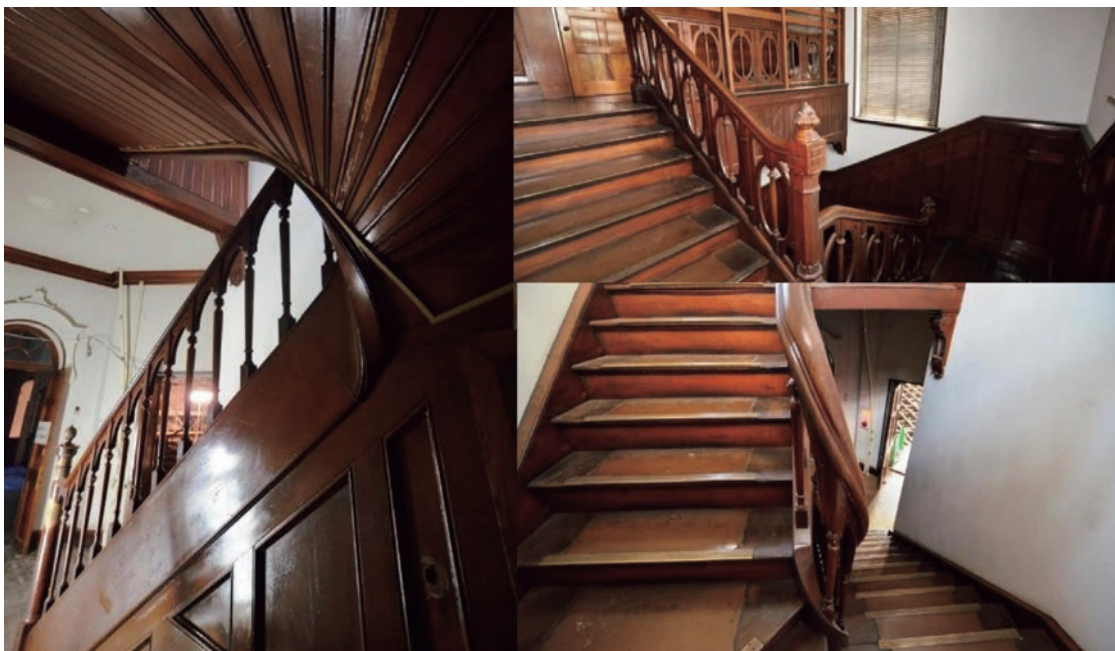
Aged deterioration and wear were seen in various places, but there was no major damage or falling parts, and there was no problem with normal use (**photo 33**).

photo 33 Stairs

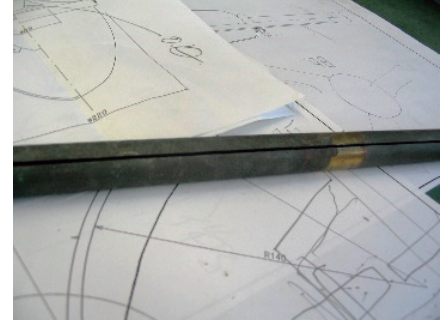
photo app.1-33 Central pipe brass joint damage crack

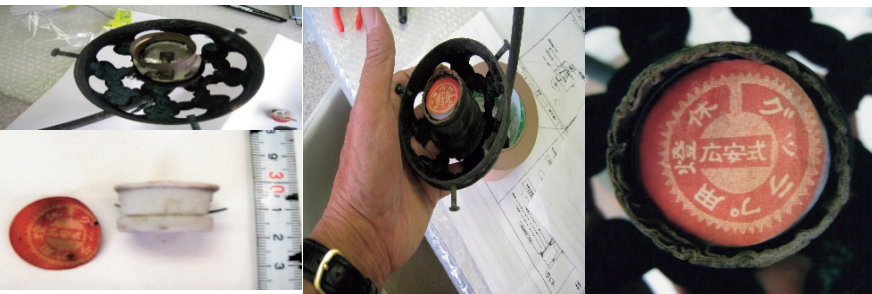
photo app.1-57 Light-blocking plug (with no light bulb fitted in the socket)

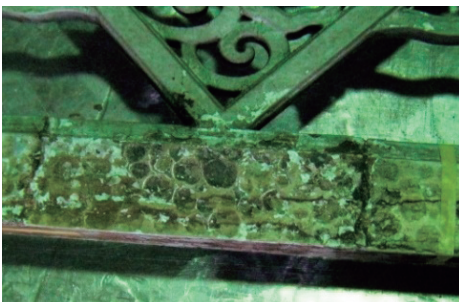
photo app.2-4 Cracks

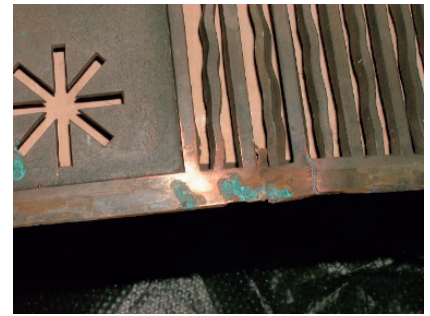
photo app.2-11 Damaged part

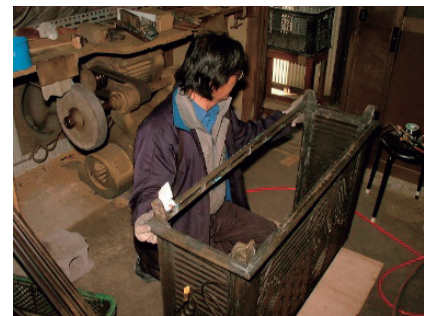
photo app.2-17 Welding of damaged frame

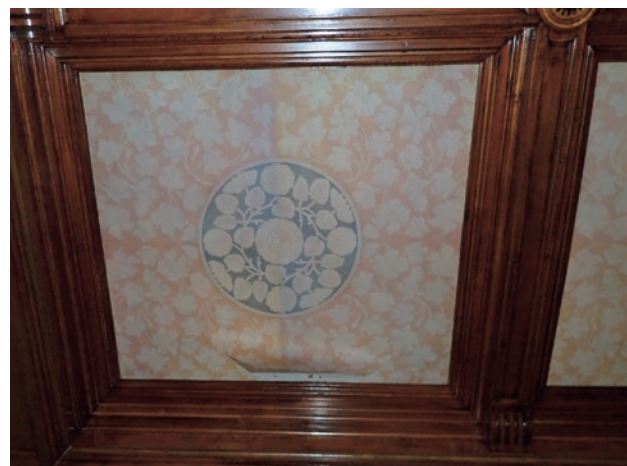
In this construction, the salesroom, branch manager's room, and reception room were restored by removing the auxiliary paint, coloring them with watercolors, taking pictures for printing, and offset printing to create ceiling paper. Currently, the ceiling paper has deteriorated again.

photo Deteriorated ceiling paper in the sales room
