在外日本古美術品保存修復協力事業
The Cooperative Program for the Conservation of
Japanese Art Objects Overseas

秋野蒔絵硯箱
*Suzuribako with design
of an autumn field in maki-e*

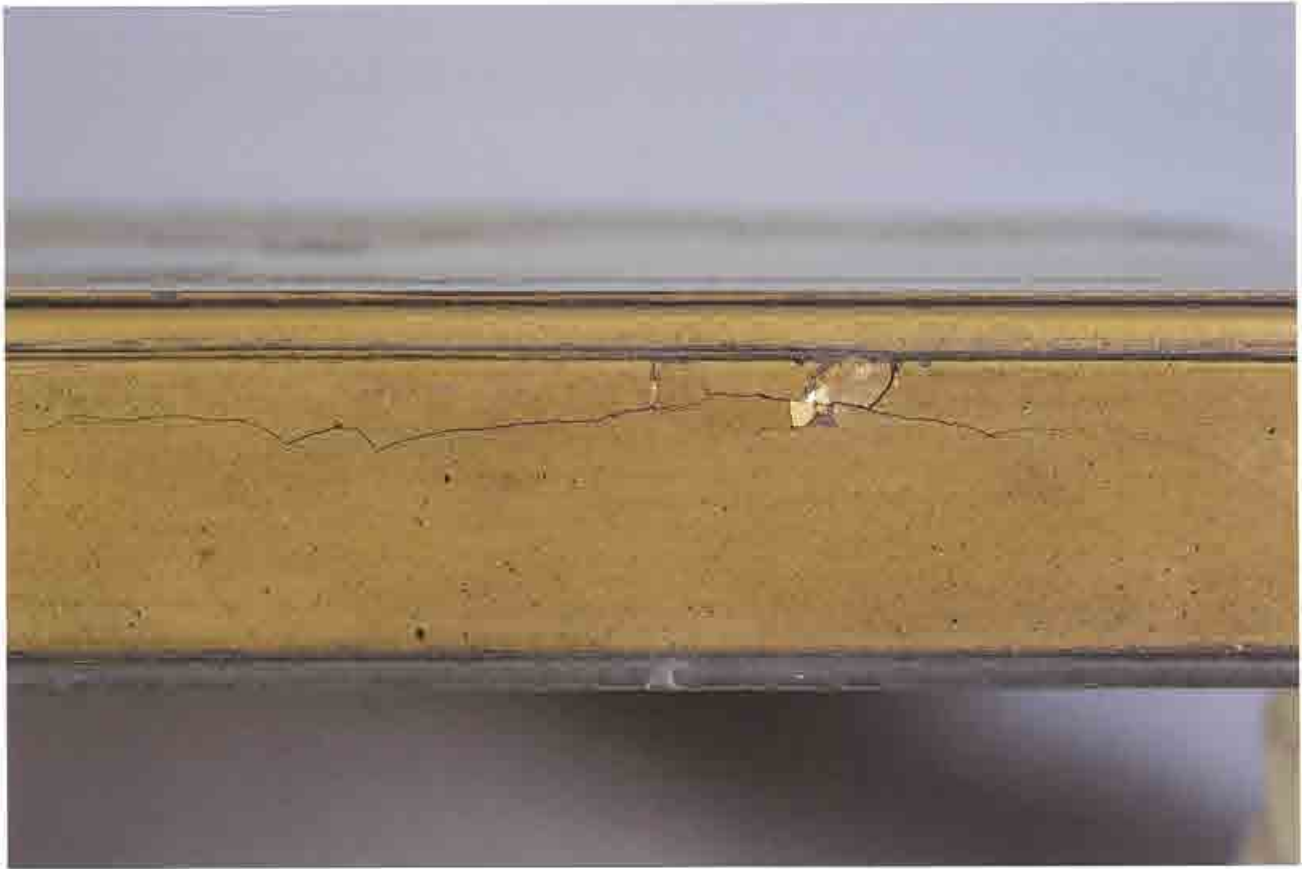
Fig. 1.7 蓋蔓背面の打損 (a)修復前
Damage due to impact on the edge of the lid at the back (a) before restoration

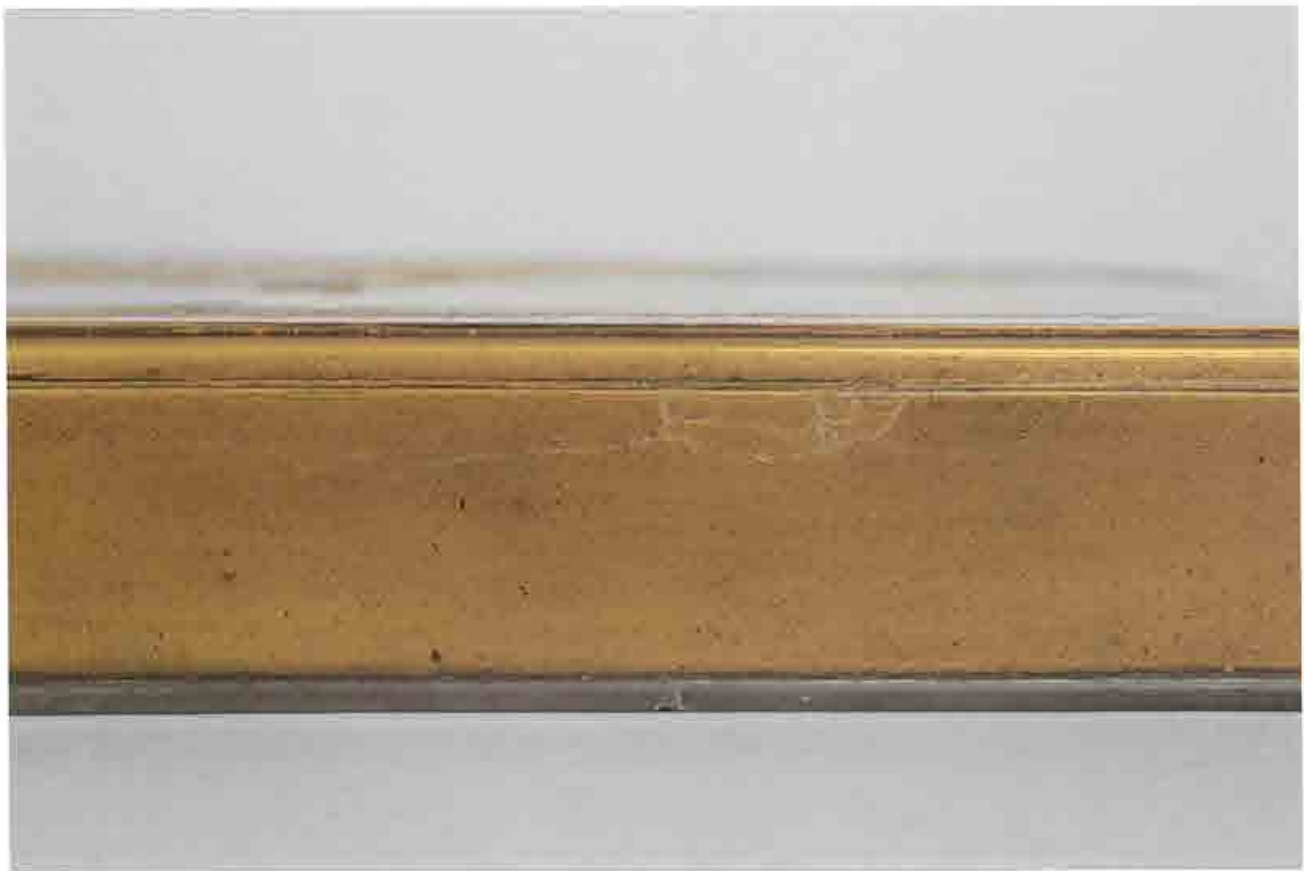
Fig. 1.7 蓋蔓背面の打損 (b)修復後
Damage due to impact on the edge of the lid at the back (b) after restoration

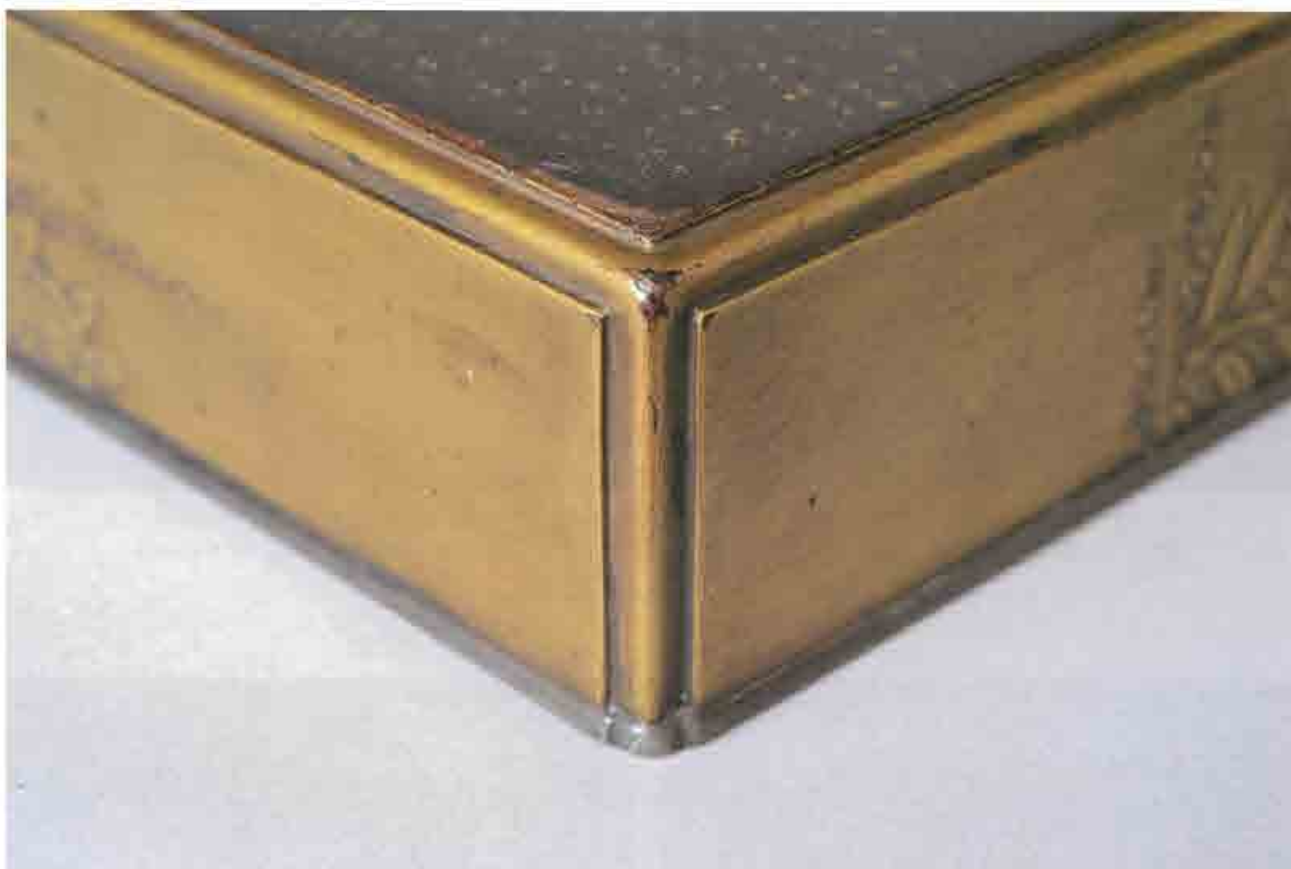
Fig. 1.8 身側板角の亀裂 (a)修復前
Crack on the corner of the side board of the body (a) before restoration

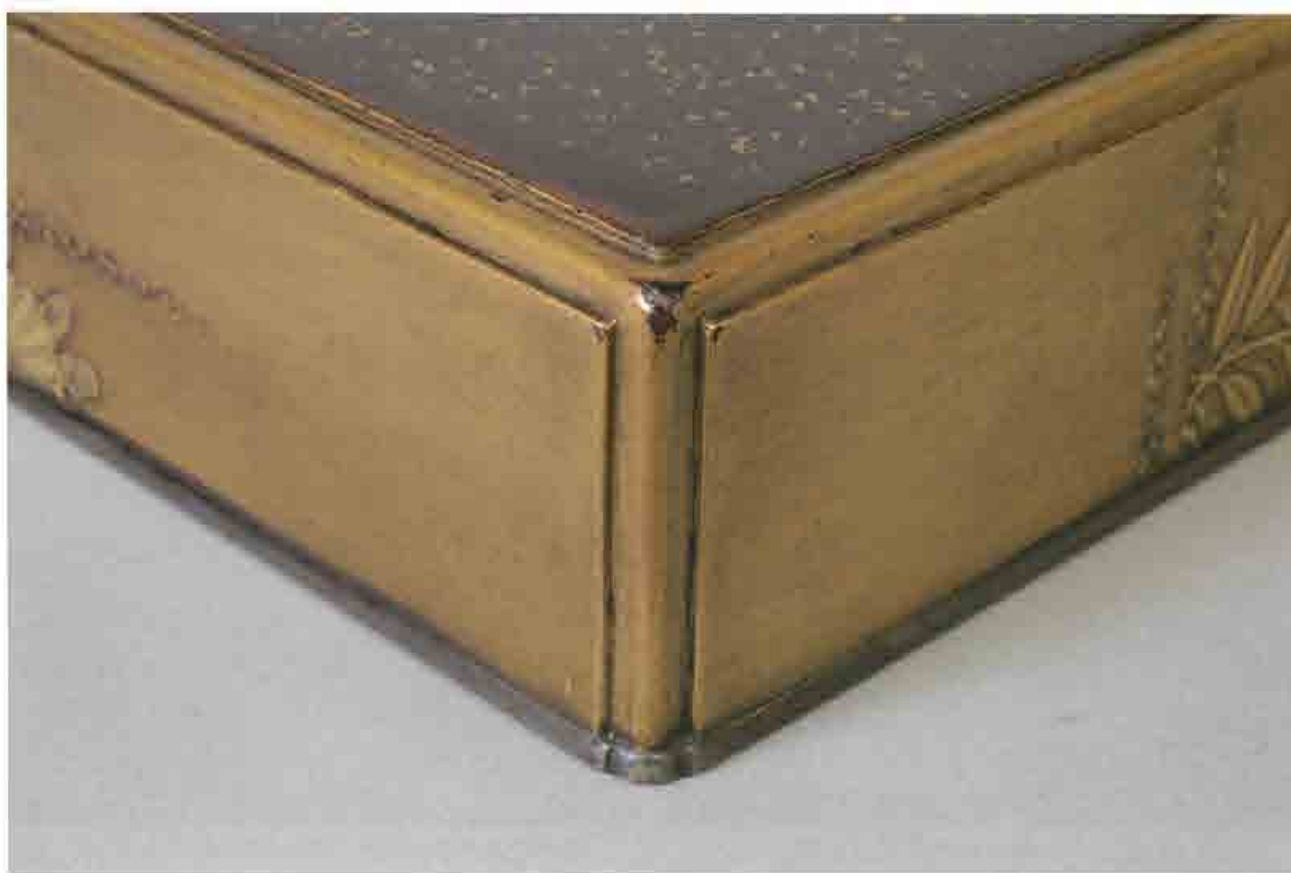
Fig. 1.8 身側板角の亀裂 (b)修復後
Crack on the corner of the side board of the body (b) after restoration

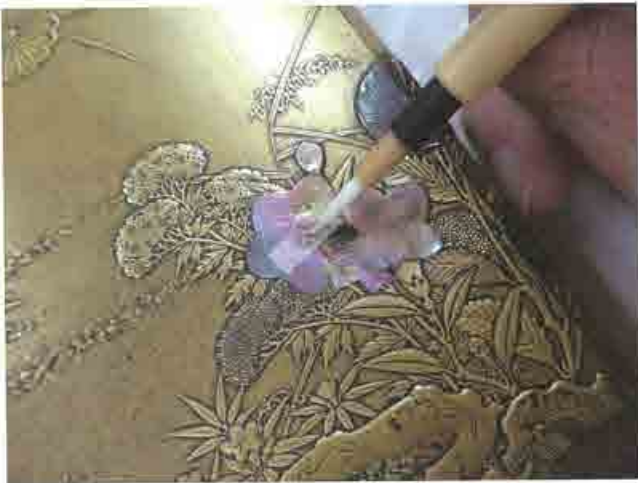
Fig. 1.9.1 養生
Facing

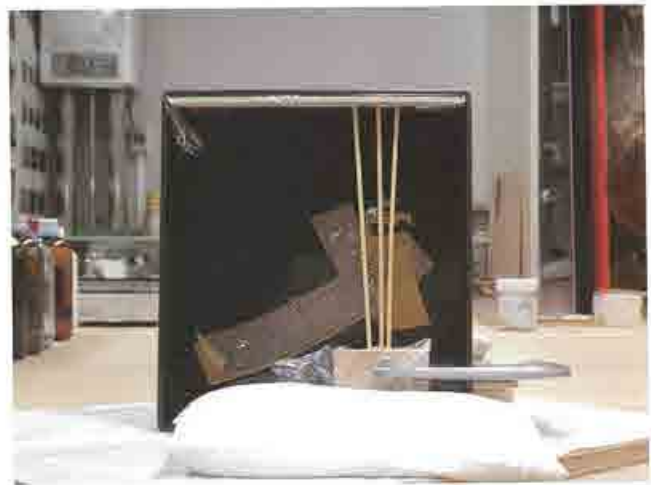
Fig. 1.9.4 蓋蔓の亀裂段差修正
Correcting the gap made by the crack
on the side of the lid

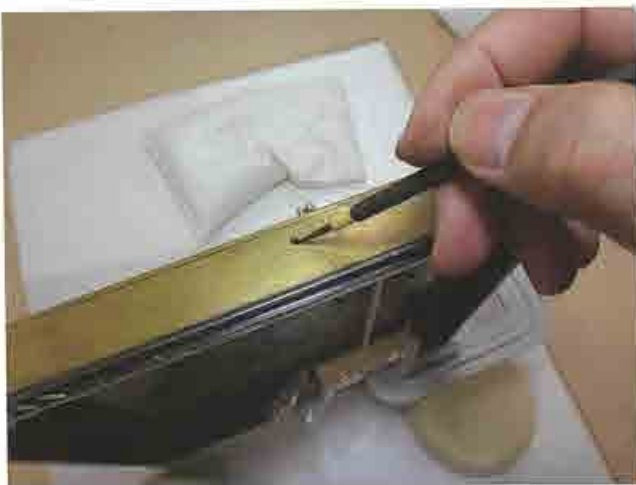
Fig. 1.9.5 亀裂部分の麦漆含浸
Impregnating *mugi-urushi* into a crack

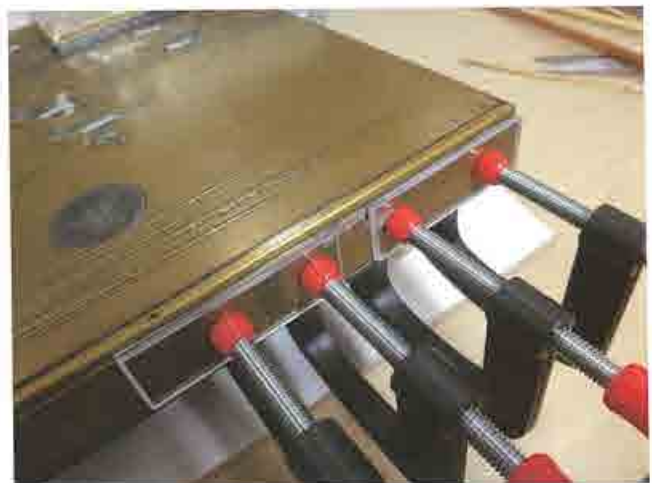
Fig. 1.9.6 蓋蔓の亀裂接着
Adhering the crack on the side of the lid

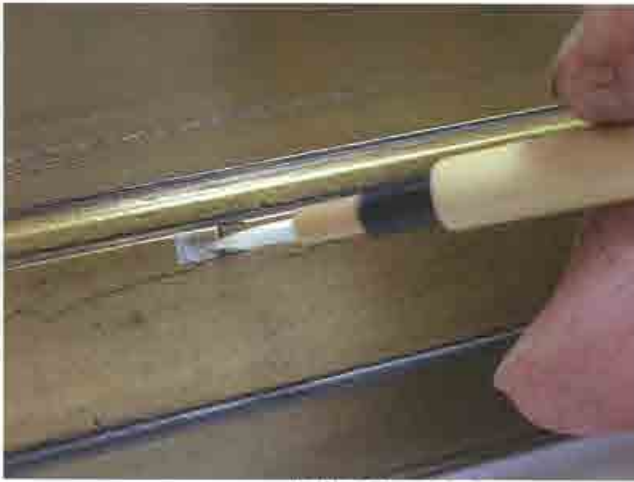
Fig. 1.9.7 蒔絵断片の養生
Facing the *maki-e* fragment

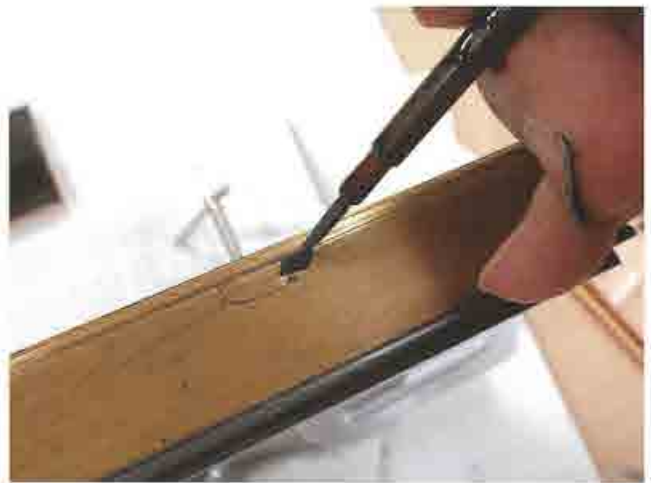
Fig. 1.9.10 漆塗膜の剥落止め
Consolidating the urushi coating film

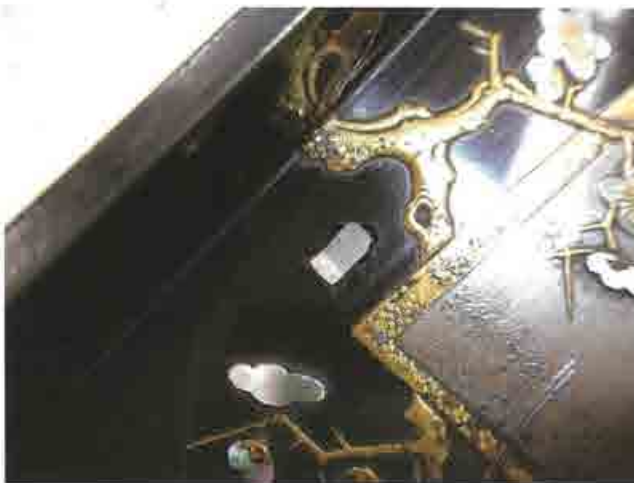
Fig. 1.9.11 打損箇所の充填 (楮紙による塗膜保護)
Filling the part damaged by impact (protecting the coating film with *kozo* paper)

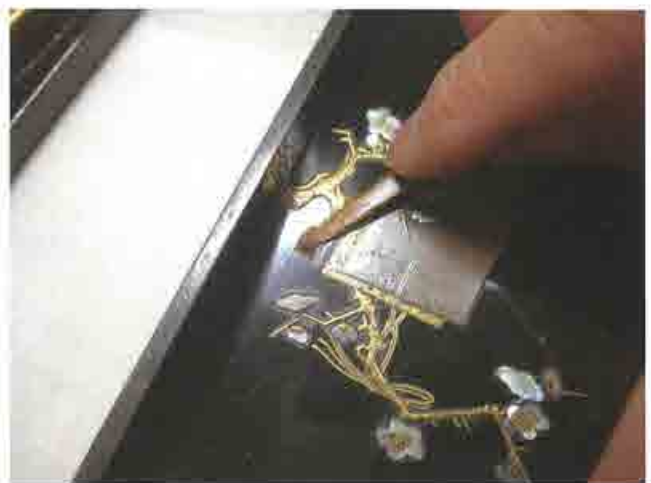
Fig. 1.9.12 抹香漆による打損箇所の充填
Filling the part damaged by impact with a mixture of *makko* urushi

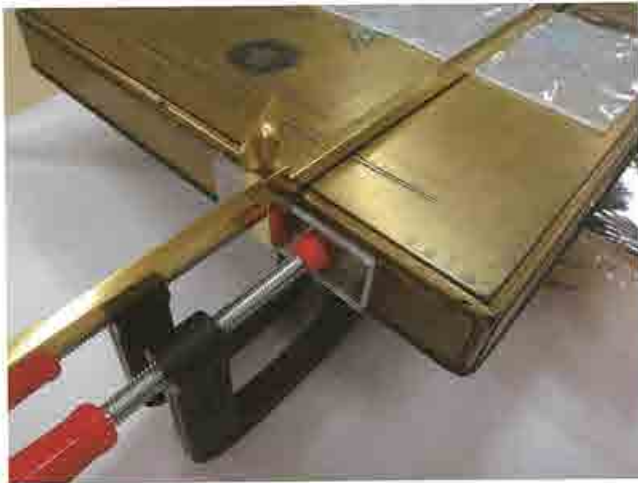
Fig. 1.9.13 蒔絵断片の貼り戻し
Re-attaching the *maki-e* fragment

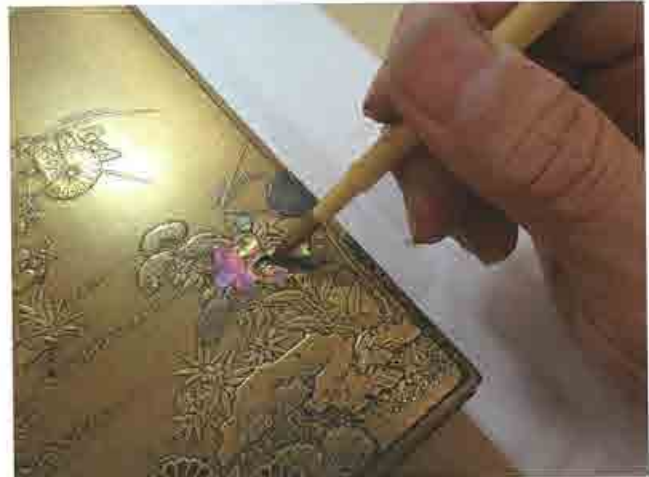
Fig. 1.9.14 螺鈿の剥落止め (膠水溶液の含浸)
Consolidating *raden* (impregnating aqueous animal glue solution)

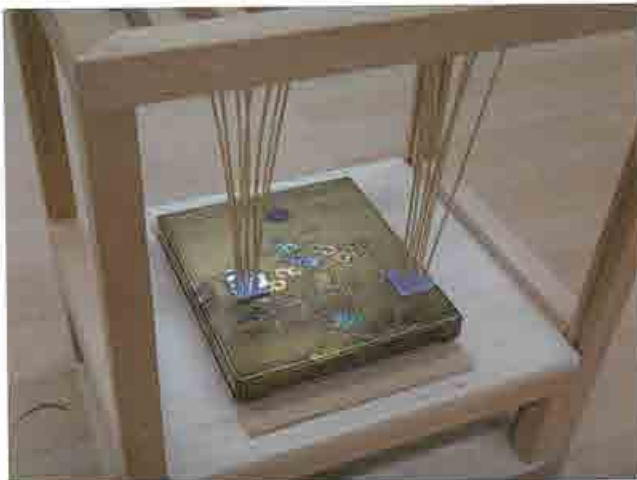
Fig. 1.9.15 木枠とラミン棒による螺鈿の剥落止め
Consolidating *raden* with a wooden frame and ramin sticks

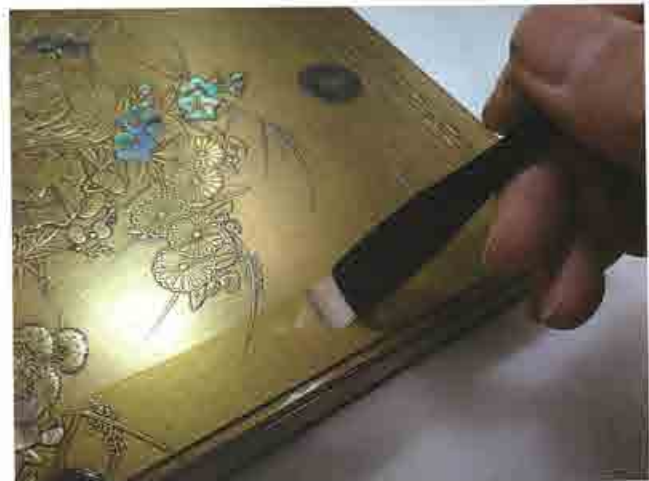
Fig. 1.9.16 蓋の漆固め
Consolidating urushi on the lid

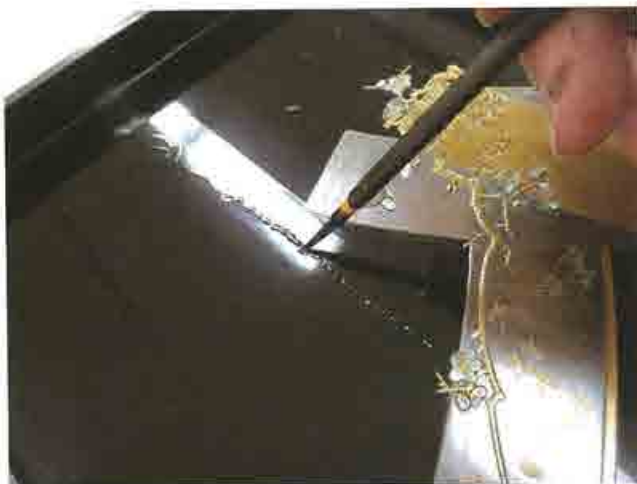
Fig. 1.9.17 蓋裏の亀裂接着
Adhering the crack on the underside of the lid

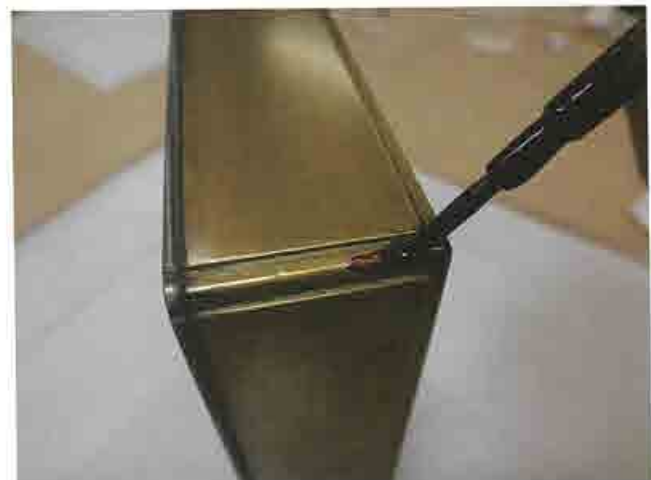
Fig. 1.9.18 身側板角の亀裂接着
Adhering the crack on the corner of the side board of the body

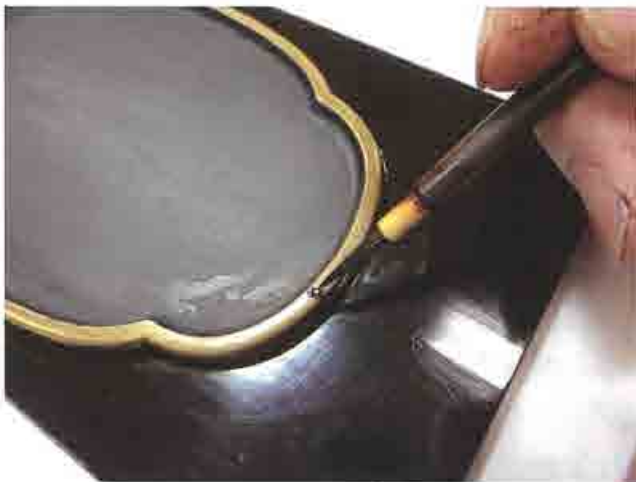
Fig. 1.9.19 硯の亀裂接着
Adhering the crack on the inkstone

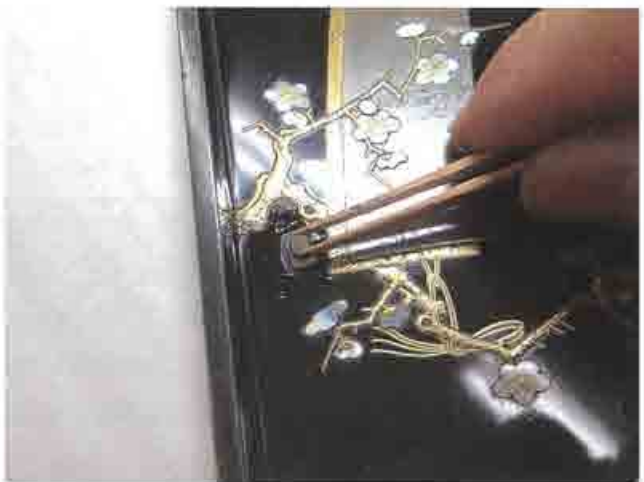
Fig. 1.9.20 色調整 1 懸子打損部の下地研ぎ
Color adjustment 1, polishing the foundation on the damaged part of the inner tray

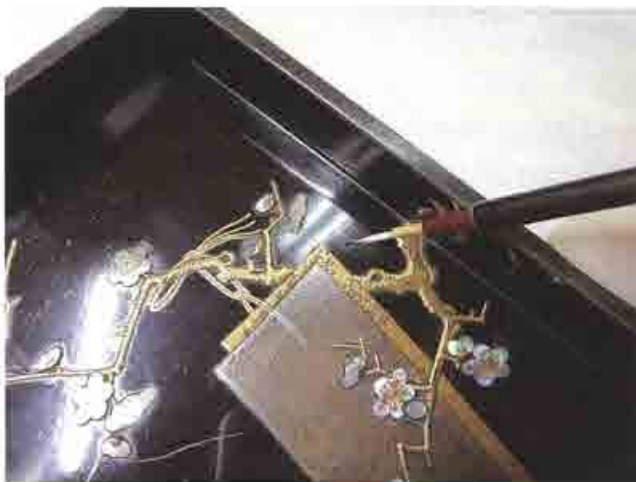
Fig. 1.9.21 色調整 2 懸子打損部の漆塗り
Color adjustment 2, coating urushi on the part of the inner tray damaged by impact.

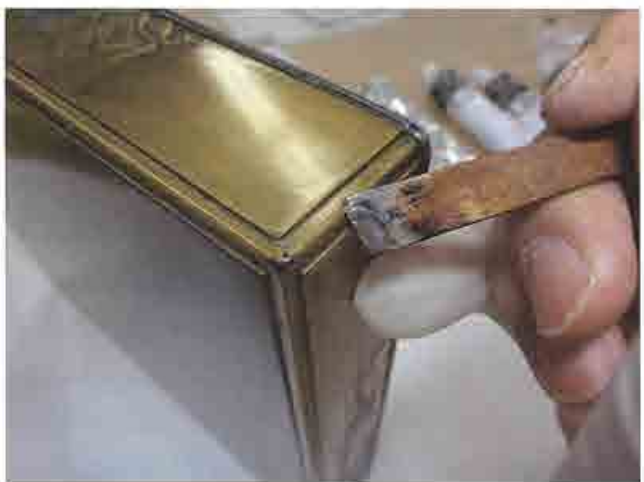
Fig. 1.9.22 色調整 3 身側板角の金色下地付け
Color adjustment 3, applying gold foundation to the corner of the side boards on the body

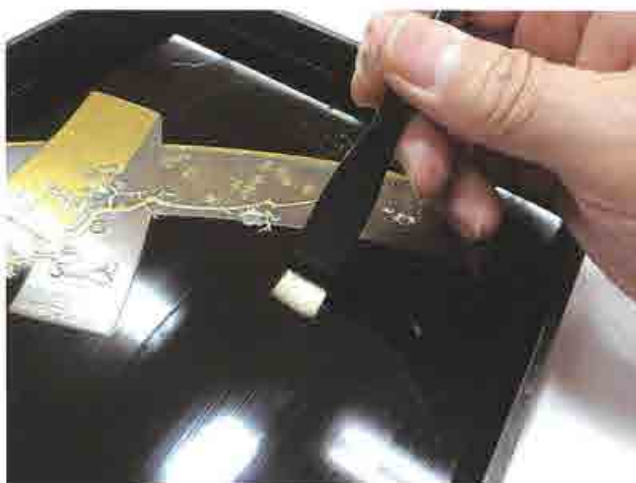
Fig. 1.9.23 漆固め 1 蓋裏の漆塗膜部分
Consolidating urushi 1, part of the urushi coating film on the underside of the lid

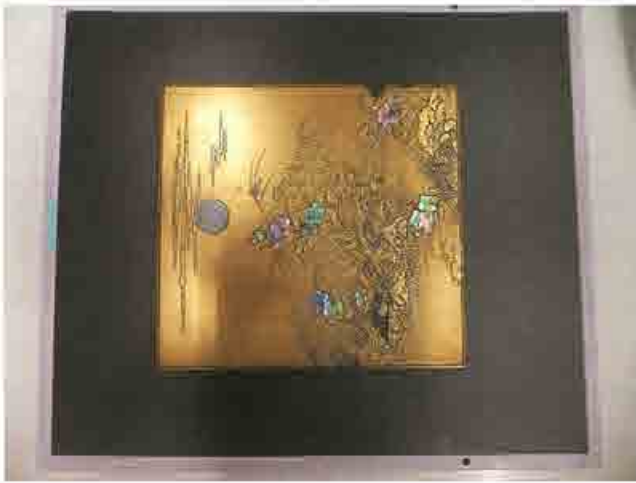
Fig. A.1.1 (1) 蓋
Lid
