Networking Core Centres for International Cooperation  
on Conservation of Cultural Heritage Project  
“Conservation and Utilisation of Historic Buildings in Bhutan”

- Examination of Restoration Plan and Utilisation Plan of Farmhouses—
- Examination of Value Evaluation of Farmhouses as Cultural Heritage—

March 2020

Tokyo National Research Institute for Cultural Properties

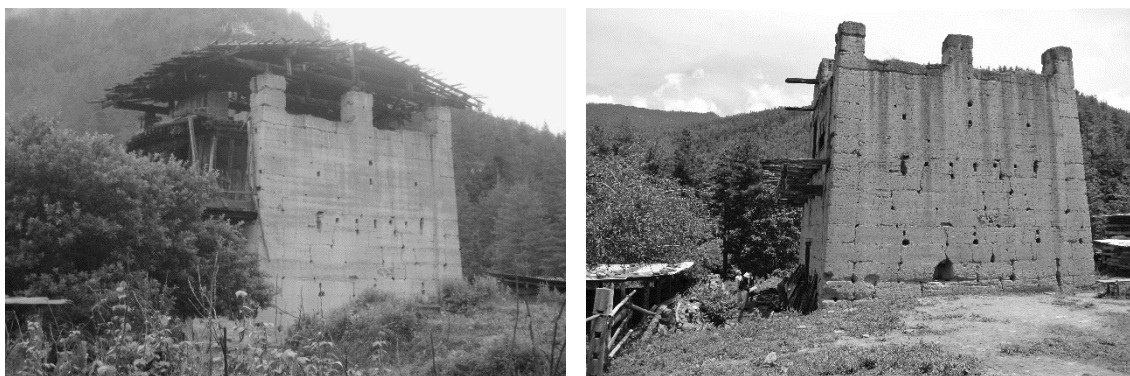
Photo 3.,4. Lham Pelzom house in June 2013 (left) and in August 2019 (right)

The building has been unoccupied from around 2008, and the deterioration over time was significant with a partly collapsing roof and veranda at the time of the survey in 2013. The inner wall and the wooden structure collapsed, leaving the outer wall in 2017, but it is still retained at a level where it can be restored as a cultural heritage site because the collapsed timbers have been recorded, collected and stored in a temporary shed through first aid work, as part of joint research in 2018.

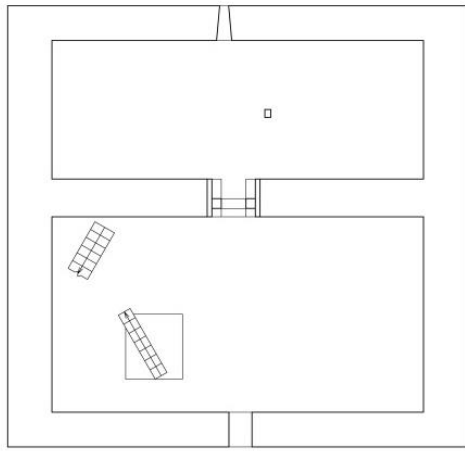
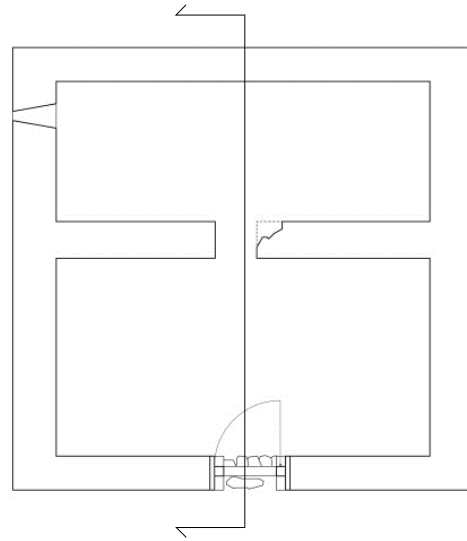
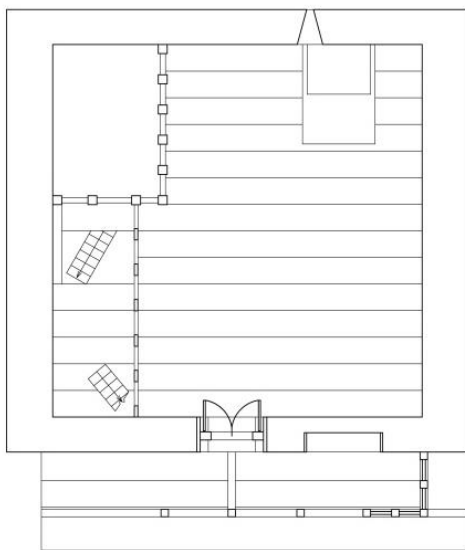
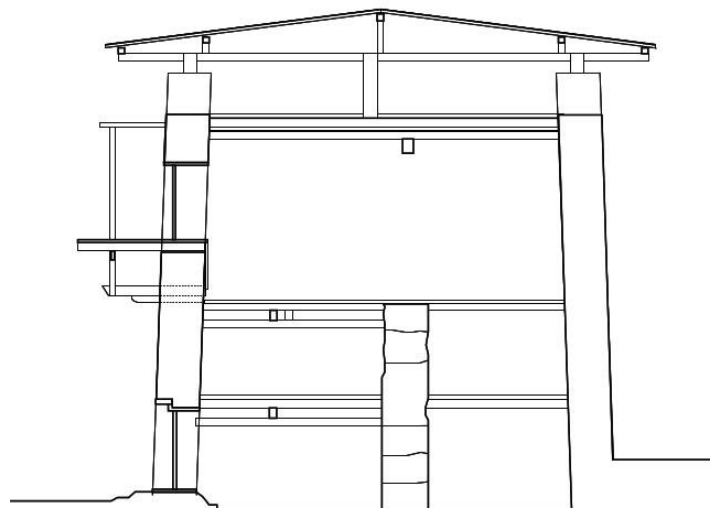
Fig 4. Drawings of Lham Pelzom house

The building faces the west and is composed of a three-storey rammed earth wall, a wooden gable shingle roof and a wooden veranda protruding from the front of the third floor. The outer wall is relatively thick, about one metre at the bottom, and the four corners are largely tilted inward (each corner has a tapering). The appearance is very closed with almost no window except in the front. The first and second floors are bisected into the front room and the rear room by an inner rammed earth wall, and the third floor comprises one room with no inner wall. It is believed that the first floor was used for livestock huts, the second floor for storage and the third as residence. The openings on the third floor are only a narrow doorway in the centre of the front and a small window at the top of the ridge, and it is very different from the traditional houses often seen today. It is believed to convey the characteristics of the primitive living space of Bhutan.

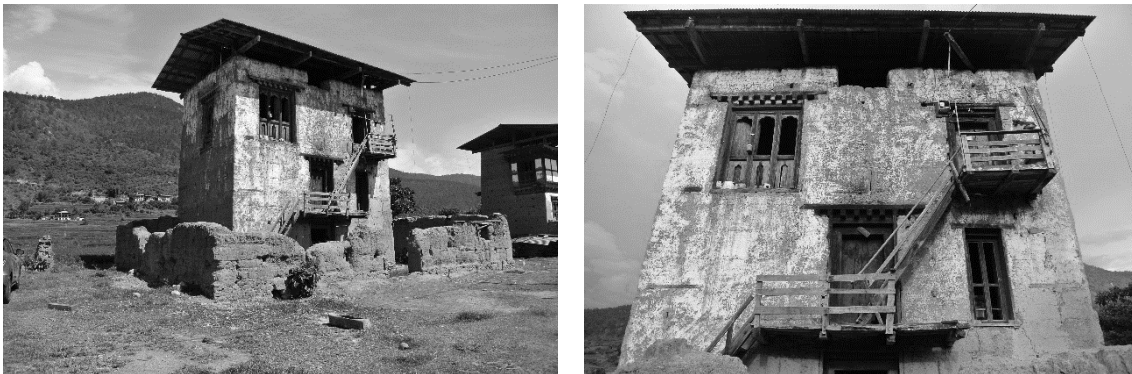
Photo 5.,6. Tandin Zam house, whole view (left), front (right)

The building faces the west and is composed of a three-storey rammed earth wall, a wooden gable steel roof, and it has a front yard that is surrounded by the rammed earth wall from the front to both sides. It has a tower-like appearance with a height relative to the building area, and the outer wall has a standard thickness of about seventy-five centimetres at the bottom, and the four corners are largely tilted inward (each corner tapers). There is an entrance on each floor in front of the building and it is connected with an external staircase. It can be understood from the remaining traces, that an internal staircase connected with the second and third floors, and later the south window on the western side of the third floor was added to the entrance, while the north window was enlarged. A veranda was initially set up on the window on the south side, but it was removed later and then renovated to a large window. The first and second floors are bisected into the north room and the south room by an inner rammed earth wall, and the third floor is also divided into two rooms by a wooden inner wall. It is believed that the first floor was meant for livestock huts, the second floor for storage, and the third floor as a residential area. The grain storage on the northern side of the first floor is a unique component where entry is only from the second floor, and it is believed to be a feature that houses of leading members exclusively have.

The building has a partial modification of later generations, but still effectively retains its original form considered to date back to the 18th century. Such tower-like closed farmhouses are often depicted in Samuel Davis' sketch of 1783, and is considered to be one of the typical architectural styles of farmhouses in western Bhutan in the 18th century. It is also worthy of being well managed by the owner and is in good condition despite the current non-resident situation.

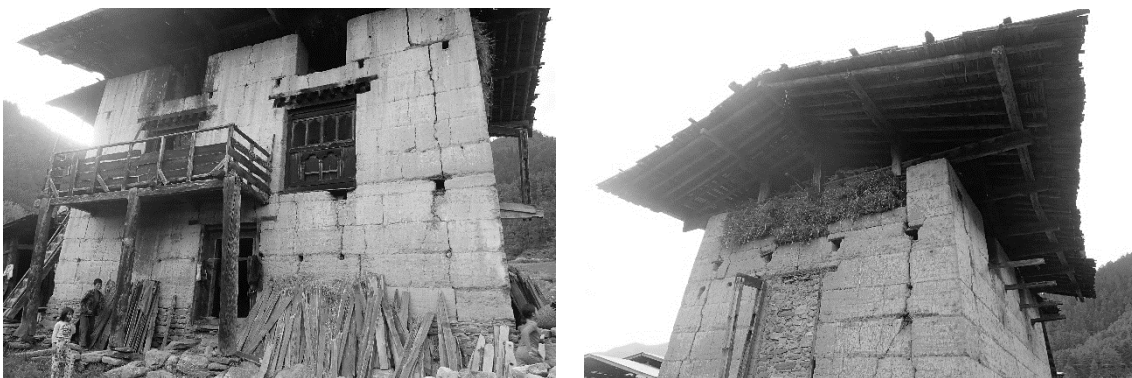
Photo 7.,8. Phub Lam house, front view (left), side and back (right)

The building faces the south and it comprises a two-storey rammed earth wall, a wooden gable shingle roof, and a front yard that is surrounded by a stone wall. There is no trace of expansion or renovation on the outer rammed earth wall, and the four corners are largely tilted inward (each corner tapers). The entrance and windows also seem to be very old-fashioned and are considered to have retained their original form. The first floor is a livestock hut, and the second floor is divided into the east room and west room by a partition. The west is a living room with a kitchen, and the east is a Buddhist altar room. The partition also appears old-fashioned, but it is considered that each floor was initially a single room because the floorboard stretches beyond the partition, and oven ash covers the entire ceiling. The floorboard is thick and directly stretches on the log structure. It is believed to convey the old technique before extending the method of soil sandwiching the soil (heat insulation layer) between the floorboard and the structure. The entrance is on the western side of the second floor with an attached lower shed. It is understood from the remaining traces that the two windows that opened to the southern side of the second floor were both originally entrances with pairs of swing doors. A veranda is now only on the western half of the southern side, but it is said that it originally extended to the east and connected to the overhanging toilet at the end of the eastern side, and part of those traces remains on the corner of the outer wall. The roof has deteriorated over time, and the plastic seat uses some parts instead of traditional materials. However, the original materials, including the structural frame, are in good condition and convey the original specifications such as laths tied with bamboo twigs and roofing boards.

The building was used as a residence until recently, and well maintained in a healthy state as a whole. Also, there are minor defects in certain parts of the outer wall. It is a valuable existence that effectively retains the old standard architectural style of farmhouses in the mountain villages in the western part of Bhutan.

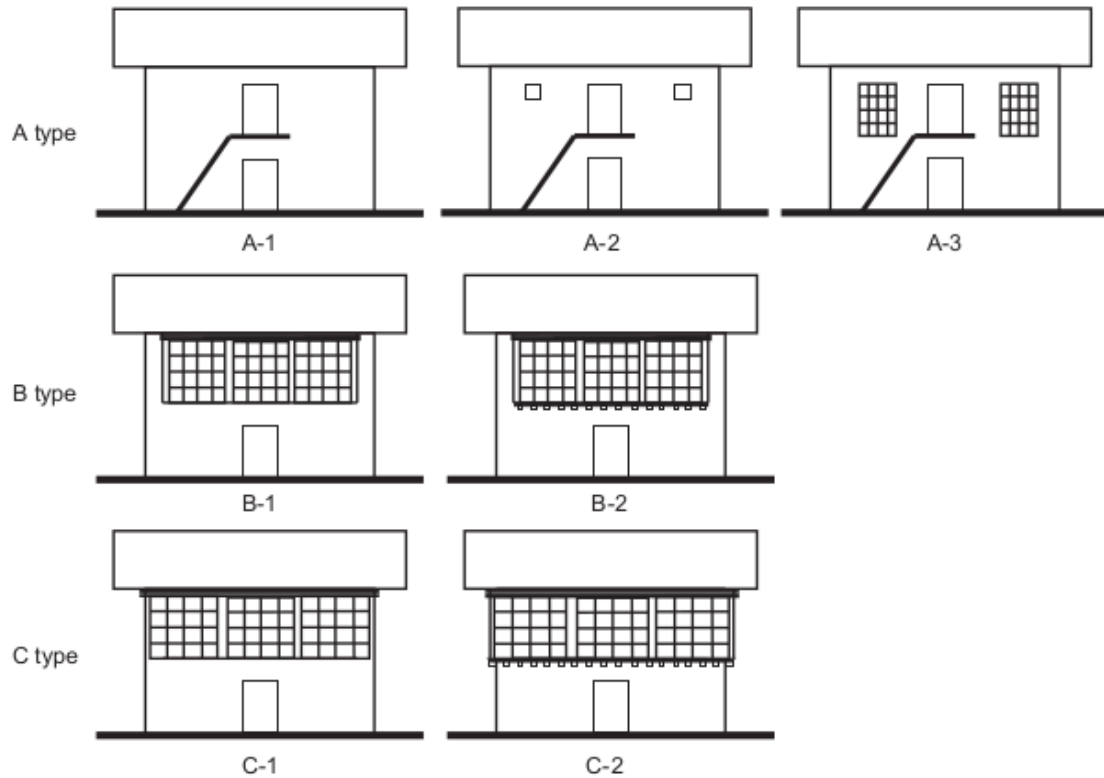
Fig 7. Building types of traditional farmhouses

In Type A, the outer wall extends to all four sides, including the upper layer, and the openings are limited to entrances and a few windows. It can be divided into (A-1) those that do not have windows, (A-2) those that use small windows with wooden lintels and (A-3) those that have relatively large windows with wooden frame.

Meanwhile, Type D cannot be classified into A to C, and includes a bay window on both the front and the rear, and it has a type of L-shaped plan. It should be noted that those types may be the result of a modification, and the original form may be classified as Type A to C.

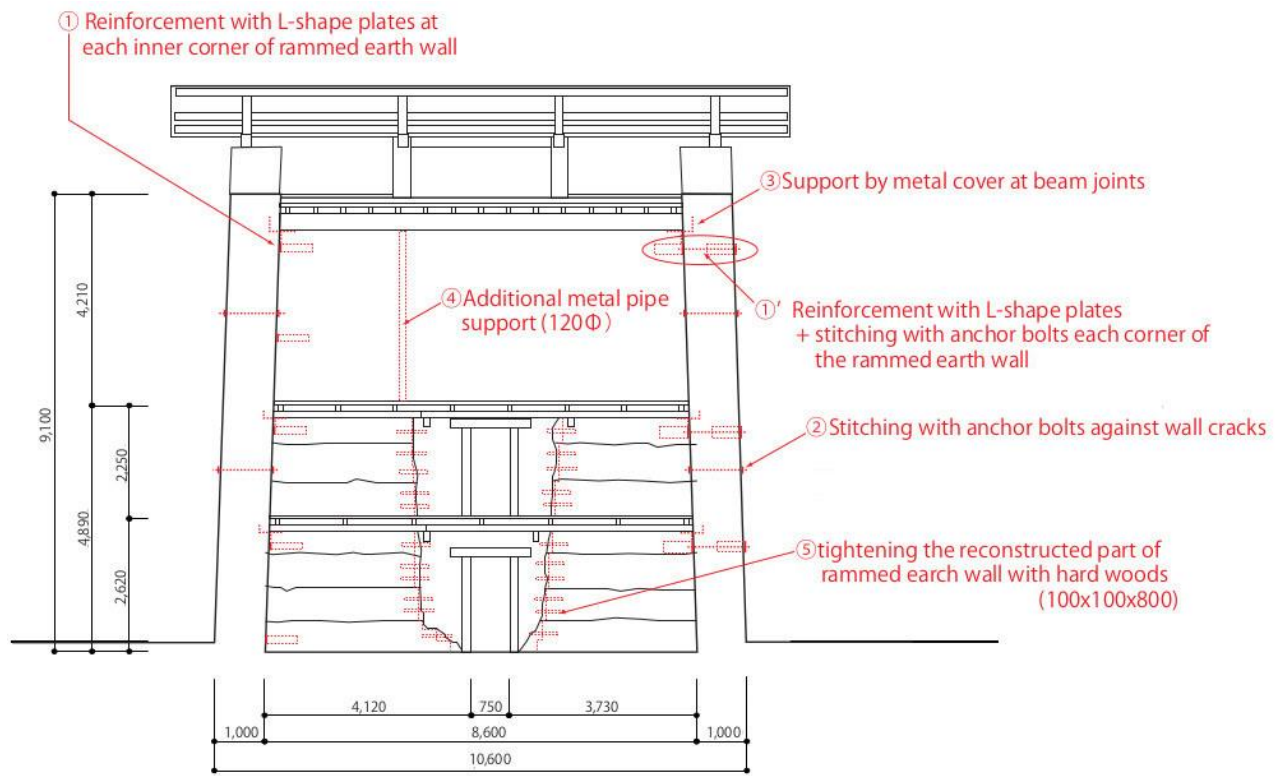
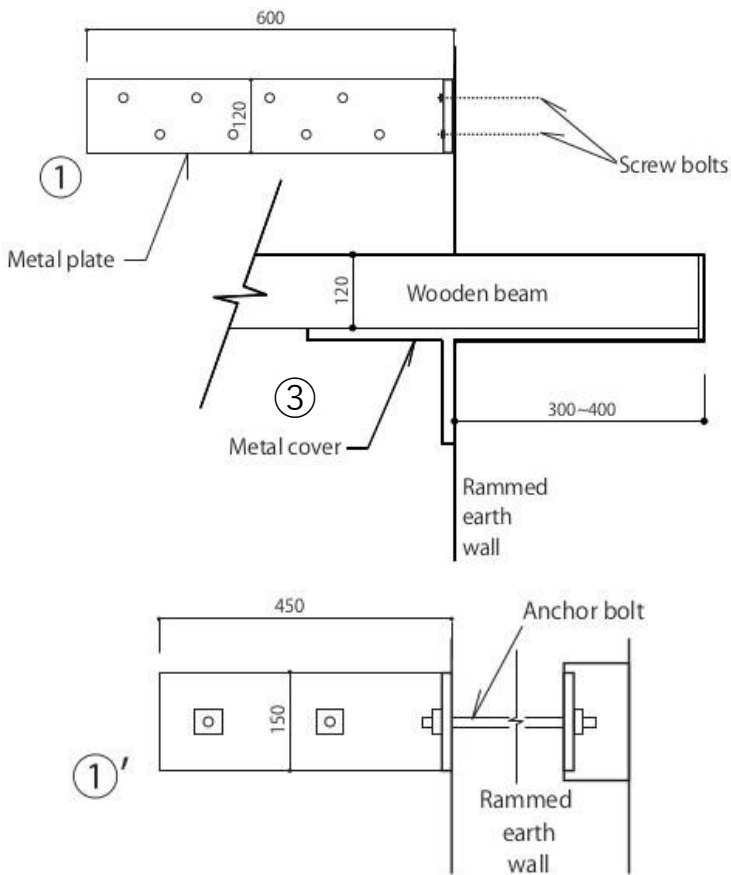
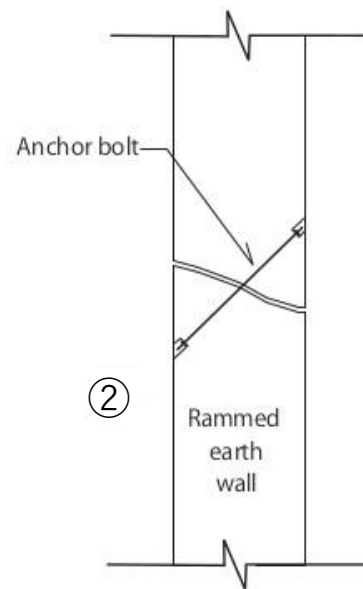
Fig 9. Restoration methods of rammed earth structure and wooden structure

Each corner falls slightly inward, and cracks and defects are partly generated, but because it is structurally stable, it is limited to the minimum partial reinforcement as much as possible. The collapsed portion of the inner wall will be rebuilt using the traditional method. The joint with the existing part should be tightly embedded with timbers. In terms of structural reinforcement, ① tightening with large L-shaped hardware inside each corner, and ② locking with anchor bolts at major cracked parts, are considered adequate. It is effective to use ① L-shaped hardware also on the outside and sandwich each corner of the wall with anchor bolts, if sufficient axial tension cannot be expected for bolt tightening on the rammed earth wall. However, since the strength and engineering characteristics of rammed earth are unknown, it is necessary to confirm its effectiveness through construction tests and experiments before deciding concrete reinforcement methods.

In principle, the existing timbers will be reused. It is imperative to minimise partial repairs of decayed and missing parts, and try to retain existing timbers as much as possible. Items that are decaying or missing and have not retained their original shape anymore will be renewed using materials of the same quality. In terms of structural reinforcement, ③ curing with a metal plate or wooden support at the joint holes of the rammed earth wall, and ④ adding supporting columns in the middle of the third floor (top floor) room are considered adequate. However, it is necessary to add further reinforcement materials depending on the expected usage situation, such as the number of people remaining indoors at all times.

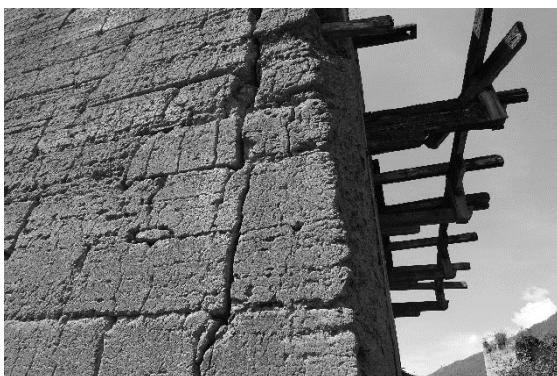
Photo 9. Distraction at the corner of rammed earth wall (left)  
Photo 10. Temporary storage of wooden parts (right)

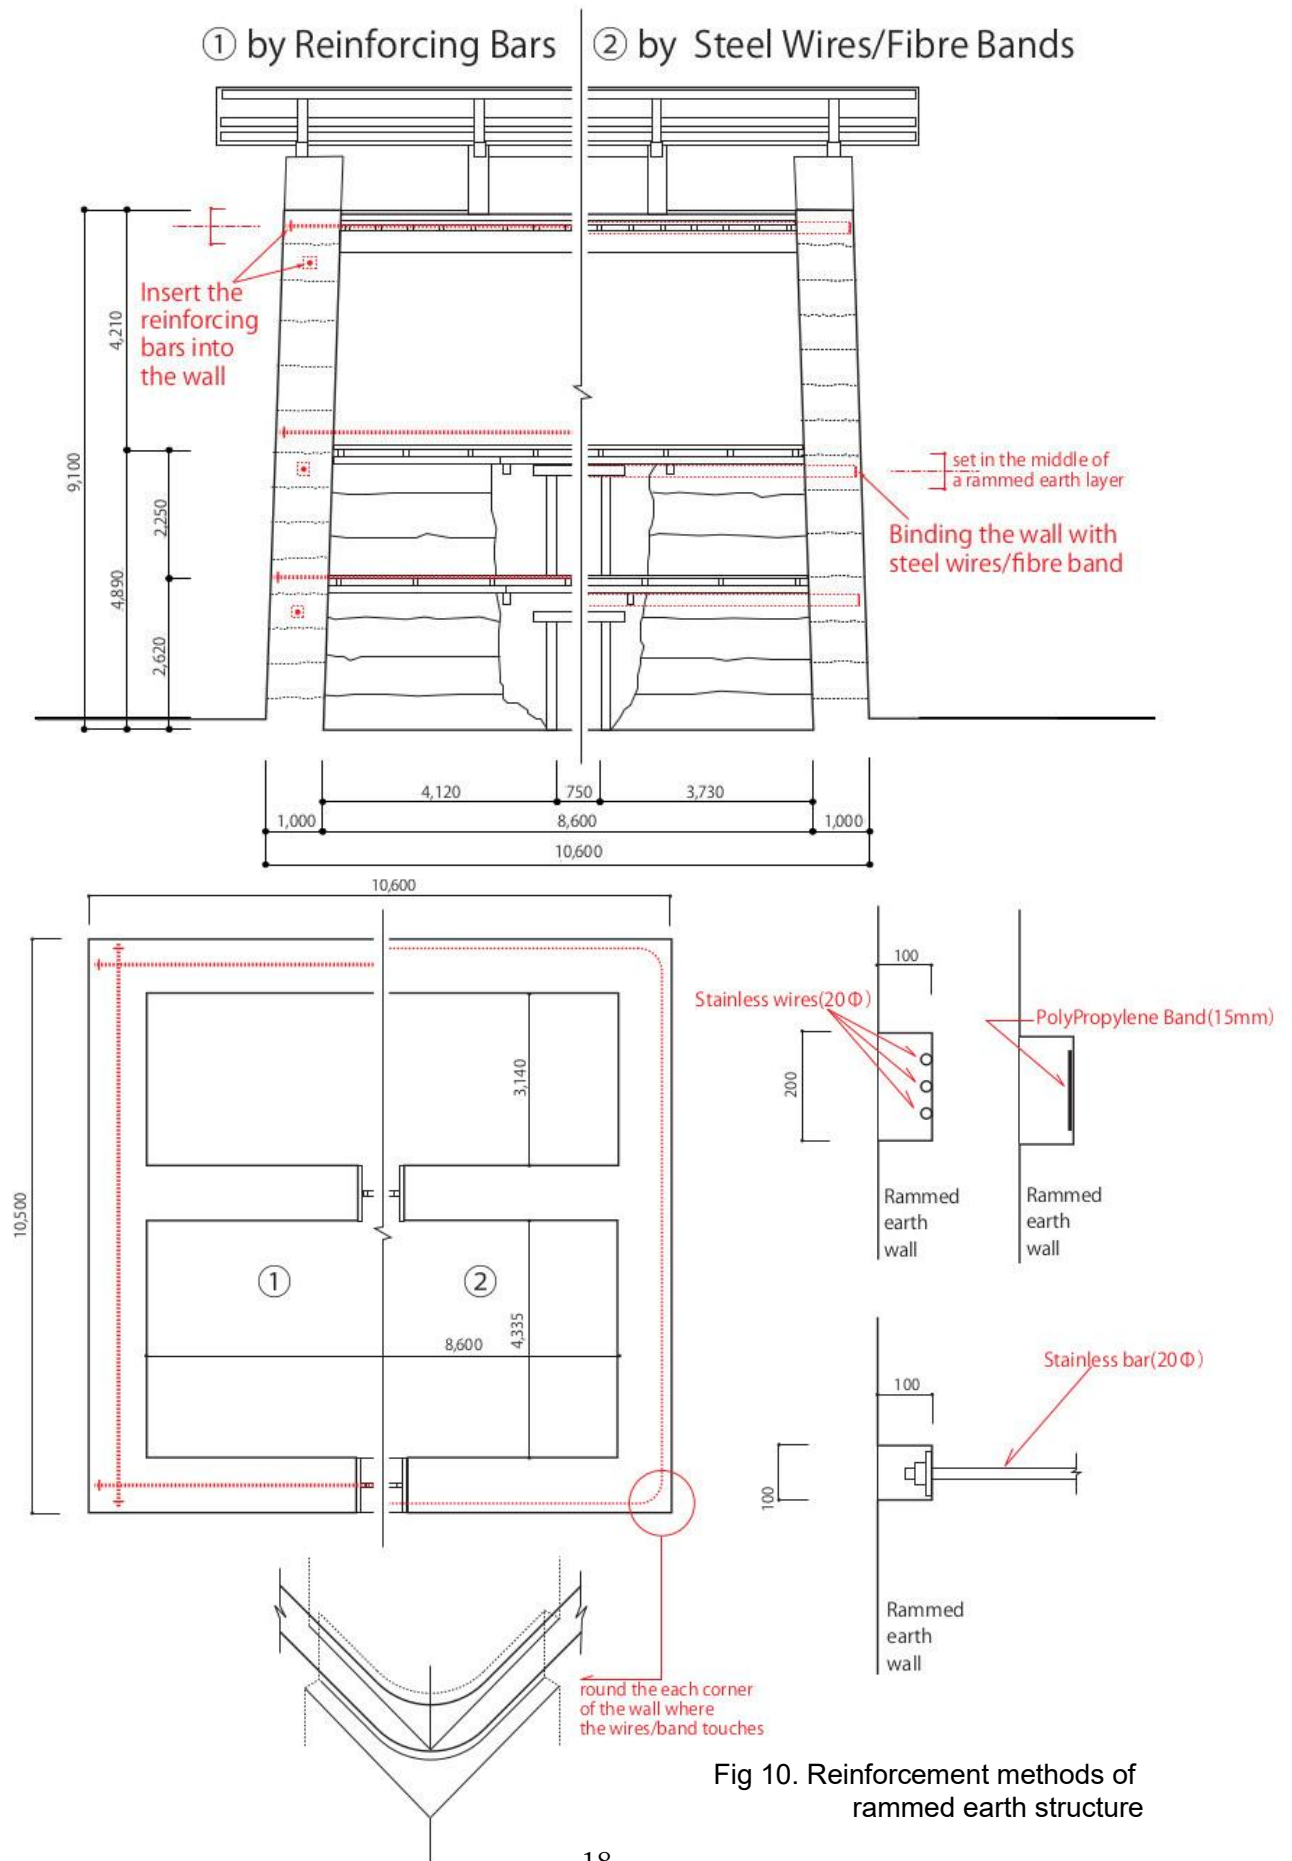
Fig 10. Reinforcement methods of rammed earth structure

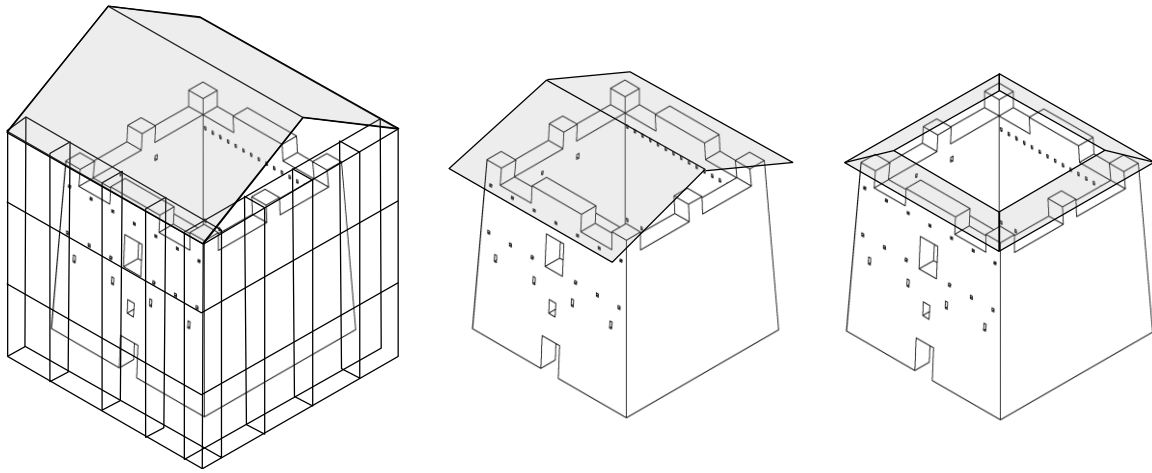
Fig 12. Temporary roof options  
Housetop roof with external scaffolding (left), Housetop roof (middle), Wall-top roof (right)

The plan is to place a temporary partial roof that covers only the top of the rammed earth wall, similar to a small roof over the top of the boundary wall. However, the wall surface cannot be protected sufficiently since the eaves cannot be projected out enough, but the advantage is that the installation costs can be minimized (BTN 100,000 estimated by DCHS).

For the present, it is practical to consider the installation of a simple temporary roof that protects only the top of the existing wall as in Plan C by around May 2020. The installation of a temporary roof with the external scaffolding as in Type A shall be considered if the commencement of the full scale restoration work would not materialized soon. Regarding the cost burden of the temporary roof installation, it is crucial to explore the possibilities extensively while discussing with DCHS.

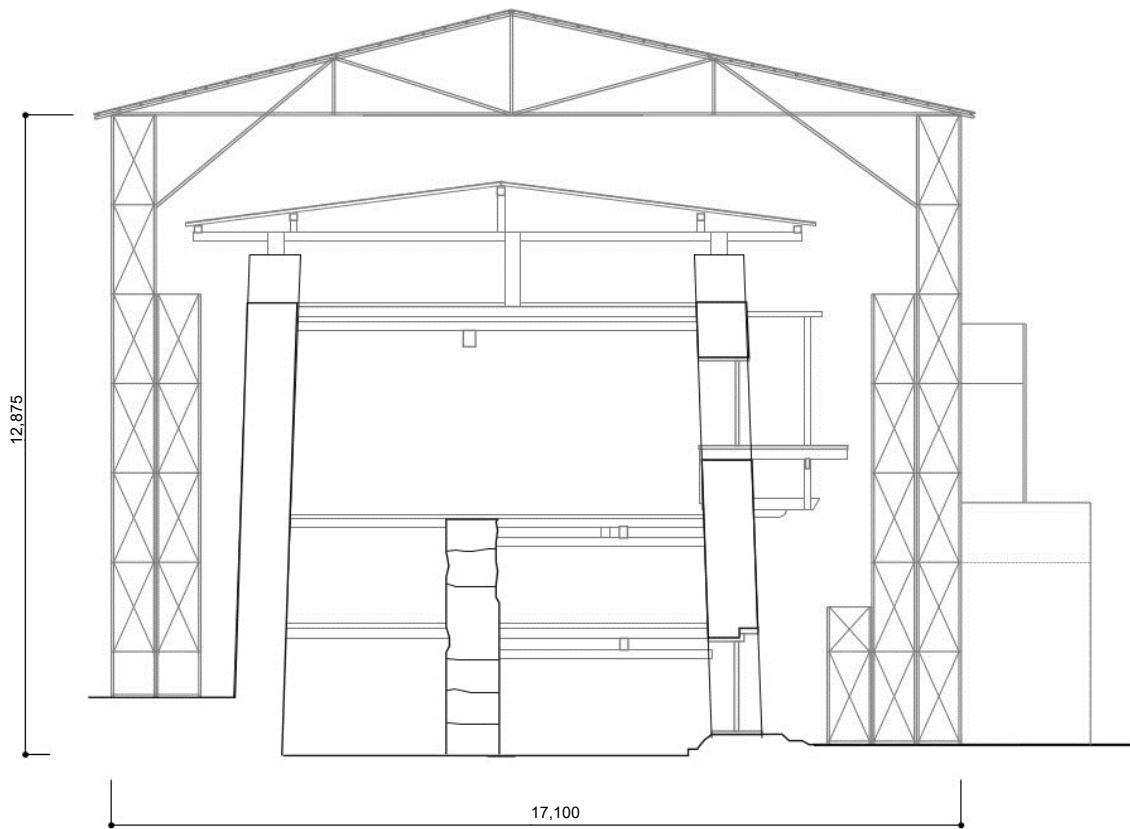
Fig 13. Detail Section of temporary roof with external scaffolding

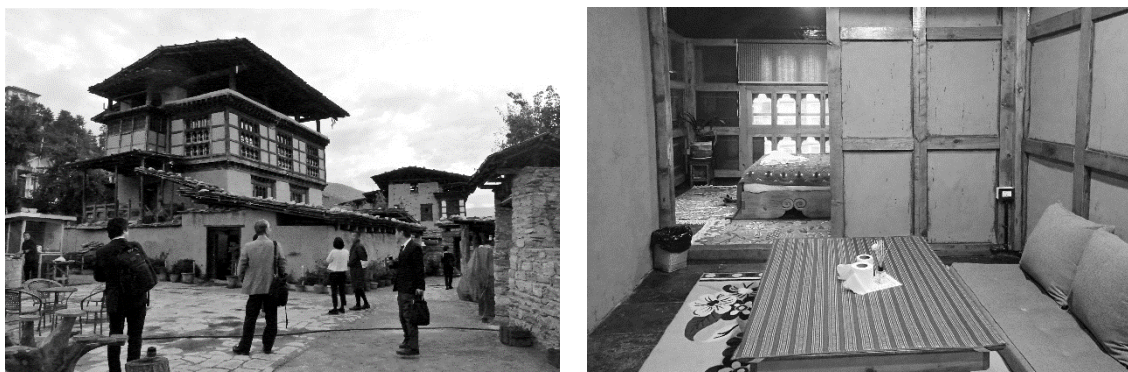
Photo 11., 12. Example of private development utilising a traditional farmhouse into a small lodging facility and restaurant (Thimphu)

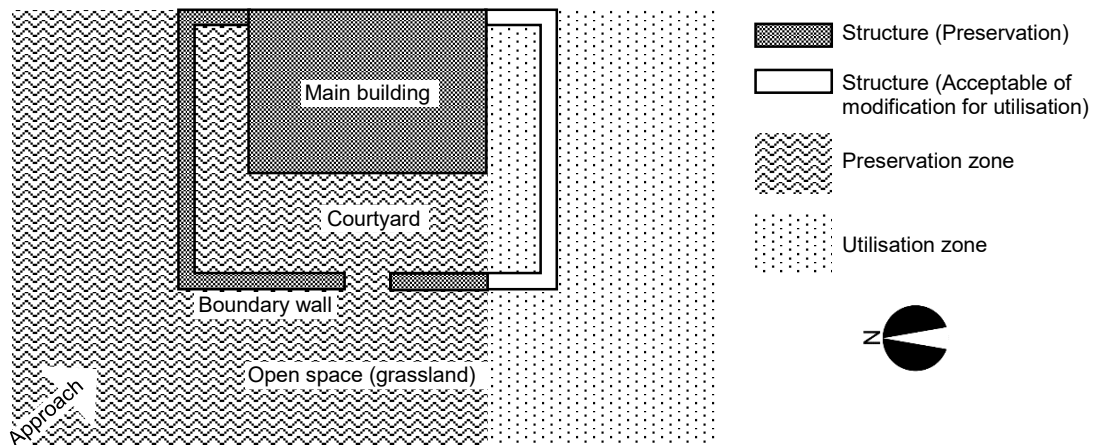
Fig 14. Zoning of the site

The front portion of the building should be set as a preservation area where no new buildings can be constructed in principle since the premises facing the wide open space on the front (west) are well maintained. The inside of the boundary wall should also be preserved in principle, while the outside area of the boundary wall on the south side of the building could serve as a utilisation area for facility development, considering a vista from the northwest approach.

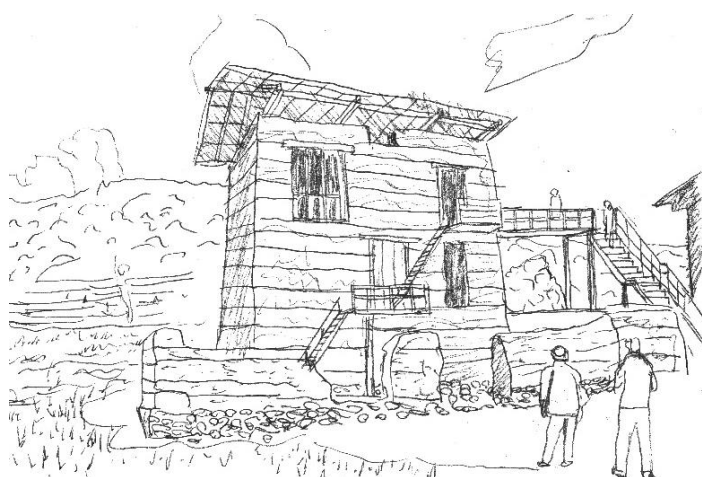
Fig 16. Image sketch of an external staircase on the southern wall

purposes, but it is possible to change the external staircase and handrail to a safer one from the point of view of convenience for users. As an alternative idea, it is conceivable that the staircase direction to approach the opening in the southern wall of the third floor has been newly built, as a part of the utilisation facility, and the front staircase could be restored in the original form.

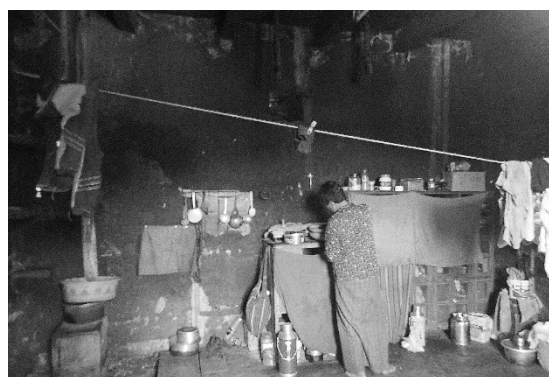
Photo 13. Interior as living space

The Phub Lham house has been left uninhabited by the administrative guidance after the earthquake, but the owner's family continues to live on the premises, revealing their intention to continue to use the building as a residence. According to interviews with the owner's family, the concerns of the subjects, can be categorised as (1) ensuring the structural safety of the building, (2) subdivision of the second-floor room which currently has two rooms, (3) repair of the roof, and (4) securing lighting by increasing the number of windows.

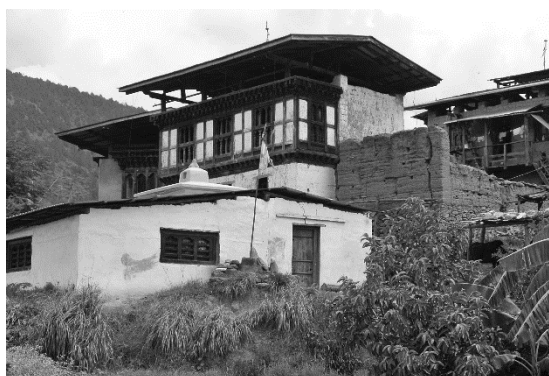
Photo 14. Farmhouse no.C19 in Yuwakha

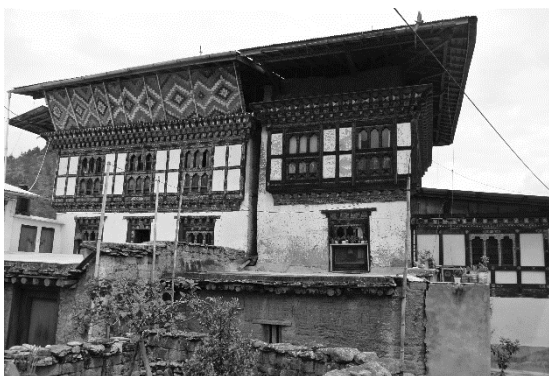
Photo 15. Farmhouse no.C25 (left) in Yuwakha

C25 is considered to have been renovated on a large scale about 40 years ago, and it is believed that the rabsel window was remodelled like C19. There are also many small-scale renovations, such as adding a hut on the front side of the building. However, the outer wall has retained the old shape perfectly, and shows an apparent inclination (taper) at the four corners. It is considered that the farmhouse is the oldest in the village.

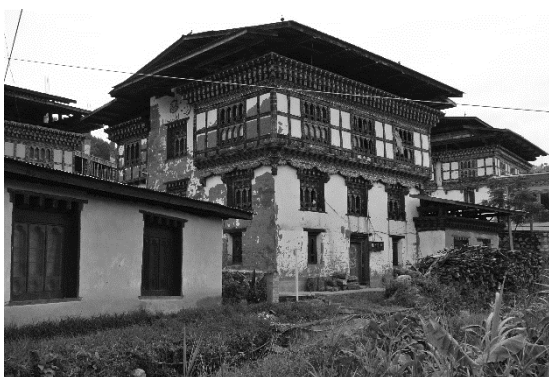
Photo 16. Farmhouse no.C42 in Sopsokha

C42 is a farmhouse that claims to be the most massive in the village and was originally two storeys high, with the third storey added about 30 years ago. On the third floor, not only the front side but also the posterior is equipped with a thick rabsel window providing a perfect finish. It is considered that the building has undergone several expansions and renovations from the current condition of the rammed earth wall and the attached lower shed. This building is also an interesting example to learn the process of changes in the traditional farmhouses.

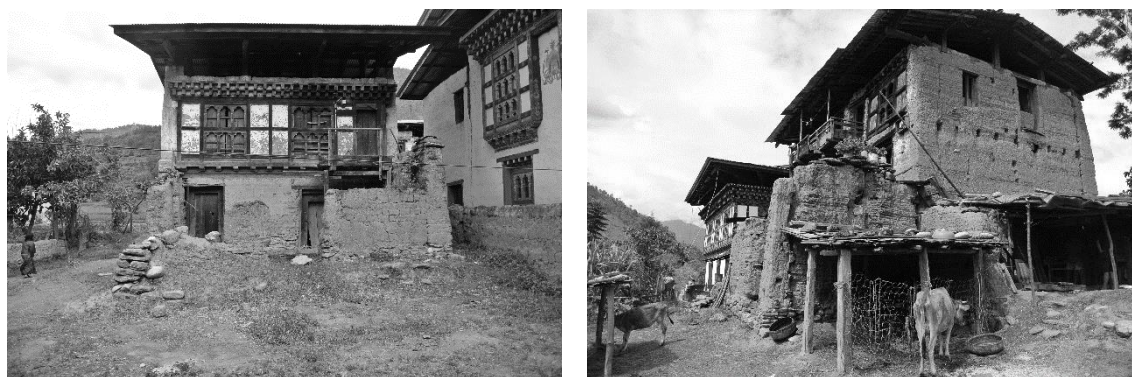
Photo 17.,18. Old style farmhouses in Changjokha, no.4 (left) and no.2 (right)

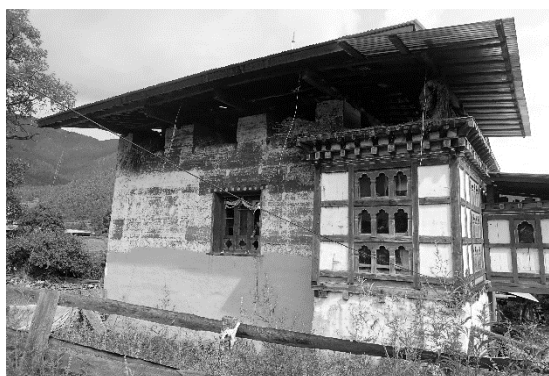
Photo 19. Farmhouse no.28 (class B) in Longlo

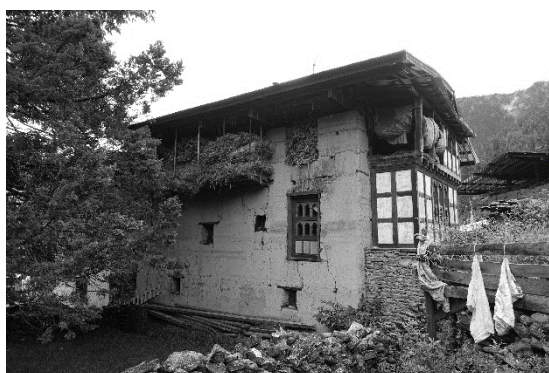
Photo 20. Farmhouse no.8 (class B+) in Tshenkhar

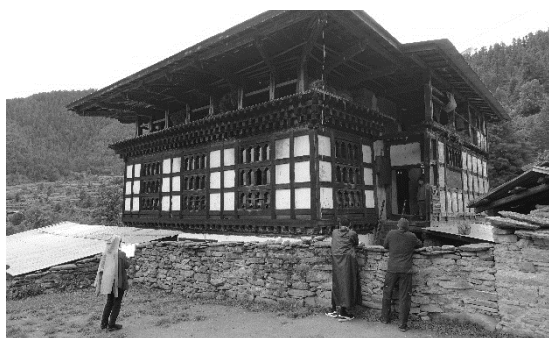
Photo 21. Farmhouse no.16 (class B) in Tshenkhar

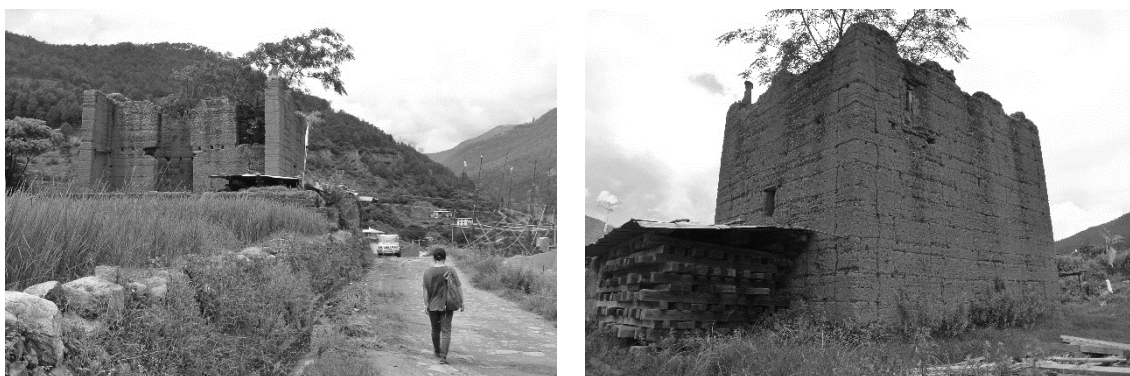
Photo 22., 23. Farmhouse remains C57-1 in Yuwakha

While the rest of the conditions vary, the remains of the private farmhouses converted into ruins by leaving the rammed earth wall can be seen in various places all over the country, and some of them have retained the original form, such as the remains in Yuwakha (C57-1). These are historical entities that convey a variety of information today, and there is no doubt that they should be protected as cultural heritage, but there are many missing parts and in an incomplete state as buildings. It is appropriate to preserve those as archaeological sites. However, it is also necessary to solve specific issues, such as what kind of evaluation, what should be preserved and how are those utilised, same as in the case of the private farmhouses.

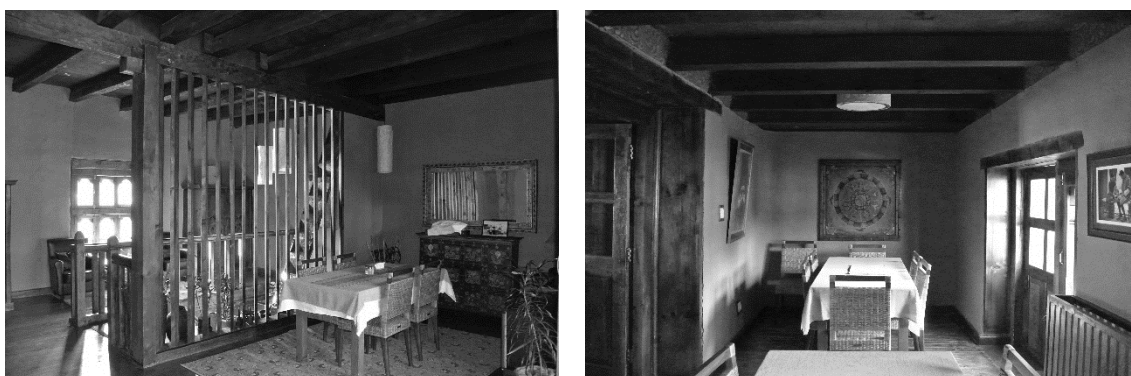
Photo 24., 25. Example of renovation of a farmhouse to a high-style tourist facility (Paro)  
Accommodation on the third floor (left), restaurant on the first floor (right)

In recent years, around Paro near the international airport, there are some cases of private farmhouses being renovated as tourist accommodations or modern facilities. Also, in Bhutan, the conservation and utilisation plan is considered to be an effective method for securing a certain level of conservation of cultural heritage, while promoting the diverse utilisation of historic buildings.
