Report on the Restoration of the East Gate,

Ta Nei Temple, Angkor, Cambodia

2019 - 2022

Tokyo National Research Institute for Cultural Properties (TOBUNKEN)

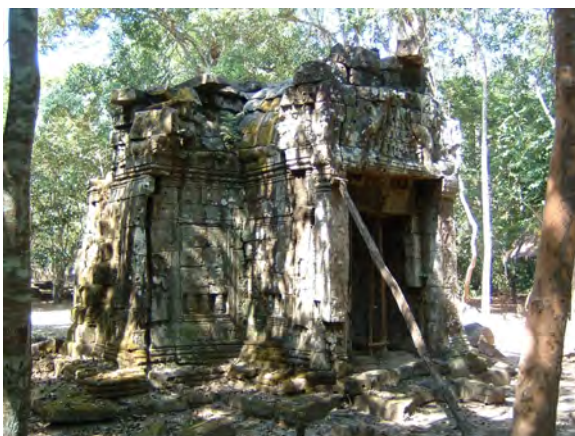
Figure 2.1.1 East Gate before restoration in 2004

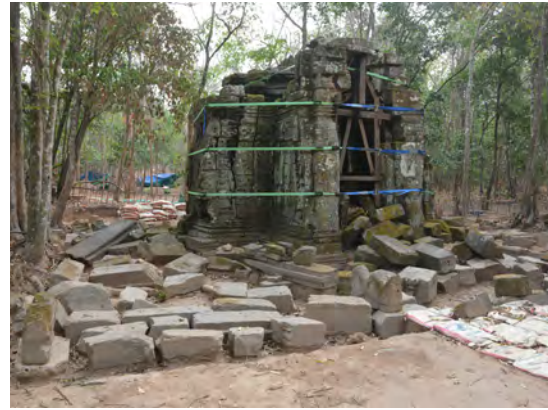
Figure 2.1.3 Collapsed members of the East Gate found during the excavation

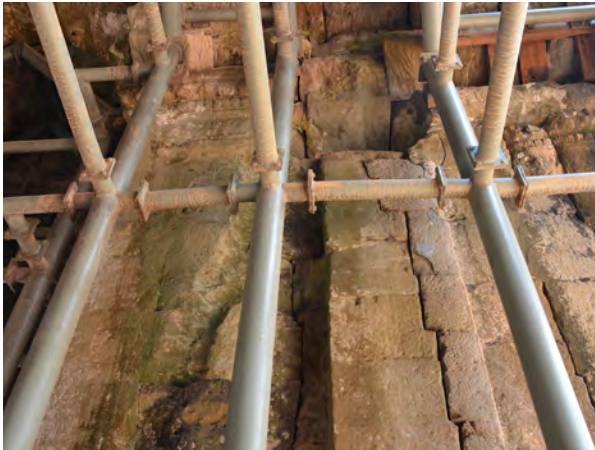
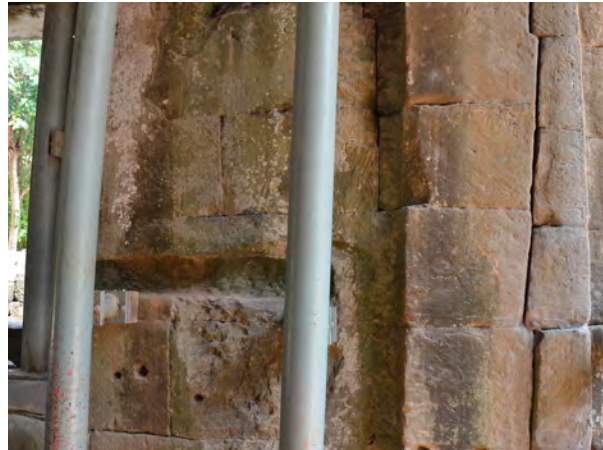
Traces of a wooden door frame were discovered on the surface around the attached columns of the outer entrance on the walls of both sides of the causeway. No traces were found around the attached columns of the inner entrance. The side chambers have not been investigated. (Figures 3.2.45-3.2.46)

Figure 3.2.45 Traces of the wooden members at the causeway, Ta Prohm Temple

Figure 3.2.46 Traces of the wooden members at the causeway, Ta Prohm Temple

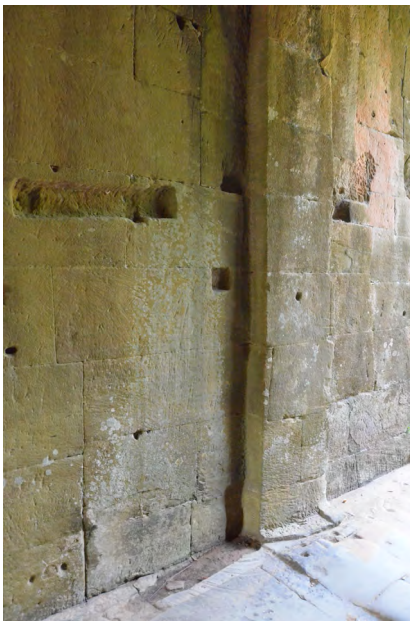
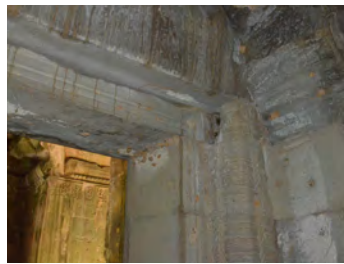
Traces of a wooden door frame were discovered on the surface around the attached columns of the outer entrance on the walls of both sides of the causeway. No traces were found around the attached columns of the inner entrance. No traces of a door were found in the first side chambers, but traces of a door were found in three directions in the second side chambers where a pedestal for a religious image was found. A pedestal was also found in the outermost third side chamber, but no door traces were found at the entrance to the second side chamber. (Figures 3.2.47-3.2.48)

Figure 3.2.47 Traces of the wooden members at the causeway, Preah Khan Temple

Figure 3.2.48 A trace at the entrance of the side chamber, Preah Khan Temple

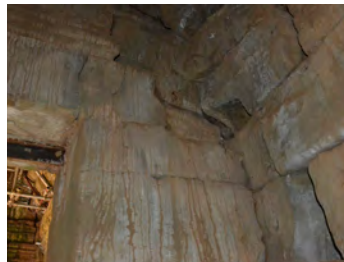
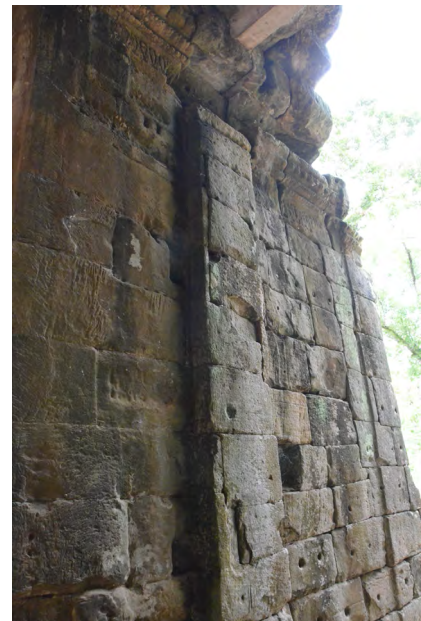
Traces of a wooden door frame were discovered on the surface around the attached columns of the outer entrance on the walls of both sides of the causeway. No traces were found around the attached columns of the inner entrance. Traces of a door were found at the entrance to the second side chamber. (Figures 3.2.49-3.2.50)

Figure 3.2.49 A trace at the entrance of the side chamber, Banteay Kdei Temple

Figure 3.2.50 Traces of the wooden members at the causeway, Banteay Kdei Temple

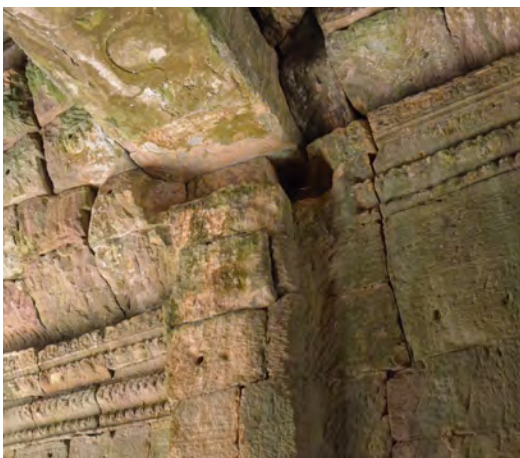
Traces of a wooden door frame were discovered on the surface around the attached columns of the outer entrance on the walls of both sides of the causeway. No traces were found around the attached columns of the inner entrance. The side chambers have not been investigated. (Figure 3.2.51)

Figure 3.2.51 A trace of a wooden member at the causeway, Ta Som Temple

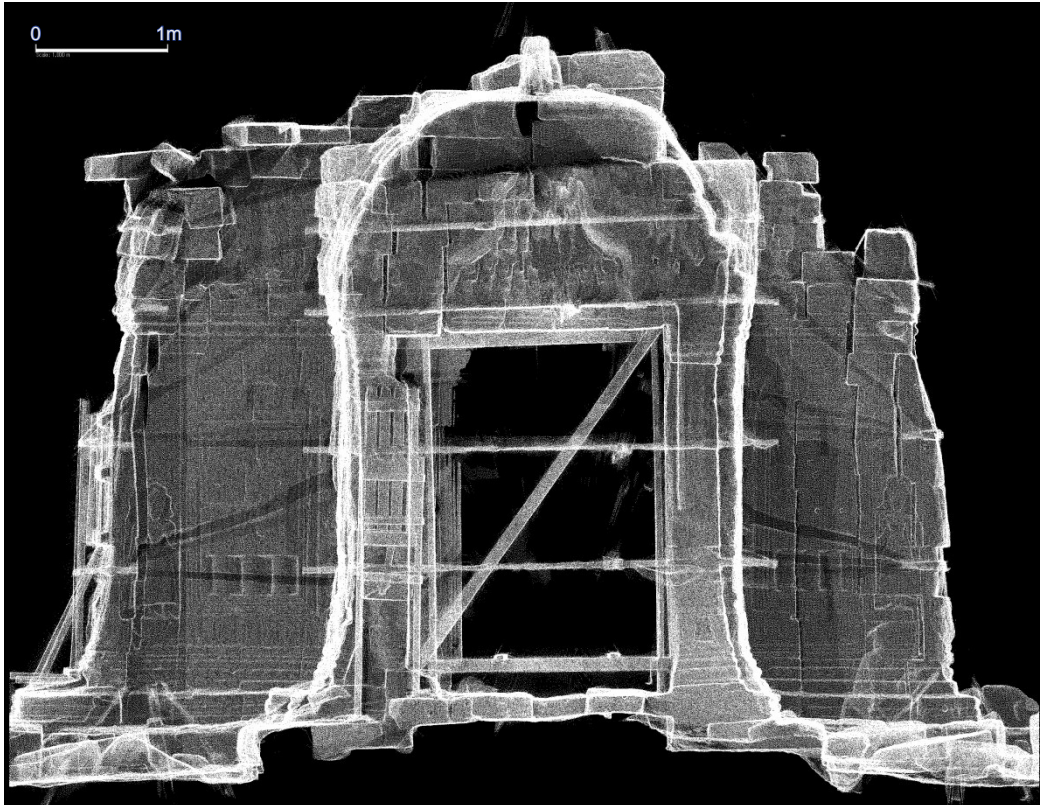
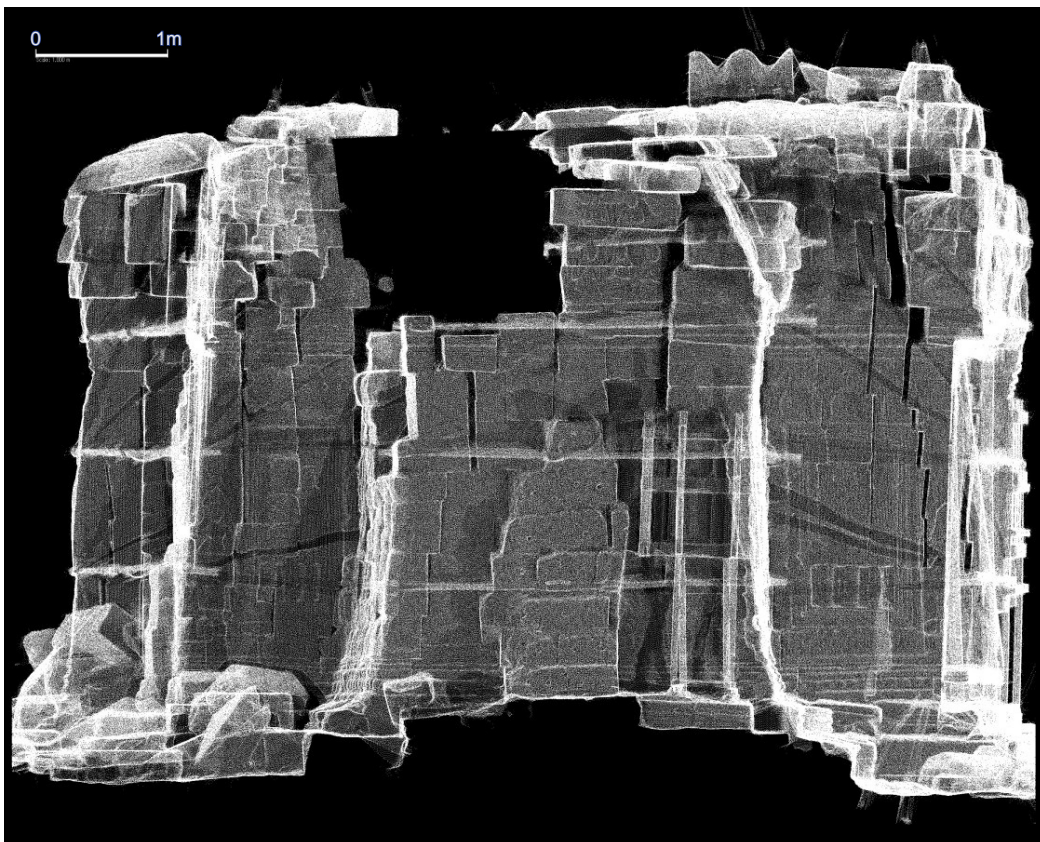
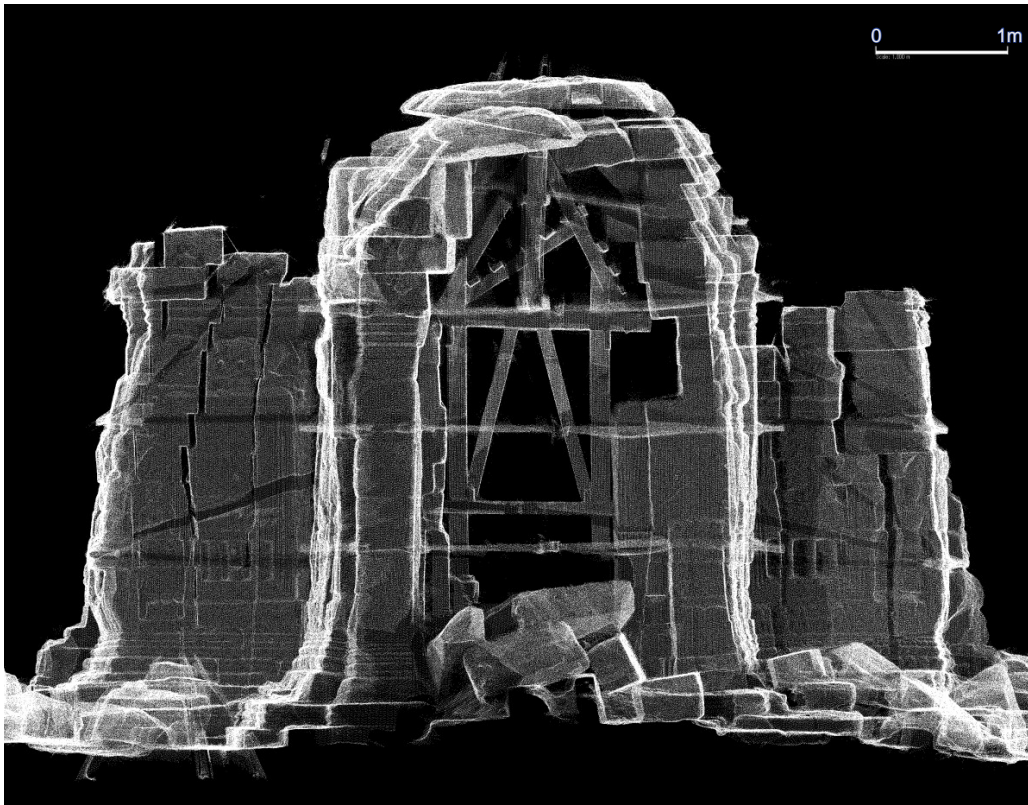
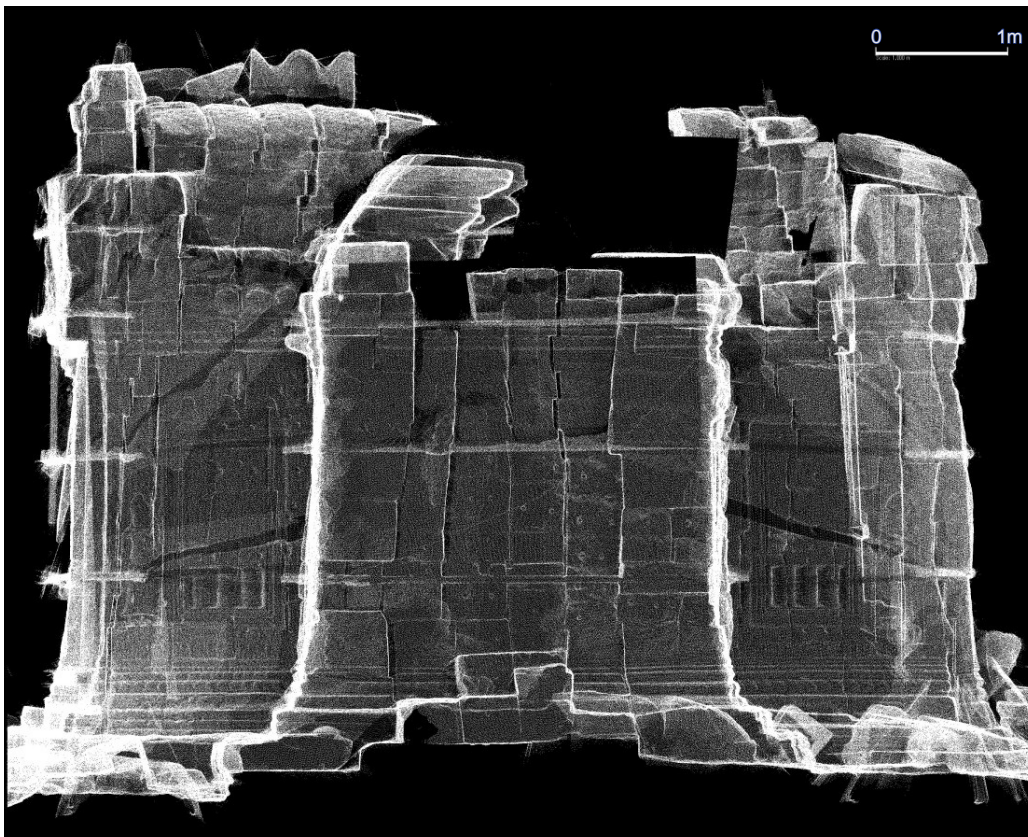
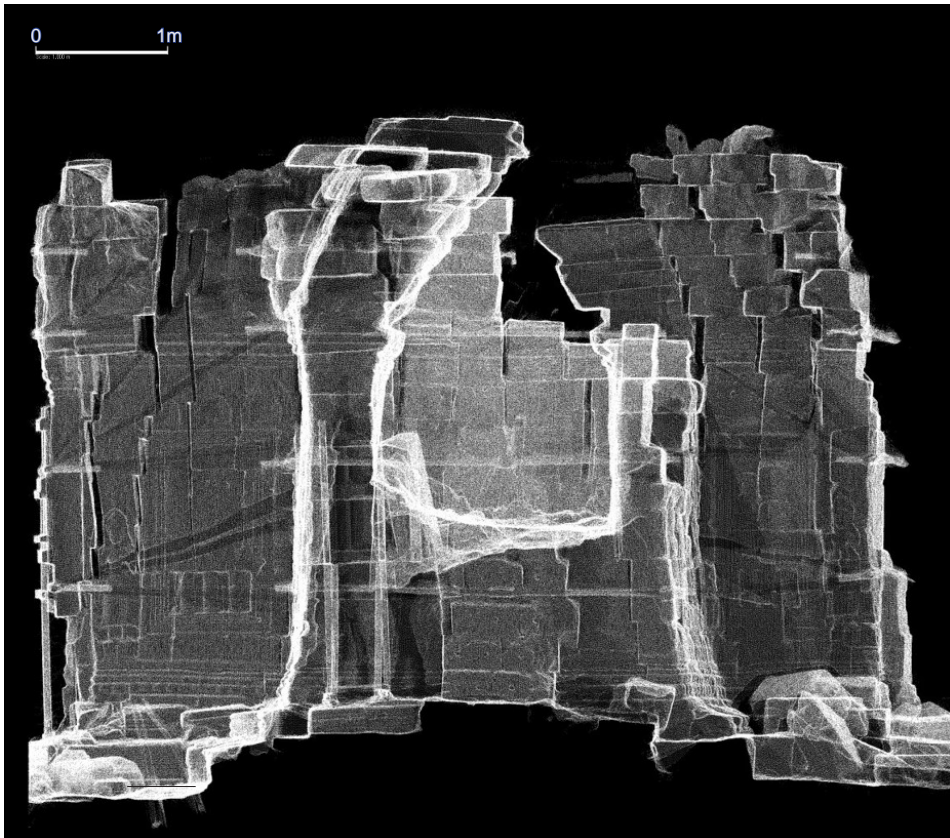
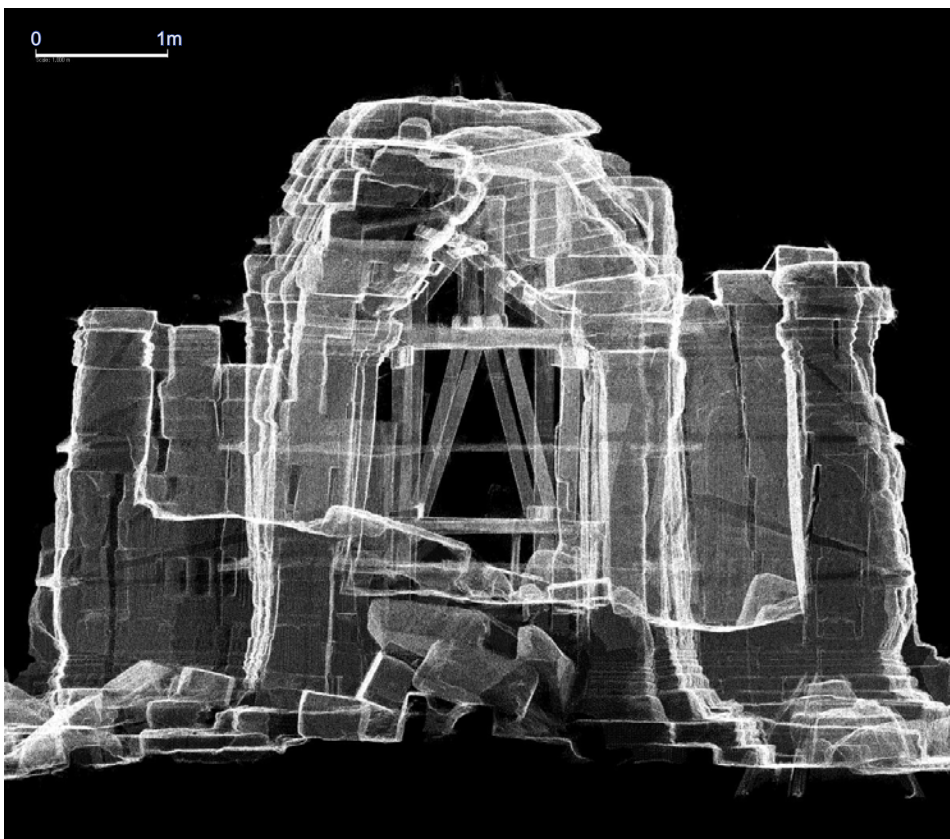
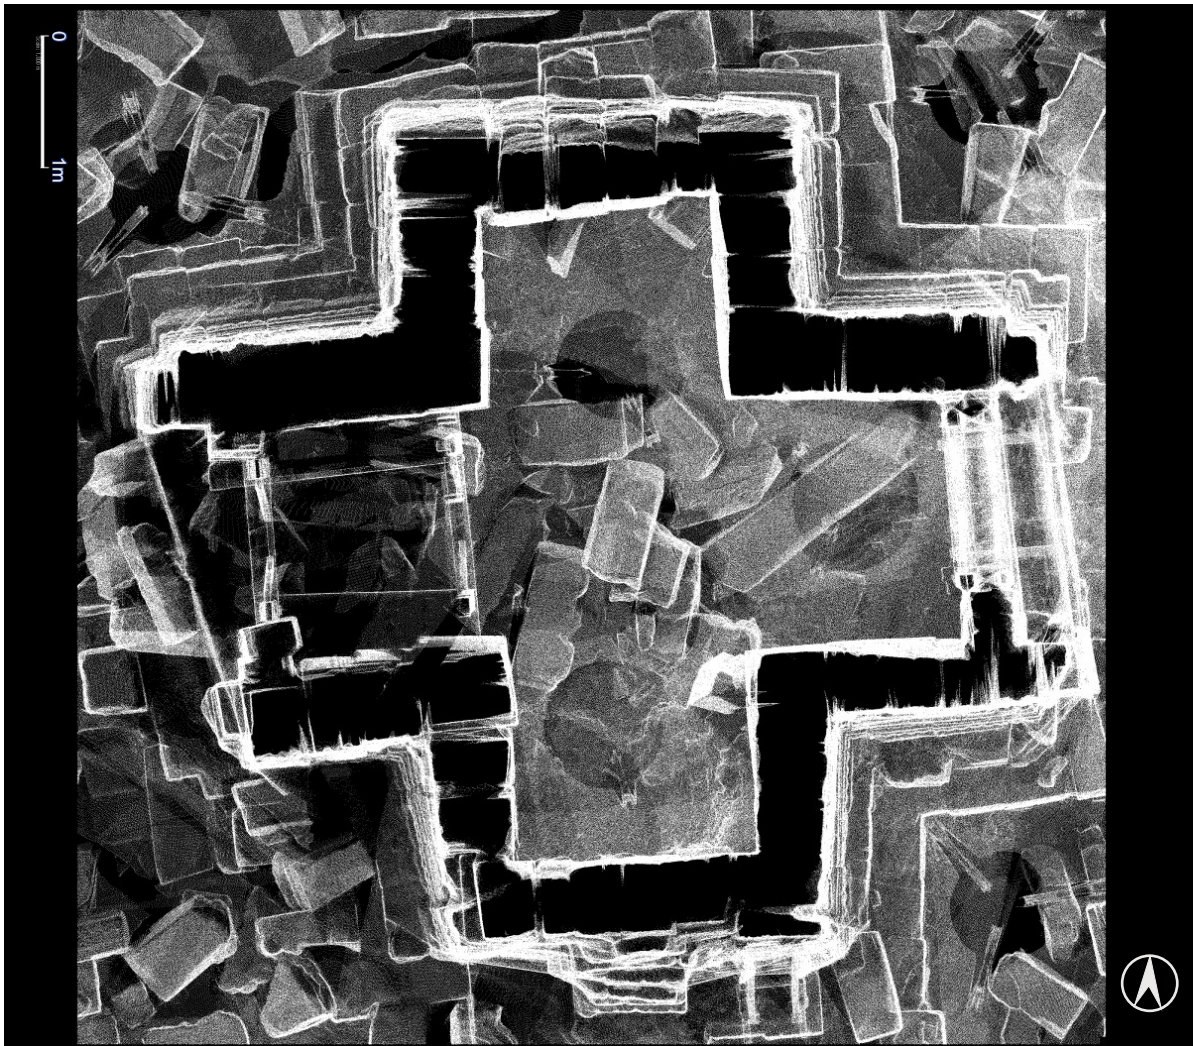
A documentation work was performed in three forms before gate dismantlement, namely, 3D laser scanning, photogrammetric documentation using Structure from Motion (SfM) and architectural documentation by manual measurement to produce drawings. SfM photogrammetry allowed to record the existing condition of the structure from all directions before starting the restoration work (Figure 4.1.1). A 3D laser scanning survey was conducted in March 12–17, 2019 with the collaboration of Associate Professor Dr. OISHI Takeshi from the Institute of Industrial Science, University of Tokyo (Figure 4.1.10) using a terrestrial 3D laser scanner (Z+F IMAGER® 5010C) by which section and elevation images were created to analyse the structural problems and failure mechanisms of the Gate (Figures 4.1.2-4.1.8).

Figure 4.1.2 East elevation created from 3D laser scanning

Figure 4.1.3 South elevation created from 3D laser scanning

Figure 4.1.4 West elevation created from 3D laser scanning

Figure 4.1.5 North elevation created from 3D laser scanning

Figure 4.1.6 East-West section created from 3D laser scanning

Figure 4.1.7 North-South section created from 3D laser scanning

Figure 4.1.8 Plan created from 3D laser scanning

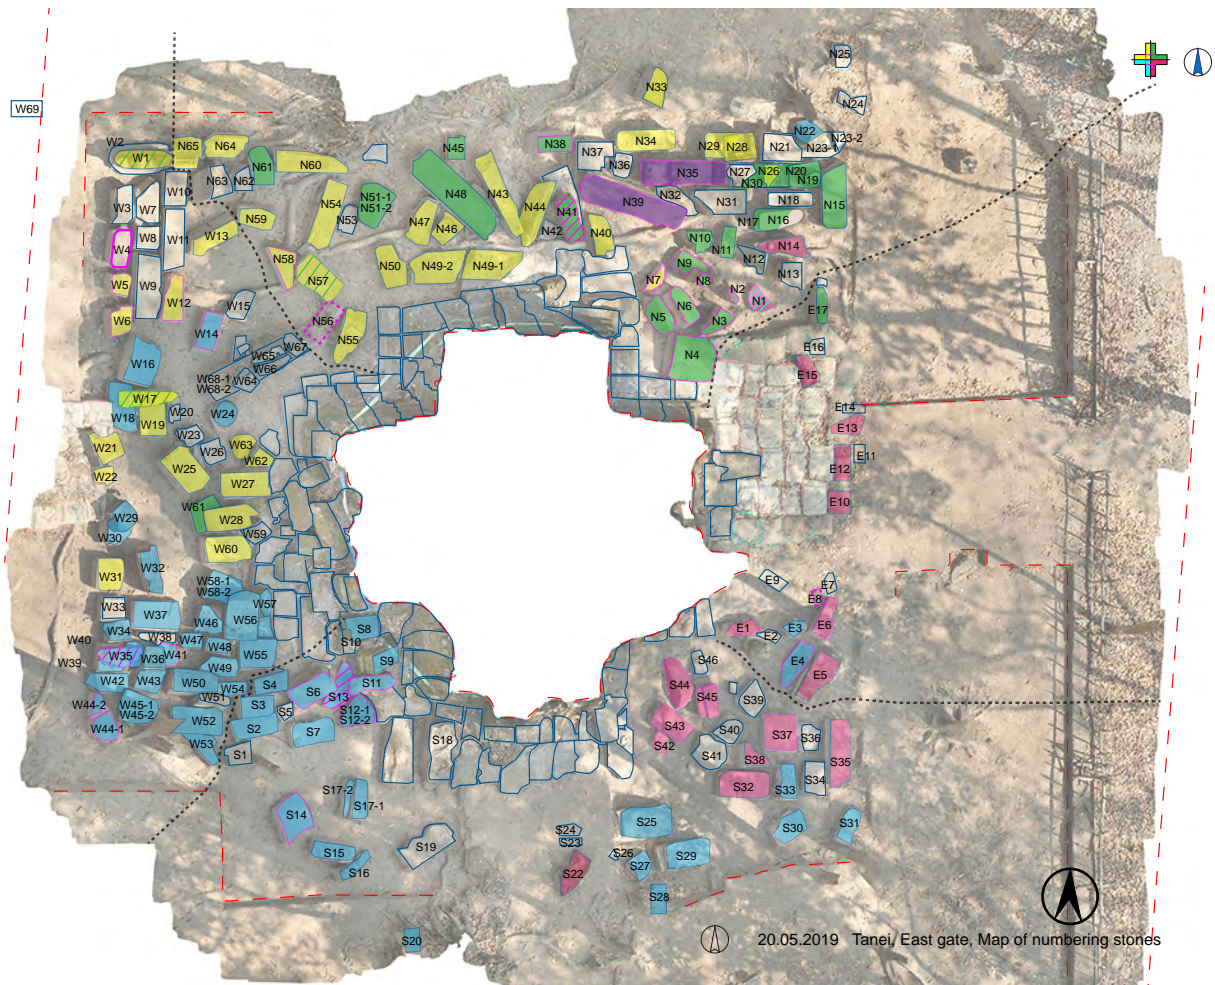
A list of the collapsed stones inside and outside the building is presented in the Tables 4.1.1-4.1.4, and the layout of these collapsed stones is shown in the Figure 4.1.12. In the layout plan, the collapsed stones were coloured according to the identification of the original position: northeast, southeast, southwest, northwest, and central. From this, it was found that

Most of the roof materials were collapsed inside the building and the pediments were collapsed outside the building, from which it could be concluded that the outercorner stones of the cruciform plan building were moved outwards and the top and innercorner of stones were moved inwards, and collapsed naturally during the long term deterioration.

Figure 4.1.12 Documentation of scattered stones around the East Gate (Colouring shows the identified original location of each stone. Northeast: green, southeast: red, southwest: blue, northwest: yellow, unknown: no colour)

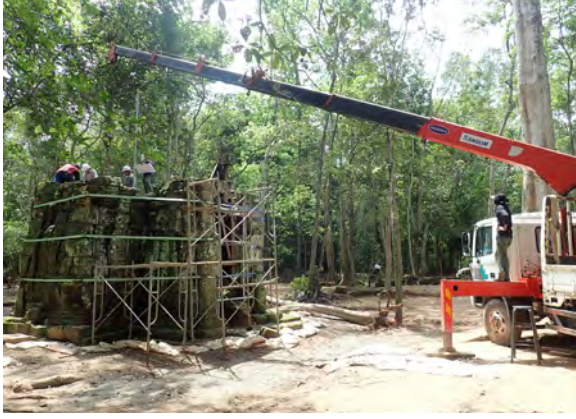
Figure 4.2.6 Dismantlement of roof structure using a crane truck

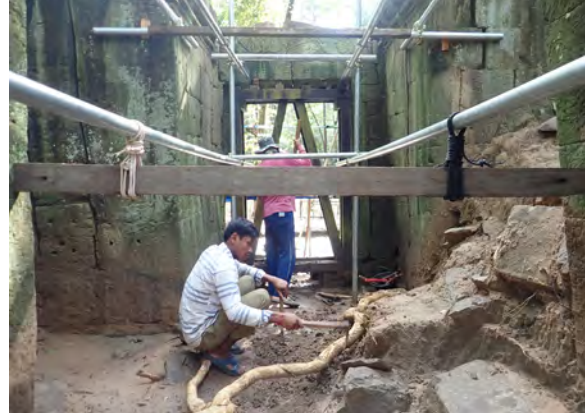
When the roof dismantlement was completed on September 20, 2019 (Layer 5), the debris inside the southern part of the gate, constituted by the accumulation of collapsed stones, anthills, soil, and tree roots, were cleaned (Figure 4.2.7). The collapsed stones were carefully removed after numbering. During this process, the fallen stones, almost 70 in total, accumulated in the southern part of the gate were found to have naturally collapsed from the roof or pediment due to aging. In addition, the head of a sculpture with approximately 56 cm height was discovered beneath the collapsed stones leaning against the western wall of the south wing (Figure 4.2.8). The sculpture was presumed to be *Avalokiteśvara* of the Bayon style, and is considered to be valuable as it might shed light on the history of Ta Nei Temple, which remains unknown. After detailed documentation using 3D laser scanning and photography, the head was brought to museum storage for further investigation (Figure 4.2.9). In addition, the condition of the newly unveiled interior walls and floor were documented at this step by using a 3D laser scanner (FARO Focus 3D Laser Scanner) and SfM photogrammetry in October 7–9, 2019.

Figure 4.2.7 Cleaning work inside the East Gate

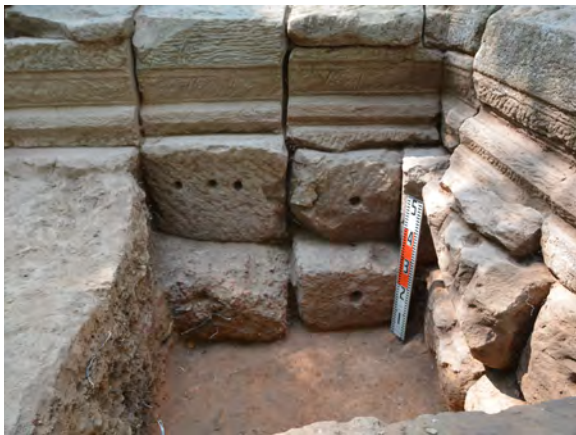
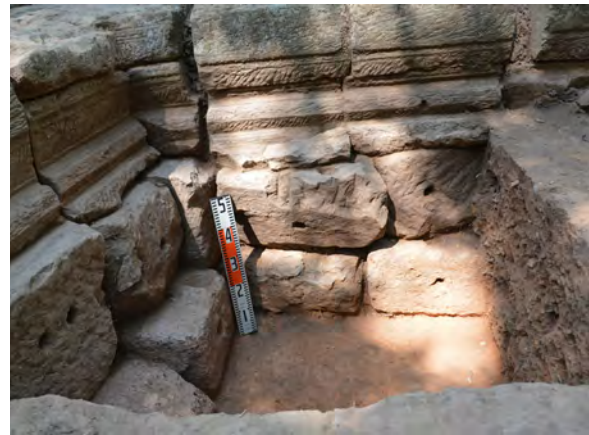
A sounding of one-meter square was set on the southeastern corner of the East Gate to reveal the bottom of the stone base structure. It revealed an underground structure consisting of a course of sandstone above the bottom laterite course. The bottom course was set about 55 cm below the original ground surface, protruding about 30 cm from the face of the sandstone materials above it (Figure 5.1.2-5.1.3).

Figure 5.1.2 Southeastern sounding facing west

Figure 5.1.3 Southeastern sounding facing north

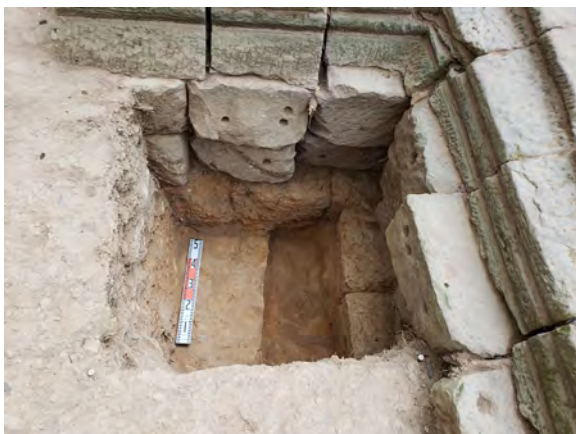
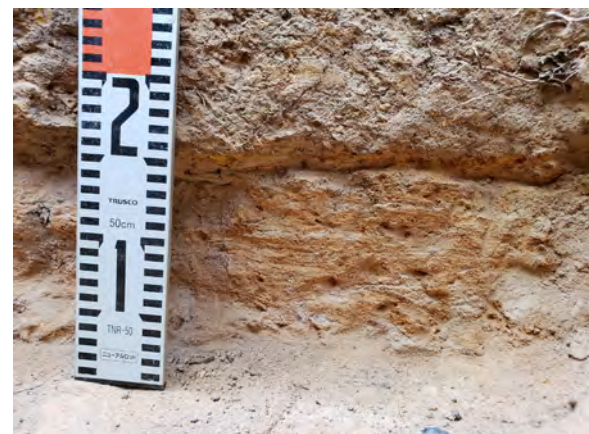
Another sounding measuring 1 m by 1 m was opened on the northwestern corner of the East Gate (Figure 5.1.4). The East Gate's sand foundation was revealed 80 cm below the ground surface of the Angkor period. This sand foundation is compact and consists of alternating layers of yellowish orange (10YR 8/8) sand and light grey (2.5Y 7/1) sand. Each yellowish orange layer is approximately 1.5 cm thick, while each light grey layer is approximately 0.5 cm thick (Figure 5.1.5).

Figure 5.1.4 Northwestern sounding facing east

Figure 5.1.5 Alternating layers of yellowish orange sand and light grey sand below the stone base structure

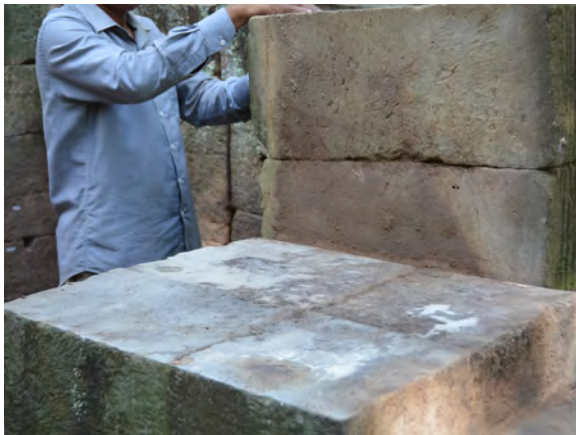
Many of the upper surfaces of the wall sandstone were confirmed to have been smoothed by polishing so that almost no linear or punctate traces remained (Figure 5.2.3). However, although the upper surfaces of the connections at the top level of the foundation (=floor level) were finished flat to remove all gaps between the sandstone blocks, linear and punctate traces remain on the connection surfaces, with only a few having been polished to the extent that they disappear. Careful polishing of the connection surfaces increases the contact area and improves the friction force between the stones. There is a possibility that the connection surfaces may have been deliberately and carefully finished at the area where the arch thrust is increased.

Figure 5.2.3 Smoothed upper surfaces of the sandstone wall

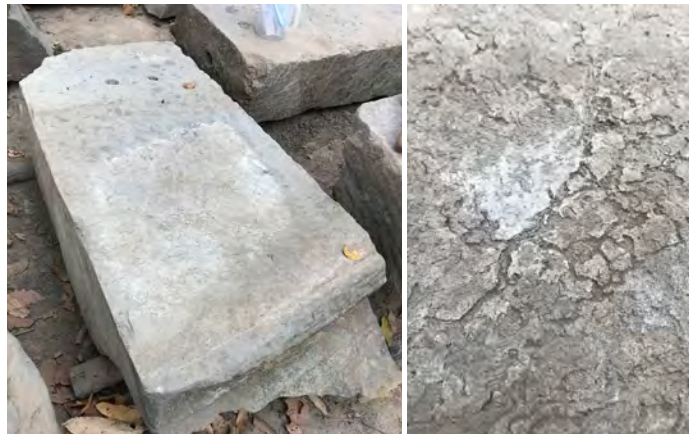
Some of the white substance was found adhered to the upper surfaces of the connections in-between sandstone blocks (Figure 5.2.6). In the upper parts of the walls (Layers 7–11), the white substance was found on 20–40% of the stones' upper surfaces in each layer; in the lower part of the walls (Layers 12–16), it was found on more than 50% of the stones' upper surfaces. In most cases, the white substance is not thick but only thinly adhered to the stone surface. However, in some places, it has a maximum thickness of approximately 2 mm. The planar shape is irregular, the range of spread is different, and there is no regularity of planar arrangement or relationship with types of processing traces.

Figure 5.2.6 White substance adhered to the sandstones' upper surfaces

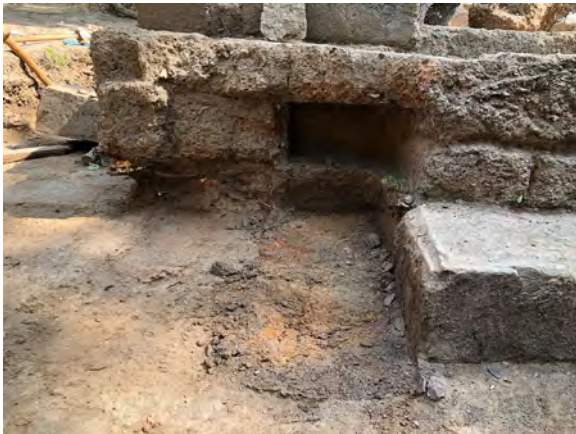
Figure 5.2.9 Absence of substrate laterite

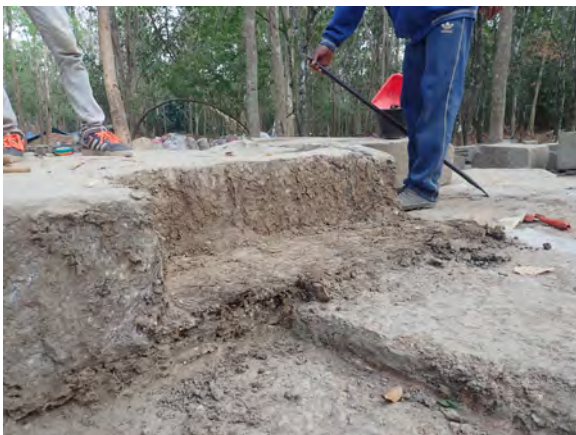
On top of the base laterite, the exterior sandstone was made to line the periphery of the cross-shaped plane, their edges facing outwards. While doing this, the outer edges of the exterior sandstone were placed dozens of centimetres inwards from the outer edge of the base laterite. The substrate laterite was placed within the exterior sandstone, with sandy soil compacted inside to form a compacted soil layer. This procedure was repeated to create two layers above. For Layer 18, laterite was made to cover the entire inside of the exterior sandstone. This makes up the substrate for the floor sandstone. At the top level of the foundation—the floor—the ends of the exterior sandstone were pulled inwards from the lower ends, with the wall sandstone stacked directly above. The floor sandstone was laid within the exterior sandstone (Layer 17). At the top of the foundation, there is a place where a part of the sandstone directly beneath the walls come under the floor stones (Figure 5.2.10), which shows that the order of the construction started with lining up the exterior sandstone directly beneath the wall, followed by the arrangement of the floor stones. Sandstone blocks of various thicknesses were used for the flooring. To ensure that the upper surfaces of the floor sandstone are horizontal, the floor stones were placed by scraping the floor substrate laterite or inserting something between the flooring sandstone blocks and the substrate laterite to adjust the unevenness. Soil mixed with a large amount of sandstone and laterite chips was used to adjust the unevenness; notably, the size of these chips varied according to the adjustment height (Figure 5.2.11). This method of adjusting unevenness was used only at the centre of

Figure 5.2.11 Material used to adjust the floor sandstones' unevenness

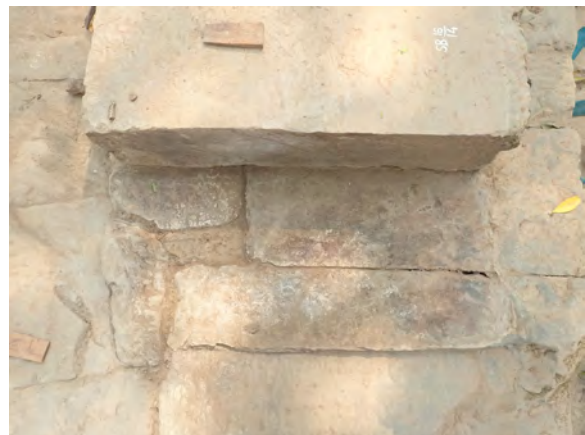
Figure 5.2.12 A gap filled with an adjustment material comprising soil mixed with either sandstone or laterite chips

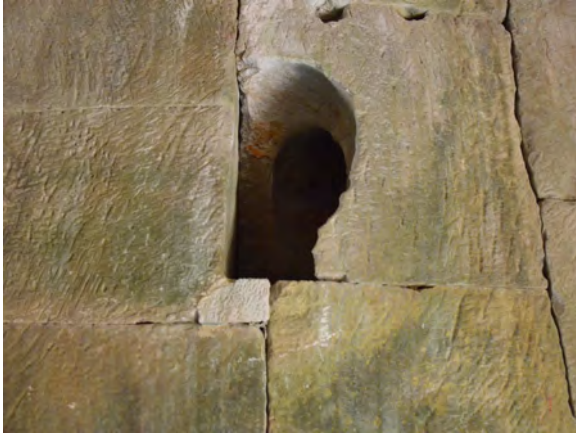
Figure 5.2.18 Cavity on the southern inner wall of the west wing

A cavity about the size of a human head can be found at about eye level on the southern inner wall of the western wing (Figure 5.2.18). This is also noted in the journal from when EFEO conducted its survey in 1920's (see Section 3.2), but it is unclear whether this cavity is human-made or natural.

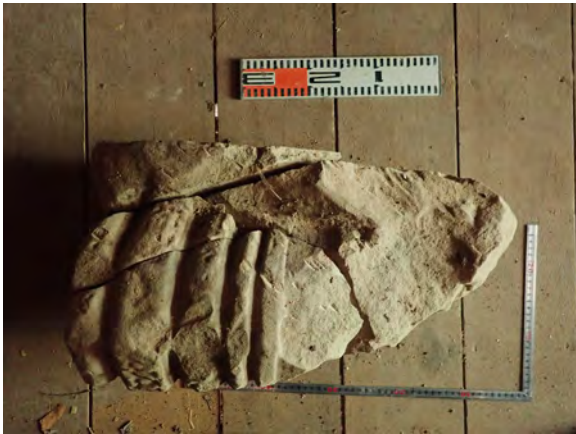
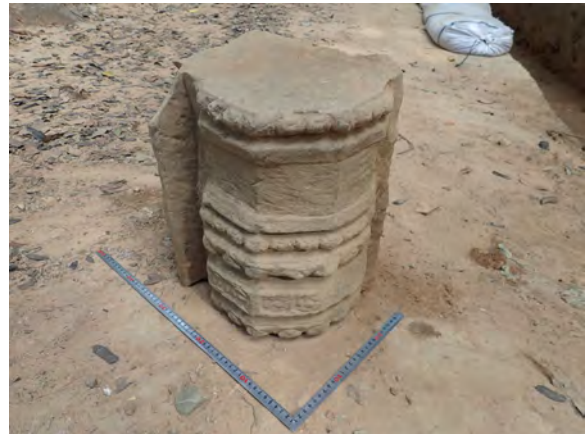
Figure 5.2.20 Colonette fragments (from the top part) found in the East Gate's surrounding area

Figure 5.2.21 Colonette fragments (from the middle part) with a flattened cross-sectional surface found in the East Gate's surrounding area

The lintel and colonette at both entrances had collapsed and gone missing prior to restoration. Only the lintel from the western entrance and fragments of a colonette were found among the stones scattered around the building, while most of the lintel and colonette on the eastern side have not been found.

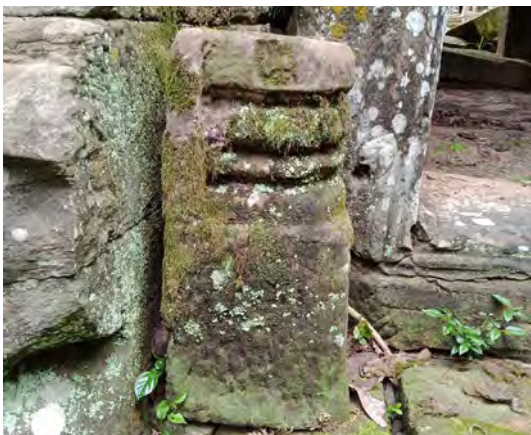
Figure 5.2.22 Bottom of the colonette that stands at the West Gate's western entrance

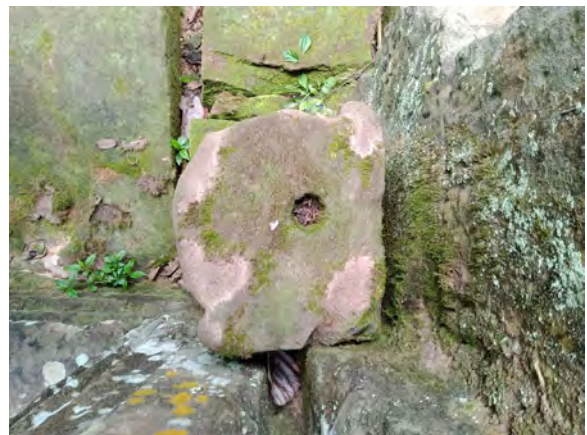
Figure 5.2.23 Smoothed upper surface with a hole in the bottom of the colonette that stands at the West Gate's western entrance

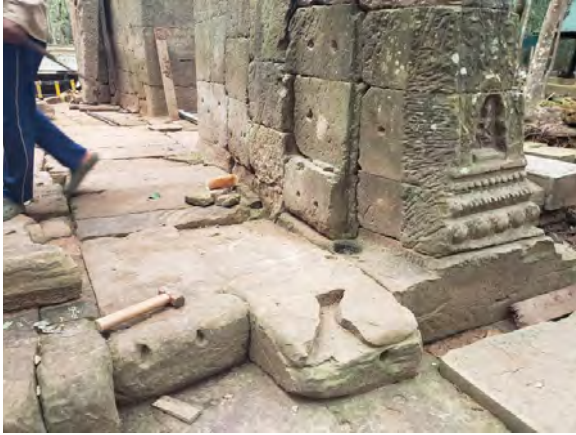
The traces on the upper surface of the sandstone floor, which is adjacent to the colonette pillar base, include a small circular mortise in the northeastern and southwestern corner where the colonette stands (Figures 5.2.24-5.2.26). The colonette was likely placed with a mortise joint at the bottom. However, in case of the East Gate, such joints differed with the places. In the southeastern corner, the colonette's pillar base is integrated with the sandstone of the pilaster base and carved out of a single material (Figure 5.2.25). In the northwestern

Figure 5.2.24 Circular mortise in the northeastern corner where the colonette stands

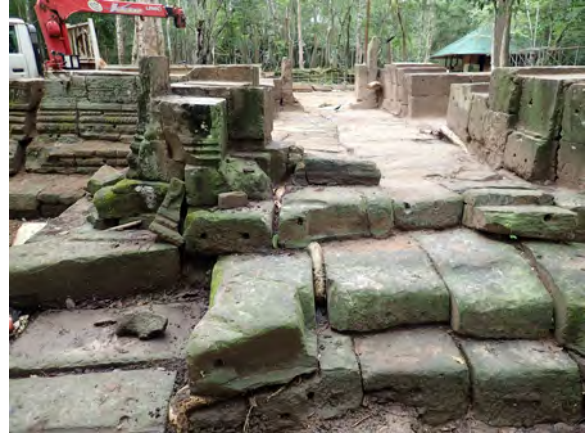
Figure 5.2.25 Colonette's bottom integrated with the sandstone of the pilaster base, carved from a single material, situated at the southeastern corner

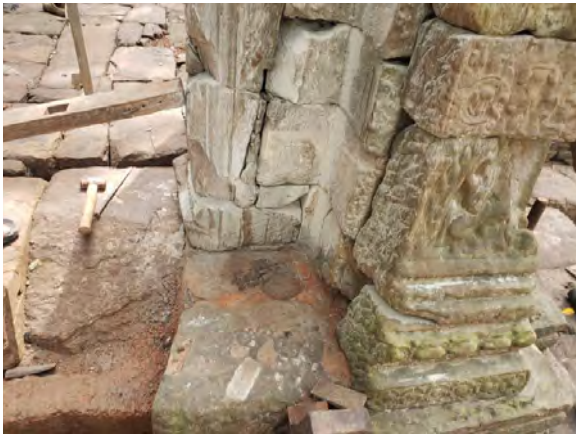
Figure 5.2.26 Circular mortise for a colonette in the southwestern corner

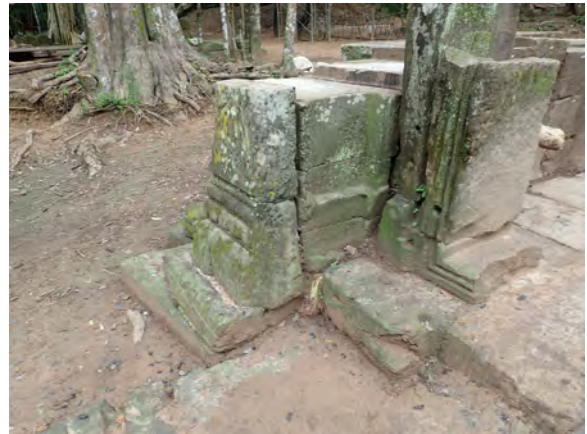
Figure 5.2.27 Smoothed upper surface without mortise in the northwestern corner where the colonette stands

corner, the upper surface of the sandstone floor on which the colonette rests is flattened without any trace of a tenon or indentation (Figure 5.2.27).

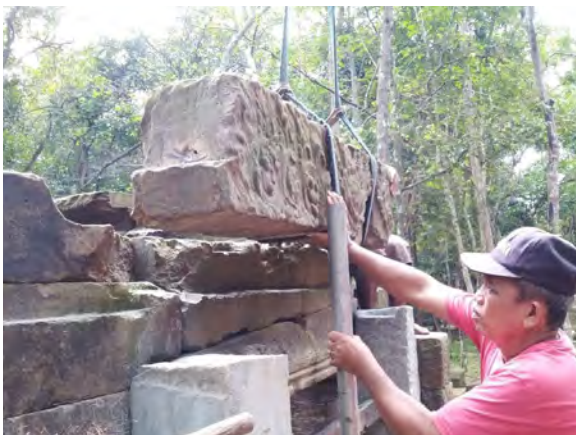
Figure 5.2.28 Tiered joints between the lintel and the upper door frame, with no mortise hole on the bottom surface of the lintel where the colonette attaches

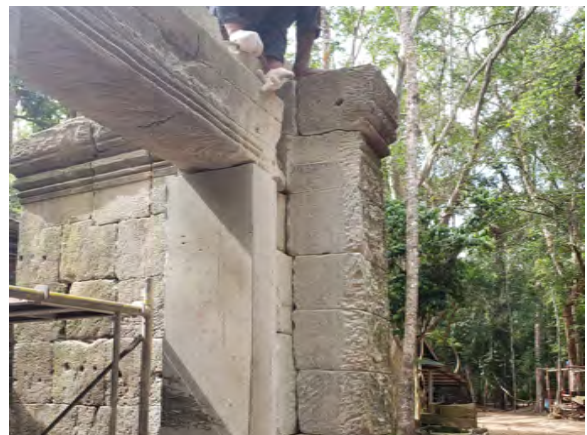
Figure 5.2.29 Traces on the north side wall show no support for the northern edge of the eastern lintel on the wall

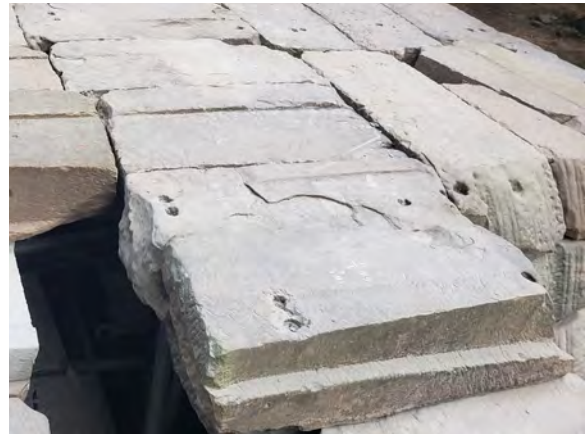
Figure 5.2.34 Roof stone layout on layer 01, with a palm-sized hole artificially drilled into the northeastern roof stone's upper surface

drilled into the upper surface of the northeastern stone, closest to the centre on the plane (Figure 5.2.34). Some kind of artefact was perhaps inserted there.

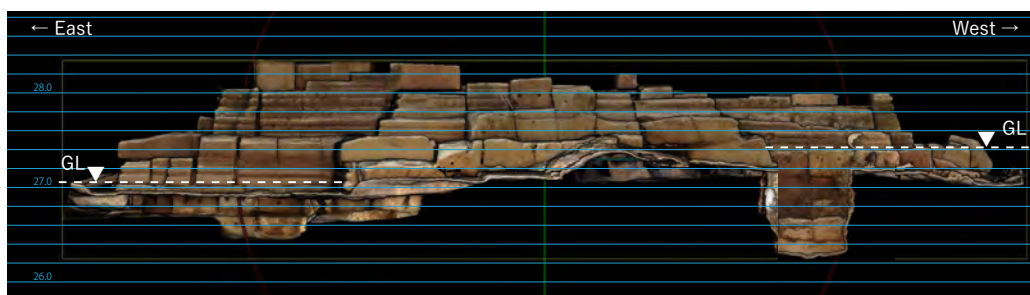
Figure 5.2.36 Base structure's north elevation created from 3D-laser scanning model, indicating the difference of the original ground level between the eastern and western sides of the East Gate

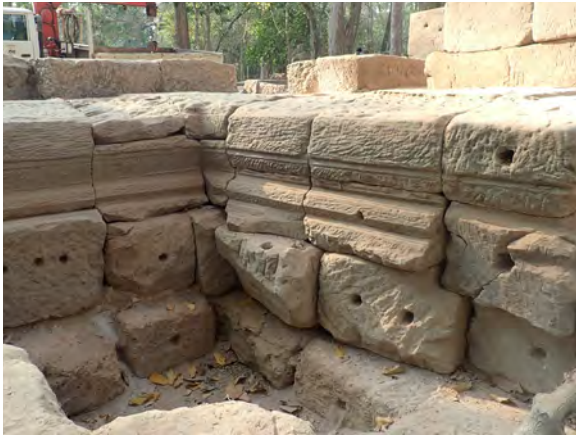
Figure 5.2.37 Engravings on the exterior sandstones, indicating the original ground level

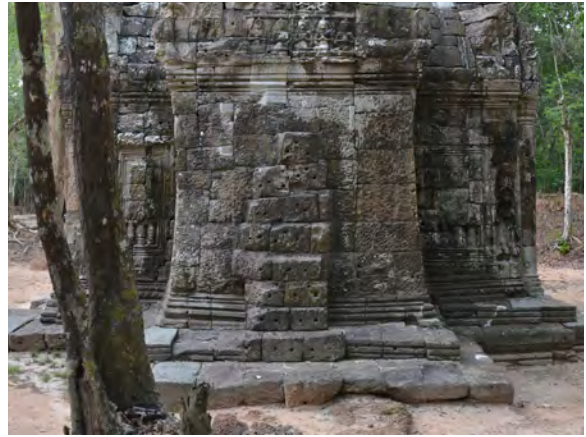
Little remains of the Outermost Enclosure, except for part of the foundation. Nevertheless, there are traces of Outermost Enclosure having been attached to both sides of the East and West Gates (northern and southern sides), assumed to have been about 3 m high (Figure 5.2.38).

Figure 5.2.38 Traces of Outermost Enclosure attached to both sides of the East Gate

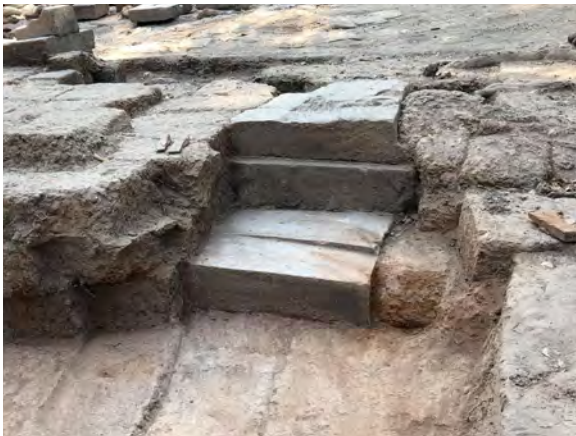
Figure 5.2.39 Part of the bottom of the remaining 'Outermost Enclosure' base under the East Gate's exterior sandstone

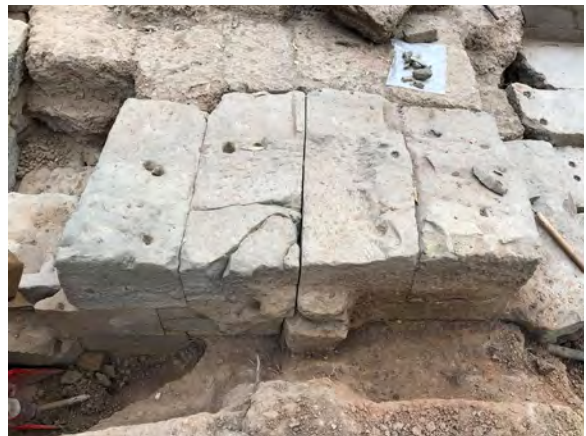
Figure 5.2.40 North side of the exterior sandstone of the East Gate's base structure, cut and processed to accommodate the 'Outermost Enclosure' base laterite

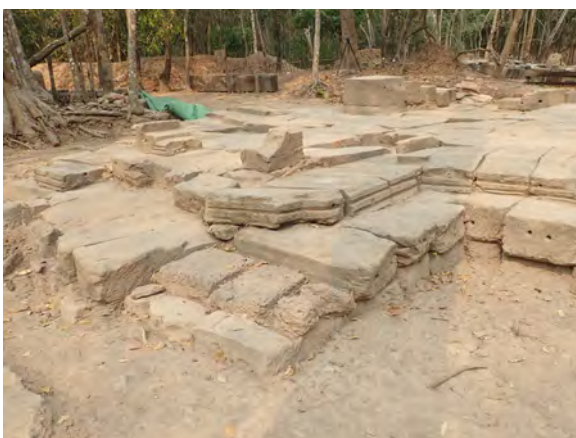
A possible candidate for this is the laterite block placed in the southwestern outer corner of the East Gate's western entrance (Figure 5.2.41). The upper surface of the sandstone directly beneath this laterite shows traces of previously having been underneath a stone of a different size. This leads us to assume that the original stone was moved at some point and that this other laterite was inserted there in its place. No corresponding stone can be found in the northwestern corner, so the details are unknown. There is another place in the southwestern corner where laterite blocks have been inserted irregularly into the exterior sandstone, which is the visible part of the base structure (Figure 5.2.42). All parts of the East Gate's exterior design comprise sandstone, with the two abovementioned stones appearing in this design as glaring exceptions. It is conceivable that the laterite in the southwestern outer corner may have been part of an approach that was laid at some point in time after the construction of the East Gate. Nevertheless, it is equally possible that it was accidentally placed there at a later

Figure 5.2.41 Laterite block irregularly placed at the southwestern outer corner of the East Gate's western entrance

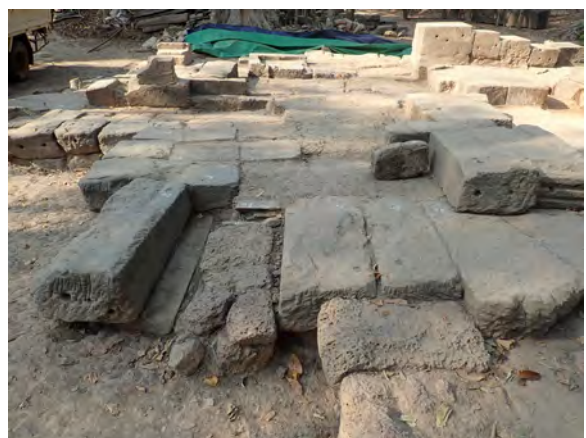
Figure 5.2.42 Laterite block irregularly inserted at the southwestern outer corner of the East Gate's south wing

time, as a laterite has been used unnaturally in another place as well. Excavations near the Cruciform Terrace have revealed traces of modifications to the eastern end of the terrace (Abe, Kansha, Sea & Sitha, 2020: 35-37), which may have been related to the construction of an approach connecting the East Gate and Cruciform Terrace.

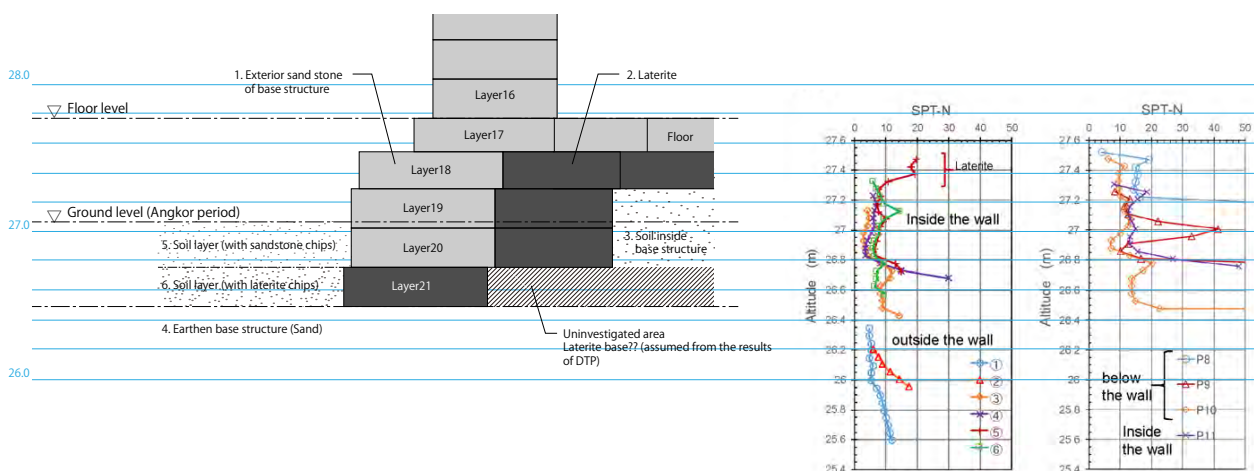
Considering that the soil filling inside the base structure is sandy, SPT-N values were estimated using equation (2-2) (Figure 6.1.3); these are almost equivalent to the minimum values estimated from equation (1). The estimated SPT-N values of the soil filling layer were determined to range between approximately 5 and 10.

Figure 6.1.3 Estimated SPT-N values

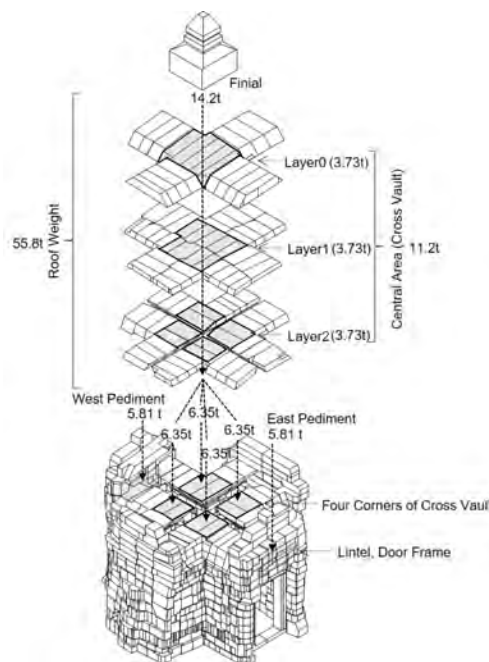
Figure 6.2.4 Schematic diagram of the parts where static load is concentrated

roof will comprise a cross vault with a central corbel arch that bears the greatest load, with a stainless steel bar to be inserted at the bottom of the arch to reduce the horizontal force caused by thrust. The stone slippage caused by the shear force and moment from the upper load will be suppressed by inserting dowels. By stabilising the central parts, we expect that the out-of-plane protrusion towards the periphery can be kept down. The pediments will be tied to a principal part of the building to prevent them from being pushed out of the plane. The materials and quantities thereof required for these reinforcements have been estimated.
