Report on the Restoration of the East Gate,

Ta Nei Temple, Angkor, Cambodia

2019 - 2022

Tokyo National Research Institute for Cultural Properties (TOBUNKEN)

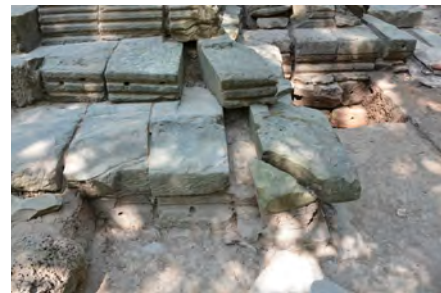
The deformation of the East Gate before restoration is described in Section 4.1 on the pre-dismantling survey. Although the superstructure exhibited a considerable wall slant and joint gaps between the stones, the base structure did not show any signs of significant irregular ground subsidence, despite some misalignment of the stones at the base structure's outer periphery and uneven flooring (Figure 8.1.1). Nonetheless, preliminary excavations around the base structure revealed that the roots of adjacent trees had reached the base structure's interior on the western side, which was assumed to be the likely cause of phenomena such as the movement of the stones making up the base structure and outflow of the internal soil fillings.

- 1) Deterioration and loss of laterite and soil filling layers owing to the partial deformation of the base structure and ingress of rainwater into the base structure as a result of this deformation.
- 2) Insufficient joining and meshing of stones at the ends and corners of the main body walls.
- 3) Inappropriate joint placement, such as small stones in locations with high stress following deformation of the main body.
- 4) A corbel arch structure that loses stress balance immediately following stone displacement.

Figure 8.1.1 Displacement of the stones on the base structure's outer periphery

Since the deteriorated laterite was not sturdy enough to withstand dismantling, it was decided to replace it with new material. During this process, the number of joints was reduced, and stability was enhanced by replacing sections with several small blocks of laterite with larger single blocks. In areas where the lower laterite layer was dismantled and replaced, tamping was performed with lime mortar directly below, and lime mortar was used to fill spaces between stones and between the inner soil filling and peripheral stones. The laterite and soil filling under the interior floor were considered harmless to the support of the superstructure, so they were left in place, even in areas that had deteriorated.

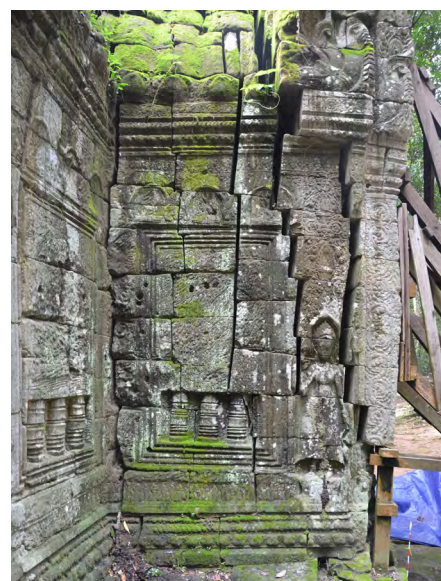
As for the walls of the superstructure, contrasting with the good state of the joints between the stones on the insides of the wall, longitudinal continuous joint breaks were observed at all external and internal corners where walls intersect orthogonally, resulting in all eight walls forming the cross-shaped plane falling inwards, while the eastern and western gable ends were sloping outward (Figure 8.1.2).

Figure 8.1.2 Continuous open joints in the vicinity of an external corner

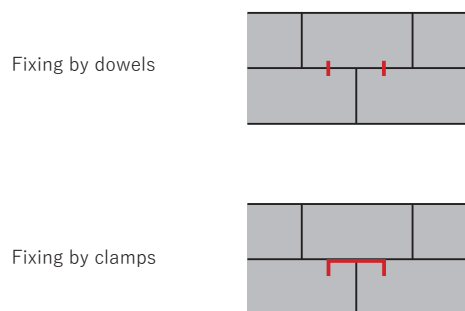
After modelling the completed building and calculating the structure of the superstructure, without considering seismic forces, no issues were confirmed, provided that every stone is rigidly settled in its original position without any displacement. Preventing long-term stone movement was considered the most crucial requirement for improving structural stability. The easiest way to fix the stones, without affecting their external appearance, was to insert connecting elements between them. However, such reinforcement causes irreversible damage to the original stone, so the goal was to minimise this as much as possible. Consequently, the decision was made not to reinforce the central part of the walls, where there had been little deviation between the stones before restoration. Instead, the focus was on fixing the base structure's outer periphery, the inner and outer corners near the upper edges of the walls, the entrance pilasters on the left and right sides, the vault intersection at the centre of the roof, and the finial, where displacement had been significant.

Figure 8.3.2 Schematic stone fixing pattern using dowels and clamps

Initially, the Japanese side proposed a method of resisting lateral slippage by inserting short metal dowels between the upper and lower stones to fix them to each other. This would minimise damage to the stone, and it was assumed to have the merit of being barely visible when applied to a stone with an exposed upper surface. However, APSARA was reluctant to use this method because it had not been widely employed at Angkor, given the time and effort required to accurately align the upper and lower drilling positions and because stability would remain uncertain as adjacent stones cannot be directly fixed to each other. Thus, they decided to adopt mainly a method of fixing the stones from the top with stainless steel clamps, which had already been extensively used.

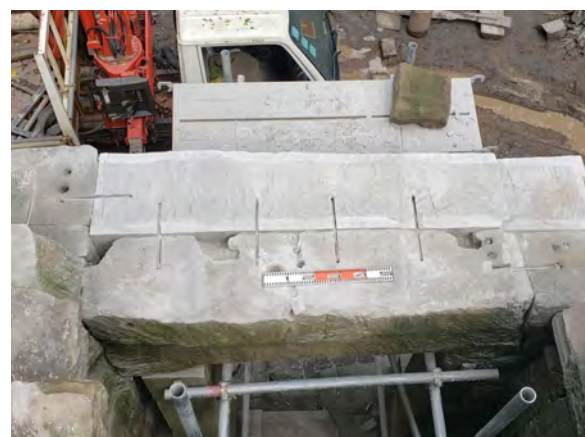
Figure 8.3.3 Metal clamp fixing on the eastern lintel's upper surface

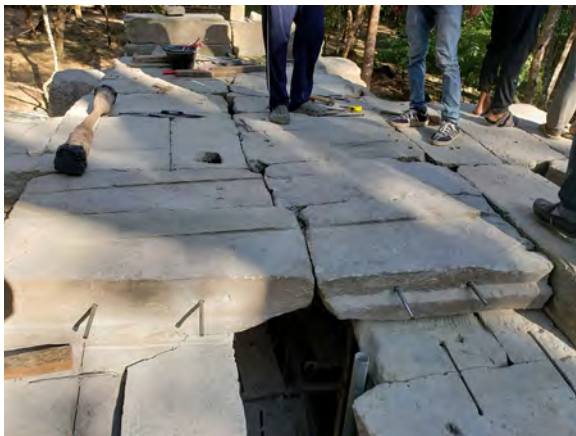
Figure 8.3.4 Insertion of stainless steel rods at the centre of the roof

At the intersection of the vaults, a square surface is formed by the parallel arrangement of long sandstone blocks. To unify the entire surface and ensure rigidity, stainless steel rods that penetrate adjacent stones in the short direction were inserted.

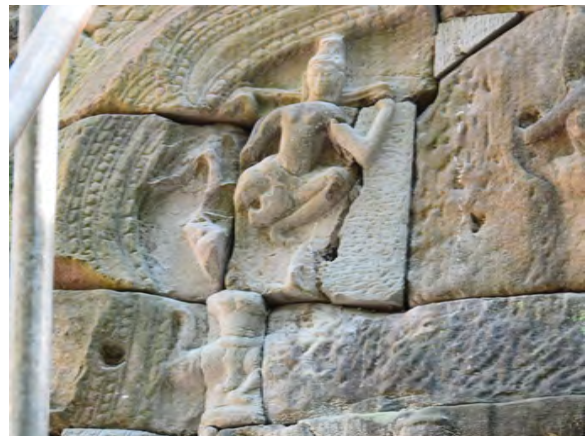
In some instances, the original materials could not be found. This was true for part of the base structure's outer periphery, near the upper end of the pediments on four sides, the lintel on the eastern side, and the colonettes on the eastern and western sides. Of these, new sandstone was supplemented at estimated dimensions to the base structure, lintel, and colonettes but not to the pediment ends. This decision was made according to the principle that defects should be supplemented if they pose risks in terms of structural stability and deterioration, while defects of primarily aesthetic import should not be supplemented.

Figure 8.3.5 Supplementary new stones at the southern pediment (work in progress)

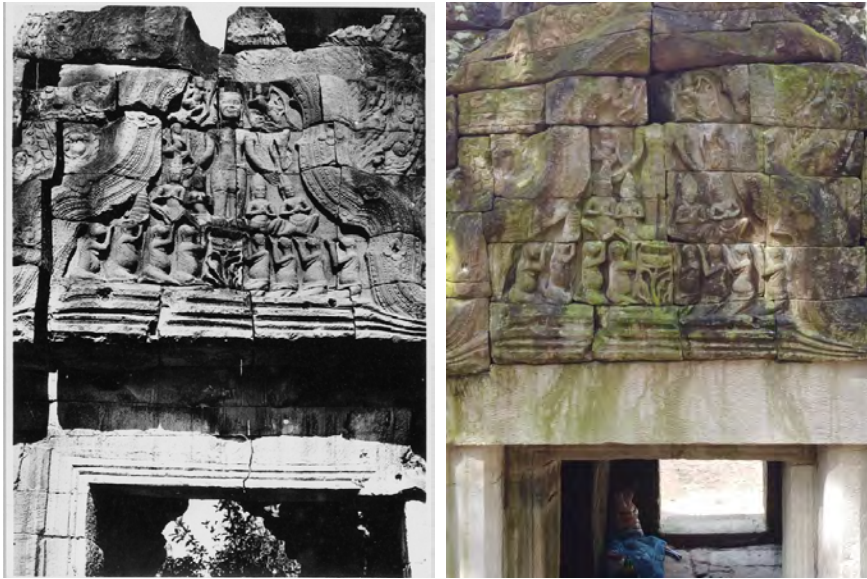
Gate, so they may be found in the future. In that case, it is expected that they will be returned to their original positions. The head of the figure at the centre of the pediment seems to have been lost due to theft, supported by the fact that it appears in old photographs, but a decision was made not to replace it in the hope that it would be recovered in the future (Figure 8.3.6). The biggest mystery surrounding this building is the absence of lintel material on the eastern side. The fact that not even fragments have been found suggests that it was removed in its entirety in the past, but no relevant records have been found in EFEO's journals or elsewhere.

Figure 8.3.6 Eastern pediment, photos from ca. 1930 (Left: EFEO_CAM08916) and after restoration (Right)

The lintel was not engraved at all on the eastern side, while the colonettes were restored only to create the silhouette of a square base and an octagonal shaft without any further details. Once completed, this will not stand out as much as initially expected. It is hoped that one day, upon the discovery of the original lintel material, the façade of the East Gate can finally be recovered, following discussions on whether to put it back to its original position or make a replica by engraving the same patterns on the existing material.

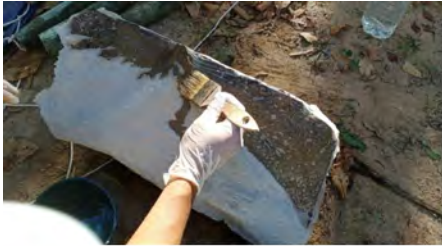
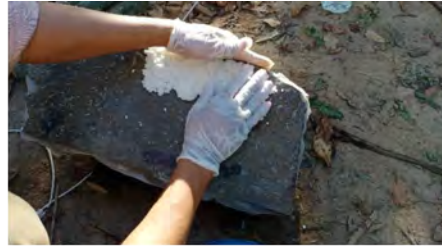
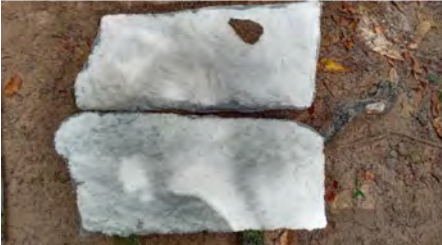
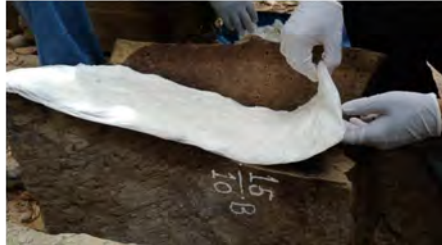
Figure 9.1.7 Removal of saline

Some stones were decayed due to salt crystallisation and the flow of rain water, causing erosion, scaling and

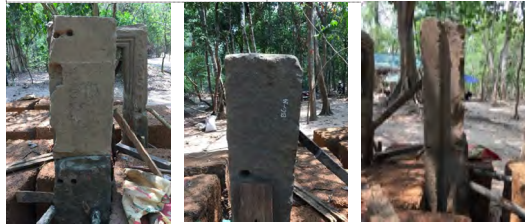
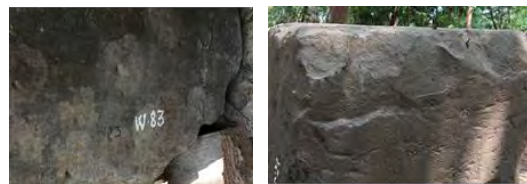
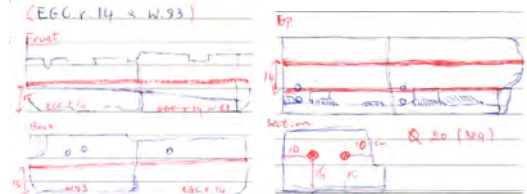
Figure 9.1.13 Examples of observation sheets for stone repair work

ពណ៌នាការខូចខាត(State of Conservation):

- ដោយថ្មទាំងពីរមួយត្រូវបានប្រែប្រួល(EGC.r.14) ហើយមួយទៀតនៅទីតាំងស៊ុមដដែល (W83) ធ្វើដោយ ថ្មមានពណ៌ខ្ពស់។
- មានដីច្រើននៅលើថ្ម(A) និងស្បែកឆ្មៅនៅលើថ្ម(B)
- នៅលើថ្ម(B) ប្រុងឆ្វេងផ្នែកខាងមុខមានបាក់ជាច្រើននៃថ្ម និងនៅលើថ្ម(A)ផ្នែកខាងមុខមាន បាក់ច្រើនផងដែរ។
- ថ្មទាំងពីរត្រូវបានបាក់ត្រឹមពាក់កណ្តាលត្រង់ល្បាក់ខ្ពស់ទាមរាង(A) និង(B)។

ប្រោសបញ្ហាទេស(Technical suggestion):

- សម្អាតដីនិងស្បែកឆ្មៅ ព្រមទាំងថ្លៃដែលដាច់ជាពីរ
- ពង្រឹងផ្នែកខាងលើ
- ដោយសារថ្មជាបង្គំត្រូវទ្រទ្រង់ផ្តែរ និងលោងជាង ដូចនេះការចិត្តការប្រើប្រាស់ក្រៅសិក្សា បន្ថែមពីអ្នក ជំនាញ Engineer ដើម្បីដោយការប្រើប្រាស់ពន្លឺមានប្រសិទ្ធភាពអាចទល់ទ្របាន និងមានប្រសិទ្ធភាព សុវត្ថិភាព។
- ចិត្តបាយអរ។

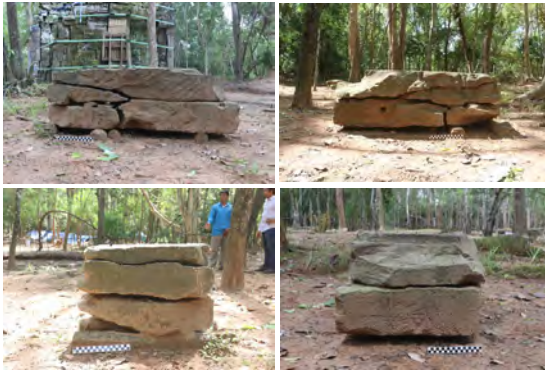
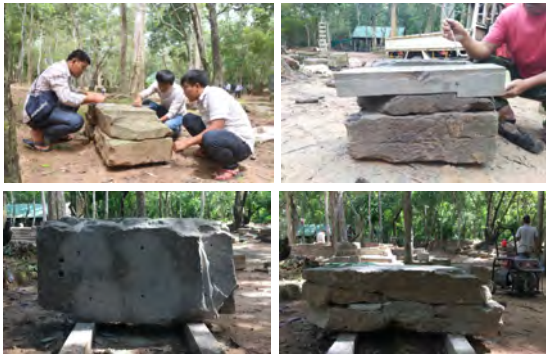
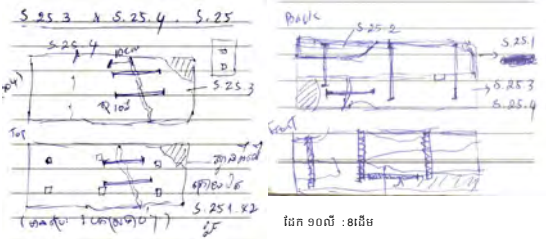
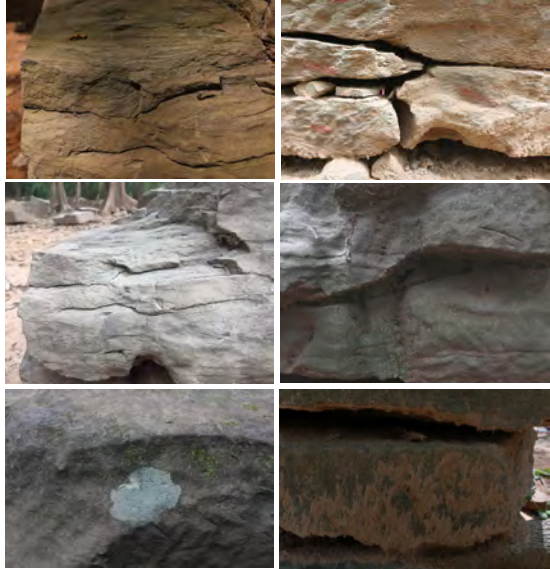
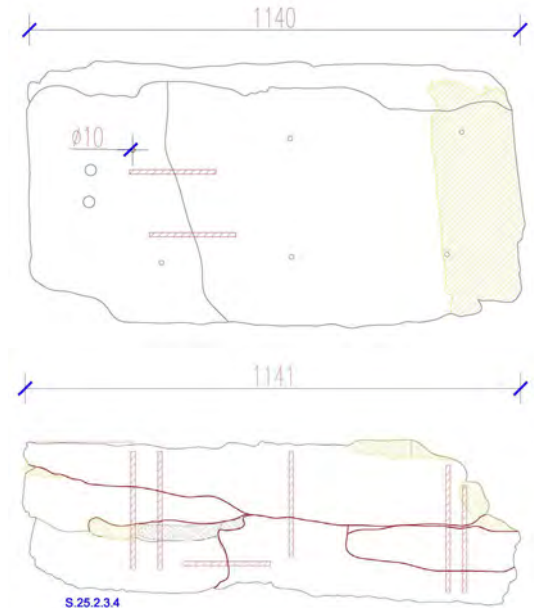
Figure 9.1.14 Examples of observation sheets for stone repair work

- ផ្ទះមានសភាពបែកធ្លុះធ្លុះជាច្រើនបំណែក និងមានបែកបាក់ផងដែរ
- សាច់ផ្ទះមានសភាពប្រេះបាក់ស្រទាប់ និងមានលក្ខណៈពុកផុយ

- សម្អាតទូទៅ
- ពង្រឹងទីតាំងពុកផុយ
- ចិតក្លាប់បំណែកតូចៗចូលមុន រួចចិតក្លាប់បំណែក S.25.2, S.25.3 & S.25.4 ដោយប្រពន្ធគ្នា
- ចិតក្លាប់បំណែកខាងលើជាមួយបំណែក S.25.1 ដោយប្រើពន្ធគ្នាផងដែរ
- ចិតបំពេញបាម និងប្រើថ្មថ្មីនៅទីតាំងដែលបែកបាក់

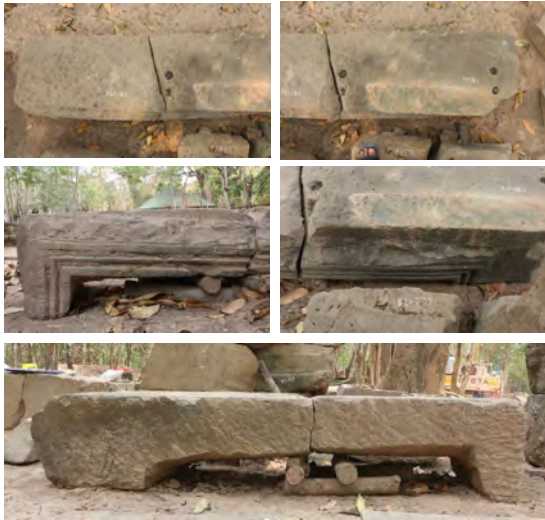
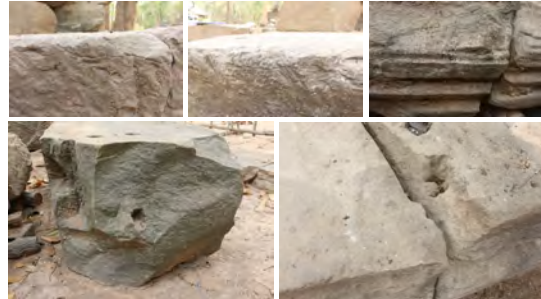
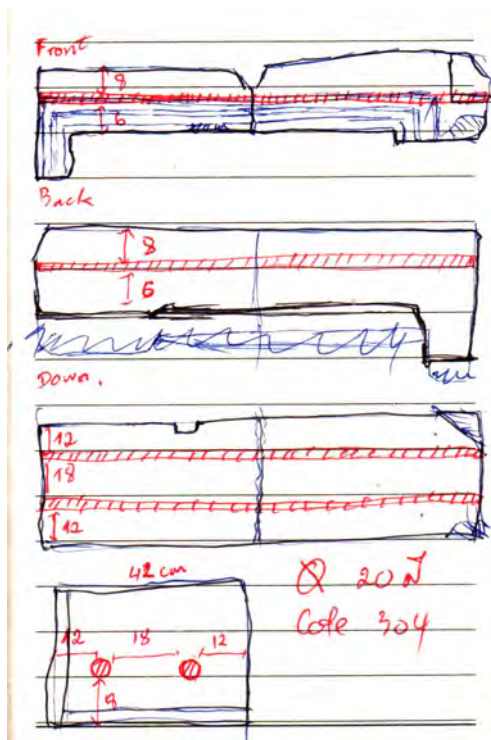
Figure 9.1.15 Examples of observation sheets for stone repair work

- បែកជាពីរបំណែកធំត្រង់ពាក់កណ្តាល
- មានបាត់ច្រើនកន្លែងនៅជ្រុងខាងឆ្វេង
- មានស្នាមប្រេះជាច្រើន(Hair Crack)
- មានស្នែងនៅផ្ទៃខាងមុខ និងខាងក្នុង

- សម្អាតដី និងស្វែងរក
- ដកអំបិល
- ពង្រឹងកន្លែងពុកផុយ និងស្នាមប្រេះ
- ចិត្តភ្ជាប់បំណែកទាំងពីរដោយច្រើនន្លូឡូ ស្ពានទម្លុះ ដោយច្រើនន្លូឡូ ២០សី ២ដើម
- ចិតបំពេញបាយអ

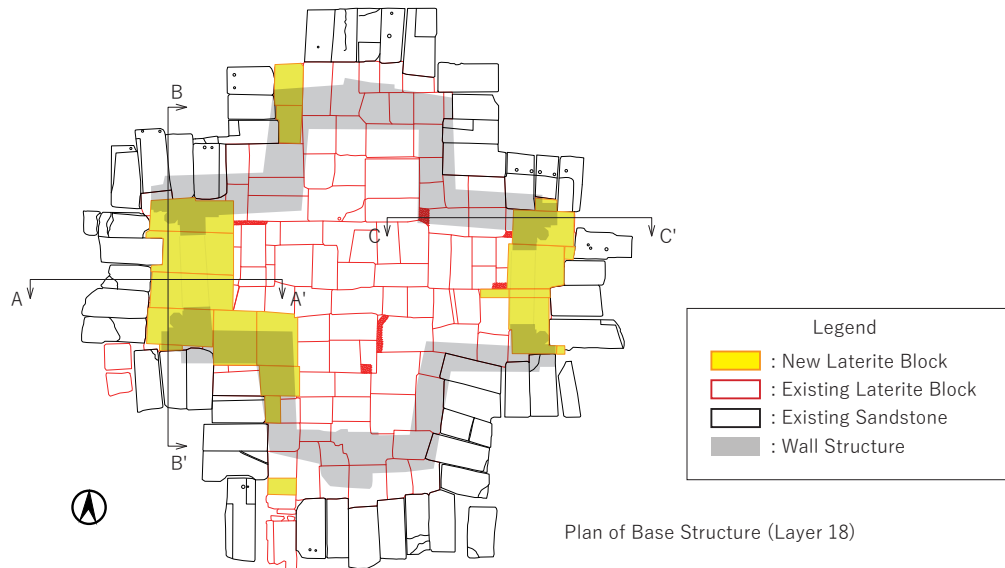
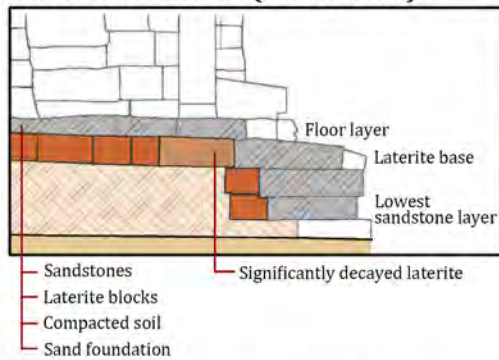
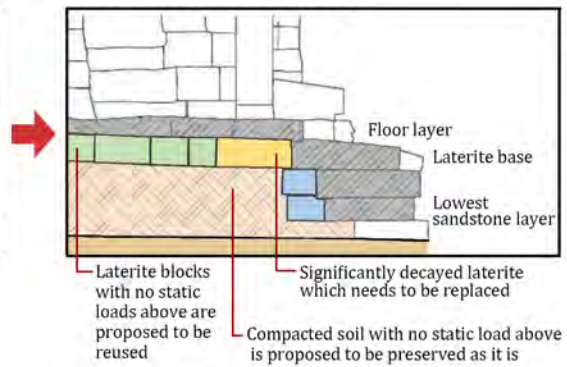
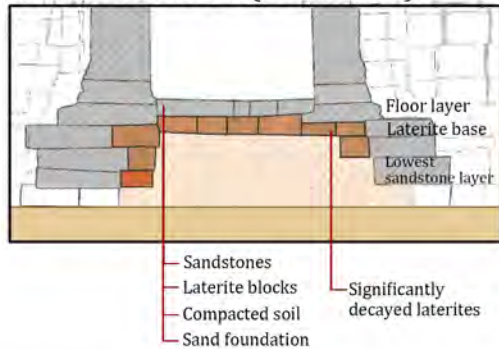
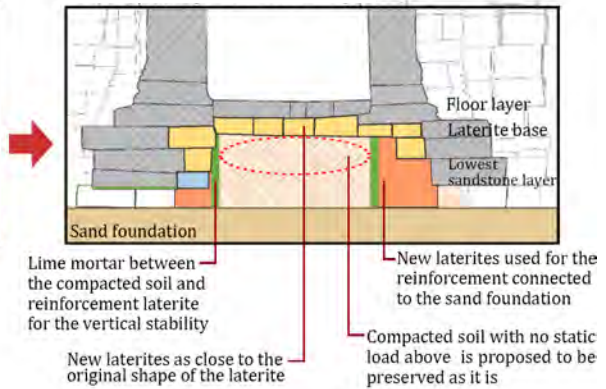
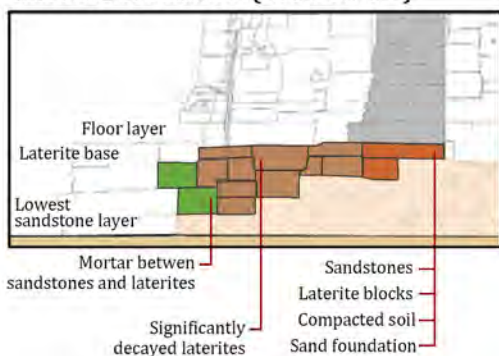
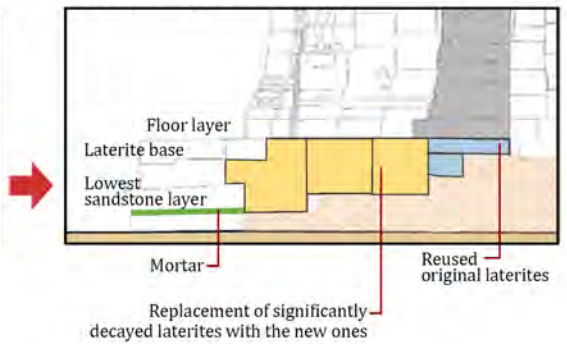
Figure 9.2.25 Diagrams showing the existing situation and the restoration policy for the base

EXISTING SITUATION (SECTION A-A)

EXISTING SITUATION (SECTION B-B)

EXISTING SITUATION (SECTION C-C)

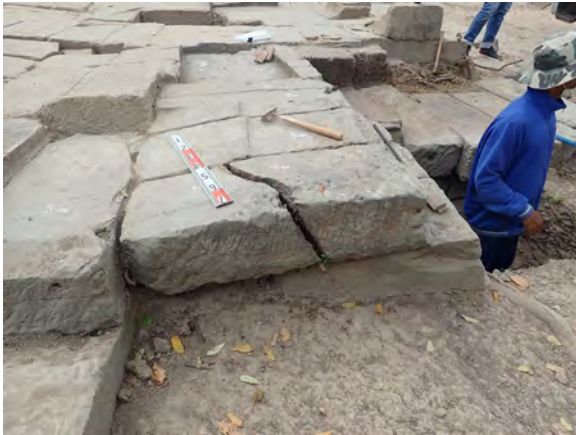
However, the dismantlement of the exterior and floor sandstones revealed deterioration of the substrate laterite.

Figure 9.2.26 Outflow of infill soil that caused the brake of exterior sandstone

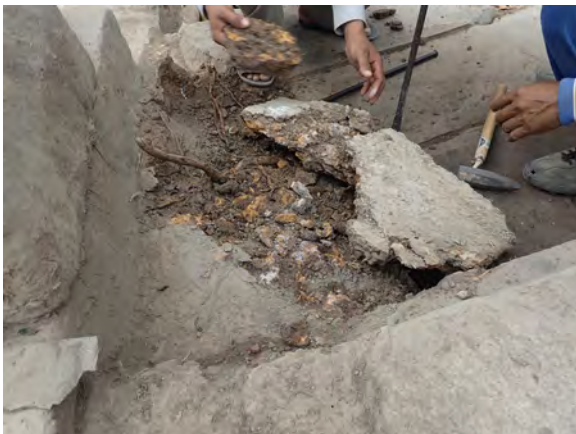
The northern side of the base structure was previously confirmed to be in relatively good condition; however, during the dismantlement of exterior sandstones, it was found that the tree roots penetrated the base structure, and the significant deterioration of the substrate laterite on the east and west sides of the north wing had caused problems, resulting in gaps between the stones. Therefore, the sandstone rows that had been used as benchmarks on the north side had to be dismantled and reassembled, whereas the reference stones on the south side were untouched (Figure 9.2.48). Lime mortar (mix ratio=fine sand: slake lime: sandstone powder: brick powder = 3:2:2:1) was compacted on the top surface of the laterite rows of Layer 21 to adjust for the unevenness of the exterior sandstones in Layer 20.

Figure 9.2.28 Fragile laterite blocks deteriorated by the penetration of tree roots

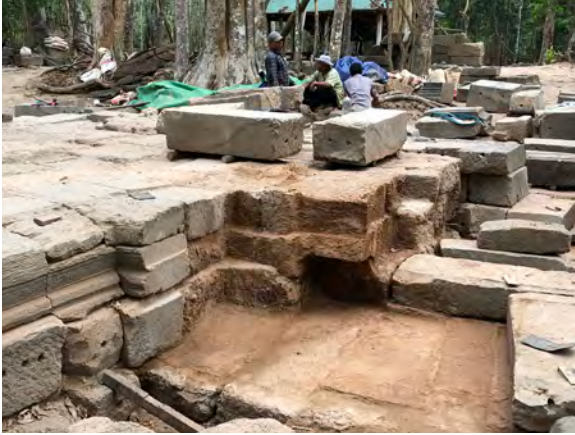
Figure 9.2.32 New laterite block inserted in the southeast part of the east wing

The substrate laterite blocks were irregularly absent in the southern half of the eastern wing of the base structure and were filled with compacted soil. This was assumed to cause partial erosion of the infill soil, and its irregular formation was considered to affect the stability of the superstructure because the part was located below the east entrance where the load of the upper structure was concentrated. Therefore, the infill soil in the absence of laterite and the surrounding laterite base were replaced and rebuilt with new laterite blocks. The laterite blocks of the northern half of the east wing were heavily deteriorated and had to be replaced with new laterite blocks (Figures 9.2.32-9.2.37).

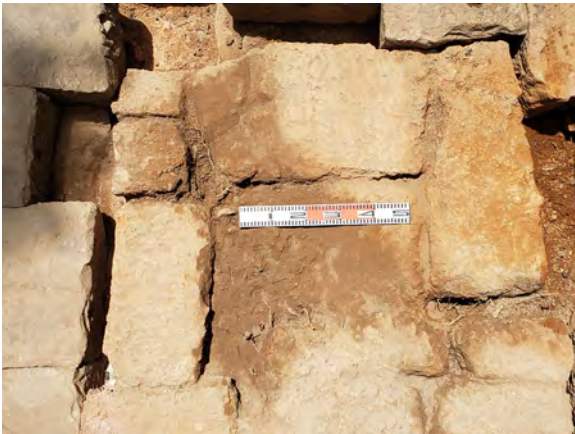
Figure 9.2.34 Deteriorated substrate laterite in the east wing

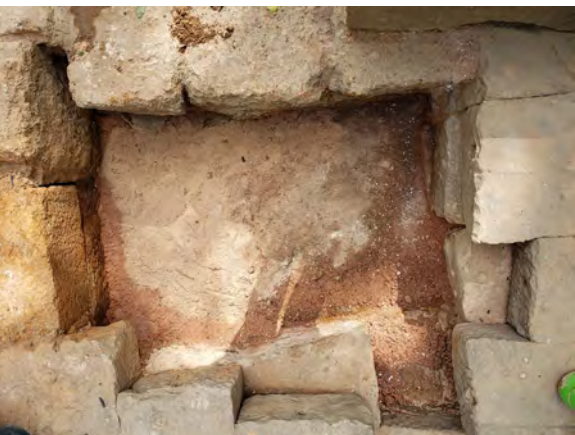
Figure 9.2.36 New lime mortar compacted on Layer 20's top surface before insertion of new laterite

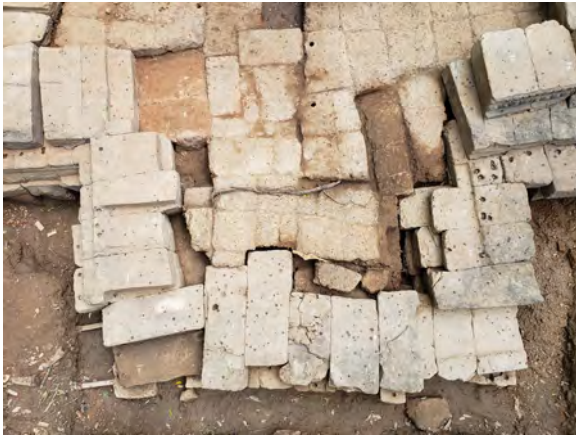
During dismantling, it was confirmed that the laterite blocks were thin and small, and had deteriorated in the area below the west entrance. Some were broken into pieces by penetration of the tiny tree roots inside the fine holes in the laterite blocks. In addition, four layers of laterite exist on the northern side of the west entrance, whereas only three layers exist in some areas on the southern side, causing foundation instability. Some areas in the foundation, which consisted of soil layers combined with laterite blocks, were in poor condition.

Figure 9.2.38 Condition of the substrate laterite in the west wing (Layer 18)

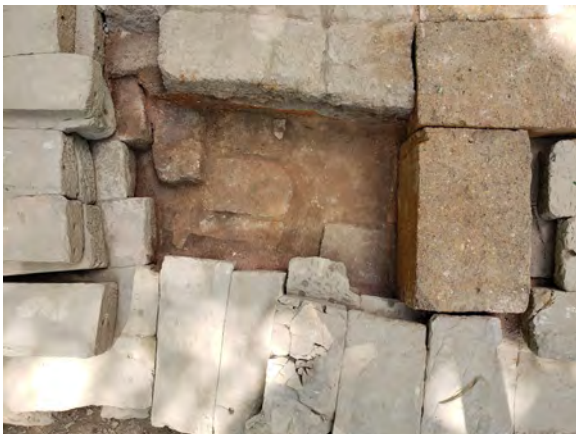
Figure 9.2.40 Condition of the substrate laterite in the west wing (Layer 20)

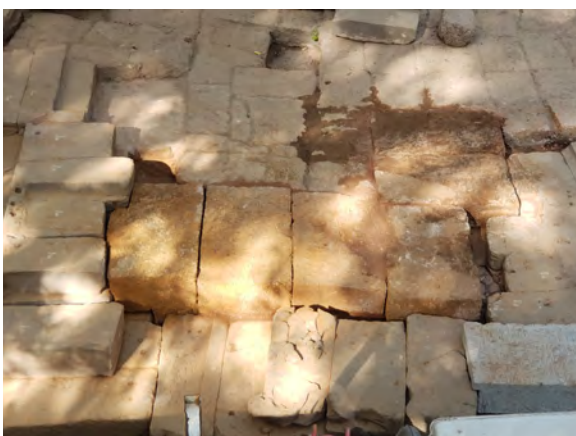
Figure 9.2.42 New laterite replacing deteriorated substrate laterite in the west wing

Therefore, it was decided that the base laterite would be replaced with new laterite blocks in the western wing area. The damaged laterite blocks below the wall structure that received a static load were replaced with new laterite blocks that were larger than the original for structural reinforcement. The stability of the new laterite was secured by applying lime mortar to fill the gap between the surrounding compacted soil or sandstones and the new laterite blocks (Figures 9.2.38-9.2.43). In contrast, the substrate laterites and compacted soil below the floor pavement, which did not bear the upper loads, were maintained in the original condition, even though they had deteriorated somewhat.

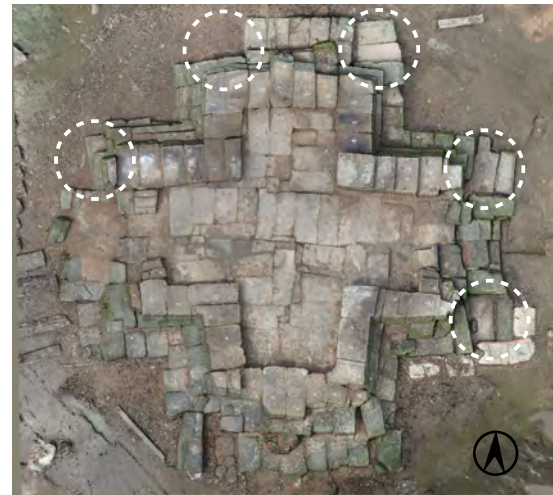
Some corner sandstones of the base structure were absent before restoration and were not found during the investigation of scattered stones in the surrounding area (Figure 9.2.45). As the missing stones could have led to lateral displacement of the base, new-material sandstones were inserted with the estimated original size.

Figure 9.2.45 Places lacking exterior sandstones

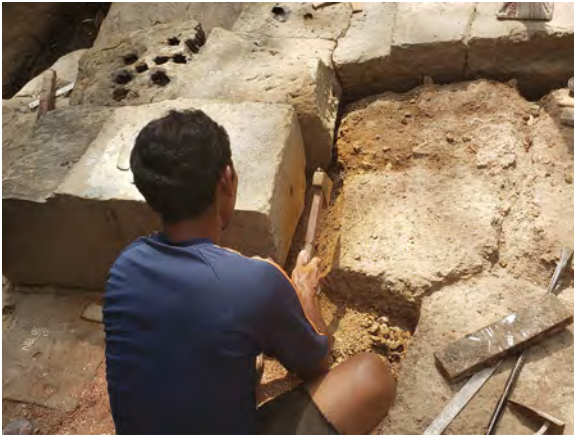
Figure 9.2.50 Cutting the displaced laterite to fix the exterior sandstones

delivered in their original position. Thus, two solutions were discussed in the online meeting between APSARA and TOBUNKEN: (a) disassembling the laterite materials in the displaced part and returning them to their original positions, or (b) cutting out the necessary parts in the outer edge of the laterites without changing their existing positions. Because the stability of the existing base structure could be estimated to a considerable extent by engineering calculations, and laterite blocks itself turned into fragile conditions, and as mentioned earlier, there was a risk of loosening the compressed internal soil layer if the partial dismantling was conducted. It was finally decided that the latter solution (b) should be implemented (Figure 9.2.50).

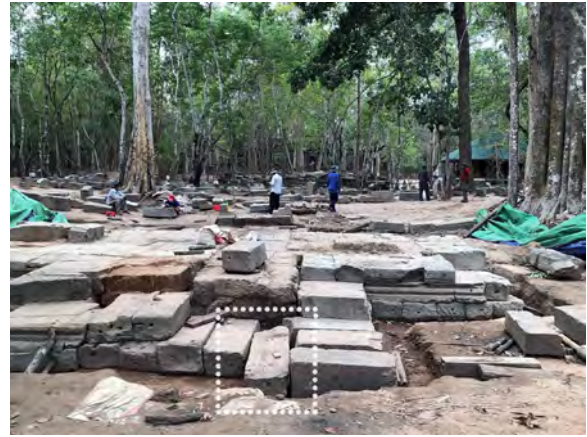
Figure 9.2.51 Gap that occurred during trial reassembly in the east wing

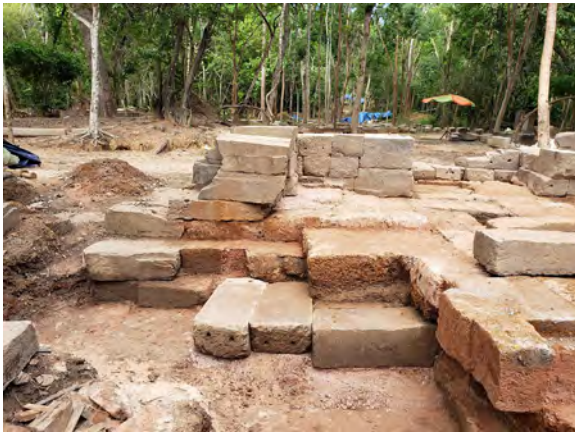
Figure 9.2.52 New substrate laterite on the west side of the north wing

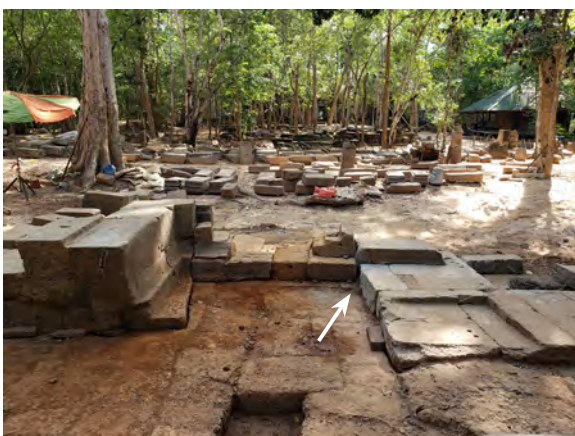
Figure 9.2.54 Gap that occurred between exterior sandstones in the northwest corner of the west wing

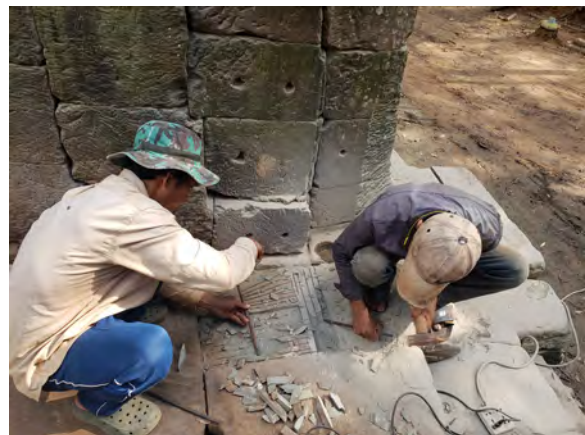
Figure 9.2.61 Scraping new sandstones' surface to place the door frame

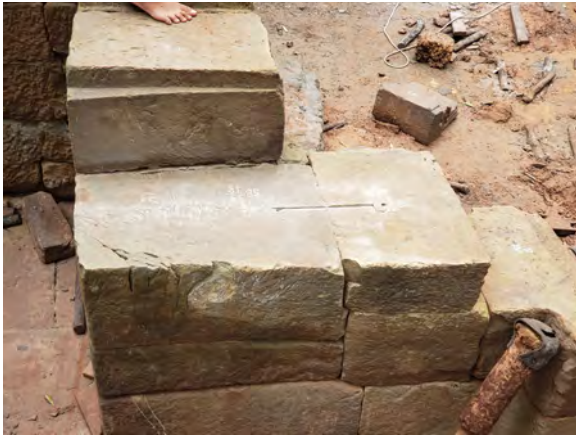
Figure 9.2.62 Stainless steel clamps inserted to prevent stone displacement

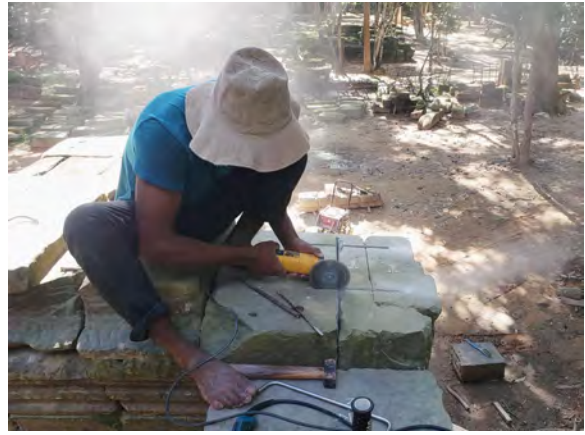
Figure 9.2.63 Use of stainless steel clamps at the wall corners for consolidation

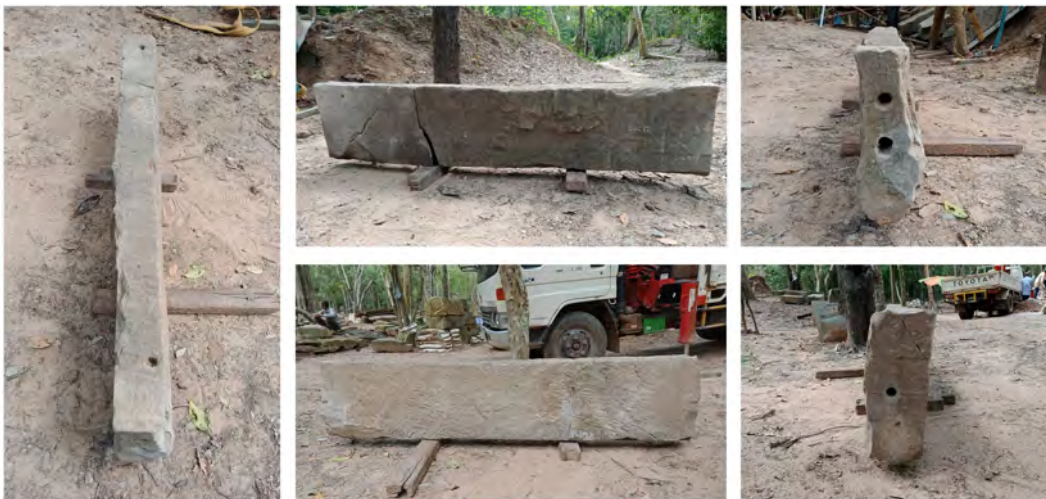
Figure 9.2.64 Vertical door frame reinforcement

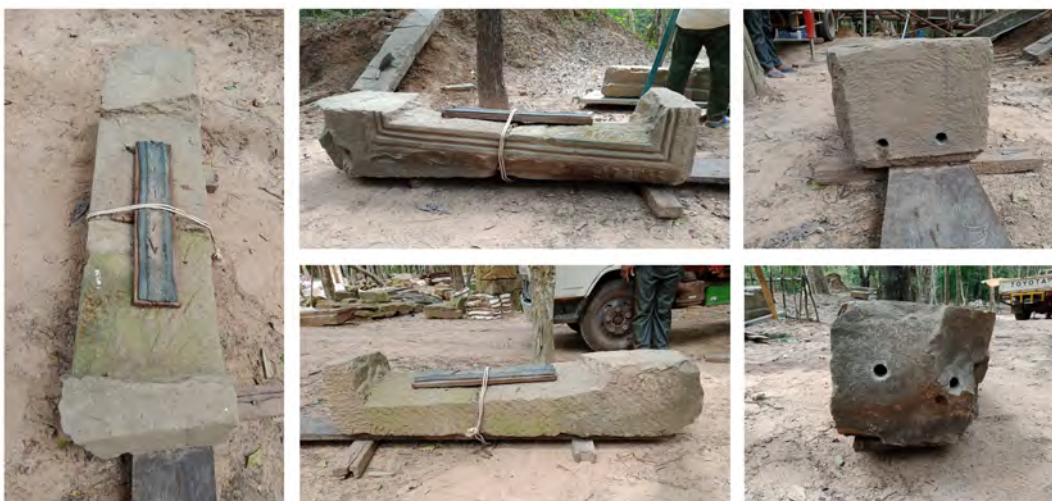
Figure 9.2.65 Horizontal door frame reinforcement

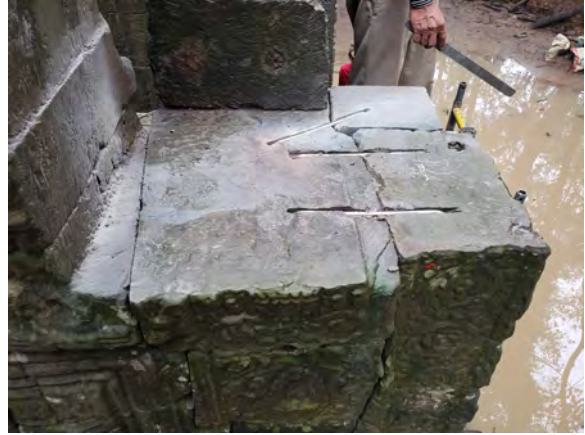
Figure 9.2.67 Stainless steel clamps inserted to prevent stone displacement

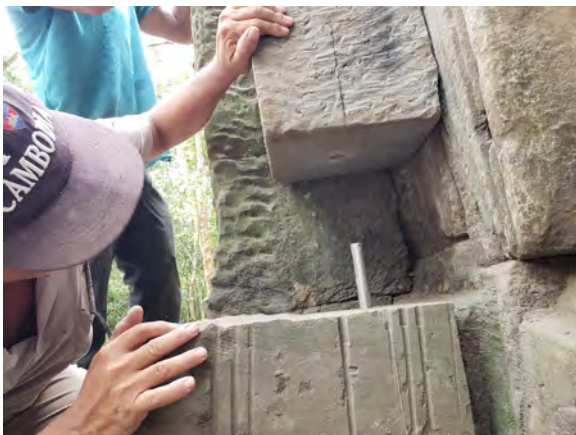
Figure 9.2.70 Stainless shear connector inserted at the bottom of the new colonette at the northwest corner

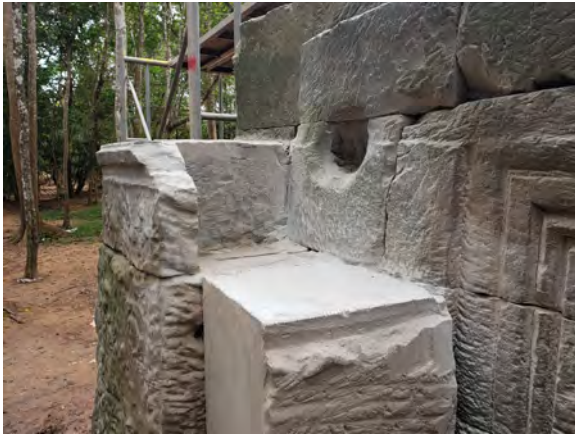
Figure 9.2.72 Cutting the deteriorated part of the pilaster to consolidate with the new colonette using a clamp

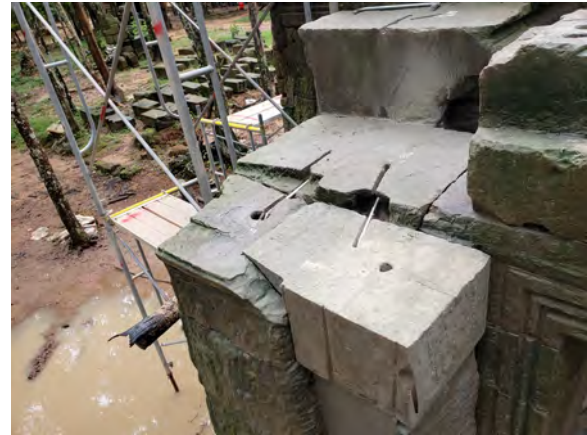
Figure 9.2.73 Use of clamps to consolidate the new colonette, the pilaster and the wall

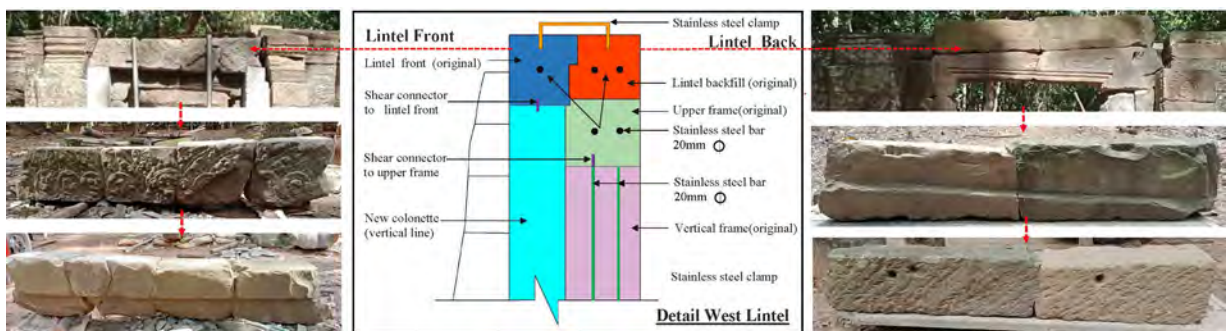
Figure 9.2.75 Reinforcement of the west lintel

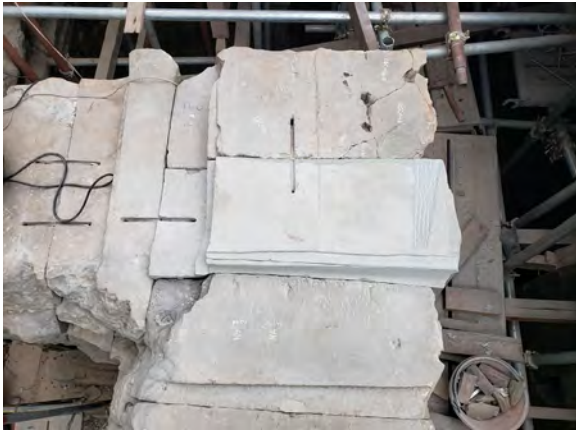
Figure 9.2.78 Stainless steel clamps used to consolidate the roof structure's inner corner

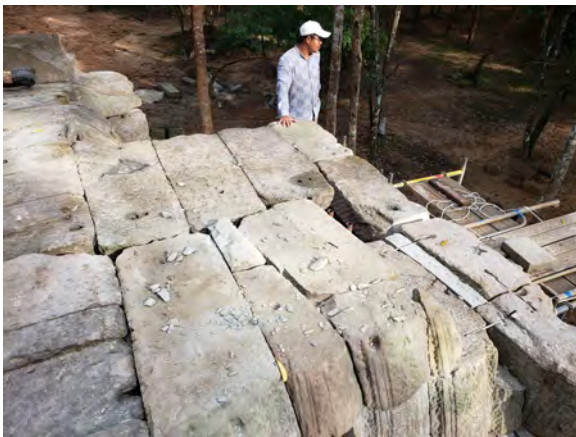
Figure 9.2.84 Layer 01's top surface and the use of stainless steel clamps at the pediment

Stainless-steel clamps were inserted at the top surface members of the pediment and adjacent roof sandstone to prevent external collapse. Shear connectors were also inserted into the pediments.

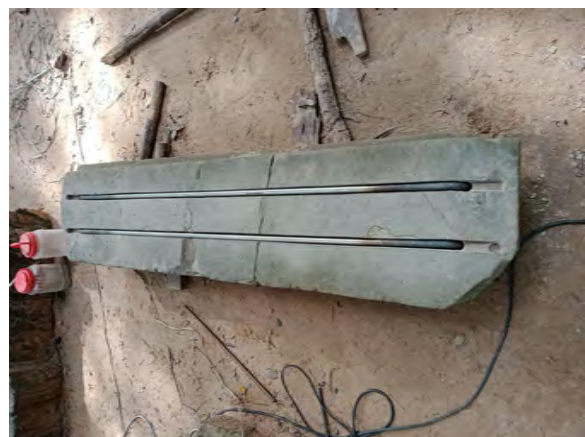
Figure 9.2.87 Repairing the topmost layer's roof sandstone

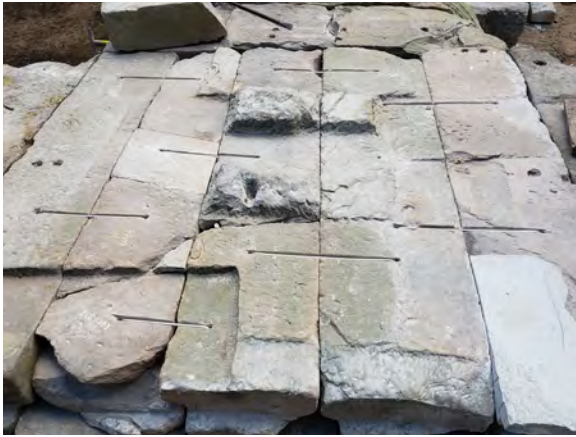
Figure 9.2.88 Consolidation of the central part of the roof using long stainless steel clamps

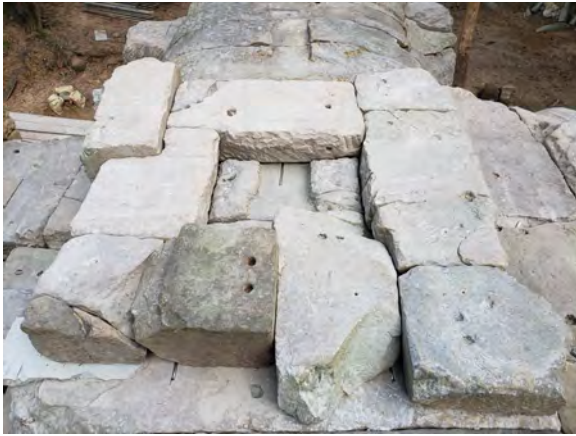
The finial was also temporarily assembled on the ground in advance as of December 2019, when the dismantlement was completed. The finial was built from a collection of relatively small stones and had more missing elements than the other parts of the building. Because it was possible to estimate the original shape of the missing parts from the remaining parts, the absent members were supplemented with new materials (Figures 9.2.90-9.2.91).

Figure 9.2.90 Bottom layer of the finial's square base

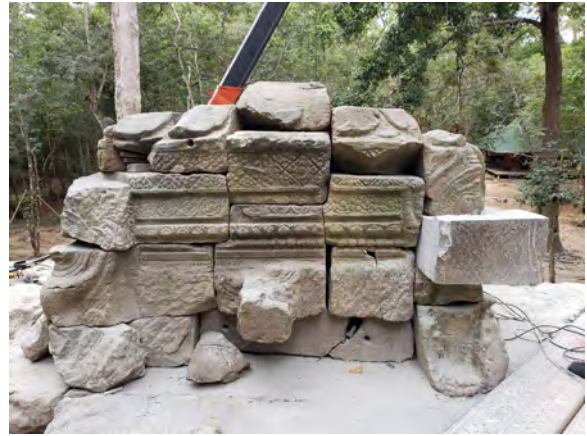
Figure 9.2.91 East facade of the finial's square base

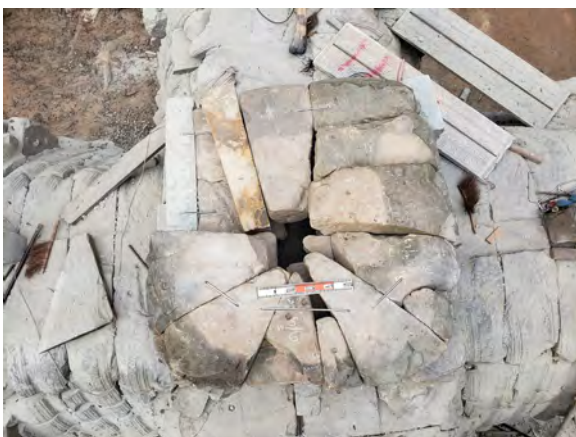
Figure 9.2.92 Reassembly of the finial

The structural reinforcement of the finial was the same as that of the others. The upper surfaces of the adjacent stones were connected with clamps, and holes were drilled vertically to connect the upper and lower stones to prevent them from shifting. Stainless-steel shear connectors were also inserted vertically between the base of the finial and the top surface of the roof to prevent displacement (Figure 9.2.92).

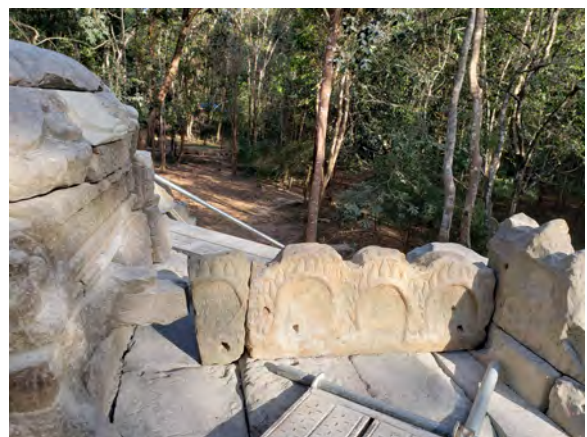
Figure 9.2.93 South wing roof ridge

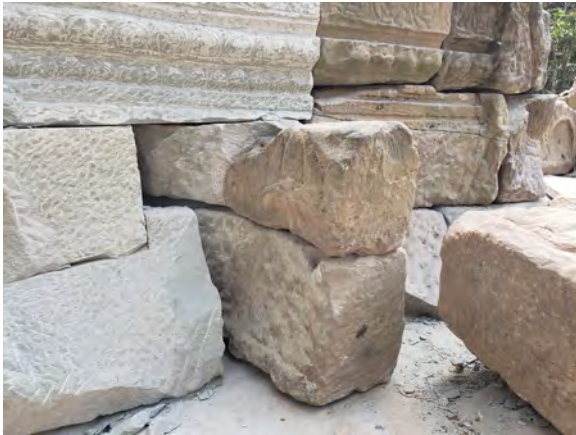
Figure 9.2.94 Connection between the roof ridge and the finial base

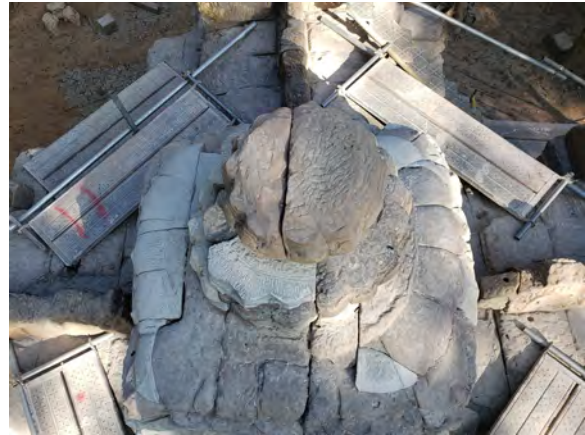
Figure 9.2.95 Flattened upper surface of the top lotus

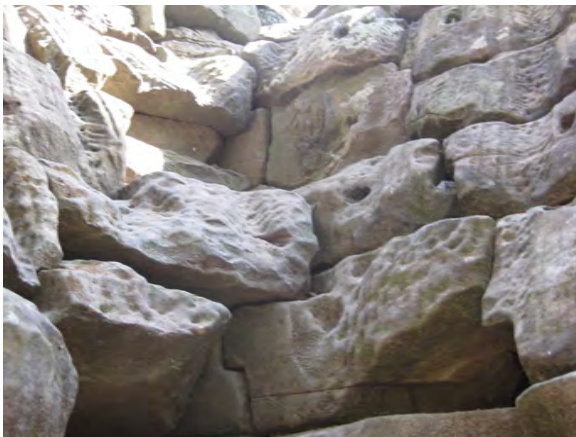
Figure 9.2.96 Minor defects at the roof's northwest corner

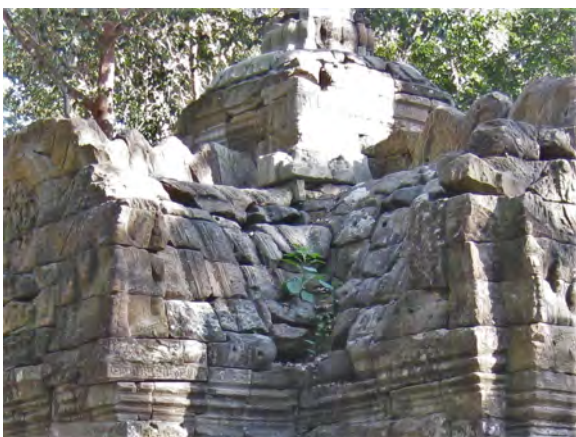
Figure 9.2.98 Roof at the northwest corner before retouching

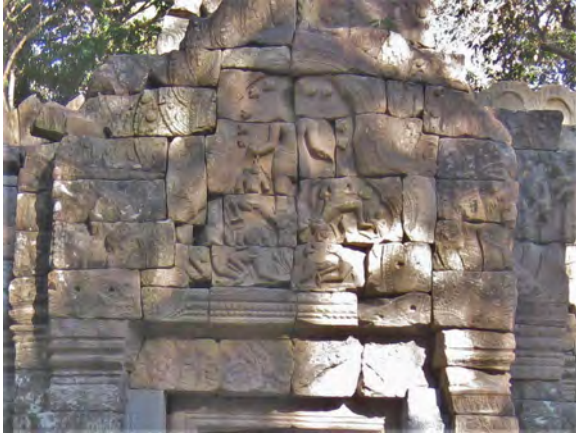
Figure 9.2.100 West lintel and pediment before retouching

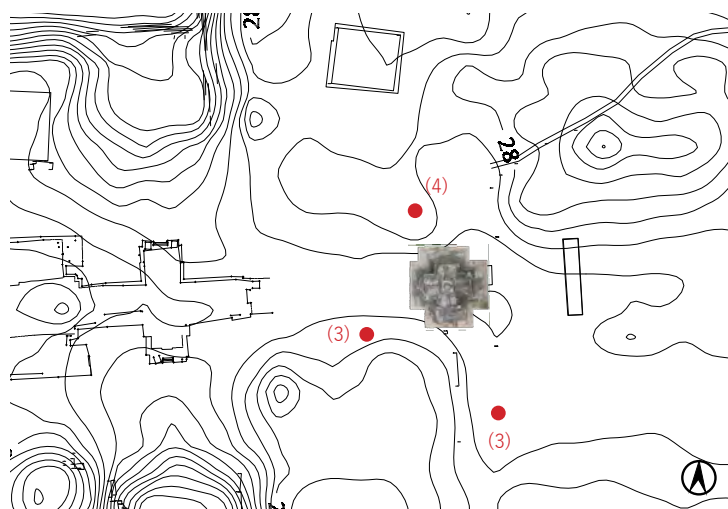
Some stone members could not be reused during the restoration work, as some were severely damaged, and others could not be identified in their original position or came from other structures in the temple, not the East Gate.

Figure 9.2.114 Locations of stone members that were not reused

For example, two ridge ornamental stones scattered around the East Gate before restoration were found, which were not originally from the East Gate, but presumably from the Outermost Enclosure, which was thought to have been attached to the East Gate. In addition, unidentified sandstones, severely damaged substrate laterite replaced with new laterite during reassembly, and fragments of the original stones were retained tentatively on the south side of the East Gate.

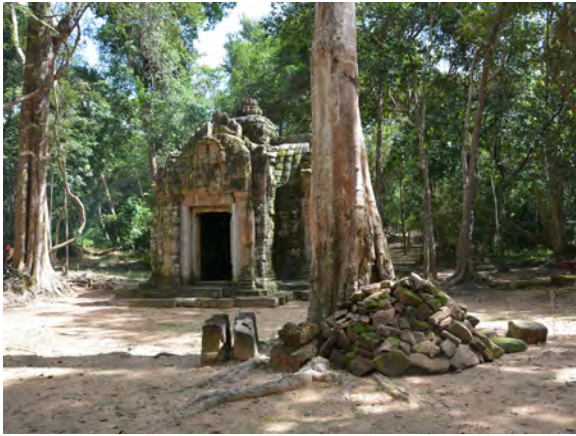
Figure 9.2.115 Original sandstone members not reused during the restoration

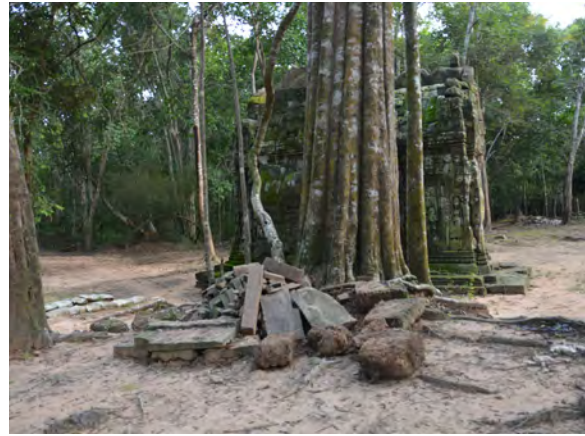
Leftovers or fragments of the new materials used in the restoration work were kept on the north side of the East Gate.

Figure 9.2.116 Leftover restoration materials

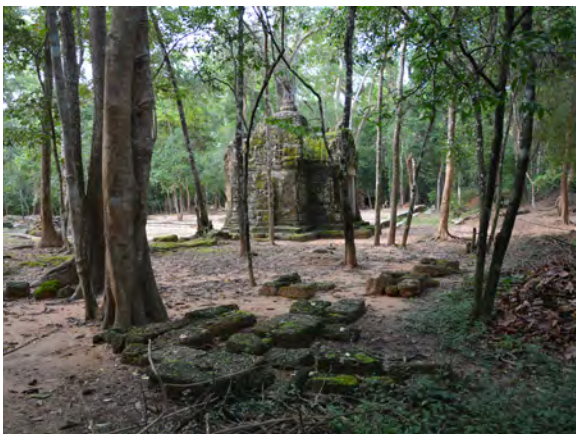
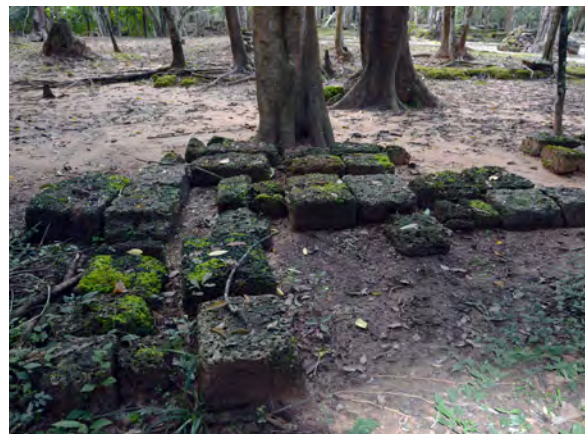
Figure 9.2.117 Original substrate laterite blocks below the floor sandstones that could not be reused during restoration

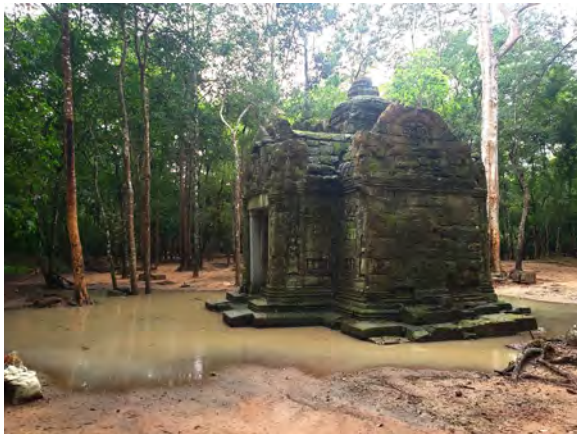
Figure 9.3.1 Water stagnation surrounding the East Gate (November 2021)
