Report on the Restoration of the East Gate,

Ta Nei Temple, Angkor, Cambodia

2019 - 2022

Tokyo National Research Institute for Cultural Properties (TOBUNKEN)

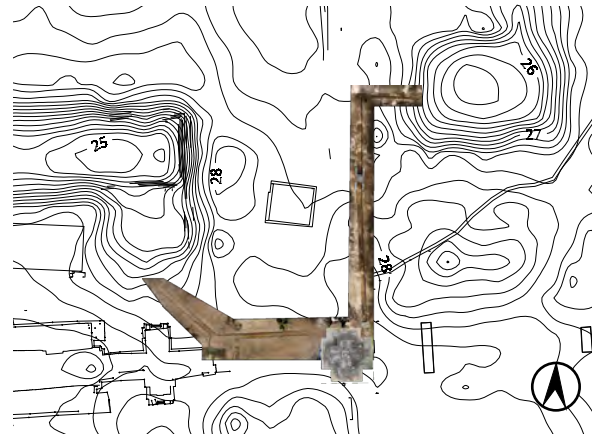
Figure 9.3.2 Location of drainage system

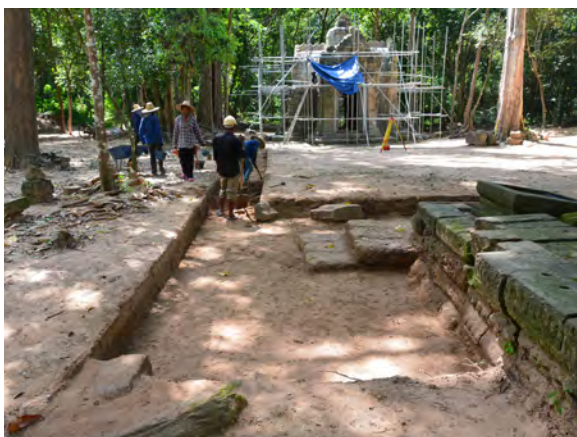
Figure 9.3.3 Digging the western drainage channel

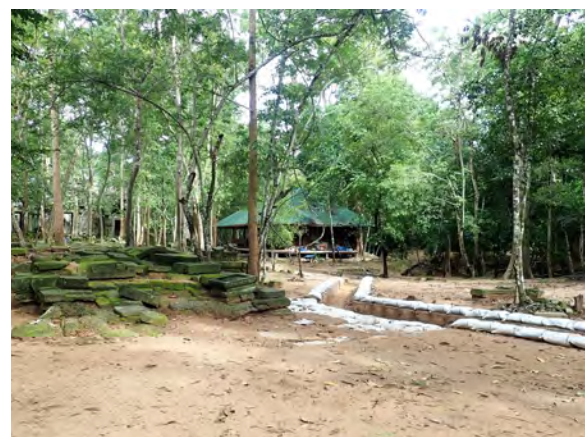
Figure 9.3.4 Eastern drainage channel extending to the northern Moat

With the addition of the eastern drainage channel, all water stagnation around the East Gate has now been improved, and the initial problem solved. In addition, after the survey in November 2022, the shoulders of the two drainage channels were cut out in consideration of the collapsing.

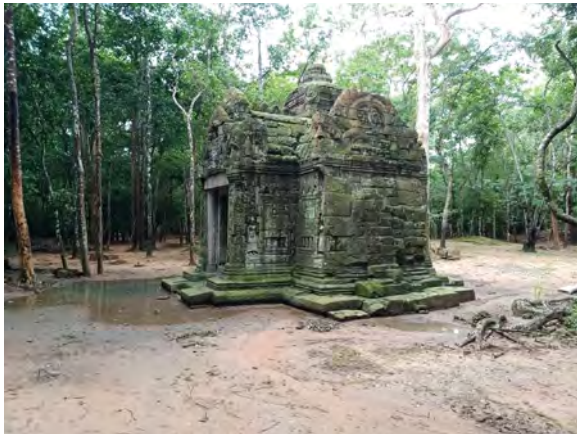
Figure 9.3.7 Unresolved water stagnation on the eastern side of the East Gate (August 2022)

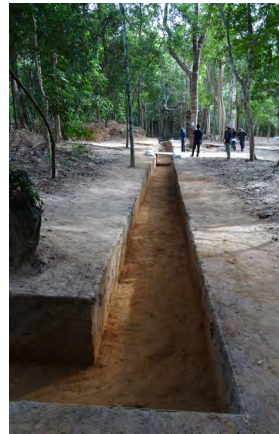
Figure 9.3.8 Eastern drainage channel from the East Gate to the corner (Left)

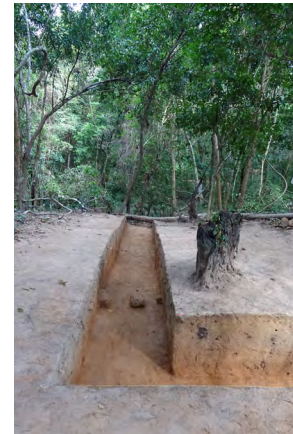
Figure 9.3.9 Eastern drainage channel from the corner to the pond (Right)

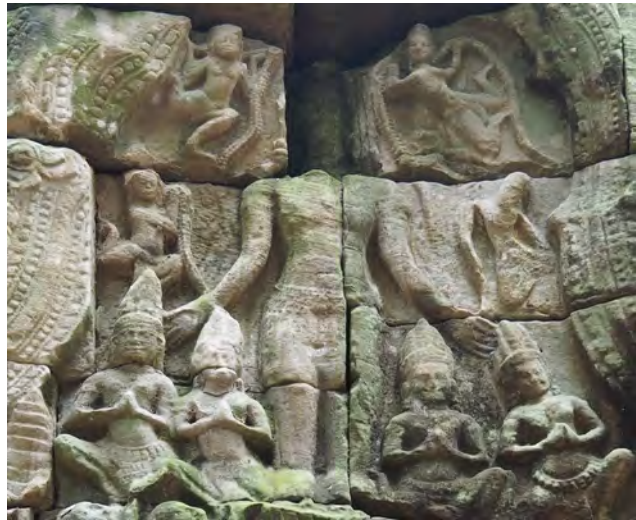
As mentioned above, upon observing the pediment on the east side of the East Gate of Ta Nei, the heads of the *Avalokiteśvara* reliefs have been destroyed, as if they had been cut off, and two out of the originally four arms have been chiselled off. Park Hyounggook mentioned that the heads and a pair of missing arms of these standing figures were lost due to the destruction of the Buddhist images.⁷

Figure 10.1.3
Bas-relief on the upper layer of the east pediment of the East Gate, the Outermost Enclosure, Ta Nei

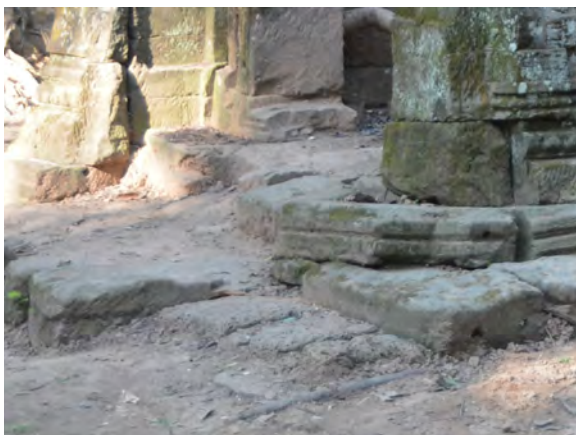
Excavations were conducted in a 10 m by 10 m area around the East Gate to detect scattered stone materials in 2018, in which no structural remains were newly detected except for the basement of the Outermost Enclosure connecting to both the north and south sides of the East Gate. However, a few heavily deteriorated laterite materials were found at the west side of the pre-restored East Gate base structure (Figure 11.1.1). They were not considered as materials from its original construction, but suggested that some remodelling could have been conducted using these materials afterwards. In the following year, 2019, a small excavation was conducted around the north-eastern external corner of the Eastern Cruciform Terrace, the entrance of the Central Building complex, located at the west side of the East Gate. This excavation confirmed that some extensions had been made at the front edge of the Terrace. The appearance of detected laterite ruins suggested a possibility of the existence of a causeway connecting between the East Gate and the Eastern Cruciform Terrace. As a causeway-like pavement made of laterite blocks can be recognised between the West Gate and the Western Cruciform Terrace at the east of the West Gate even now, it is also highly possible that a similar causeway existed at the west side of the East Gate (Figure 11.1.2).

Figure11.1.1 Laterite members of the East Gate base structure at the southwest corner

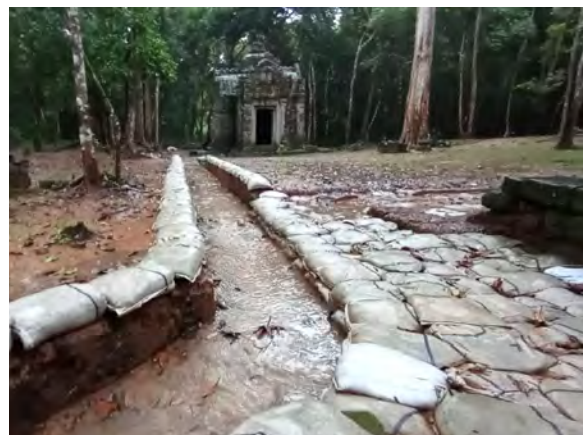
Figure11.1.4 Water drainage during the rainy season

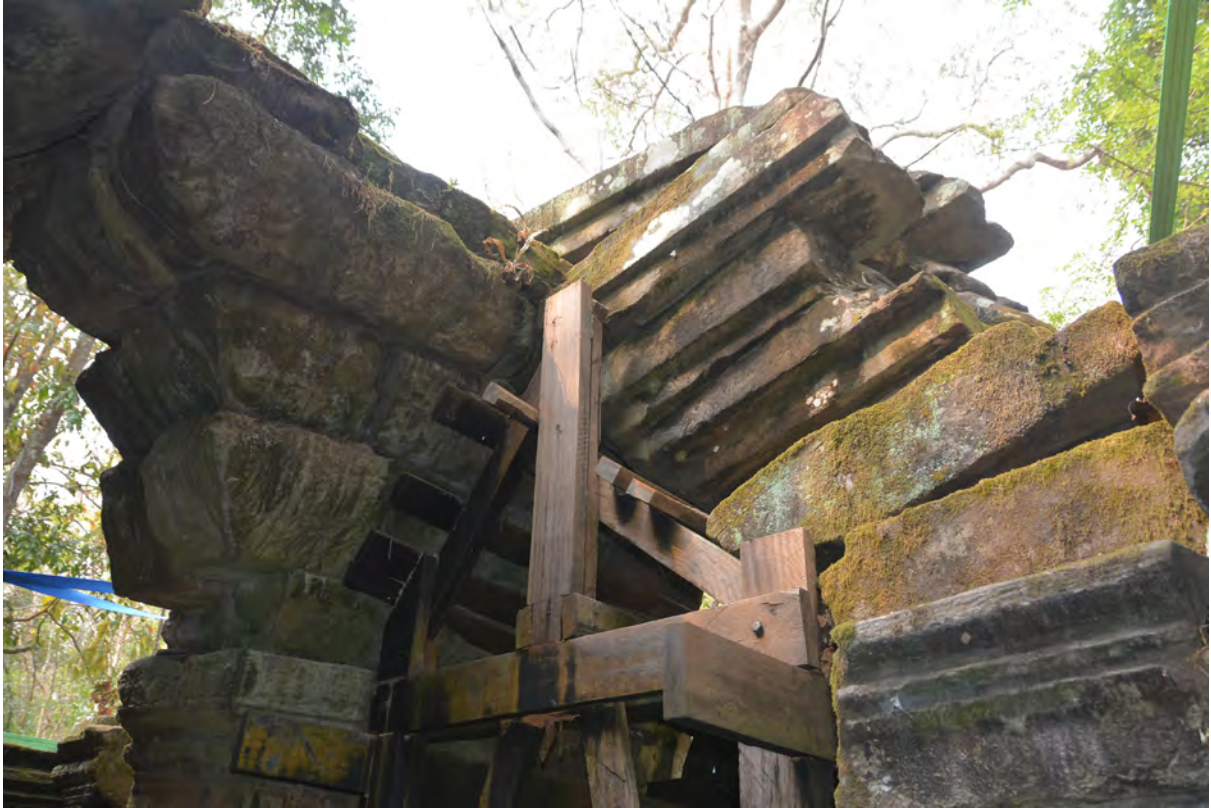
South ceiling before dismantlement in March, 2019

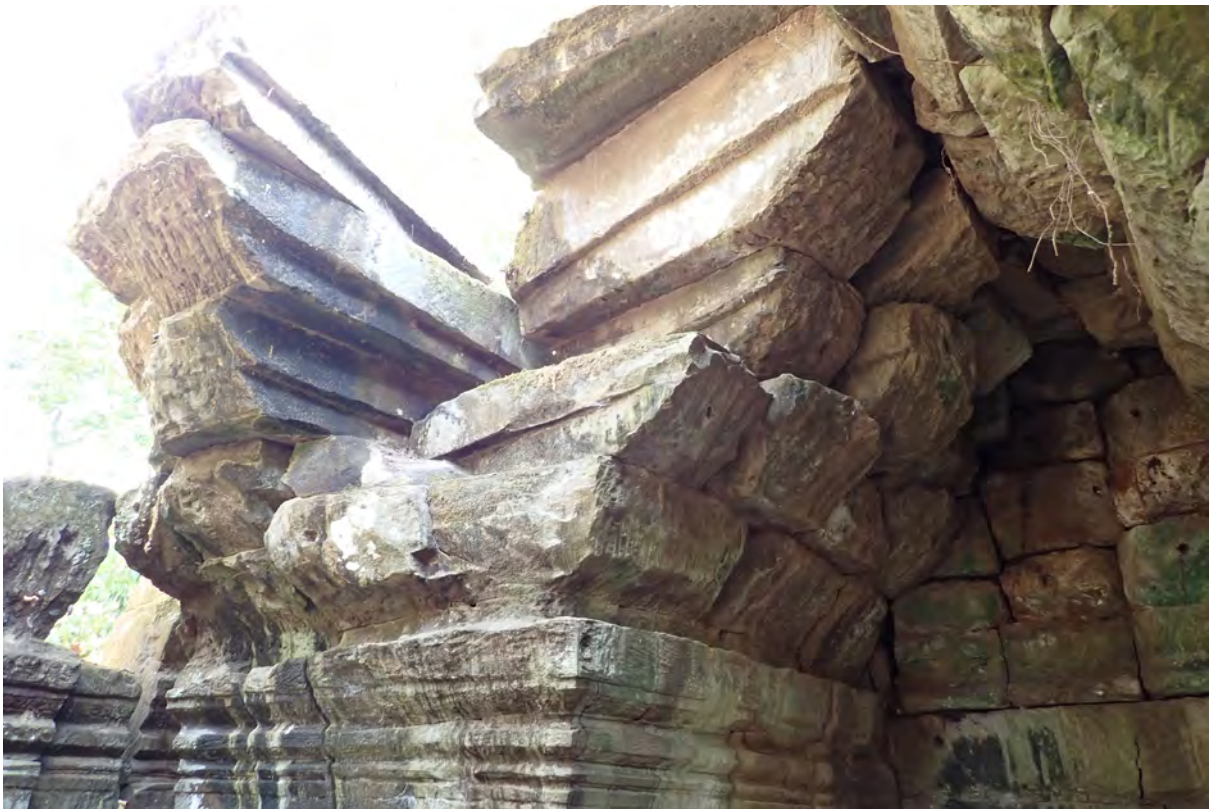
Northeast ceiling before dismantlement in January, 2019

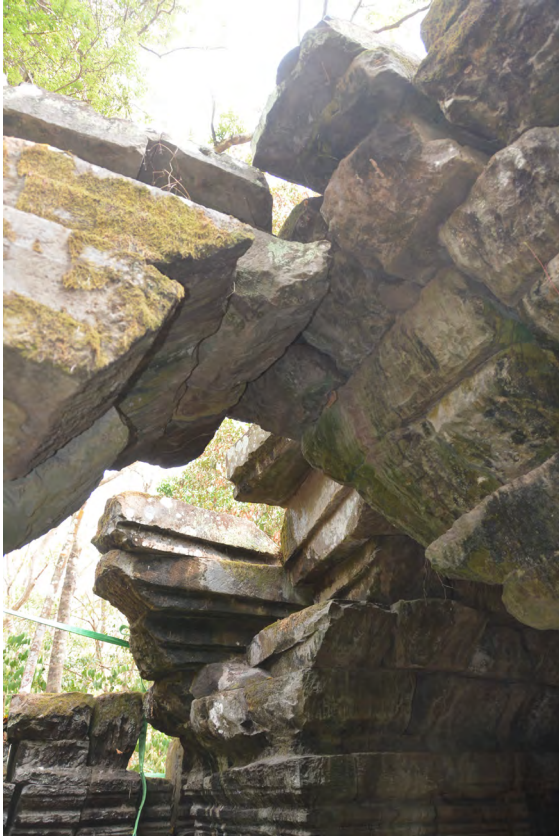
Cross Vault before dismantlement in March, 2019

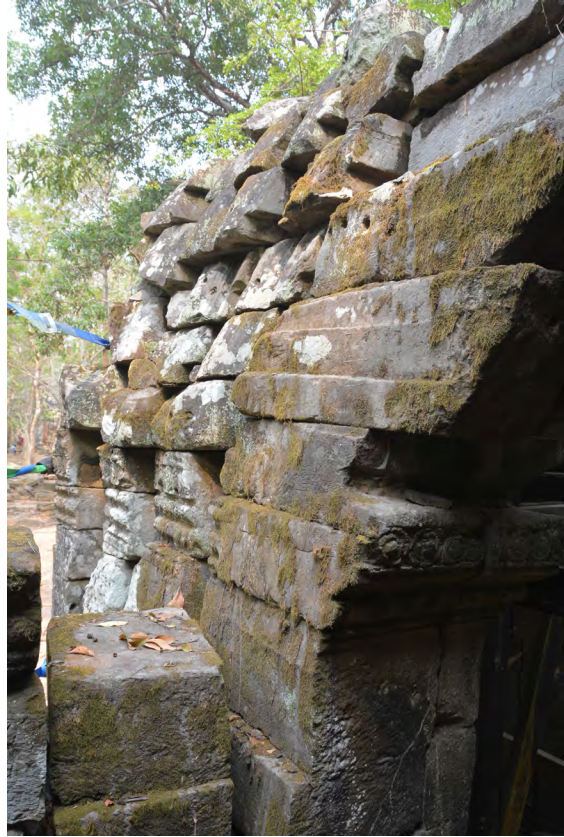
South side of the west wing's roof before dismantlement in March, 2019

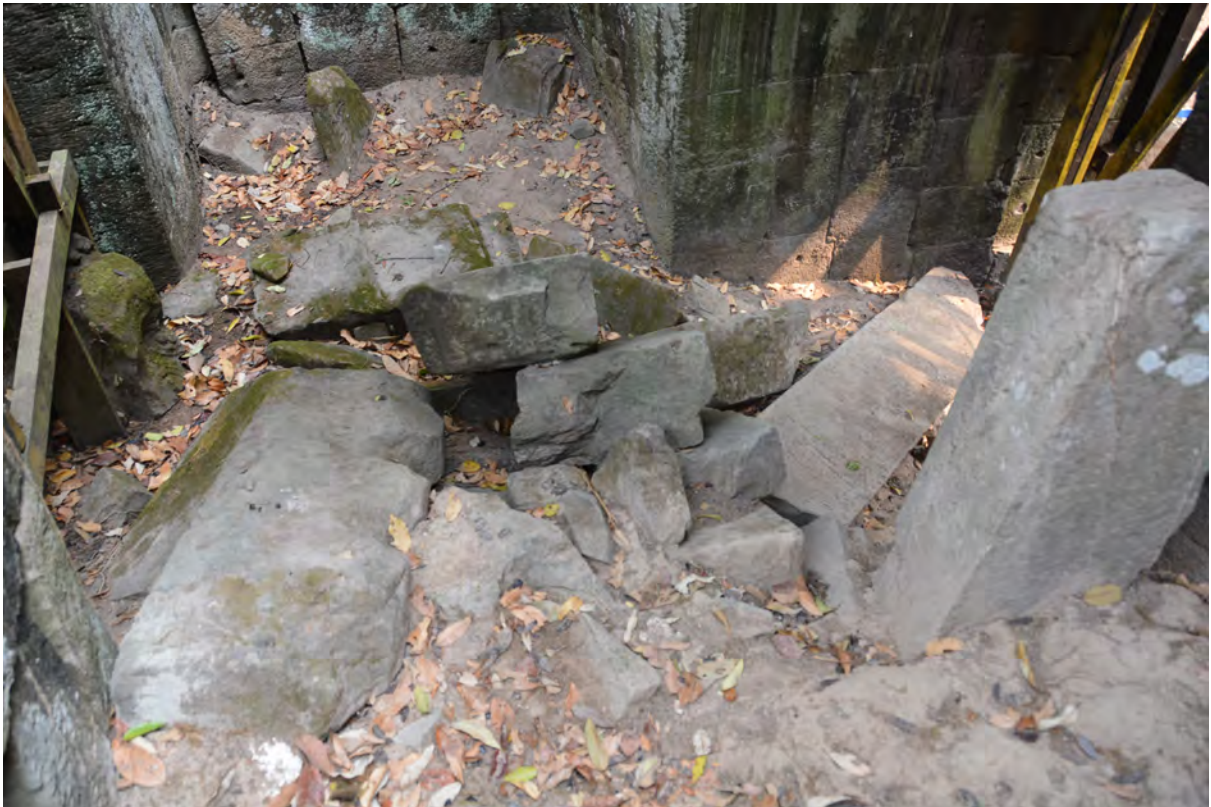
Collapsed stones inside the East Gate in March, 2019
