黒漆兜(雑賀鉢)

平成10・11年度
在外日本古美術保存修復協力事業

品名：黒漆兜(雑賀鉢) (江戸時代16～17c)
所蔵：メトロポリタン美術館 アメリカ合衆国
品質構造：鉄、漆塗
所蔵番号：28.60.3

請負者	田口 善明
修理担当者	田口 善明
原稿執筆	田口 善明

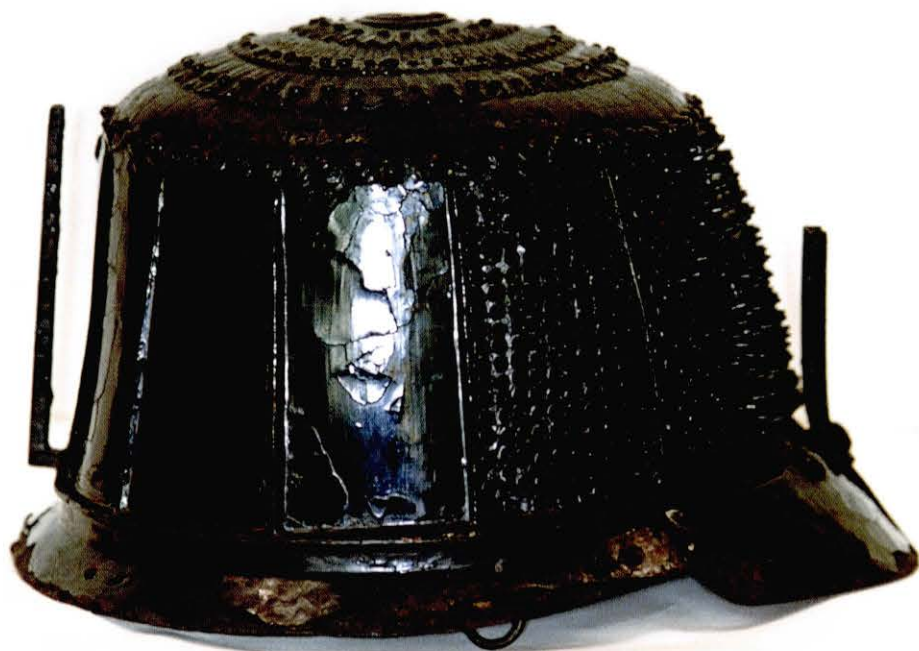
15 黒漆兜側面（修復後）
"Kuro-urushi Helmet" (side, after restoration)

17. After all the pieces had been returned to their positions, *sabi* foundation was applied to the edges (Fig. 200).
18. Restoration was completed (Figs. 15, 16 & 186).

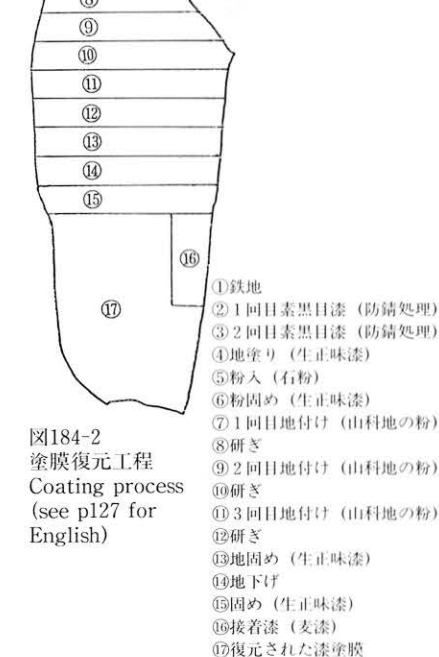
図184-2
塗膜復元工程
Coating process
(see pl27 for
English)

- ・周囲の漆塗膜との調和を図るため、同じ方法で漆塗膜を製作し、欠損部分に象眼して接着治具で押えた。

横10cm、縦15cm、厚1.5cmの石膏版に離型剤として、水で希釈した米糊を数度含浸させ、乾燥後、地漆を薄く付けて素黒目漆を3度塗り重ねる。その後、裏の石膏面から水を浸透させ、離型剤の糊を溶かして漆塗膜を剥離して、欠損部分の形に切り取り、象眼を行った。

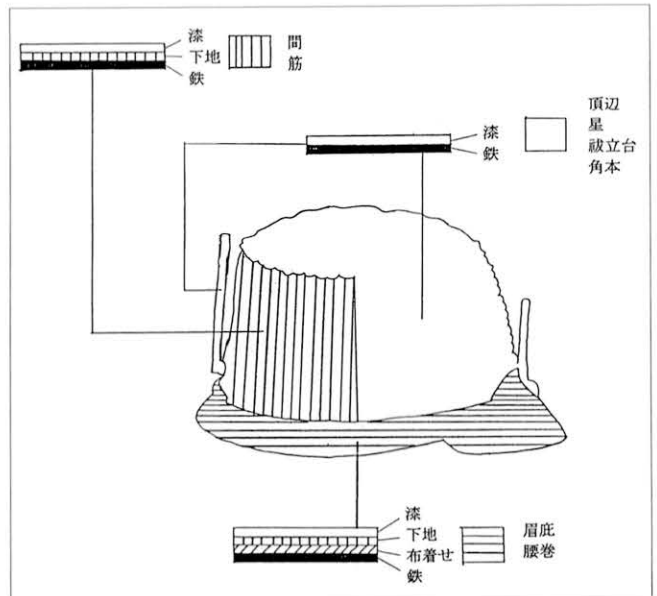
前方部分、5間の小星、頂辺、祓立台、角本には直接、鉄地に漆が数回薄く塗りかさねているので密閉性が良く、鉄錆が出にくかったのではないかと推測する。また、後方部分の7間は、漆に土を混合した地を付けた後、漆を塗っており、直接漆を付けた部分よりも漆に土を混

図185 塗装方法
兜（鉢）の部位により塗装方法が異なる
Method of coating
(coating method differs by parts)

入した分、衝撃に脆く密閉性に欠け、湿気を含み、徐々に鉄錆が侵食したと思われる。

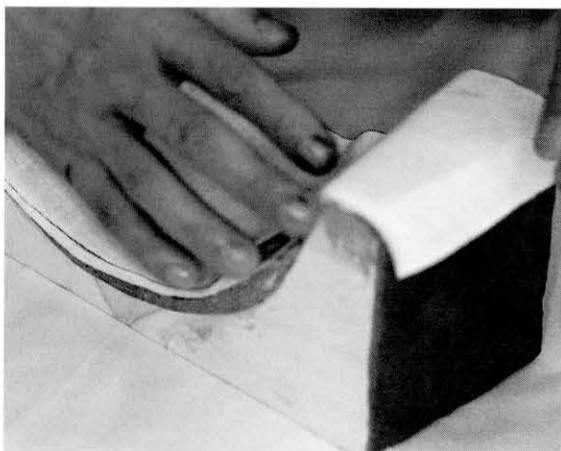
図188 修理作業台の製作
Making a mold for the receptacle

- 1、事前調査、写真撮影と記録 (図186、187)
- 2、修理作業台及び接着工具の製作 (図188、189)
 - ・修理台の設計、発注をした。
 - ・木粉と樹脂の混合物で兜の外側左右、内側の型を取り、受け台の製作を行った。
 - ・接着道具類の製作を行った。
- 3、クリーニング (図190)
 - ・表面に付着している埃を毛棒で払い落としした後、綿棒または先端を尖らせた竹の棒に木綿の布を包み、僅かに湿気を加えた布、またはエタノール溶液を含ませた布で古色を損なわないように表面の汚れを拭き取った。
- 4、漆塗膜の移動 (図191・192)
 - ・後方7間の筋部分に浮き上がった漆塗膜の罅と欠失した漆塗膜の原寸図を起した後、浮き上がった漆塗膜に薄く研ぎ込んだプラスチックの篋を差し込み、おこし上げながら慎重に剥がし取り、塗膜を図面の所定の位置に仮止めし、保管をした。この塗膜の剝離作業中、刎板接合部分の鉾が数箇所欠失し、鉾穴に漆下地が詰まっていることを確認し、過去に塗り直しが行われていたことを推測した。
- 5、地金と漆塗膜裏の錆の除去 (図193)
 - ・筋部分の浮き上がった塗膜を剥がし取った後、鉄地表面に露出した錆をリューターで慎重に除去し、残留した微粉末の錆を綿棒で丹念に拭き上げた。

1. We took photographs and recorded the condition of the helmet before restoration (Figs. 186 & 187).
2. We made a receptacle to hold and support the object during restoration. This was the most important preparatory step. After taking a pattern of the shape of the helmet, we traced it on plywood board and cut it out with a saw. Then we placed styrol foam between the boards to give thickness (Fig. 188).

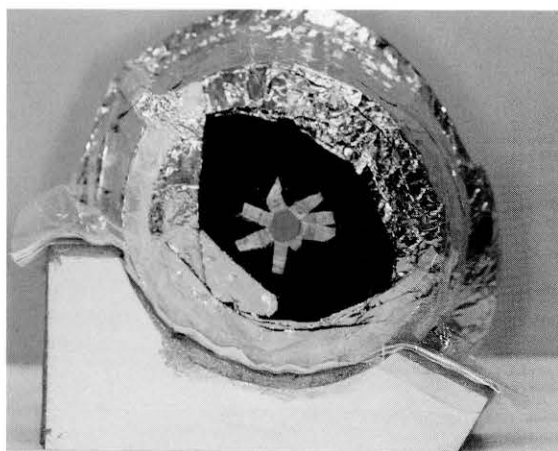
図189 接着工具の製作
Tool for restoration

Following the completion of the framework of the receptacle, we applied a filler, which was a mixture of sawdust and synthetic resin, evenly to the object-holding face of the stand and covered it with a Saran wrap sheet. We placed the helmet which was covered for protection with a 0.01mm-thick tin foil. To increase the accuracy of the mold, we applied a thin layer of synthetic resin on the object-holding face of the receptacle and placed two or three pieces of cotton cloth. Then we put the helmet and removed it after the resin had dried. Thus the receptacle was completed (Fig. 189).
