# 弁財天図

平成11年度修復事業

品名：絹本著色、弁財天図、南北朝、1幅  
所蔵：大英博物館  
所蔵番号：ADD-28

修復施工：岡墨光堂  
工期：平成11年5月～平成12年3月

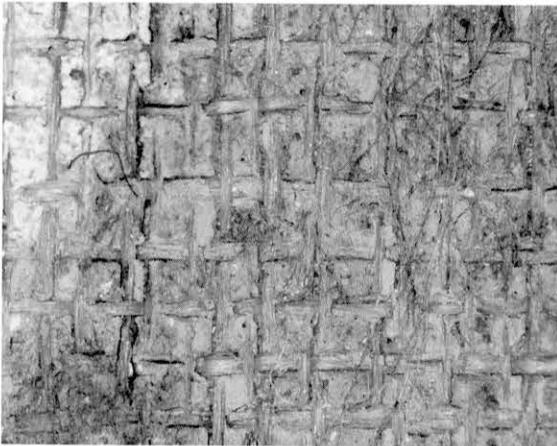
図362 宝冠飾り部分の裏彩色 (顕微鏡写真)  
verso painting on the reverse side of the silk

本紙の裏彩色が認められたので写真記録をした。(図363、364)

Verso painting was observed by microscopically from the recto. (photo-363, 364)

裏彩色の残存が確認されたので、旧肌裏打ち紙の除去は最小限の水を使用して行った。  
(乾式法)

画面を数層の紙で養生し、乾燥させた後、肌裏紙に小面積づつ少量の水を与えて、織紙をむしり取るようにして、紙を徐々に薄くして行き、本紙料絹の裏に施された裏彩色を動かさないよう作業する。(図356)
