## 花鳥螺鈿食籠

山下好彦

品名：花鳥螺鈿食籠  
 所蔵：ベルリン東洋美術館 ドイツ  
 品質構造：木製、乾漆製、黒漆塗り、螺鈿、  
 所蔵番号：ID.25922-a

Report on the Restoration of “*Kacho Raden Jikiro*”  
in the Collection of the Museum of East Asian Art, Berlin

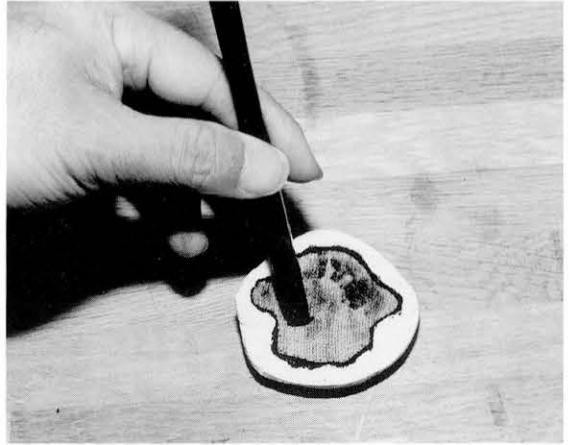
図91 乾漆による欠損刳足部分の製作  
Making the missing part of the *kuriashi* with *kanshitsu*

- ⑦ 6本の刳足のうち4本が破損、欠失し、自立出来ない状態だった。また、刳足内側の木地が一部欠失していた。
- ⑧ 身の合口部分、立ち上がりの一部が2箇所欠損し、木地が露出していた。
- ⑨ 高台の一部が大きく崩れ、非常に危険な状態にあった。
- ⑩ 各所に打損や擦り傷が認められた。
- ⑪ 各所に後世修理がすでに施されていた。刳足の一部に合成樹脂による接着跡があった。螺鈿は広い面積が合成樹脂によって再接着され、周囲を下地で埋めていた。また、塗膜剥落部分に朱漆、透漆が塗り込まれていた。
- ⑫ 身立ち上がりの木地が露出した部分に朱色の補彩があった。
- ⑬ 一部に西洋塗料や朱漆の付着がみられた。

- ・足の本型を作り、割れた部分の断面の形を刻苧で正確に写し取った。
- ・本型を石膏の雌型に置き、石膏を流し、断面の形を型に写した。
- ・乾漆の離型材として、石膏に薄めた上新粉を数回塗り重ねた。
- ・石膏雌型表面に漆下地を2回行った。
- ・#100の麻布を型に合わせて切り、少量の地の粉を混入した麦漆で貼った。
- ・麻布の目を埋めるため、漆下地で目摺りをした。
- ・#40の麻布を前述と同様の方法で3枚貼り重ねた。そのつど目摺りを行った。
- ・60度で30時間、90度で7時間、電熱器で貼り重ねた型を十分乾燥させた。
- ・水に石膏型を浸し、石膏を割り、乾漆部分を取りだした。
- ・損傷した刳足部分にあて鑪で形状を修正した。断面や修正部分に漆下地を行い整えた。
- ・外側に数回漆塗りを繰り返し、表面を整えた。
- ・麦漆で高台の断面に復元した刳足を接着した。このとき、足の高さや角度を十分注意した。
- ・刳足の内側に残った檜の薄板に合わせて補材を作り、麦漆で接着した。
- ・補材の周囲を刻苧で充填した。
- ・刳足の内側中央に残った痕跡に合わせて竹の棒を作り、麦漆で接着した。
- ・刳足内側全体に刻苧を付け形状を作った。乾燥後、漆下地を行い表面を整えた。
- ・外側と同様に漆塗りを数回繰り返した後、非常に細い炭粉を蒔いた。
- ・炭粉の上は透漆で固めを行い、最後は希釈した透漆を極く薄く塗り込んで周囲と違和感のないように艶を合わせた。
- ・朱部分は色を合わせた乾漆粉を作り、篩いにかけて粉蒔きした。艶を合わせるため、透漆で固めし、摺漆を数回行った。

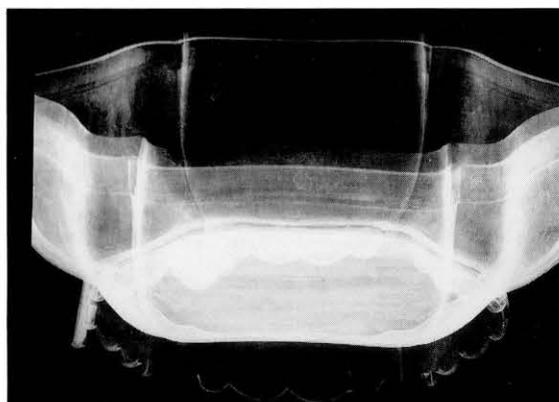
図101 X線透過写真  
X-ray radiography

X線透過写真をから、次のことが分かった。蓋甲板と身底板は、針葉樹の柾目板二枚を剥ぎあわせ、素地が狂わないように中央に垂直方向に同種の板を抜けないように差し込む。側板は六弁各面ごとに乾漆で作り、六枚を寄せて接着する。蓋身とも口縁部は柾目針葉樹の曲物作りで、内外両側から薄い板を寄せ、木釘で止める。高台と刳足は乾漆造り、刳足内側から三本の薄板で補強する。

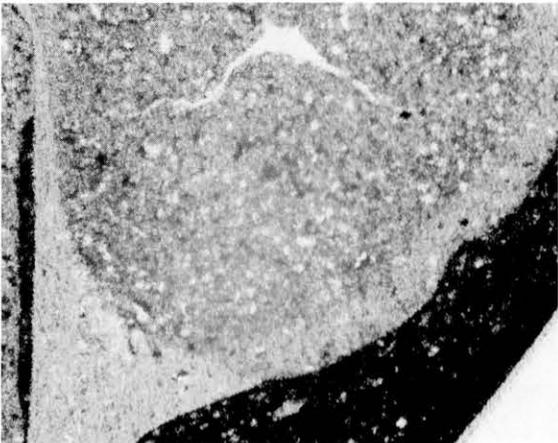
図106 身高台玉縁のクロスセクション  
Cross section of the edge of the *kodai*

剥落片を対象にエポキシ系の樹脂で封入し、耐水ペーパーで薄くした後、光学顕微鏡で下地構造を観察した。漆塗膜は2層で、黒色の顔料を混入した漆で下塗りし、透き漆で上塗りしている。下地は漆下地で、濃茶色の荒い下地を3層、濃い灰色の細かい下地を1層施す。高台の玉縁部分は、茶色の下地を型で引き、こい灰色の荒い下地と細かい下地を2層付けて表面を整えている。刻苧は木粉と漆、さらに少量の下地を混入したものと判明した。
