# 清水宇治図屏風

平成14年度修復事業

品名：清水宇治図屏風 6曲1双  
所蔵：ベルン歴史博物館

## 修理報告

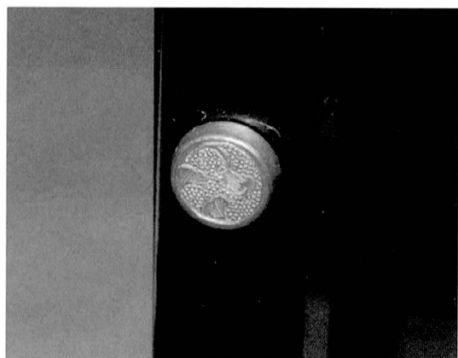
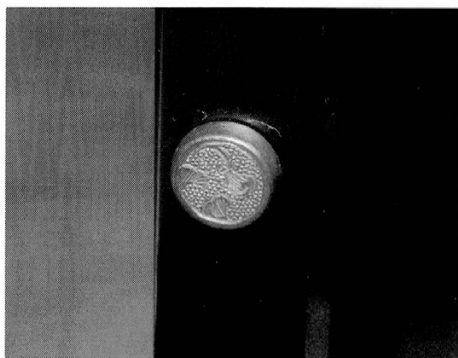
108 左隻 飾鉾の復元 復元新調分  
Left side screen Restoration of the decorative nails  
Restored new nails

3. 各扇とも無地場ではほぼ全面に、波打ち際では部分的に砂子が蒔かれている。当初は一部に切箔が施されている程度だったと思われるが、いずれかの時期に無地場全面に砂子が蒔かれたと思われる。(図99、100、101)
4. 画面同士の擦れ、あるいは人為的な擦れが随所に認められた。下地の変形によると思われる箇所がある。(図102)
5. 絵具層の膠着力が低下していると思われ、剥落箇所も随所にある。(図103)
6. 絵具層の一部に当初のものとは思われない光沢のある箇所が認められた。過去の修理時に行われた剥落止め処置の結果と考えられる。
7. 画面全体に汚れた雰囲気があるが、自然なものか人為的なものかは不明である。また、水濡れによると思われるシミや絵具のようなものの飛沫の付着等が見られた。
8. 蝶番の断裂によって右隻の第1扇、左隻の第6扇は完全に分離していた。光沢のある硬い接着剤、リネンテープや鋏などによる補修が施された箇所もあり、折り畳めるといふ蝶番本来の機能が損なわれていた箇所もあった。(図104～107)
9. 左扇左の散鋏1つが欠失していた。(図108、109)

1. 現在の装丁を解体し、裏打紙は除去する。
2. 絵具層は膠着力が低下しているので、膠水溶液にて剥落止めを施す。
3. 補紙の重なりは必要最小限まで削り取り、亀裂部分には裏面から楮紙の帯を貼り付ける等の処置を行う。
4. 新しく楮紙の肌裏紙を小麦澱粉糊にて打ち直す。さらに2回目の裏打ちも施して十分な乾燥を行う。
5. 下地及び緑裂、裏貼紙(唐紙)、襲木は再使用に耐えないと判断し新調する。新調に際しては現状の寸法を基本とする。裂に関しては見本を所有者に送付して確認を取る。飾金具は欠失した散鋏のみを復

元新調し、他は調整して再使用する。

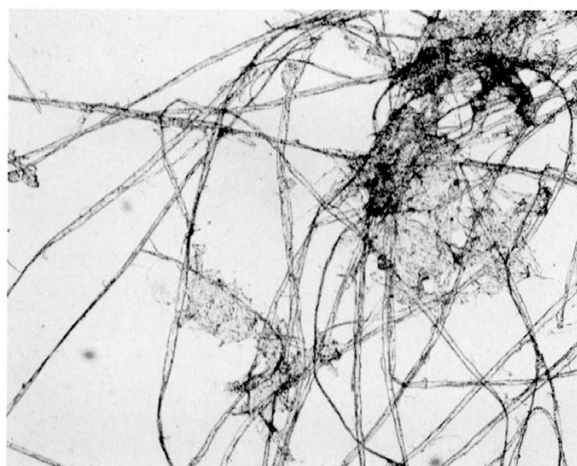
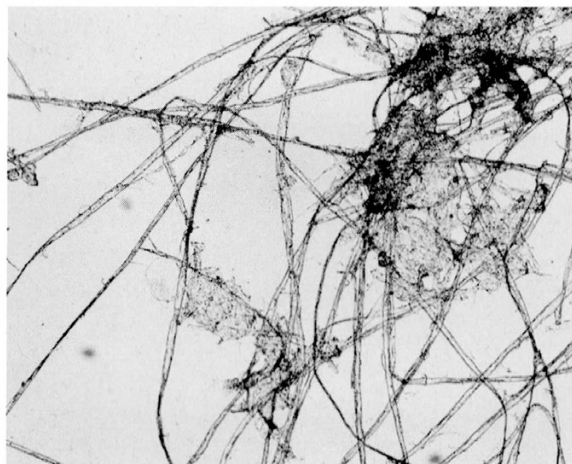
111-2 同  
As above

1. 名称 『清水宇治図屏風』
2. 所有者 ベルン歴史博物館（スイス）
3. 品質・形状 紙本金地著色 屏風装（6曲1双）
4. 本紙紙質 米糊入り雁皮 高知県紙産業技術センター調べ（図111）
5. 制作年代 17世紀前半

111-1 繊維組成の顕微鏡写真  
雁皮の繊維。米糊を配合しているため、染色すると青い点々が観察される。  
Microscopic photographs of the fiber contents  
Fibers of *gampi*. As it contains rice glue, *gampi* appears with blue  
dots after being dyed.

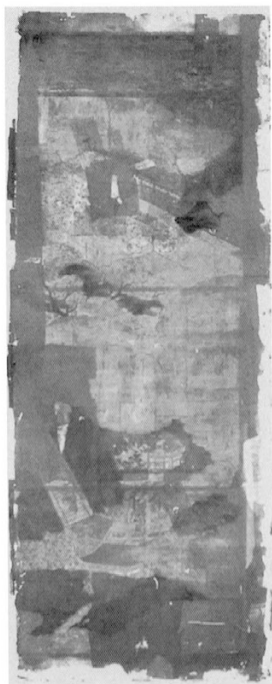
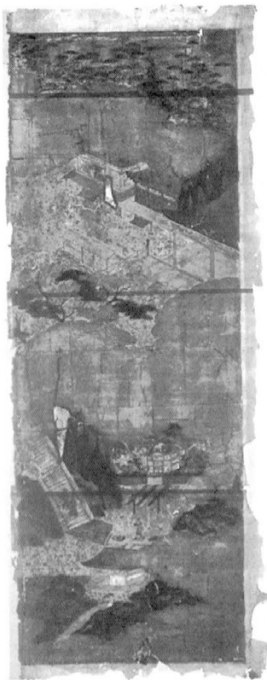
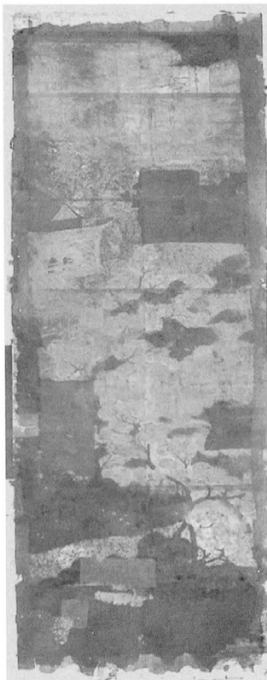
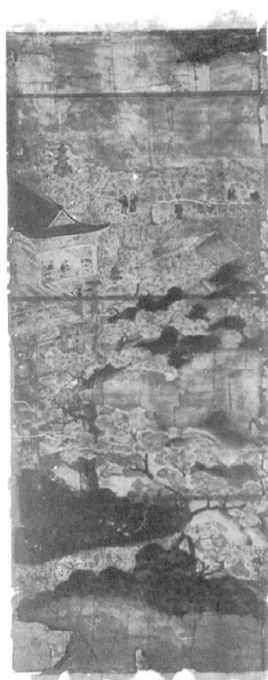
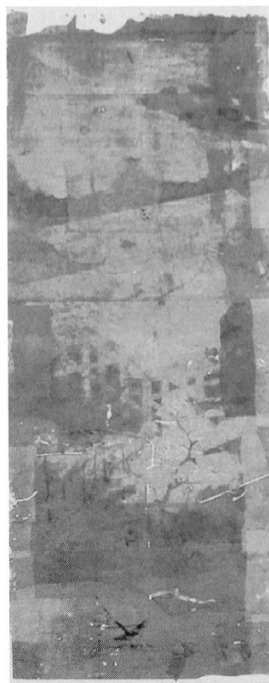
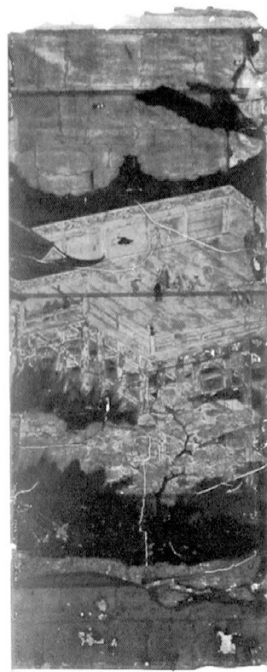
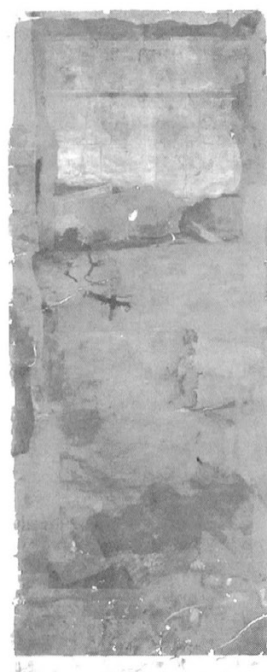
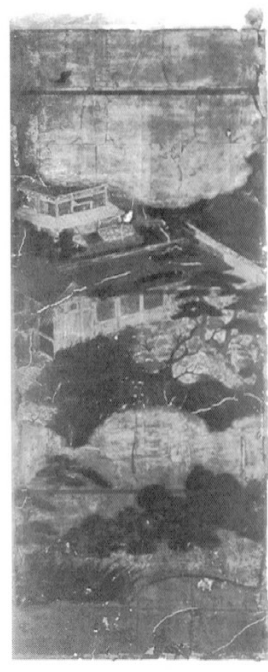
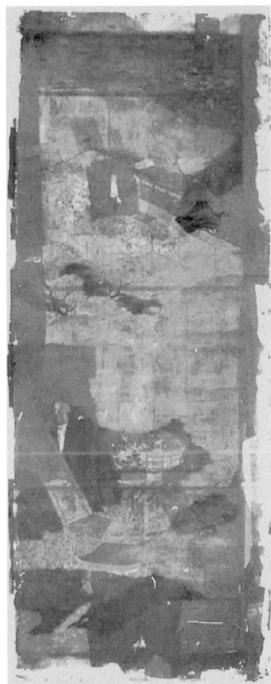
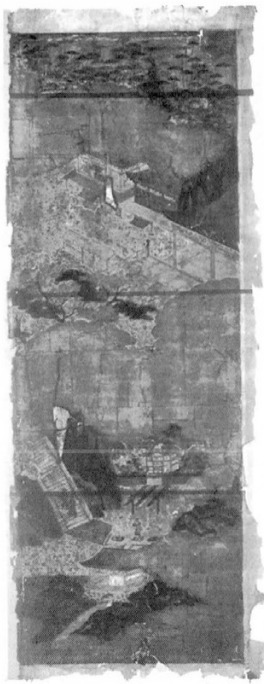
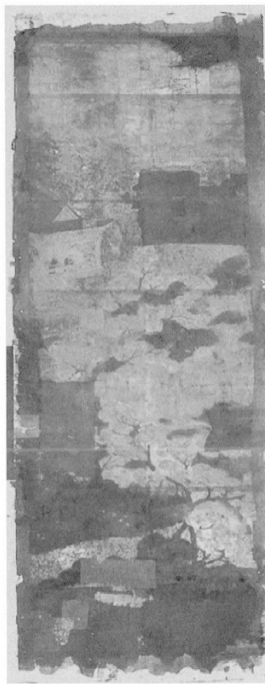
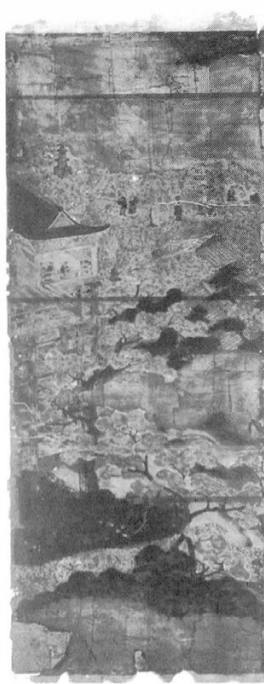
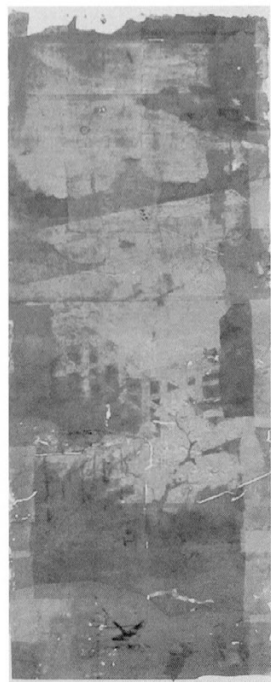
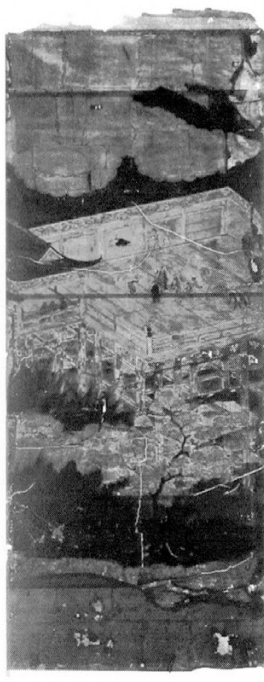
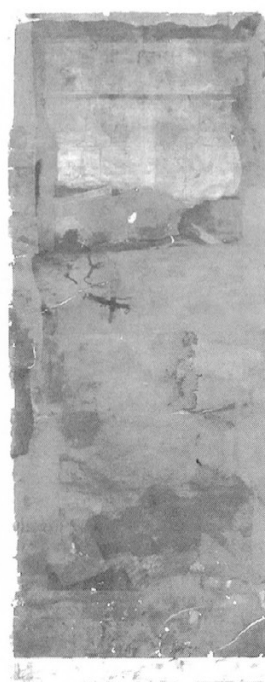
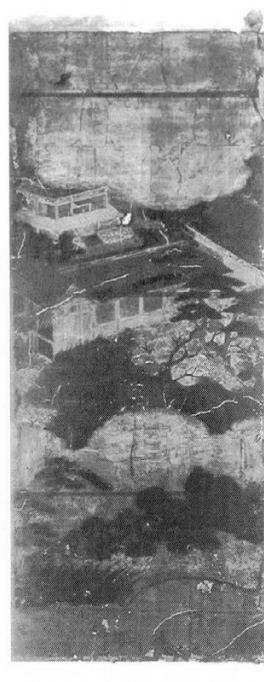
## 112 透過光による写真記録

1. 旧修理時における裏打ちを除去した段階で透過光による写真撮影を行った。旧修理時以前の裏打ち紙が残されている部分、必要以上に大きく充てられた補紙の様子がよくわかる。(112a,c,e,g,i,k,113a,c,e,g,i,k)
2. 旧裏打紙、不必要な旧補紙の重なり部分を除去し、欠失部に新たに補紙を施した段階で再び透過光による写真撮影を行った。(112b,d,f,h,j,l,113b,d,f,h,j,l)

本紙料紙を調査し、本紙と同質の雁皮紙を用い、裏面より欠失箇所に補紙を施した。また旧補紙の重なり部分を必要充分なだけ残し、削りとった。

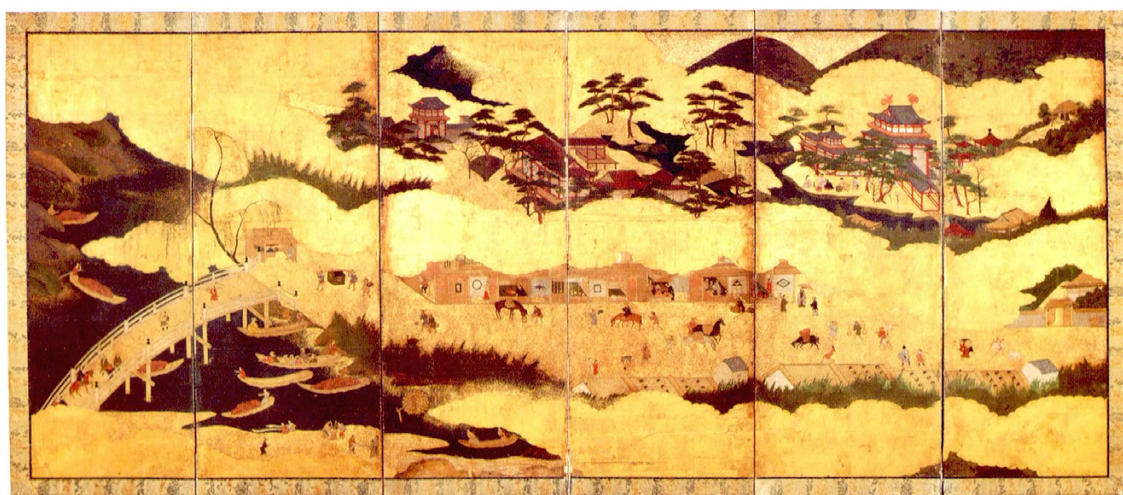
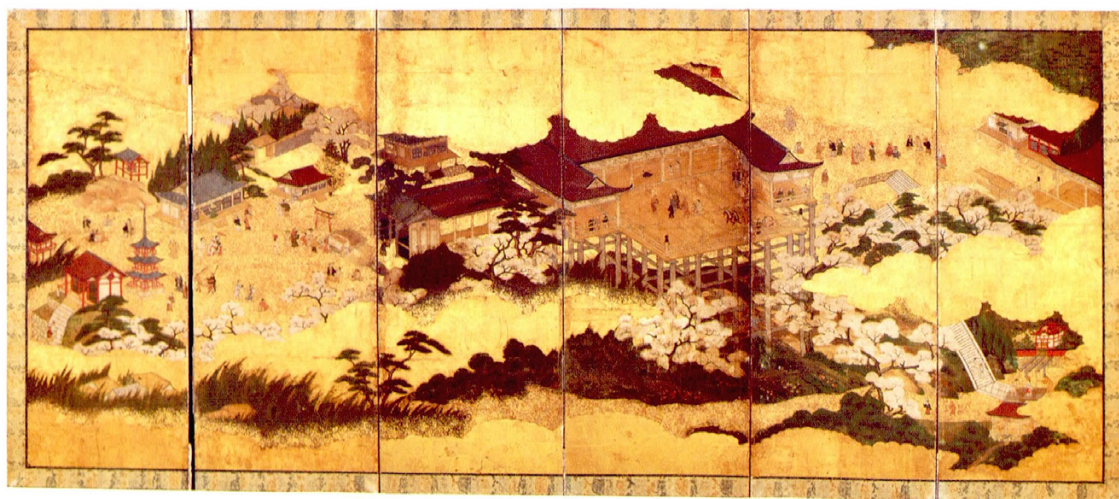
17 清水宇治図屏風 修理前 (ヘルン歴史博物館)  
 Scenes of Kiyomizu and Uji <Before treatment> (Bernisches Historisches Museum)

全体に劣化、損傷が進んでいる。奥尾背付近の擦れや断裂など屏風装に特有な損傷も多く見受けられるが、右隻、左隻共に中の2扇の損傷が激しく、焼けや汚れも著しい。既に過去の修理で処置された箇所も多いが、必ずしも適切な処置とは言えず、却って損傷を与えている箇所さえある。また、損傷に対する処置だけではなく、補筆や砂子による加飾等、視覚上の処置もかなり行われている。
