伝狩野山楽筆 四季耕作図屏風（田植え・灌水）

修理報告

Scenes of Rice Cultivation: Spring and Summer attributed to Kano Sanraku

Treatment report

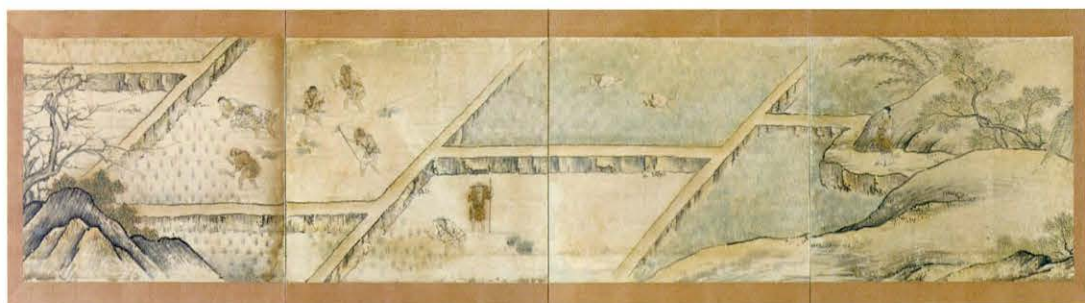
3 伝狩野山楽筆四季耕作図屏風 (田植え・灌水) 修理前 (ミネアポリス美術館)

Scenes of Rice Cultivation: Spring and Summer attributed to Kano Sanraku <Before Treatment>
(The Minneapolis Institute of Arts)

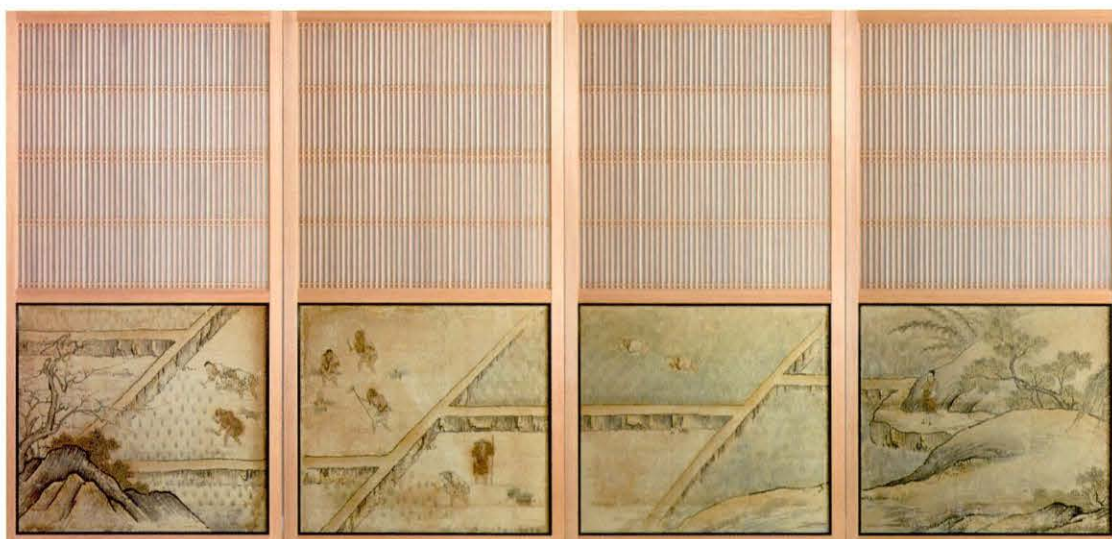
4 伝狩野山楽筆四季耕作図障子 (田植え・灌水) 修理後 (ミネアポリス美術館)

<After Treatment>
